TECHNICAL REPORT GL-89-10

IN SITU SEISMIC INVESTIGATION OF FOLSOM DAM AND RESERVOIR PROJECT

September 1989

Final Report

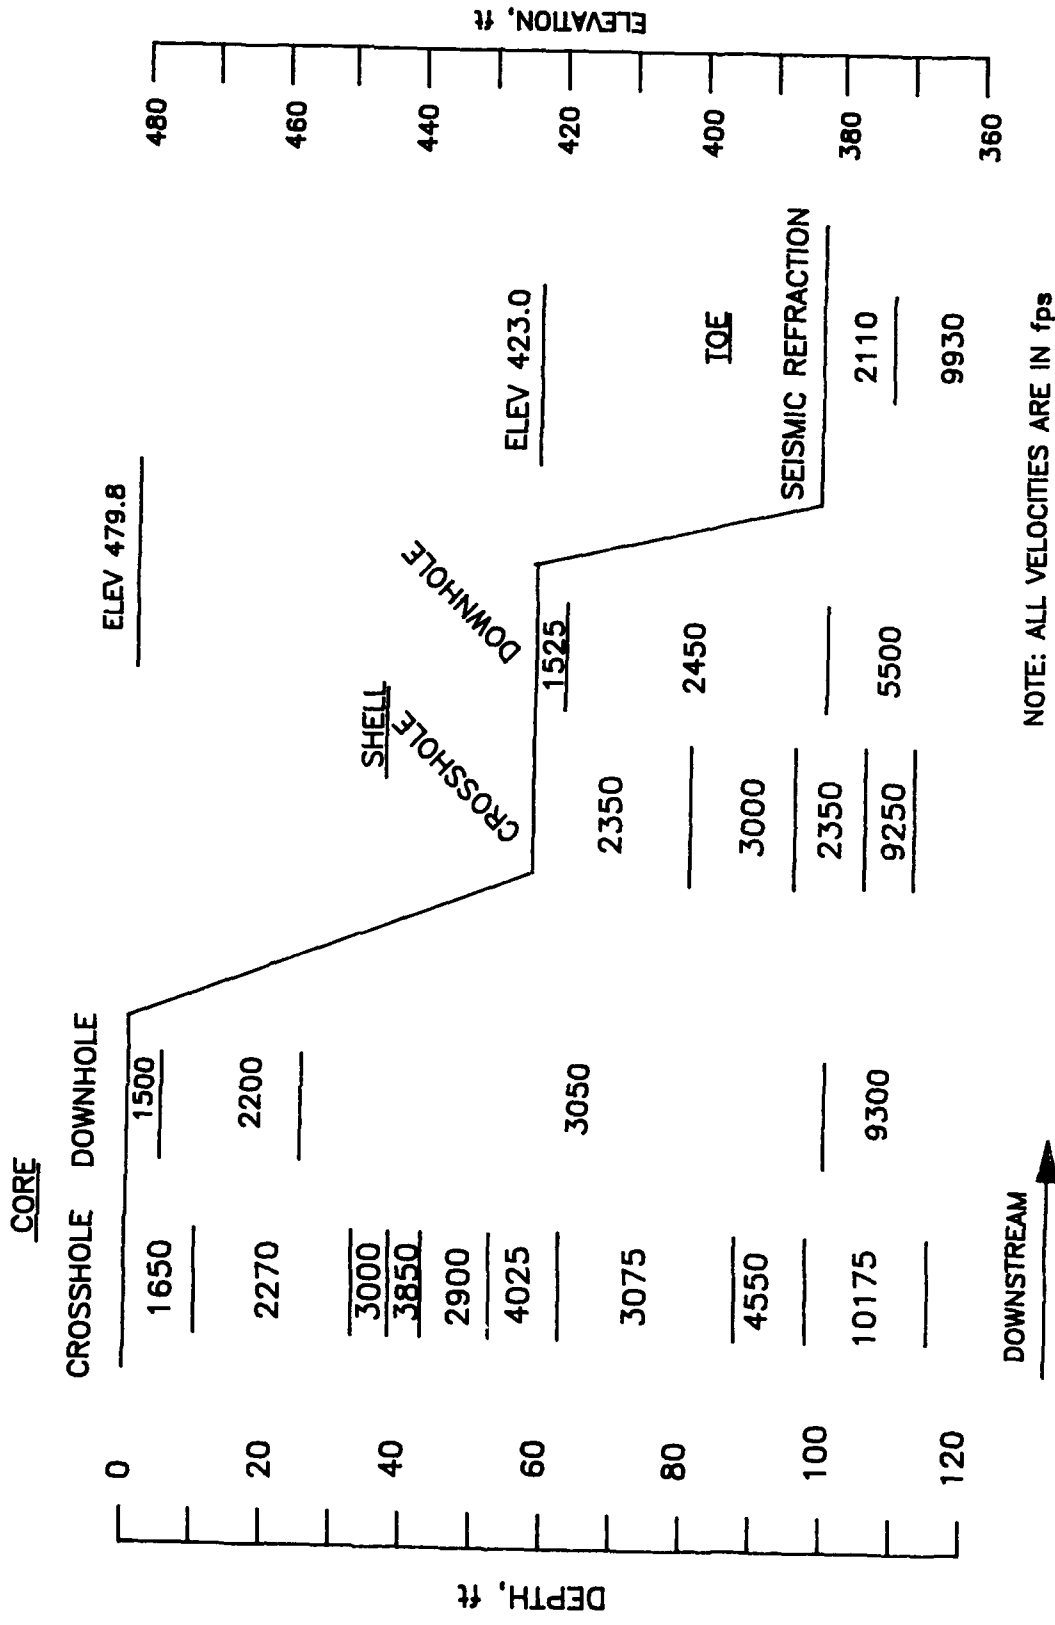
Figure 21. S-wave composite for cross section through approximate Station 180+50 - Dike 5

37. As depicted in the S-wave composite (Figure 21) tests were conducted in the core, shell, and foundation of the dike. Results from crosshole and downhole tests are presented for the core, shell, and foundation materials beneath the dike. Also shown are results from surface vibratory tests for the core materials. Velocities and depths to interfaces differ somewhat because of differences inherent with these test techniques.
