**THE FRAGMENT CONTAINMENT CHARACTERISTICS OF  
EXPLOSIVES BUILDINGS AND OTHER FORMS OF FRAGMENT  
PROTECTION FOR HD 1.1 AND HD 1.2 CHARGES UP TO  
2.5 kg TNT EQUIVALENT**

**PROGRAM AND MANAGEMENT SUPPORT  
WEAPONS SYSTEMS RESEARCH LABORATORY**

TECHNICAL REPORT  
WSRL-TR-01/89

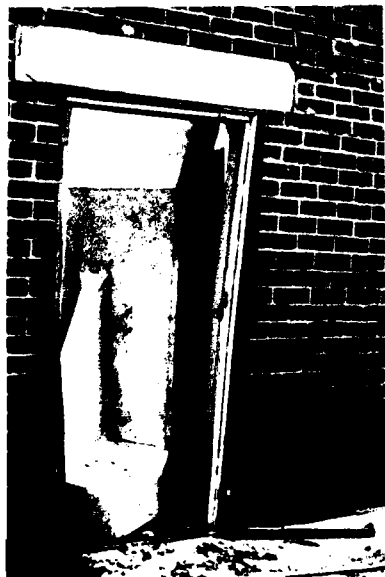
Figure 9. Results of 2.5 kg bare charge detonation

The detonation of the 2.5 kg bare charge was accompanied by an impulse sound and fire ball, as observed on the TV monitor, considerably greater than that of the shell. A door was seen flying off the building, which on closer examination was due to the projection of an unsecured cement block, located to protect the door opening.

Although the inner surface of the wall had been scorched by the fire ball and the outer walls bowed under the pressure, no spalling or scabbing of bricks from the outer wall or the outside of the inner wall were recorded. These results are illustrated in the photographs comprising figure 9.
