REPAIR, EVALUATION, MAINTENANCE, AND  
REHABILITATION RESEARCH PROGRAM

TECHNICAL REPORT REMR-CS-26

ANALYSIS OF A SHORT PULSE RADAR SURVEY  
OF REVETMENTS ALONG THE MISSISSIPPI RIVER

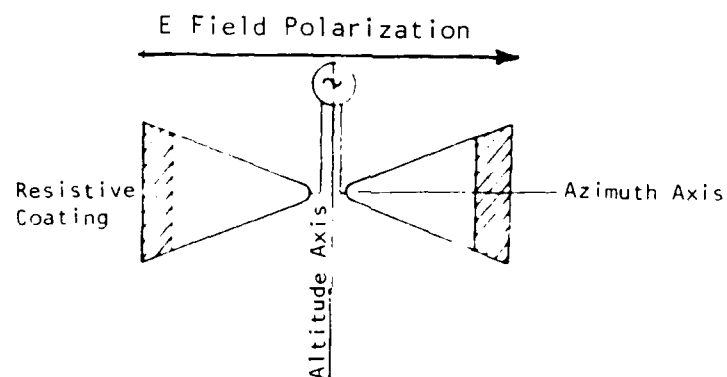
Figure 1. Schematic of a short pulse radar antenna

8. A schematic of the antenna design is shown in Figure 1, and a typical radiated wavelet is shown in Figure 2 (not from the antenna in Figure 1, but from similar designs). The wavelet consists of a very few oscillations that quickly attenuate, as opposed to conventional surveillance radar that produces bursts of a carrier frequency lasting for hundreds of oscillations. The time units of the wavelet are arbitrary but range from 1 to 10 nanoseconds. The short-burst nature of this wavelet gives it a very broad bandwidth. Antennas of this design are mainly characterized by the center frequency of their spectrum, or roughly, the frequency at which the peak of the power spectrum lies. This is found with good accuracy by simply inverting the period of the major oscillation. The author's personal experience with model 3207 is that in air the peak lies at approximately 280 MHz. When placed on ground

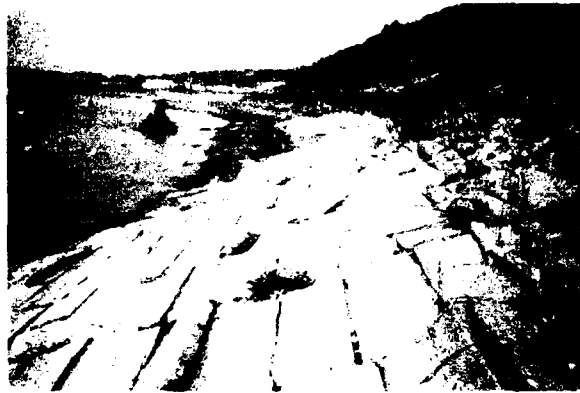
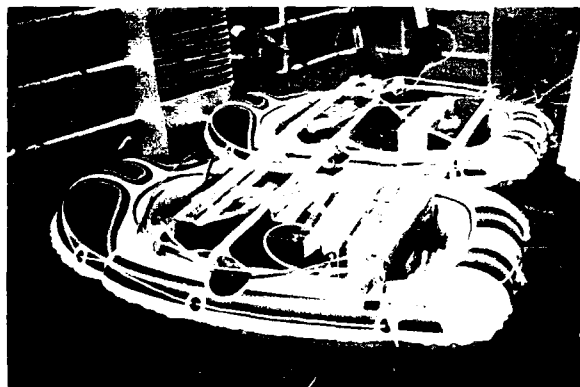
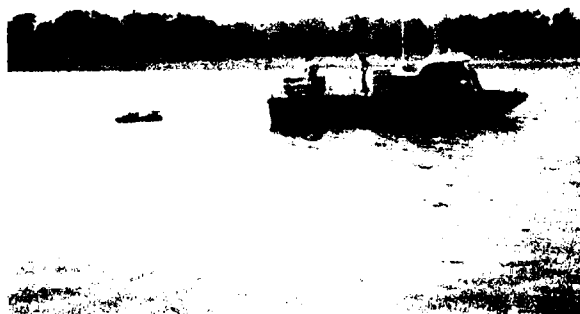
Figure 3. Three views of bistatic  
antenna configuration

9. Separate transmit and receive antennas are generally used because echoes can return from near-surface targets before the transmit antenna has stopped radiating. A photograph of the antenna configuration used in this survey is shown in Figure 3. Each antenna was placed in a small, recreational raft, and the separate units were braced together. The separation of the antennas is estimated at about 1.5 to 2.0 m. This separation will be seen later to cause severe reverberation problems between the antennas. The bracing of the two units have also caused reverberation if the system periodically lost water contact in the presence of waves or during the boat's acceleration. The antennas were polarized perpendicular to the direction of tow (or profiling), a fact that could have some consequence in light of arguments for or against transmission through the revetments.

a. Photograph of revetment  
along the shore

b. Transmit-receive (bistatic)  
antenna configuration

c. Position in the water

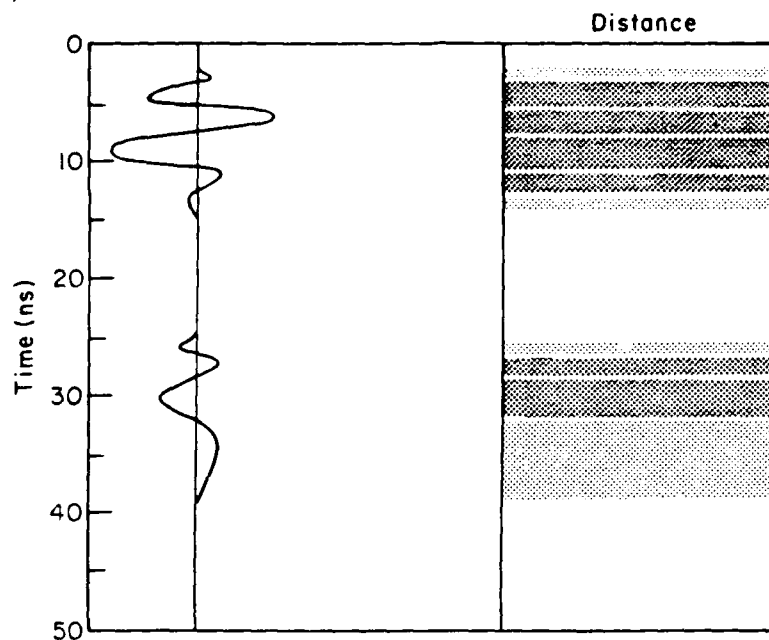
translation of a series of scans of hypothetical, identical events into the graphic representation is shown in Figure 4. This is a superior mode of display when signal returns are strong as the continuity of events or banding from a single reflector is easy to recognize. The identification of these bands indicates coherency (i.e. retention of the phase integrity of the incident wavelet) in the reflected wavelet.

Figure 4. Hypothetical scan consisting of two events and its equivalent graphic representation should these wavelets remain unchanged as the antennas move a short distance. Thin white lines in the graphic indicate zero amplitude; their continuity in a record indicates coherency in the radar returns

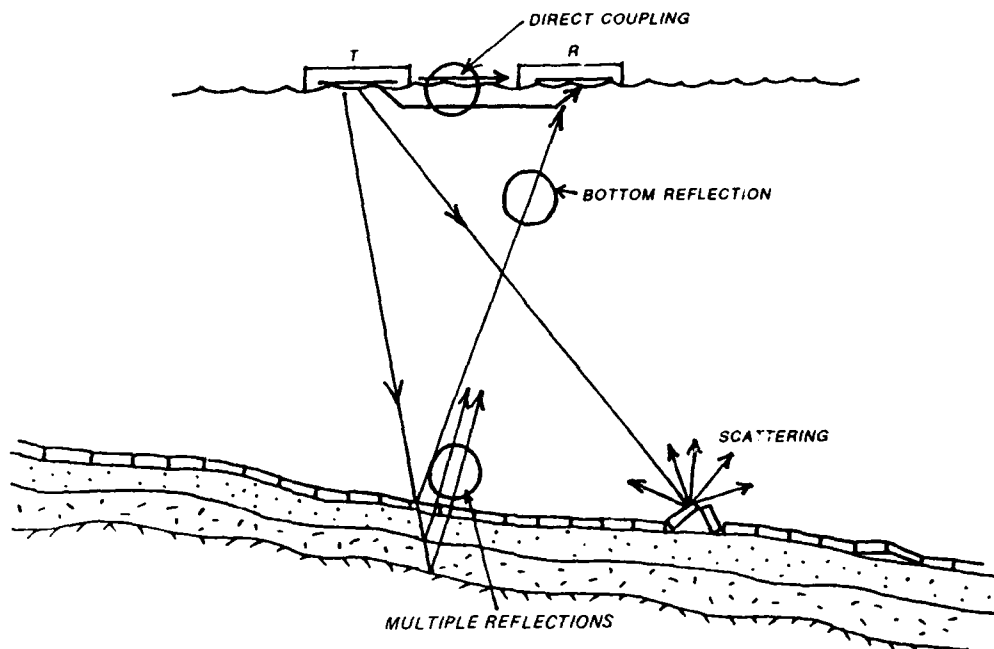
12. A schematic representation of the wave propagation events that occur in the surveying described here is given in Figure 5. The events are depicted by arrows as if they were solitary rays, but in fact they are complex electromagnetic fields expanding in three dimensions. The idealized wavelet of Figure 2 forms by about 1 to 2 m beneath the transmit antenna.

13. The two events labeled direct coupling in Figure 5 are transmissions passing directly from transmit to receive antenna, one in air and one in water. These are known as near-field events and die out very quickly with distance. Unfortunately, they are very strong in the proximity of the antennas and require antenna separations much greater than were actually employed.

Figure 5. Schematic of some expected radar events for the revetment survey. The event marked scattering can be a coherent or incoherent event. Coherent examples characterized by hyperbolic spatial patterns (caused by changing distance between antenna and target) will be seen in the data

14. Events such as the one labeled bottom reflection are truly reflections only if the bottom is flat over a distance of several wavelengths. Otherwise, the echoes are really scatter and are often incoherent and appear as noise. Coherent noise is reflections from objects not of interest. The dominant wavelength  $L$  of the transmitted pulse in water is found from the formula

15. Also shown in Figure 5 are events called multiple reflections that are reverberations within the stratification of the bottom sediments, including revetments. Such events are generally much weaker than the primary bottom reflection because of the large electromagnetic wave impedance contrast between the water and bottom (not true for saturated fine-grain bottom sediments). The reflection coefficient for a water/concrete revetment interface is estimated to be 0.64. The actual value may be near -1.0 due to the wire grid holding the concrete blocks together. An absolute value of unity indicates total reflection. When penetration of the bottom does occur, the subsurface reflections often appear in many multiples. Resolution of layers closer than  $L$  is generally not possible.

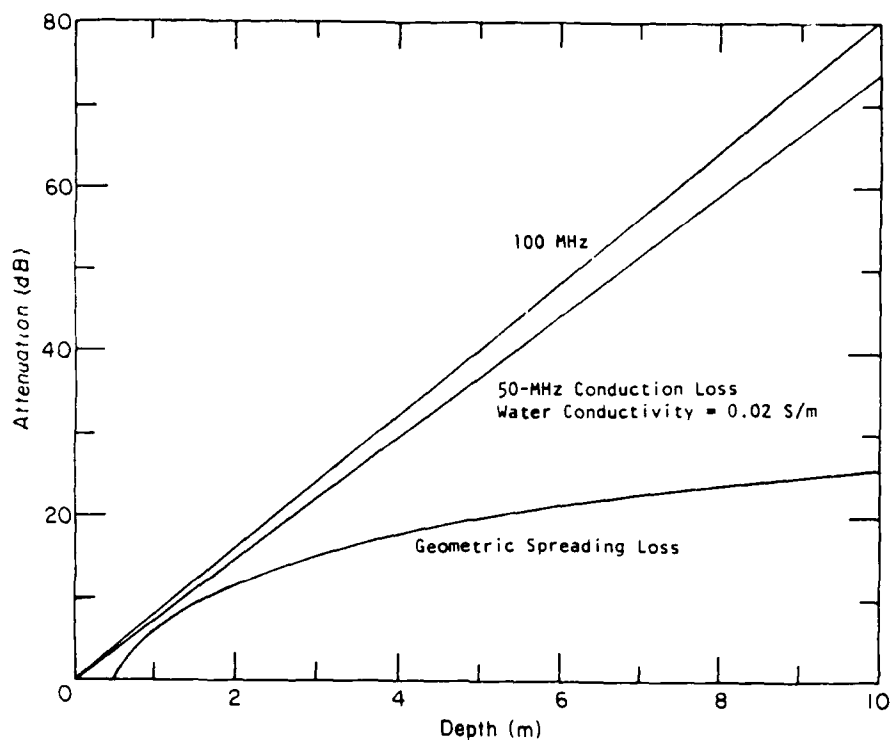
16. A severe limitation to the use of subsurface radar is signal attenuation. This occurs primarily due to antenna-ground impedance mismatch, the geometric spreading of the beam, wave attenuation due to the conductivity of the water (conversion of wave energy into electric current energy), and losses due to transmission through the bottom sediments. Generally, GSSI radars can tolerate up to a 120-dB loss in transmitted signal amplitude. Mismatch losses are difficult to estimate, but the other factors are not. Figure 6 graphs the losses expected as a function of water depth for geometric spreading and conductive absorption at 50 and 100 MHz for a water conductivity of 0.02 S/m (Siemens/meter or mhos/m). The loss values account for the round trip of propagation. Assuming antenna gain and mismatch losses to be about 10 dB, we see that maximum expected penetration of a 100-MHz wavelet is about 10 m and slightly more at 50 MHz. Higher values of conductivity will further decrease penetration.

Figure 6. Attenuation due to conductive loss and geometric spreading of 50- and 100-MHz signals propagating in 0.02-S/m conductivity material

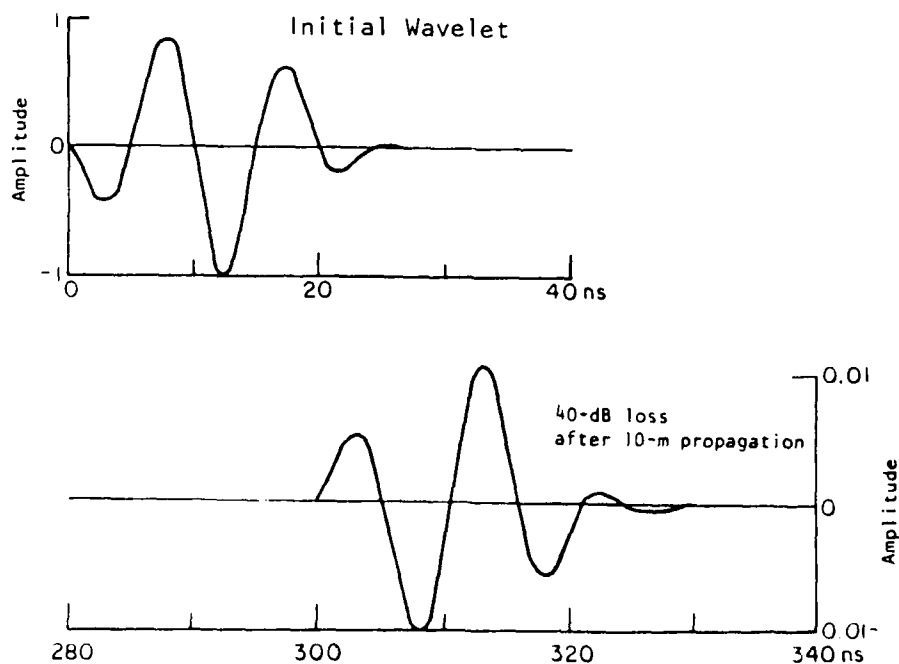
17. An additional problem associated with transmission in a conductive medium is wavelet distortion. Generally, higher frequencies in the pulse spectrum suffer far more attenuation than do lower frequencies; thus causing the pulse to spread out. Figure 7 shows that this is not to be expected for the Mississippi River. After 10 m (5-m depth) of propagation of a 100-MHz wavelet, there is hardly any change in wave shape despite great attenuation. Lower frequency wavelets will also remain free of distortion.

Figure 7. The 100-MHz wavelet is seen to undergo insignificant distortion but substantial attenuation after 10-m propagation (5-m depth), including a phase reversal off an assumed wire grid

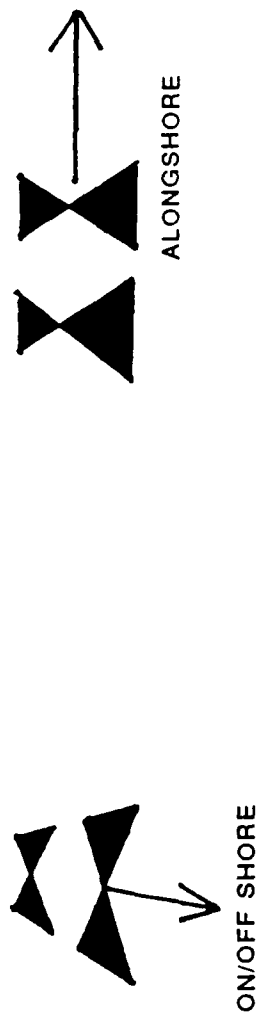
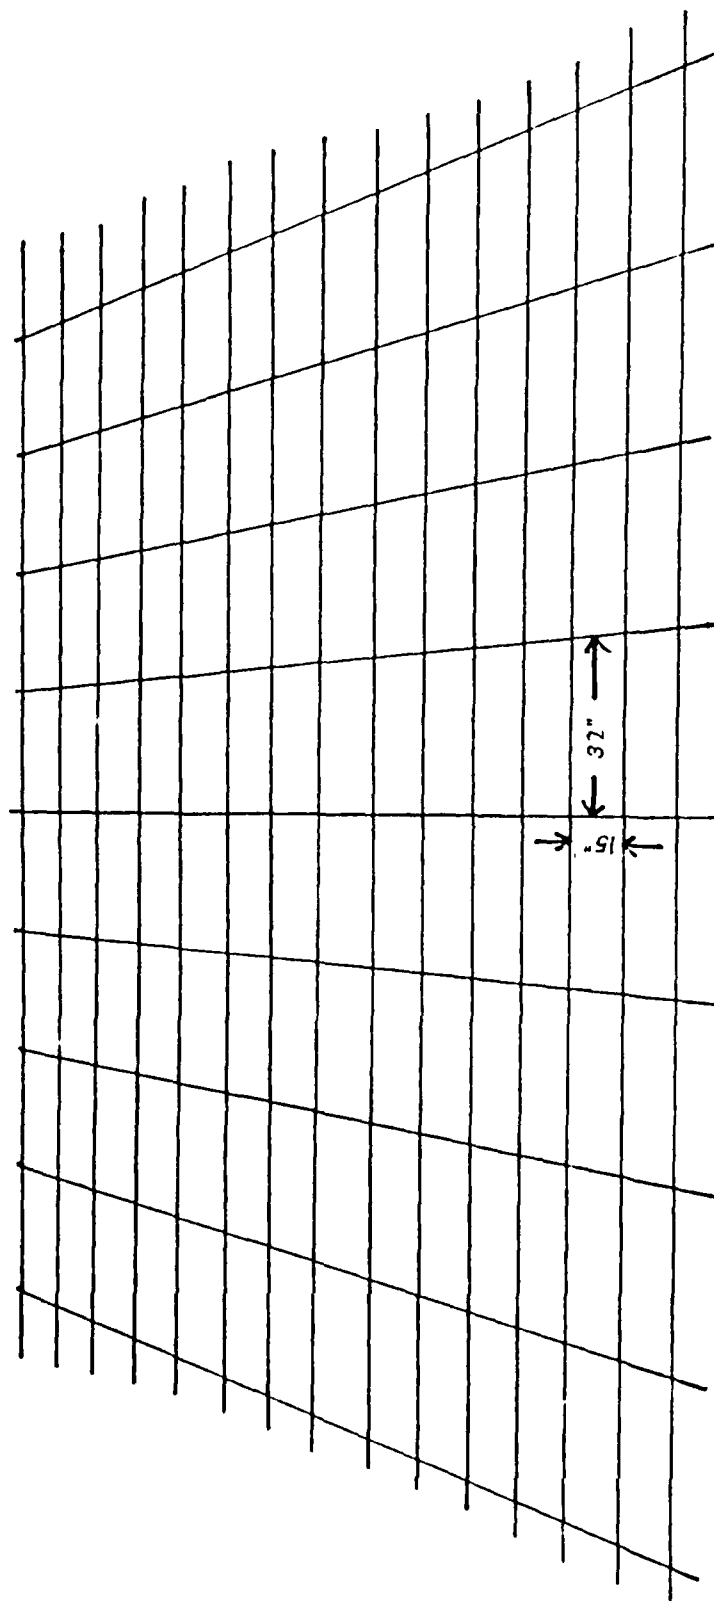
18. A schematic diagram of the revetment map is shown in Figure 8. The mat consists of concrete blocks, approximately 17 by 48 by 3 in. in dimension, wired together into long articulated mats that are laid down side by side. Interblock wiring is fixed to wires that are cast into the blocks. The resulting grid size of the wire mesh is approximately 15 by 32 in. or about 38 by 81 cm. This metallic grid is extremely important in arguments pertaining to whether or not the radar signals can penetrate the revetments into the sediments below. Any metal grid spacing closer than  $L/2$  will not pass electromagnetic waves with an electric field polarized parallel to the wire direction.

19. Assuming the index of refraction to be about 2.0 in the concrete (assuming the concrete is hydrologically impermeable), then  $L/2$  at 100 MHz is equal to 75 cm, and is greater at lower frequencies. Consequently, radiation at any frequency less than 100 MHz for both profile directions indicated in Figure 8 should not penetrate the revetments.

Figure 8. Orientation of the antenna polarization for the surveys relative to the wire grid of the revetment mats

does respond to local disturbances. These disturbances must be within or above the revetments because the wire grid of the revetments prevents deeper penetration given that the diagram of Figure 8 is correct. A desirable aspect of the project would have been more experimentation or ground truth (i.e. river bottom truth). The extent of mud cover on the revetments and the cause of the many interesting phenomena observed in the records, especially the double bottom returns and the hyperbolae, could have been determined by further testing. The survey itself is in great need of an accurate positioning system (or a buoy grid on the river) to locate areas of interest. Sophisticated signal processing schemes do not seem necessary.

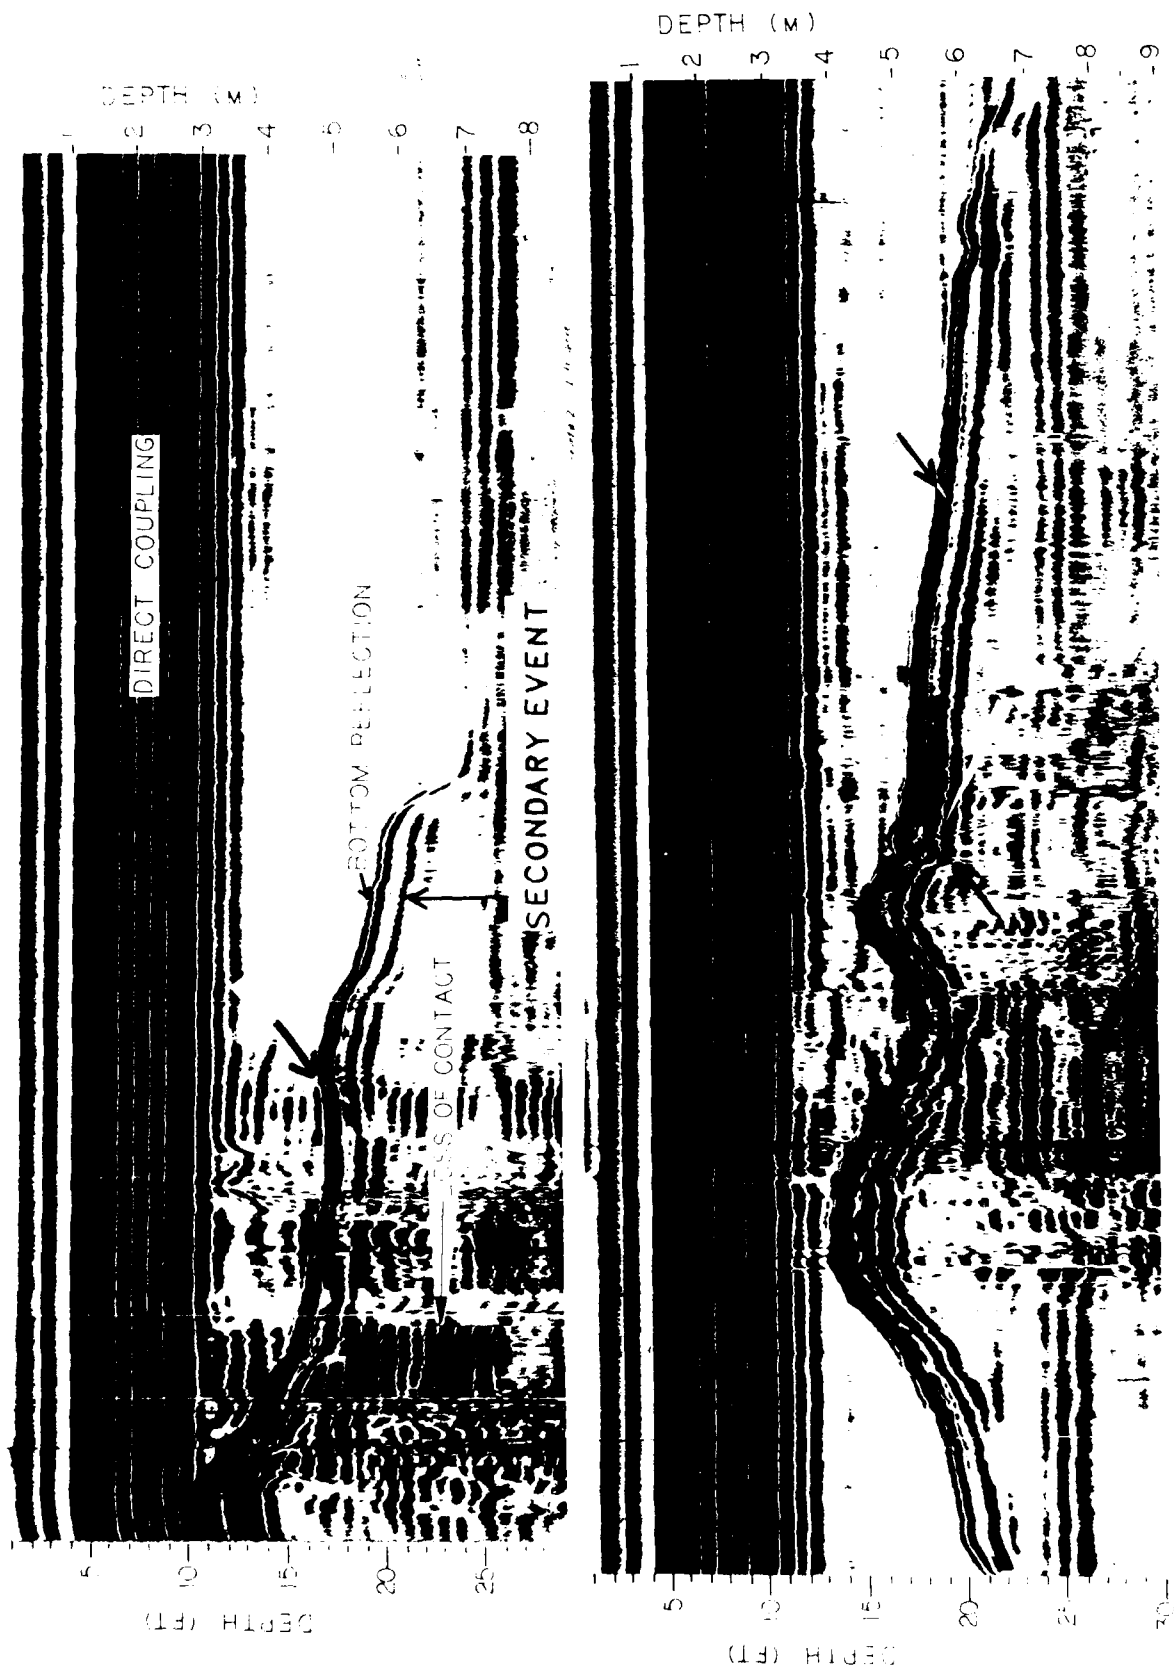
20. Figures 9 and 10 display the graphic records of several profiles that were made both perpendicular and parallel to the shore near the Wolf River Channel near Memphis Harbor. The upper record of Figure 9 was made (reading left to right) with the antennas towed away from shore. The lower record contains a return to shore, a turn around, and then a profile away from the shore. The direct coupling between antennas and the bottom reflection are indicated. Arrows point to hyperbolic shapes originating at the bottom. In Figure 10 are three sections of one continuous (read left to right, and down the figure) alongshore profile. The numerous discontinuities in the horizontal direction are believed to be a malfunction of the radar system. No notes are available concerning the length of these profiles, but it is estimated that each displayed section is approximately 20 to 30 m long.

21. Figure 9 shows many interesting features. The direct coupling is divided into two parts. The first two wider bands are the air path coupling, and the next series of approximately 10 dark bands are the water path coupling. This useless information extends approximately 200 ns into the record

Figure 9. Radar profiles onshore and offshore over revetment mat. Black arrows point to hyperbolae that are indicative of local bottom disturbances. Estimated length of each section is 10 to 15 m

and, therefore, seriously interferes with all bottom information at a depth of 11 ft or less. Suggestions for minimizing these events are given in paragraphs 28 and 29. The reflection of the downward radiated signal is within this direct coupling region at the left of the upper profile. Here, this reflection and the direct coupling interfere to produce an apparently higher frequency signal, but this is not true. Below 11 ft, the bottom reflection contains the true character of the downward radiated signal. The time duration of the two dark bands (or one oscillation of the wavelet) is about 17 ns, and this translates to a center frequency of approximately 60 MHz. This is surprisingly low in view of past performance of the Model 3207 antennas on land and reflects the severe loading caused by the water environment. It is also low enough to prevent any penetration of the revetment wire grid. The vertical stack of horizontal bands labeled "loss of contact" are believed to be resonances between antenna and water surface when either of the antennas was lifted from the water surface.

22. Immediately below the bottom reflection is a return labeled "secondary event." The origin of this event is not clear, but is not believed to represent sedimentary layering beneath the revetments because of arguments presented in paragraph 21. Additionally, it parallels the bottom reflection too precisely, is too uniform to be sedimentary layering beneath the revetments, and is at too great a time delay to be a reflection from the bottom of the revetments. The author's speculation is that the return is (a) the true revetment reflection and the bottom reflection is from an overlying mud layer; or (b) a secondary emission associated with the structure of the antenna package. If it is from a mud layer, then the layer must be more than several feet thick. Therefore, some ground truth must be carried out to determine the origin of these events.

24. Of great interest in the profiles of Figure 9 are the hyperbolic shapes originating within the bottom reflections. These are indicated by the

heavier black arrows and may be too faint to be seen in the reproduction of the figure. They are associated with any sort of disturbance in the continuity of the bottom; presumably erosion or displacement in the revetment mat. The use of a positioning system would have allowed their location and investigation.

25. A second feature of interest is the wavy modulation most evident in the bottom reflection of the lower profile of Figure 9. It may have been surmised by Mr. Dean ("The ripples of the mat elements can be seen beneath the smooth mud layer," communication to Mr. Henry Thornton of WES dated March 21, 1986, found in Mr. Dean's file) that these are responses to individual concrete blocks, although it is not readily apparent why a flat mat of blocks should produce a modulation in depth. They could also be depth modulations due to surface water waves. Since no distance scale is available, these ideas are only speculation.

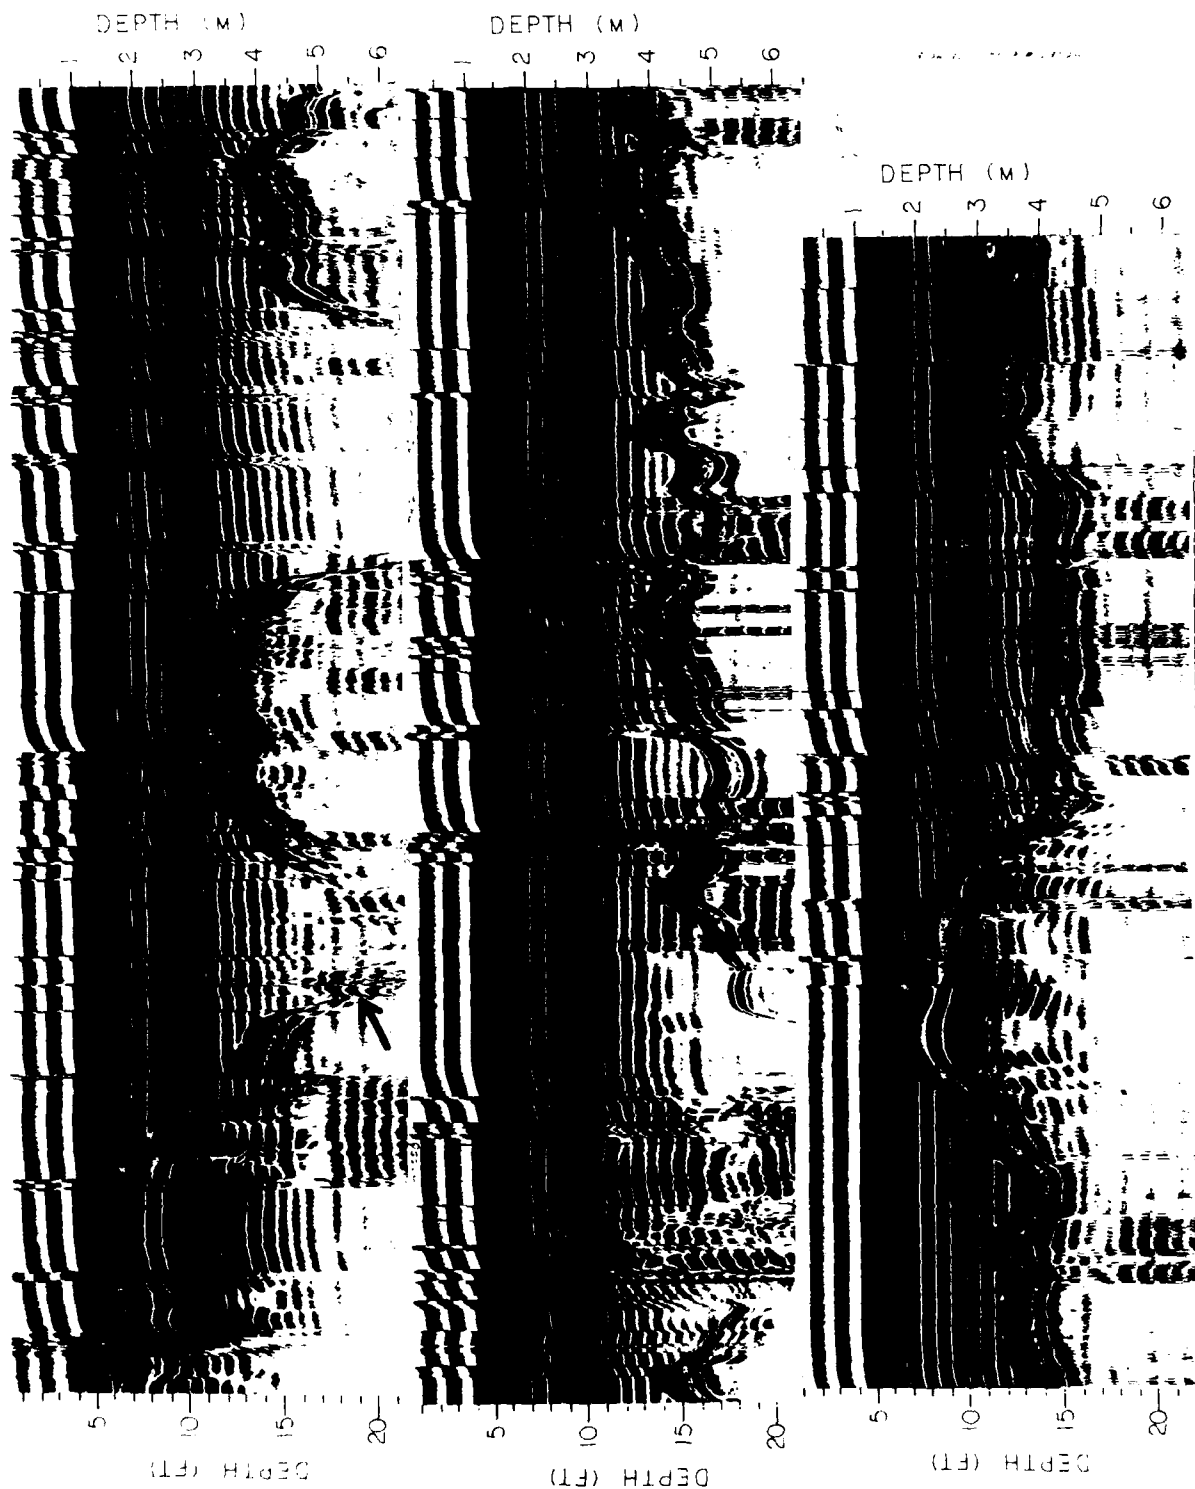
Figure 10. Radar profiles alongshore over revetment mat

26. Figure 10 is a more extensive alongshore profile. Again we see the extensive interference of the direct coupling. The bottom profile is not visible in several sections, and the reason for this is not clear. The rapid increase in range (depth) at the margins of these zones indicates a rapidly deepening section. Most of these transitions are smooth and not associated with hyperbolic patterns. The depth scale shows these variations to be greater than 10 ft, and it would be important to know if this is expected for this area. Personal notes of Mr. Dean indicate that these areas were muddy, but it is difficult to see how this was concluded if the note referred to the bottom condition.

27. Figure 10 also shows the same secondary event structure beneath the bottom reflection that occurs in Figure 9. It is more difficult to follow because of the direct coupling interference, but the middle profile contains sections where the two events can be readily distinguished. As in Figure 9, the secondary event parallels the bottom reflection almost perfectly.
