## Helicopter Visual Segment Approach Lighting System (HALS) Test Report

Barry R. Billmann  
Scott Shollenberger

DOT/FAA/CT-TN89/21

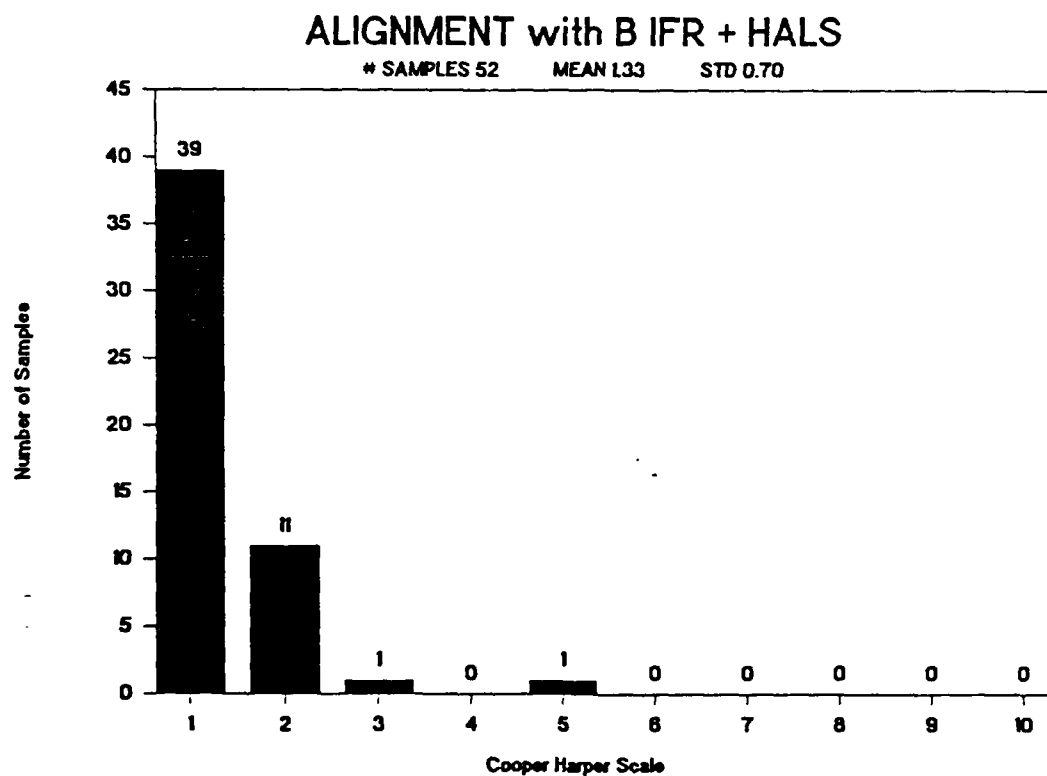
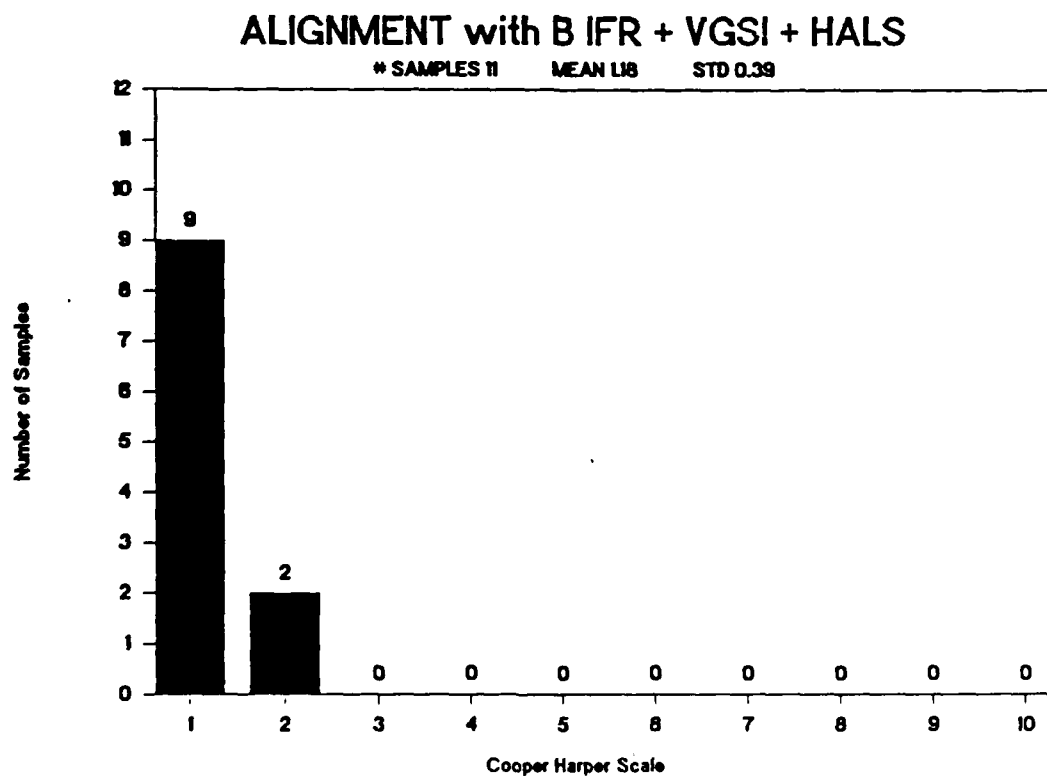
FIGURE 7. ALIGNMENT RATING HISTOGRAM OF PILOT RESPONSE (SHEET 1 OF 2)

FIGURE 7. ALIGNMENT RATING HISTOGRAM OF PILOT RESPONSE (SHEET 2 OF 2)

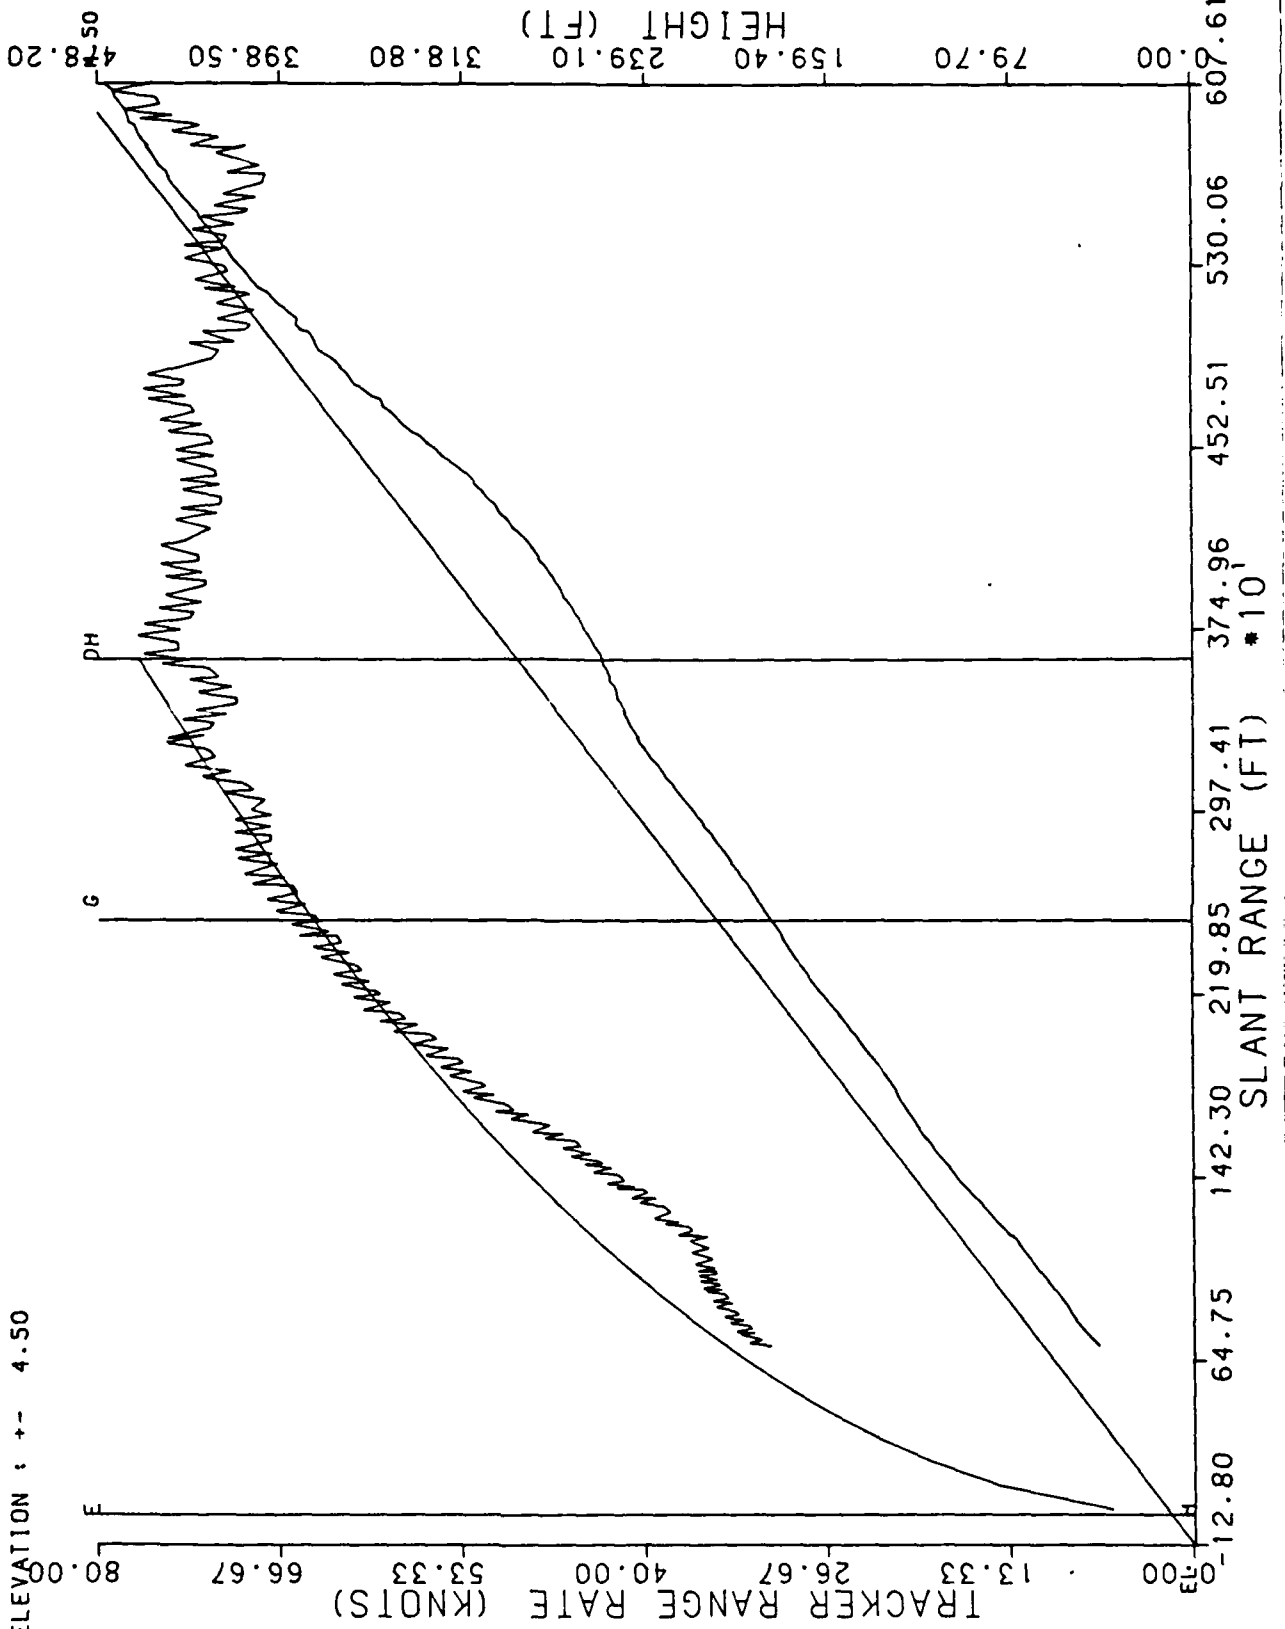
4/28/88 UH1 HALS 4.5 DEGREE EL 250 FT DH 138 DEGREE AZ OFF

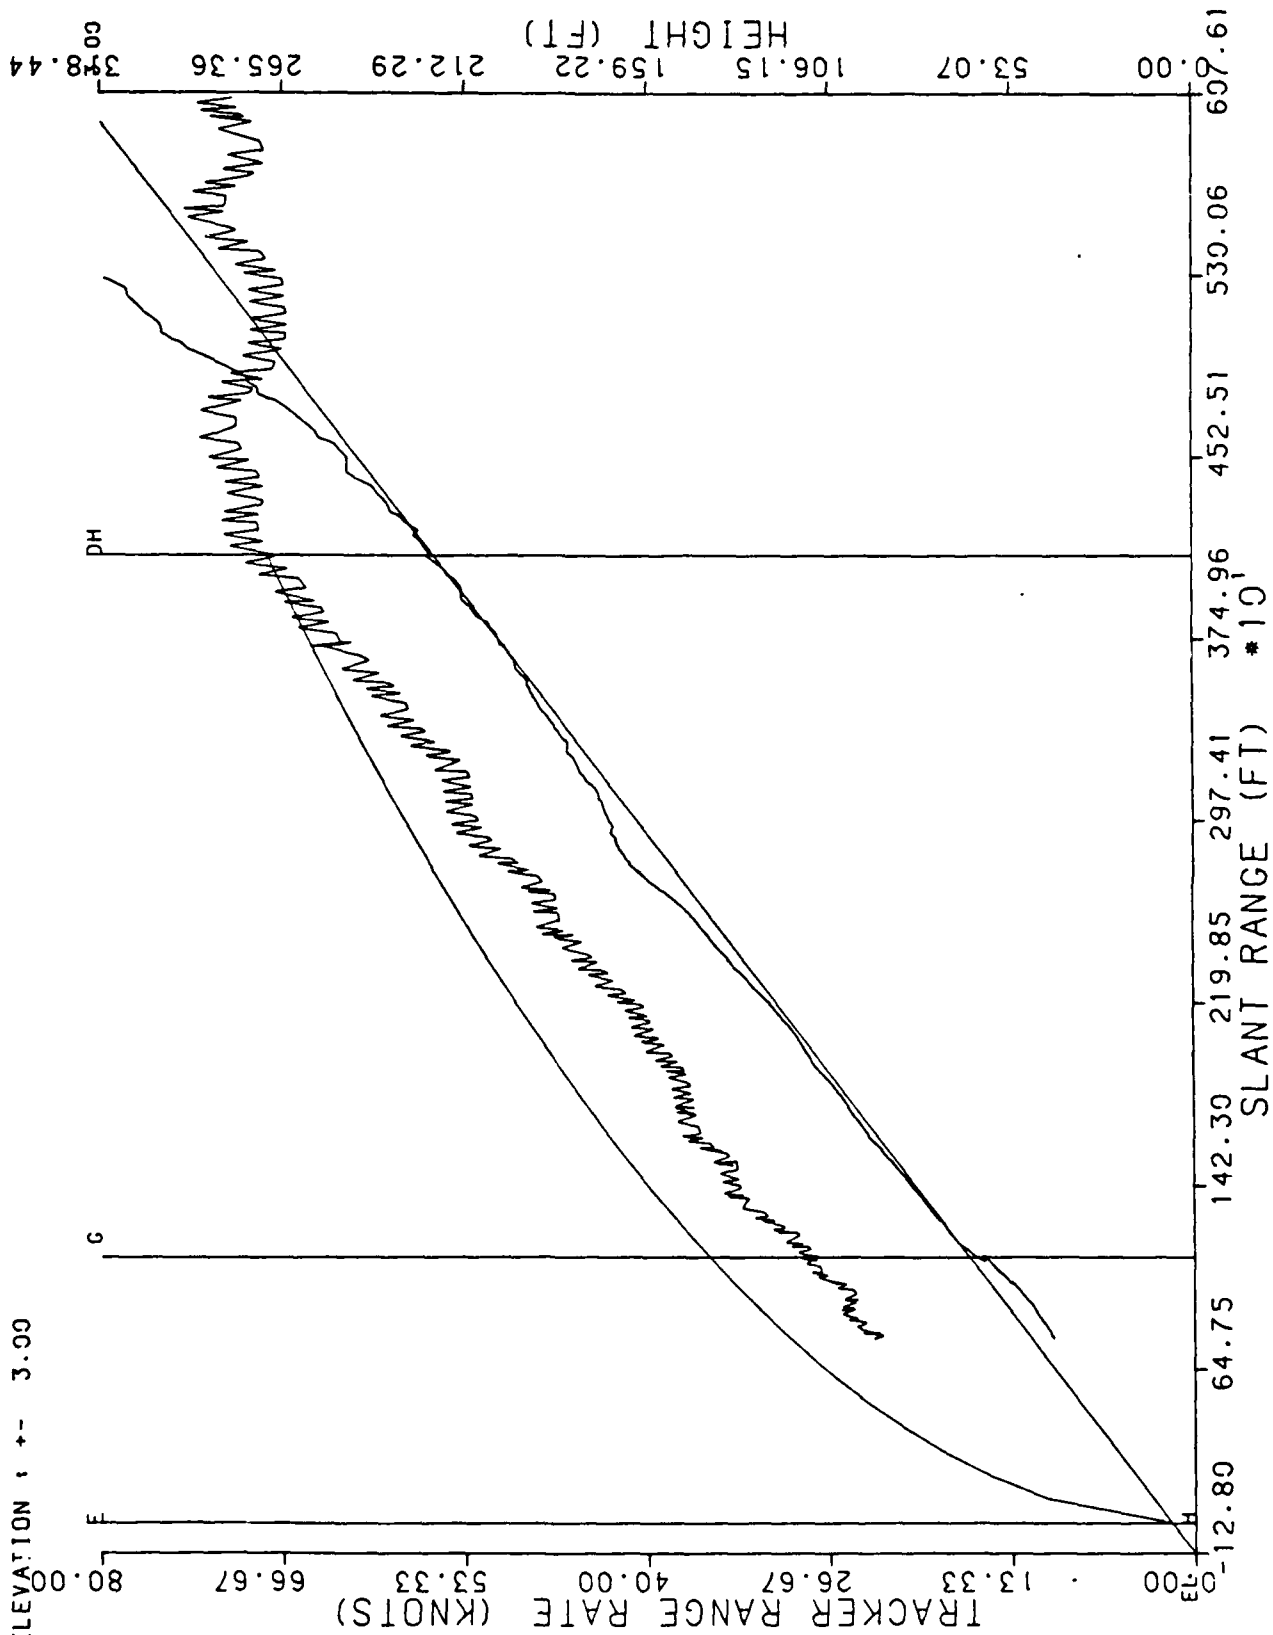
4/20/88 UH1 HALS 3 DEG 200 FT DH CL OFF LANDING

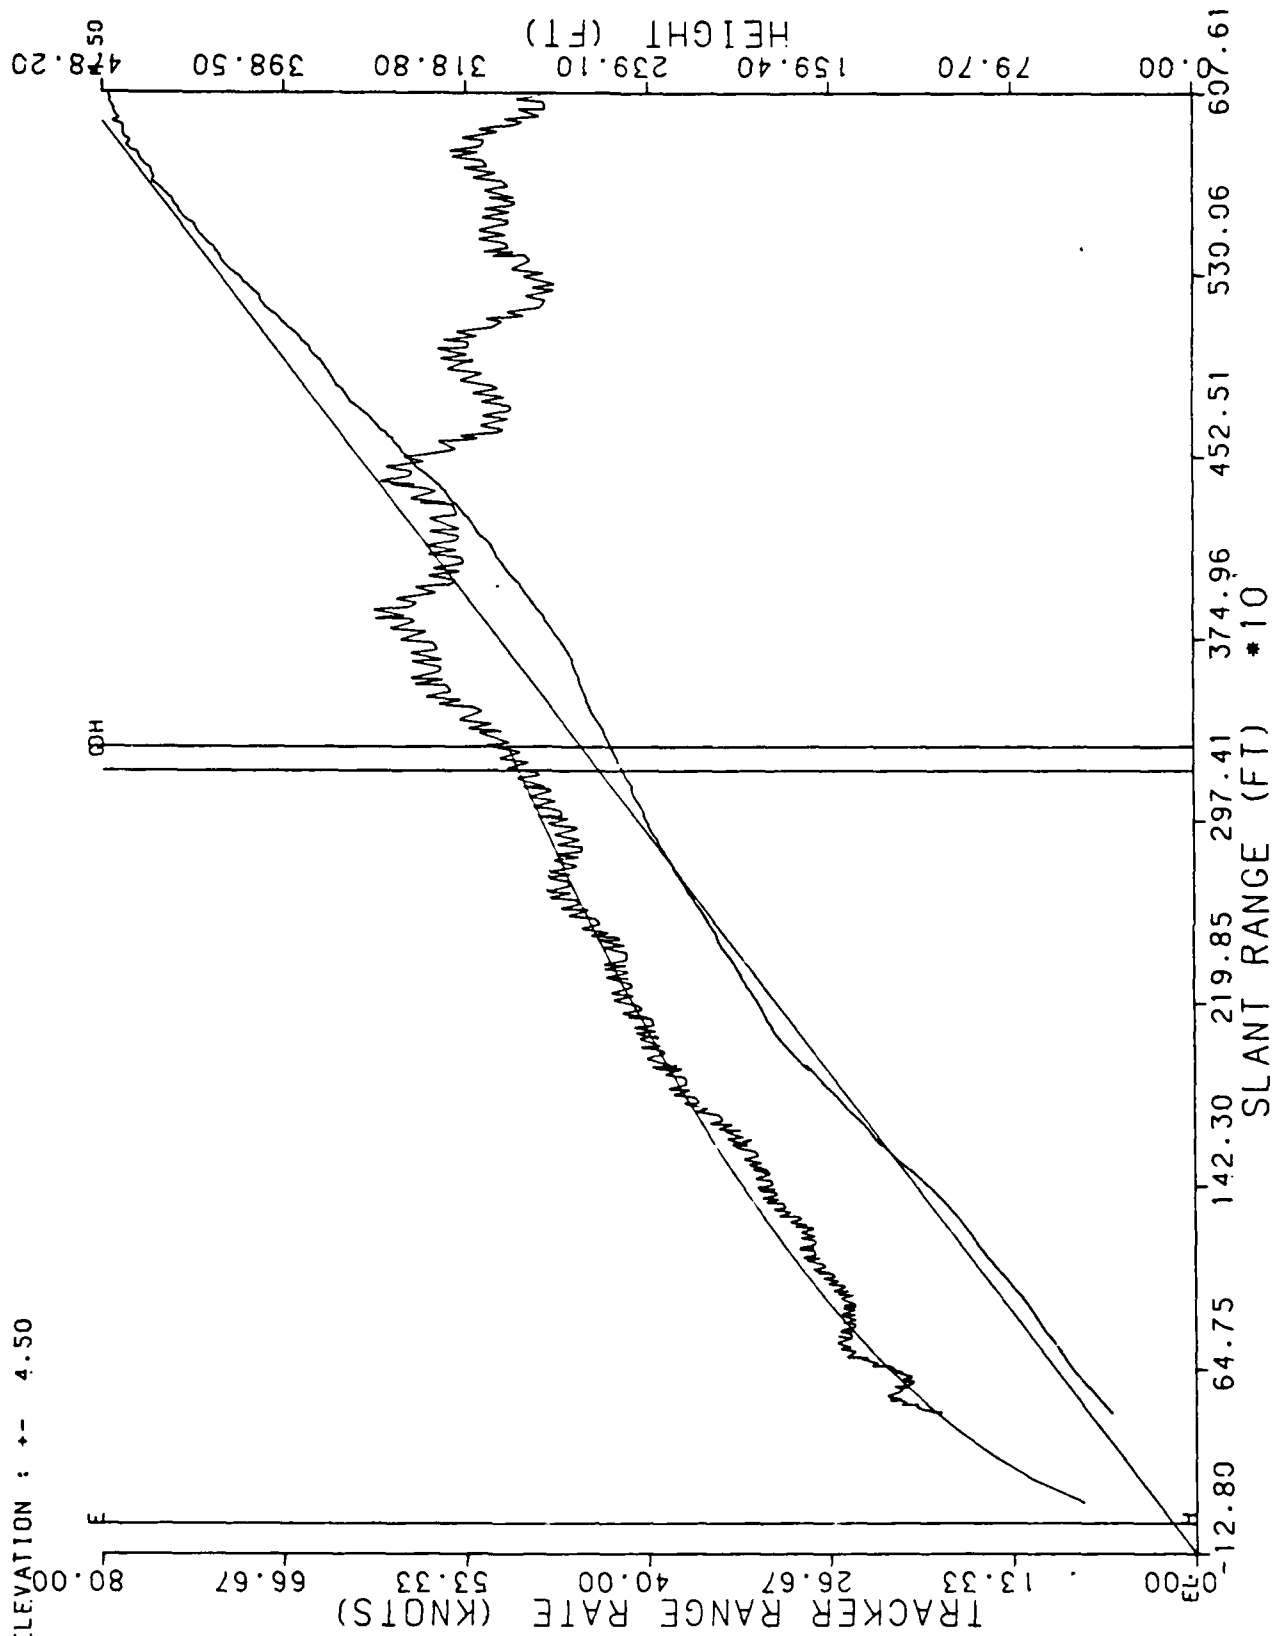
RUN # 6  
4/20/88 UH1 HALS 4.5 DEGREE 250 FT DH CL OFF LANDING  
AZIMUTH : +- 0.00  
ELEVATION : +- 4.50
