TECHNICAL REPORT RD-ST-89-3

TOW MOTOR CASE PAINT EVALUATION (U)

**U.S. ARMY MISSILE COMMAND**

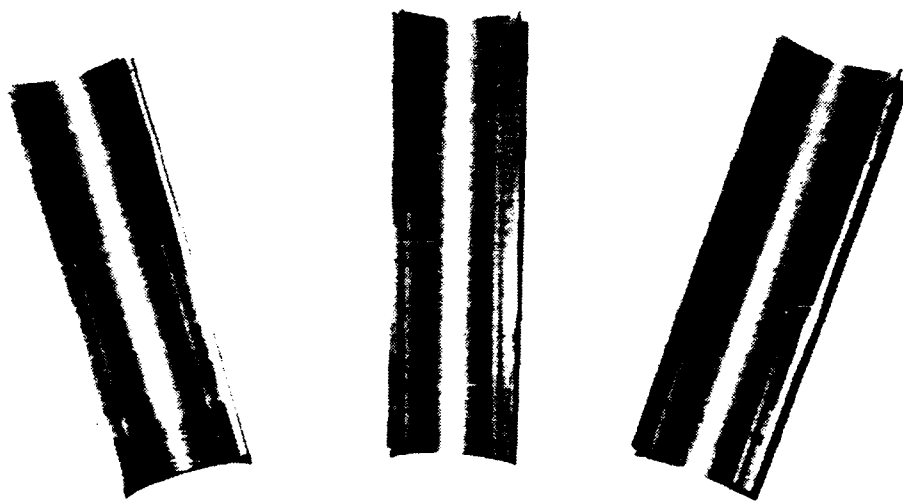
Figure 1. Adhesion test specimens, interior view.

Specimens for investigation were prepared by cutting motor cases in half longitudinally. This was accomplished by using a Buehler Ltd. cutoff wheel number 10-4412 for hard steel. Specimens are shown in Figures 1 and 2.
