TECHNICAL REPORT CERC-89-12

# STABILITY OF ARTICULATED CONCRETE MATTRESSES FOR HERBERT HOOVER DIKE IMPROVEMENTS LAKE OKEECHOBEE, FLORIDA

Coastal Model Investigation

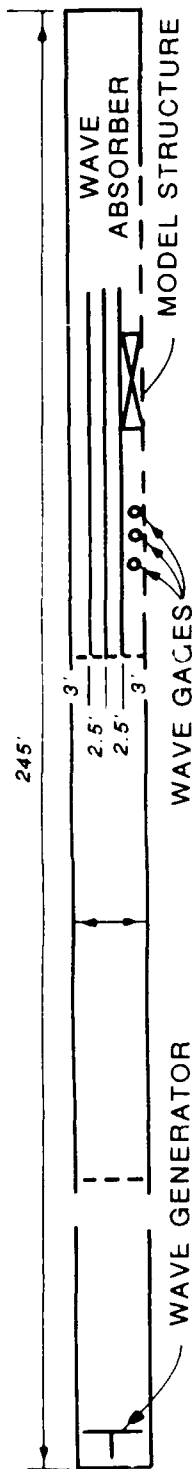
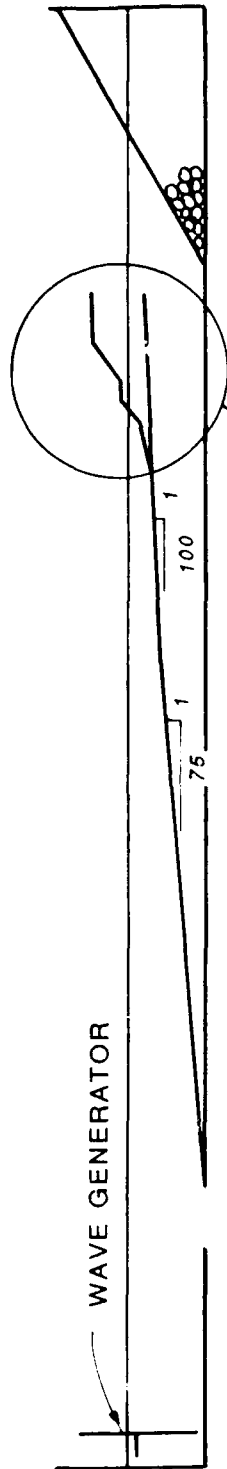
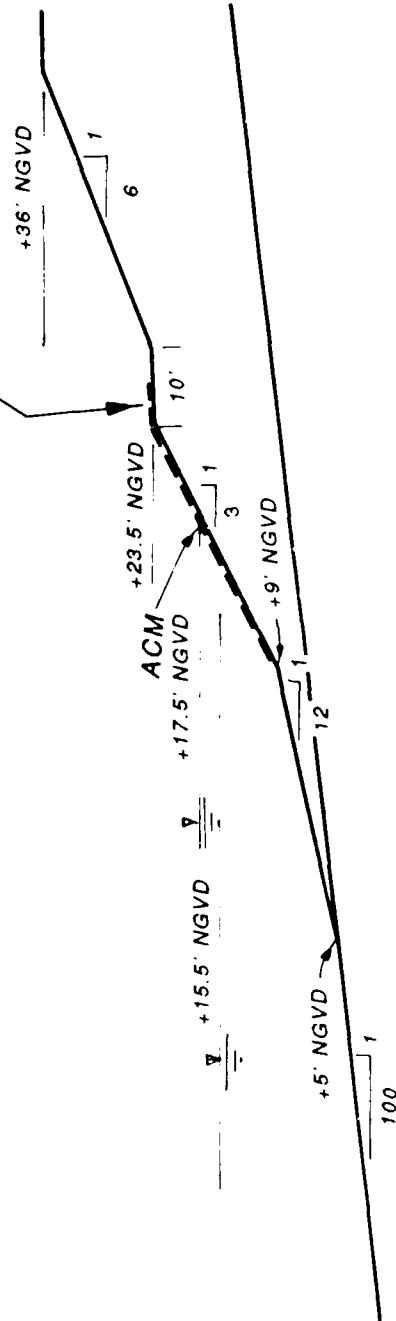
Figure 2. Flume layout and test section

5. All tests were conducted in a concrete wave flume that measured 11-ft wide and 245-ft long. The cross section of the tank in the vicinity of the structure was partitioned into two 3-ft-wide channels and two 2.5-ft-wide channels (Figure 2). Test sections were constructed in the glass-sided, 3-ft-wide portion of the flume. The remaining empty channels acted as absorbers. Irregular waves were generated by a hydraulically actuated piston-driven wave board. Test sections were installed approximately 190 ft from the wave board.

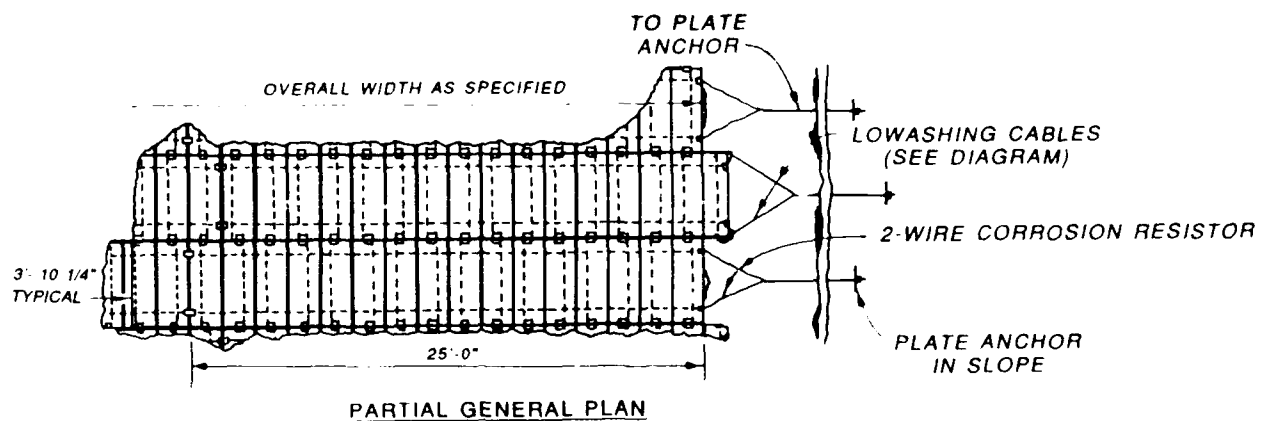
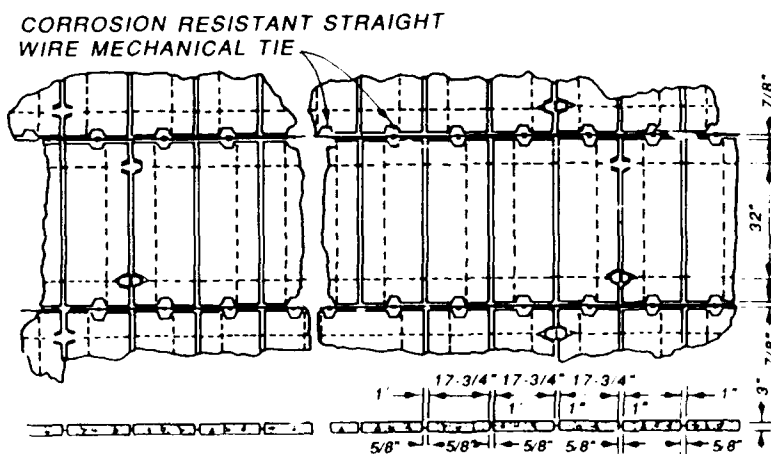
DETAIL SECTION OF MATTRESS

Figure 3. Typical ACM

8. It was determined that the prototype mat(s) should measure about 50 ft upslope and downslope and be continuously connected along the slope. Since the model flume width (3 ft) was equivalent to 30 ft prototype, model mats were constructed which correctly reproduced both the geometry and weight of 27-ft-wide by 50-ft-long prototype mats. Details of a typical prototype mat are shown in Figure 3.

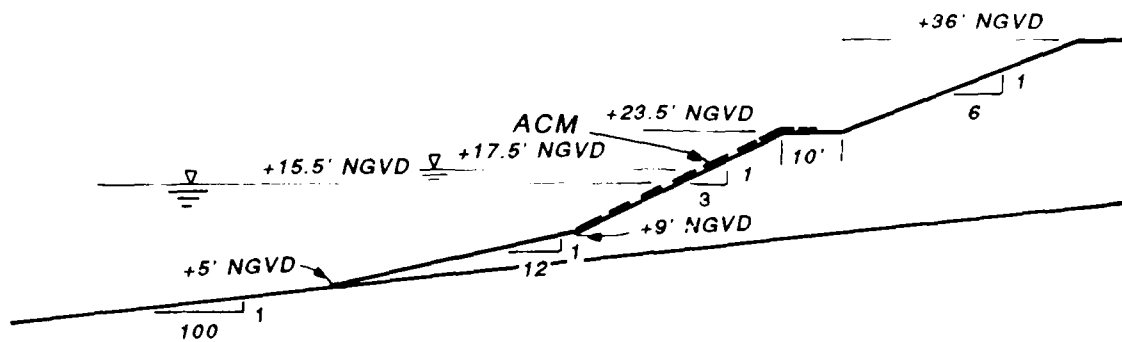
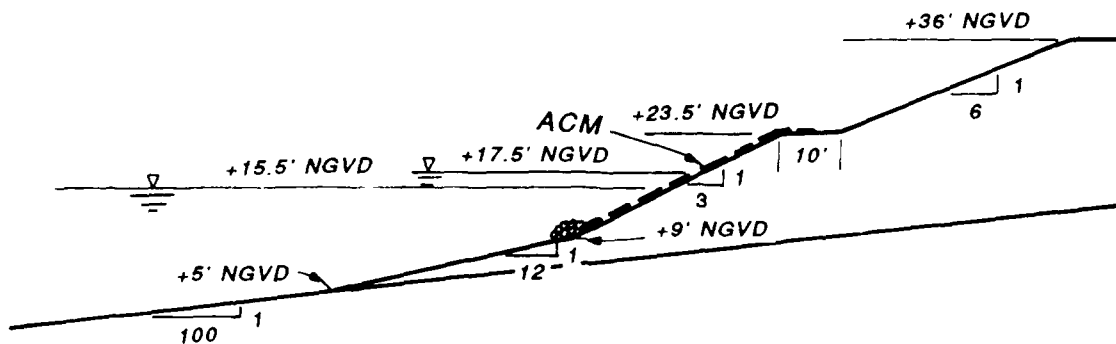
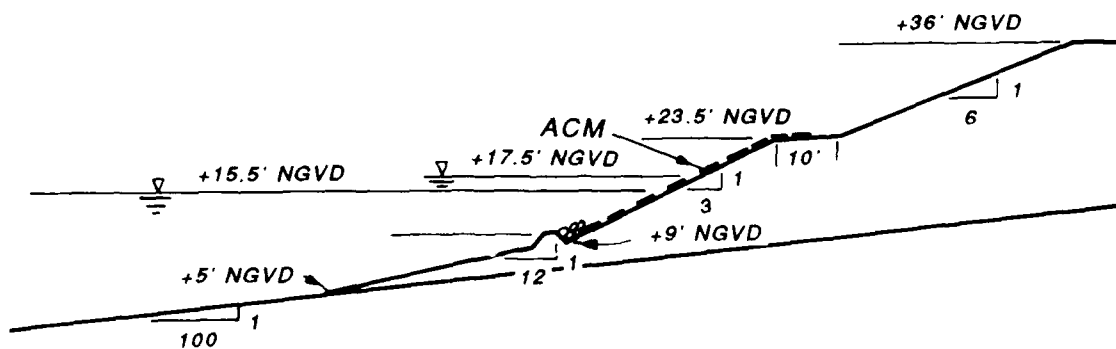
a. No toe protection

b. Onslope toe stone

c. Toe trench filled with stone

Figure 4. ACM toe conditions tested

9. All mats were secured in the model by top anchors at the berm (el = +23.5) and extended downslope to a toe elevation of +9.0. Initial test plans did not incorporate toe protection (Figure 4a), whereas subsequent test plans used onslope toe protection (Figure 4b) or simulated placement of the toe stone in a 3-ft-deep trench (Figure 4c). Detailed descriptions of individual plans are presented in Part III.

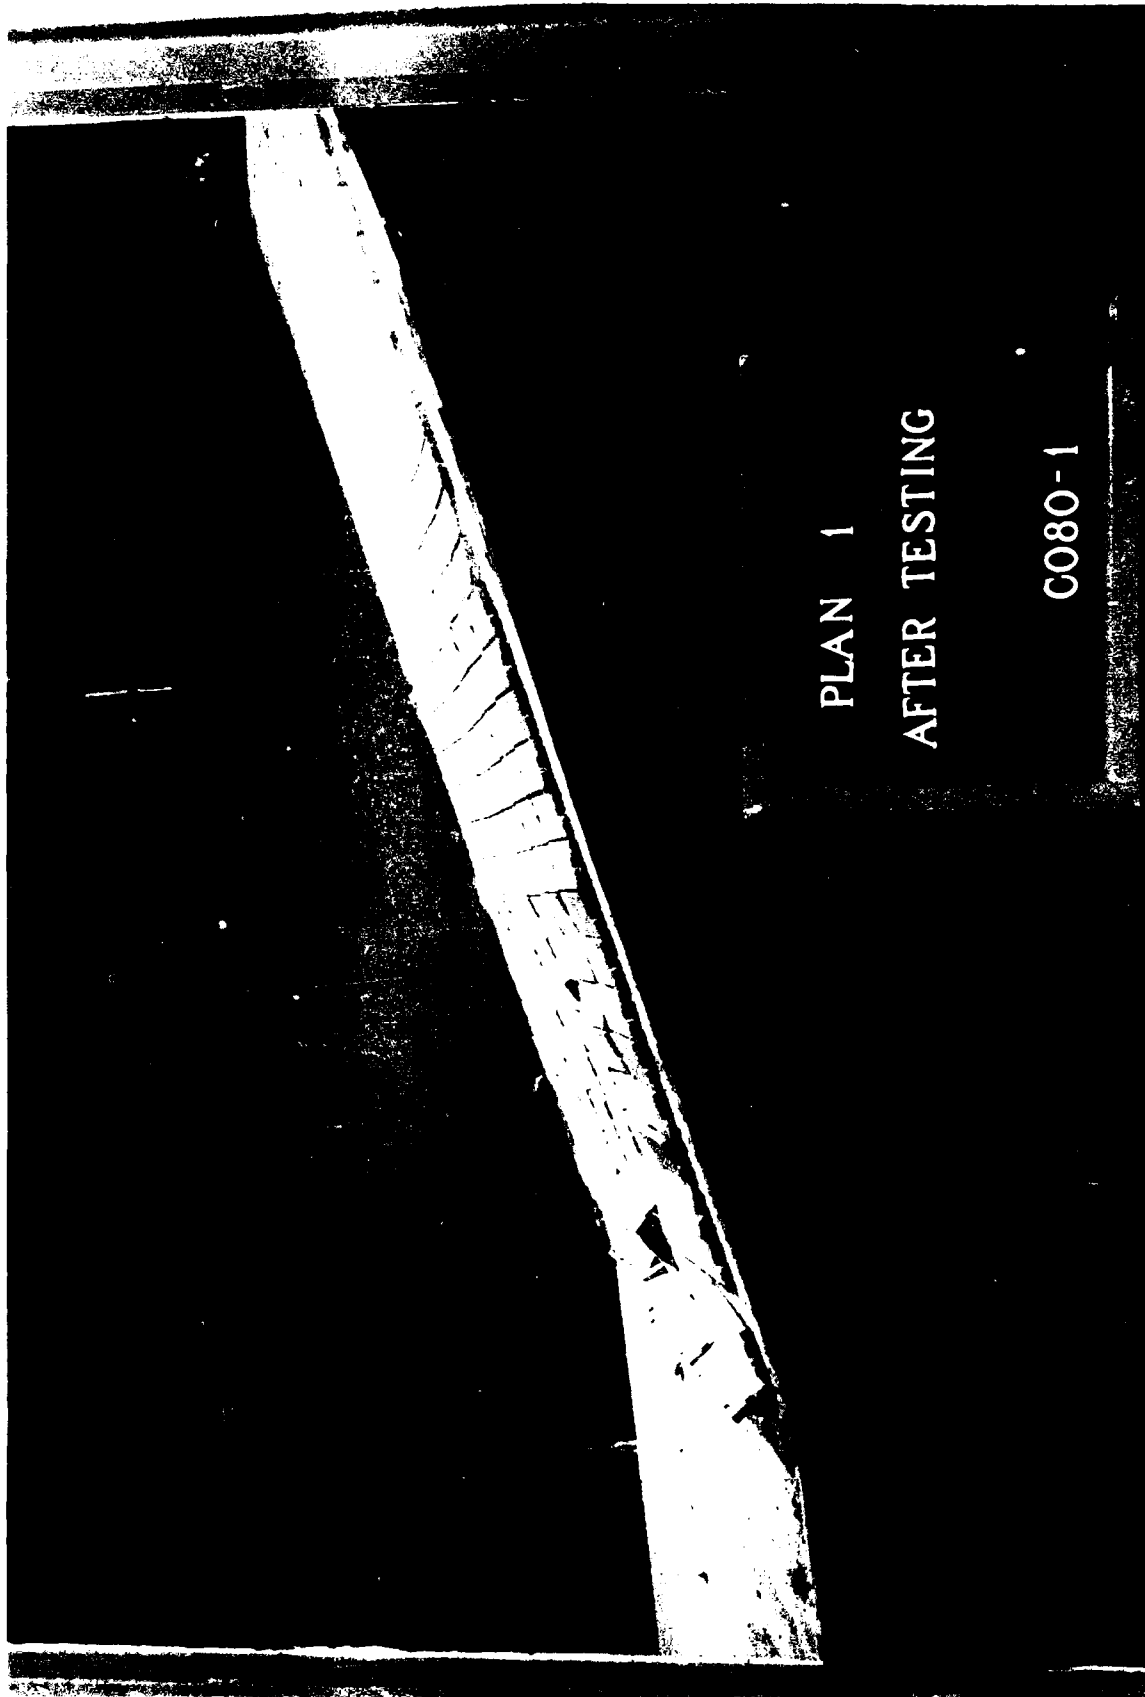
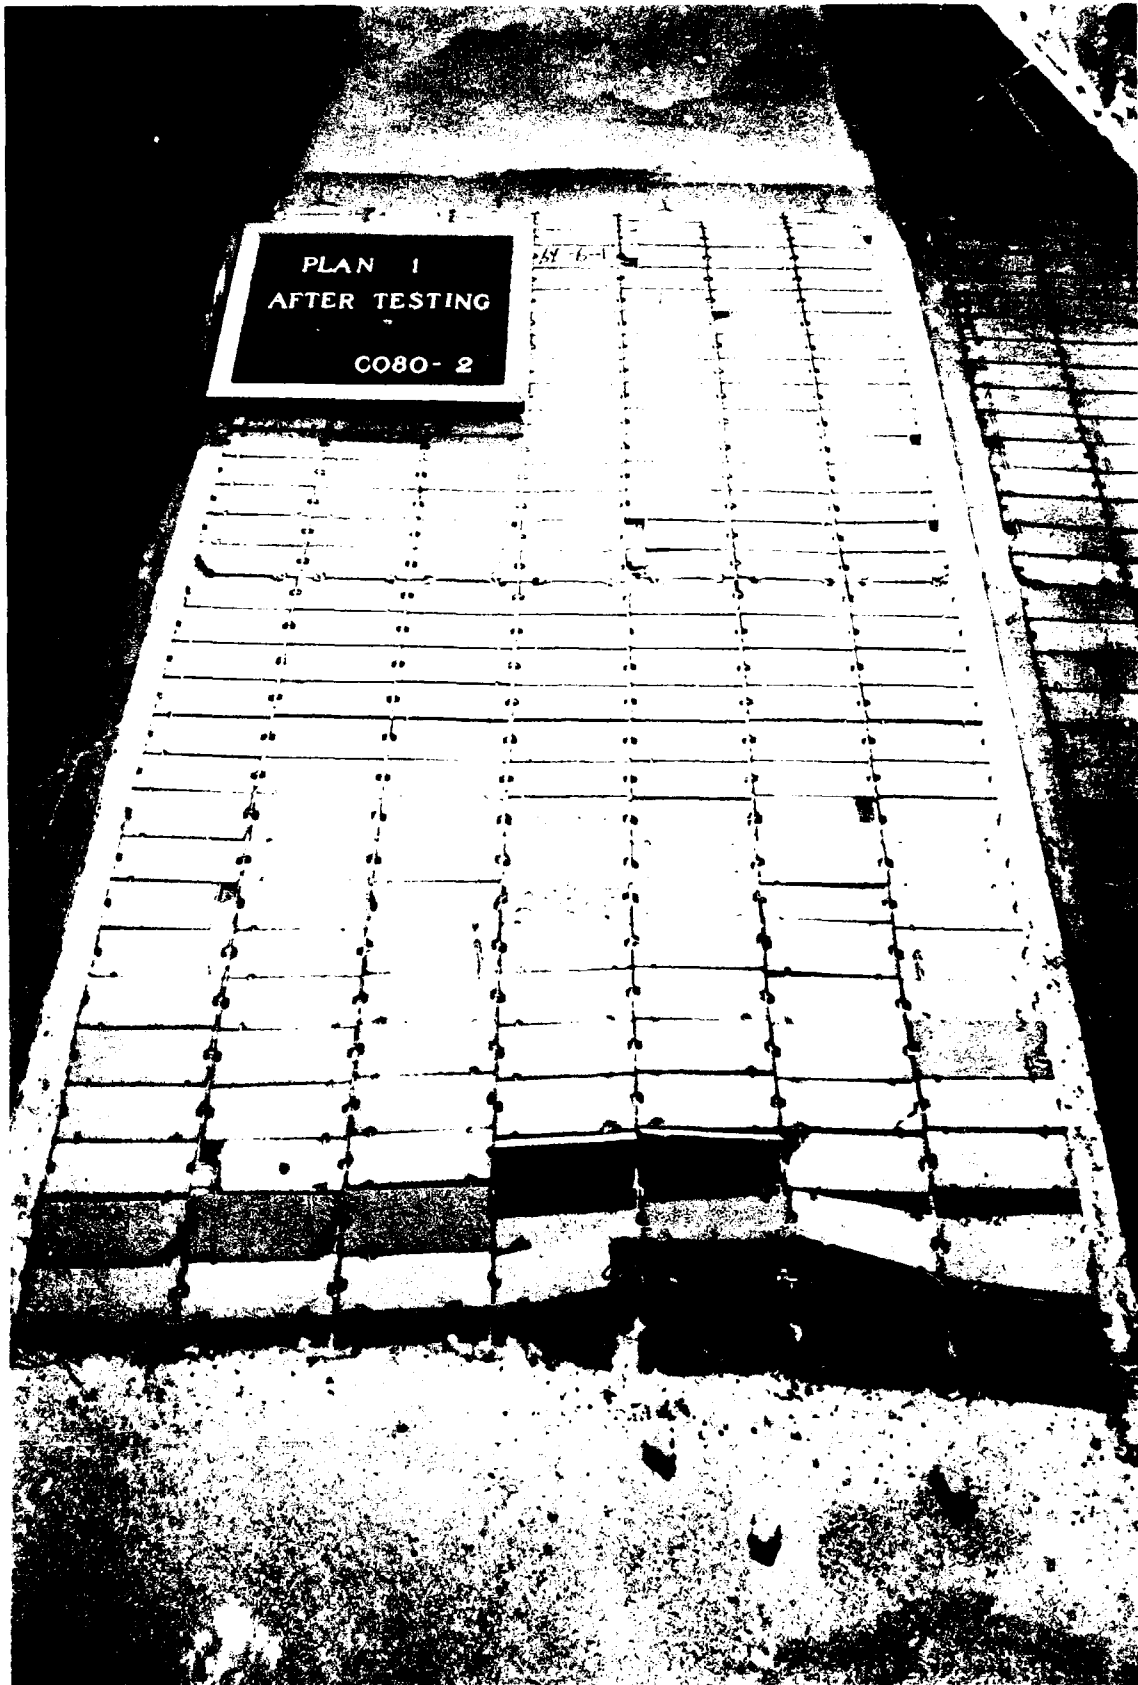
Photo 1. Side view of Plan 1 after wave attack

Photo 2. Sea-side view of Plan 1 after wave attack

13. Plan 1 consisted of a one-layer mat secured only by top anchors. This plan was stable for 2- and 3-ft waves; however, the 4-ft waves produced some lifting near the toe, and both the 5- and 6-ft waves caused the mat to roll upslope. Violent motions associated with the 5- and 6-ft waves caused some blocks near the toe to crack and/or break loose from the mat. Maximum observed runup was el +29. Runup values for all wave conditions investigated are presented in Table 1.

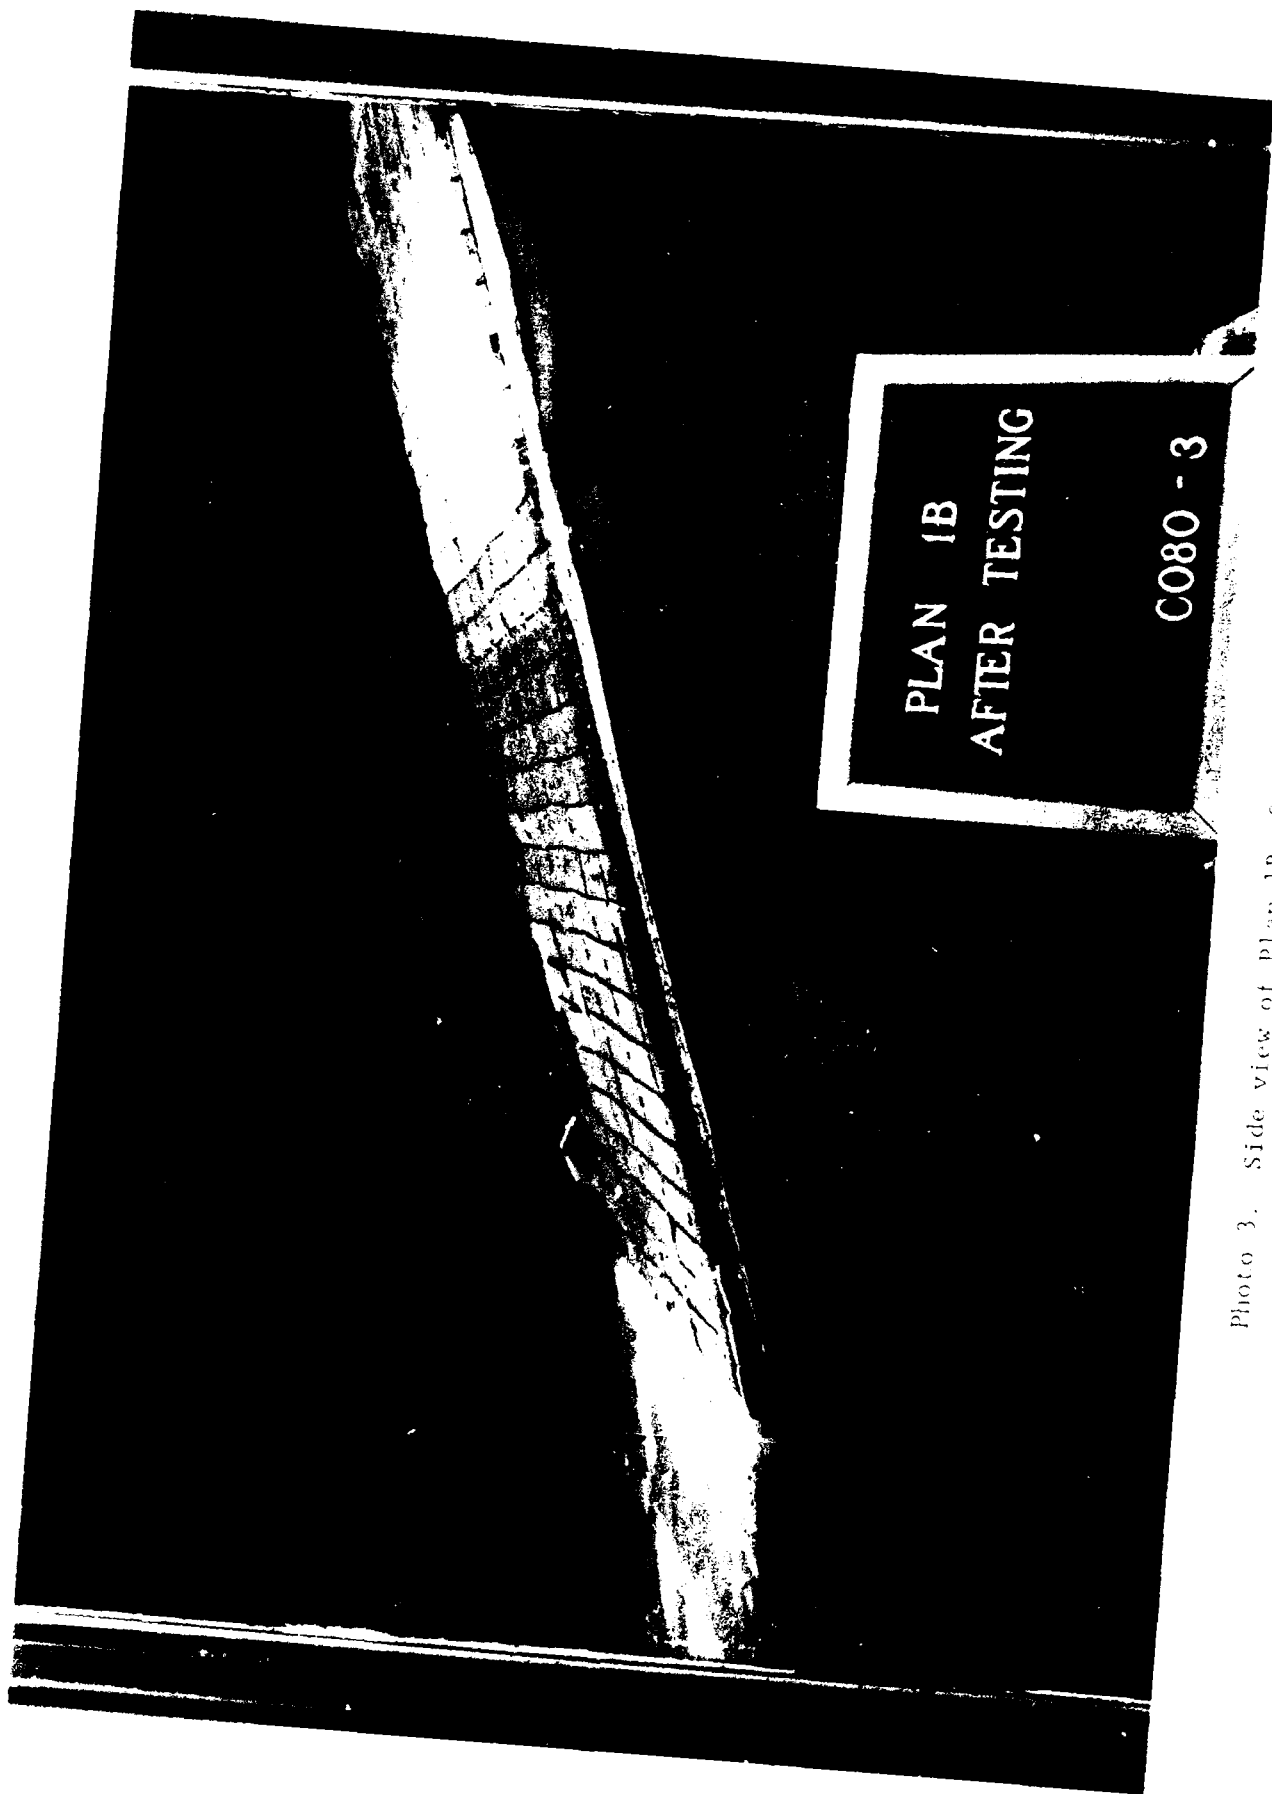
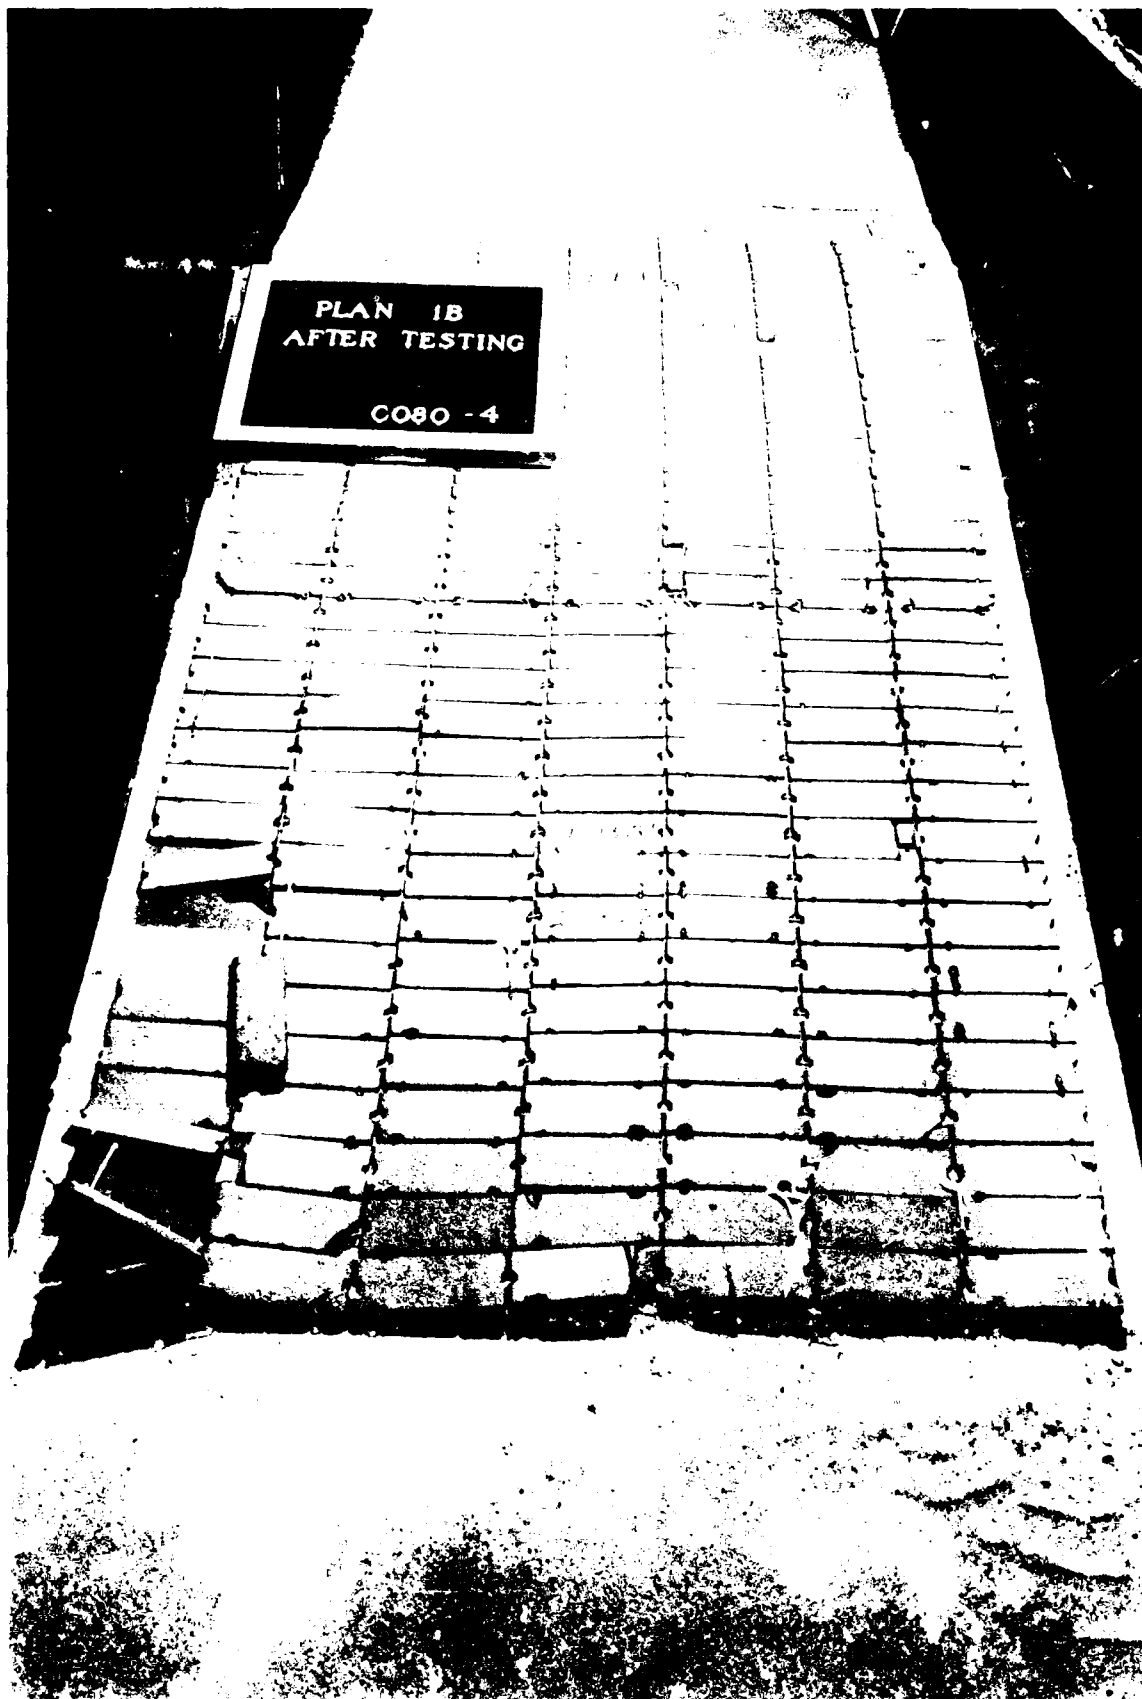
Photo 3. Side view of Plan 1B after wave attack

Photo 1. Sea-side view of Plan 1B after wave attack

15. Plan 1B was the same as Plan 1A except two rows of toe anchors were added. Stability improved slightly over previous plans; however, excessive lift still was observed in the unsecured area between the swl

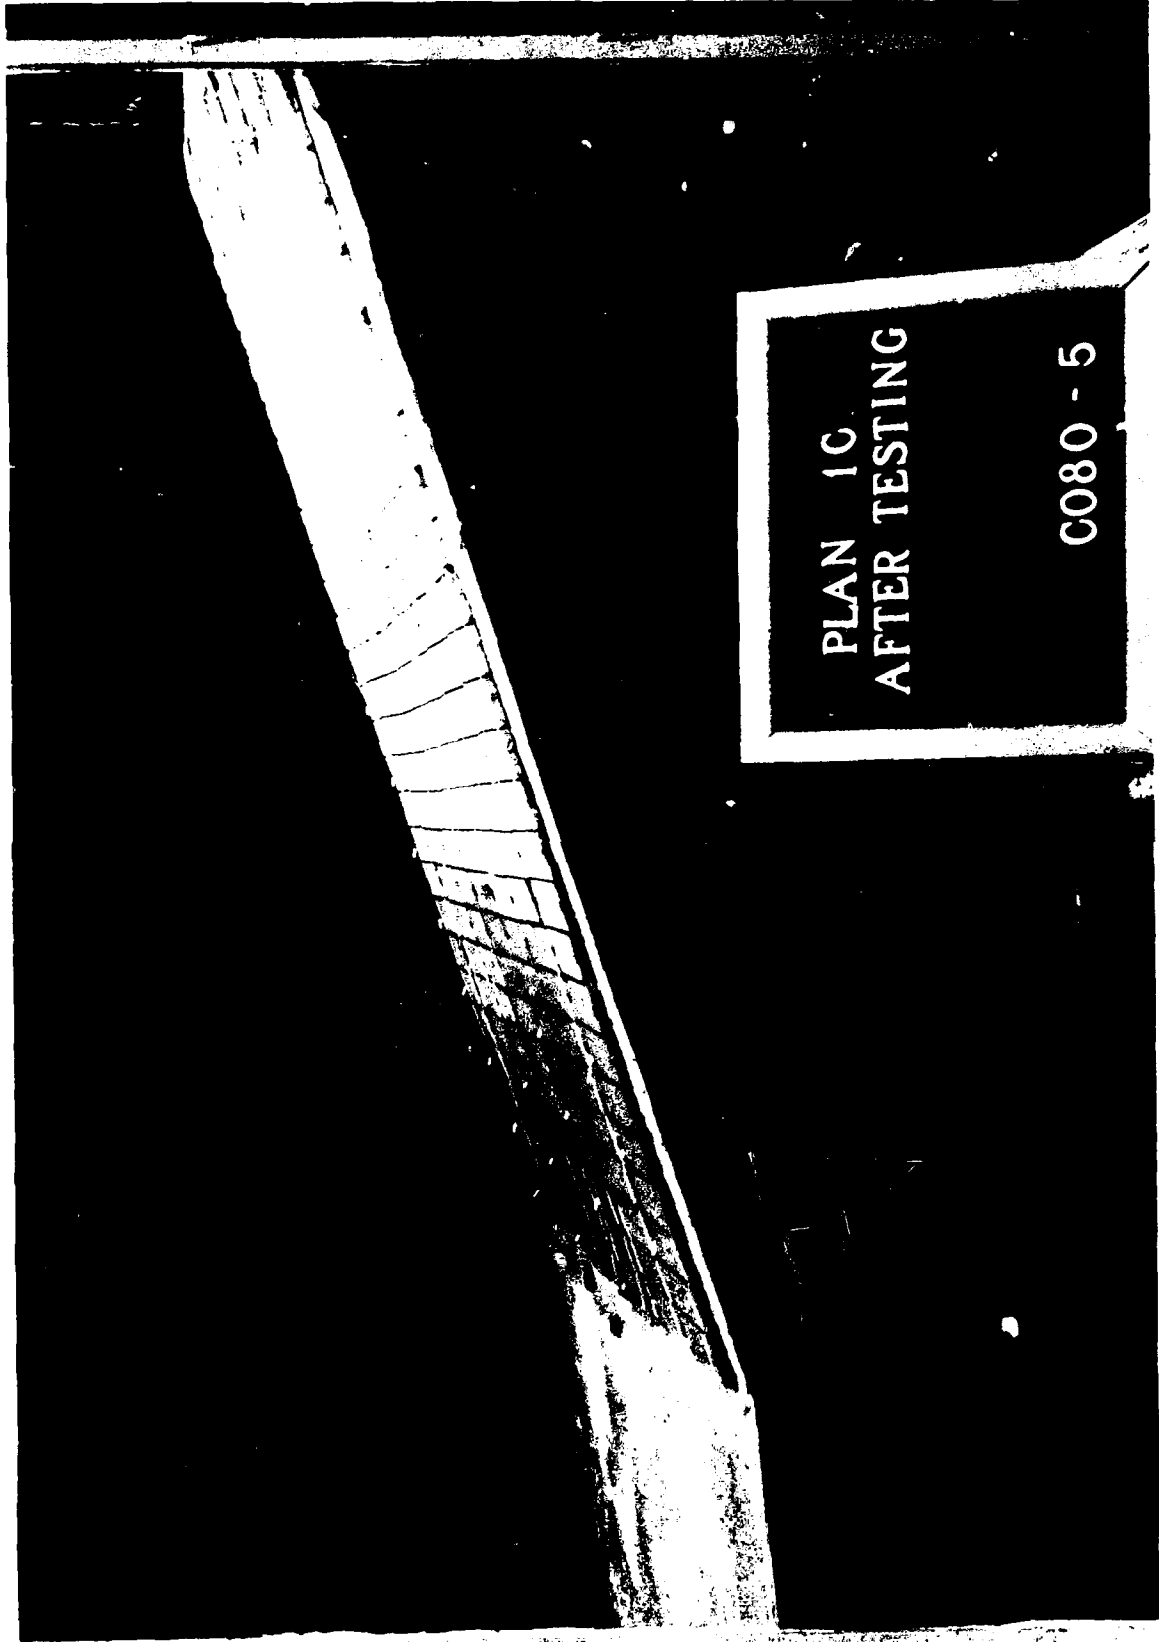
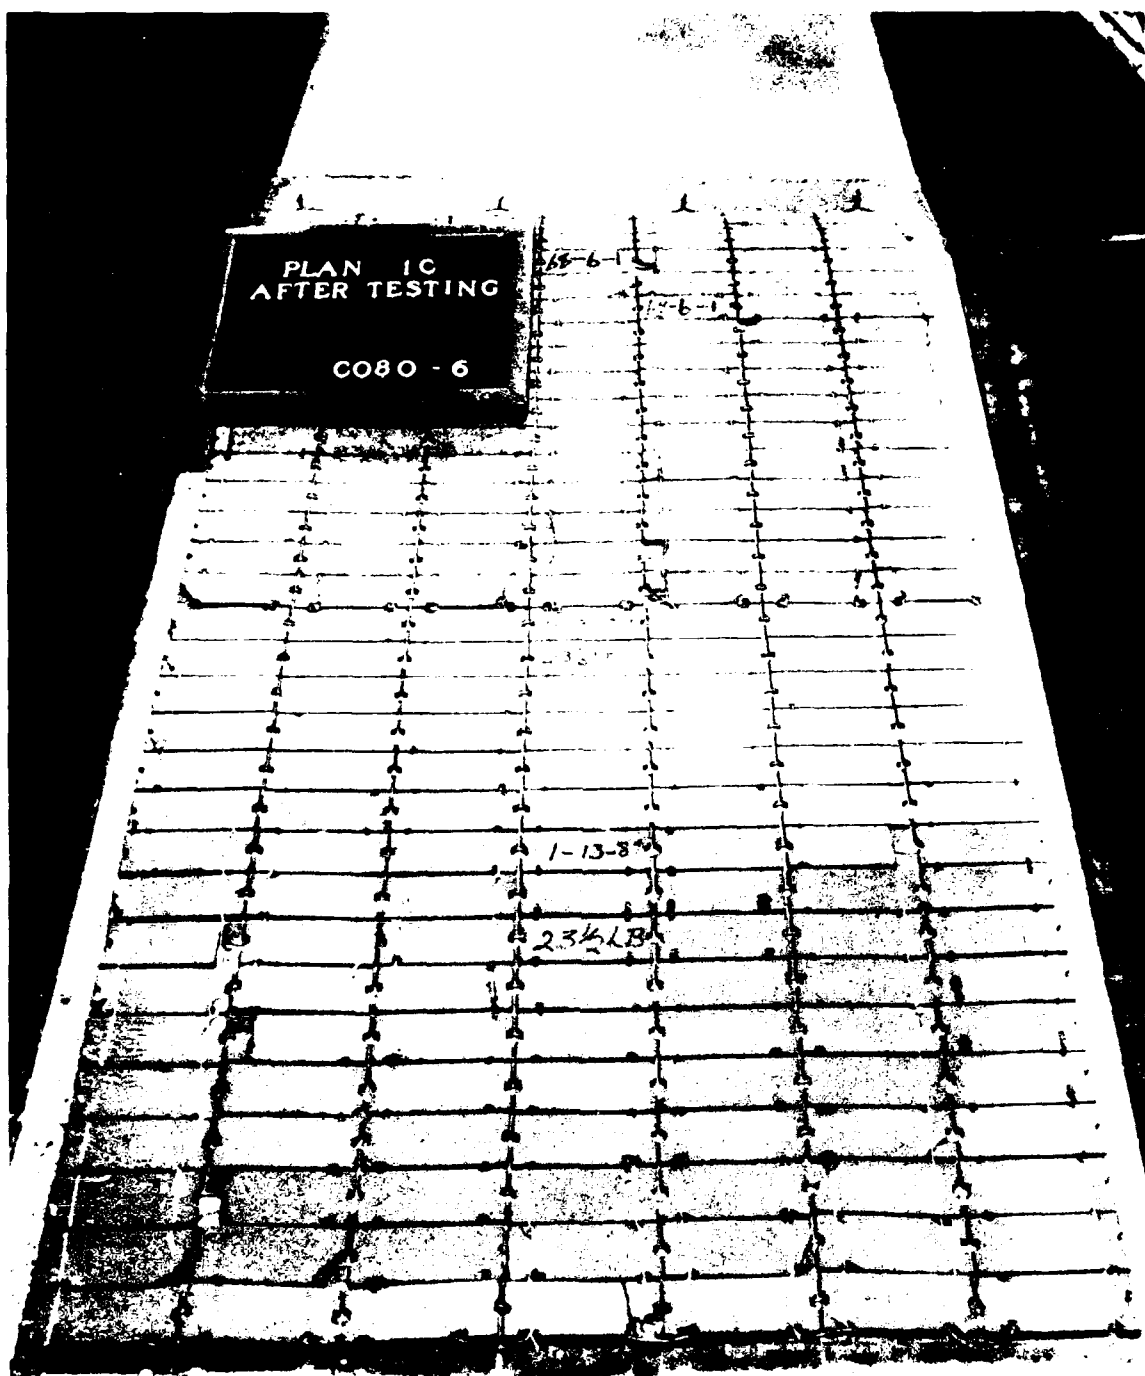
Photo 5. Side view of Plan 1C after wave attack

Photo 6. Sea-side view of Plan IC after wave attack

16. Plan 1C was similar to Plan 1B except additional anchors were added at alternate joints from the swl to the toe. As expected, this plan proved stable for all wave heights. Maximum runup was unchanged.

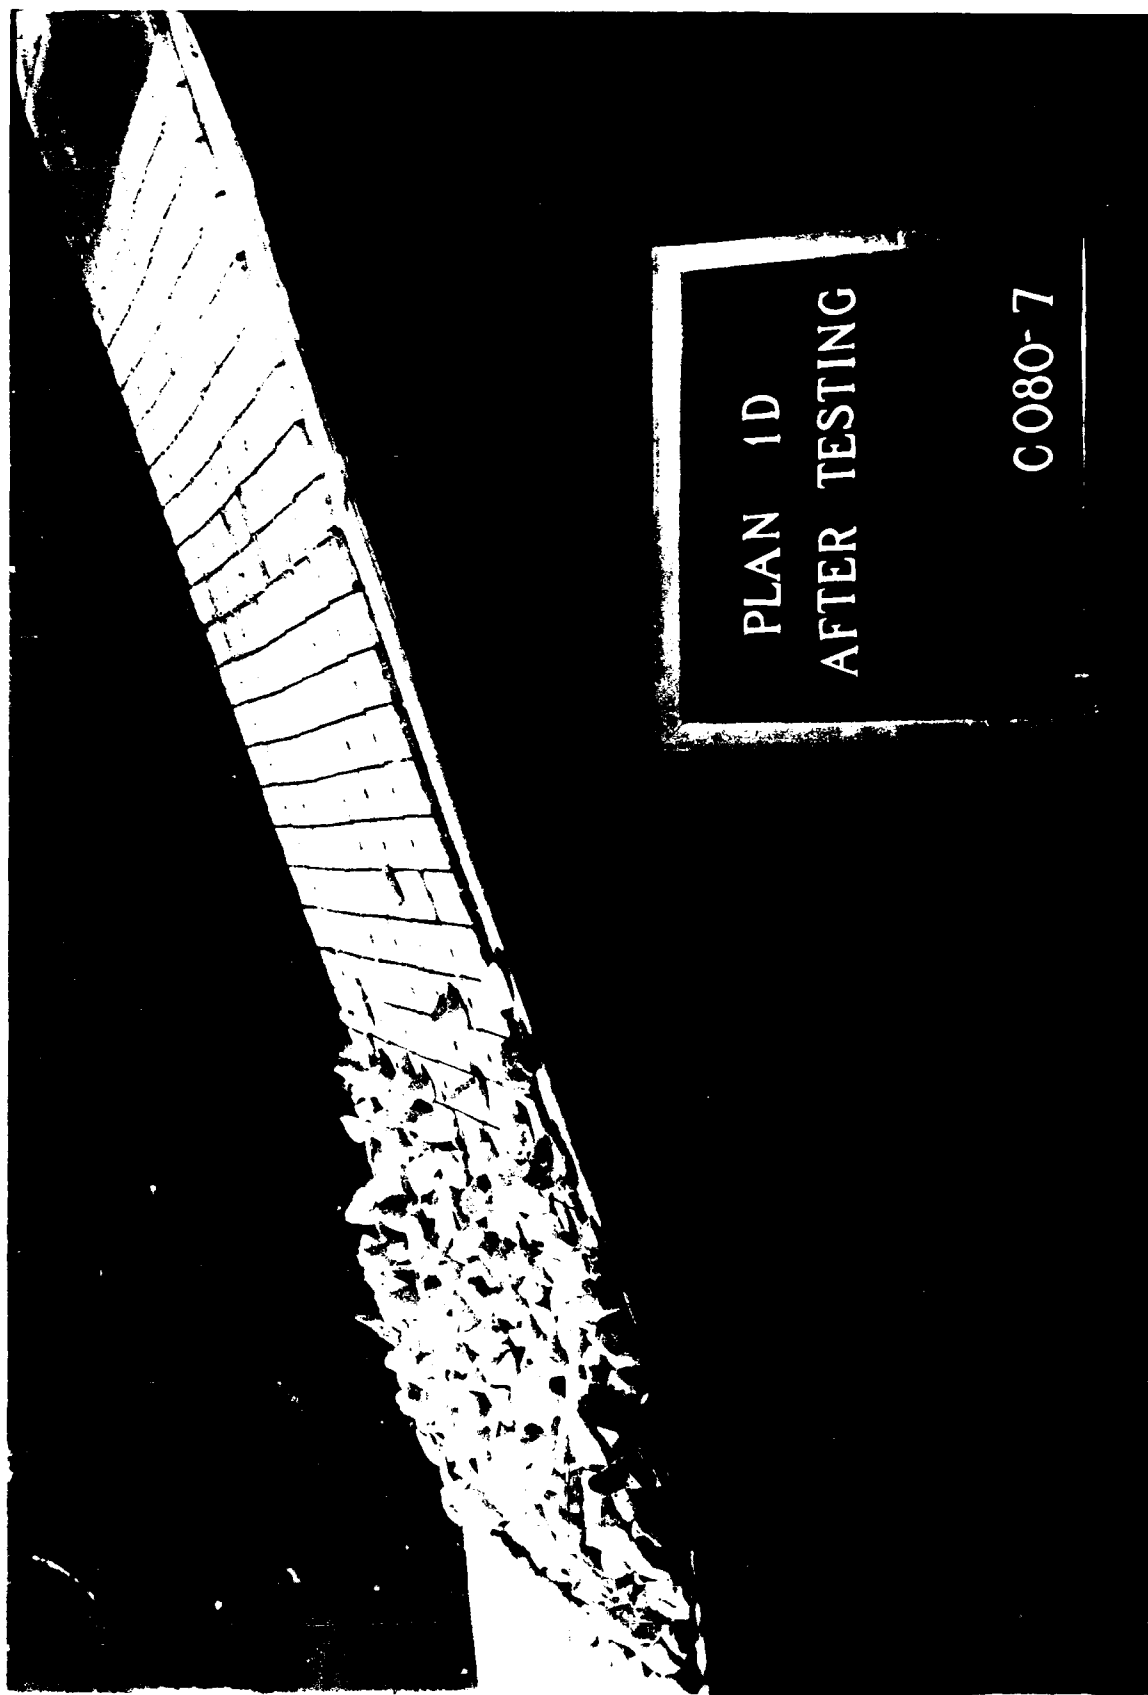
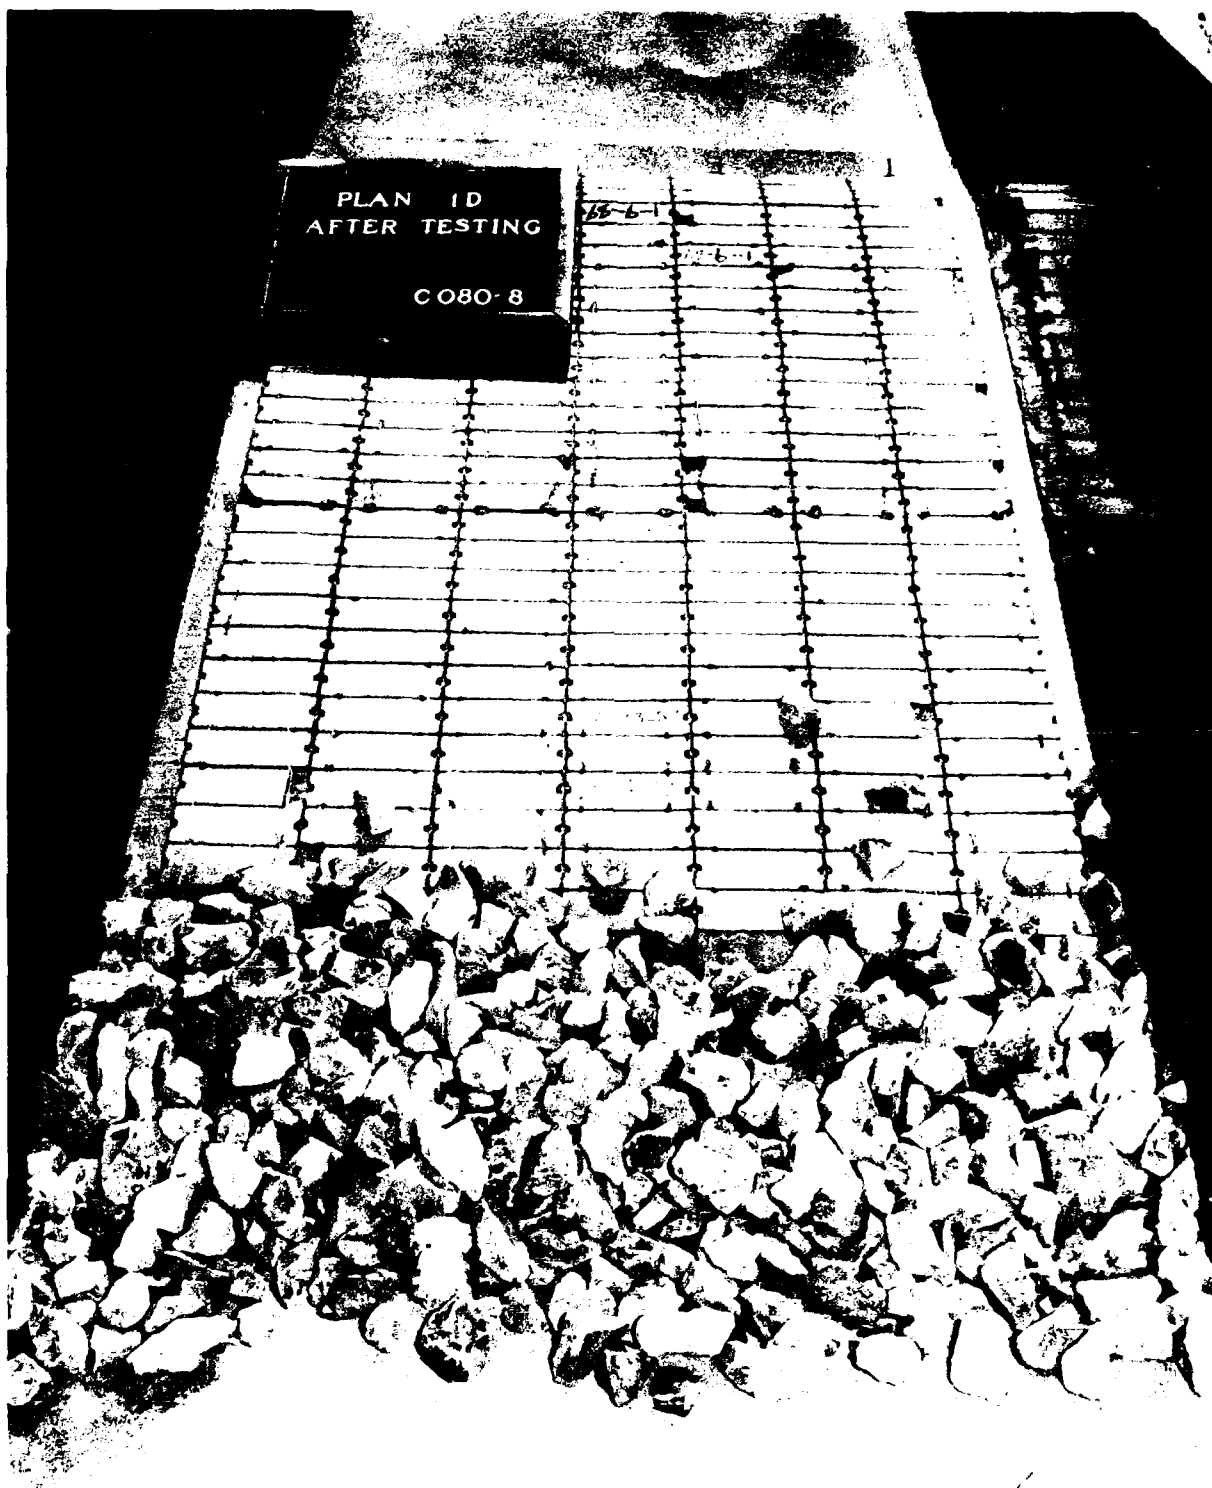
Photo 7. Side view of Plan 1D after wave attack

Photo 8. Sea-side view of Plan 1D after wave attack

17. Plan 1D was secured by top anchors and a 6-ft-wide, two-layer berm of 500-lb toe stone. This plan proved to be stable for 2- and 3-ft waves; however, the 4-ft waves produced significant movement of the toe stone and the 5- and 6-ft waves caused excessive numbers of toe stone to roll upslope and downslope. Excessive lifting of the mat also was observed in the vicinity of the swl for 5- and 6-ft waves. Maximum runup was reduced to +28.5.
