TECHNICAL REPORT CERC-89-12

# STABILITY OF ARTICULATED CONCRETE MATTRESSES FOR HERBERT HOOVER DIKE IMPROVEMENTS LAKE OKEECHOBEE, FLORIDA

Coastal Model Investigation

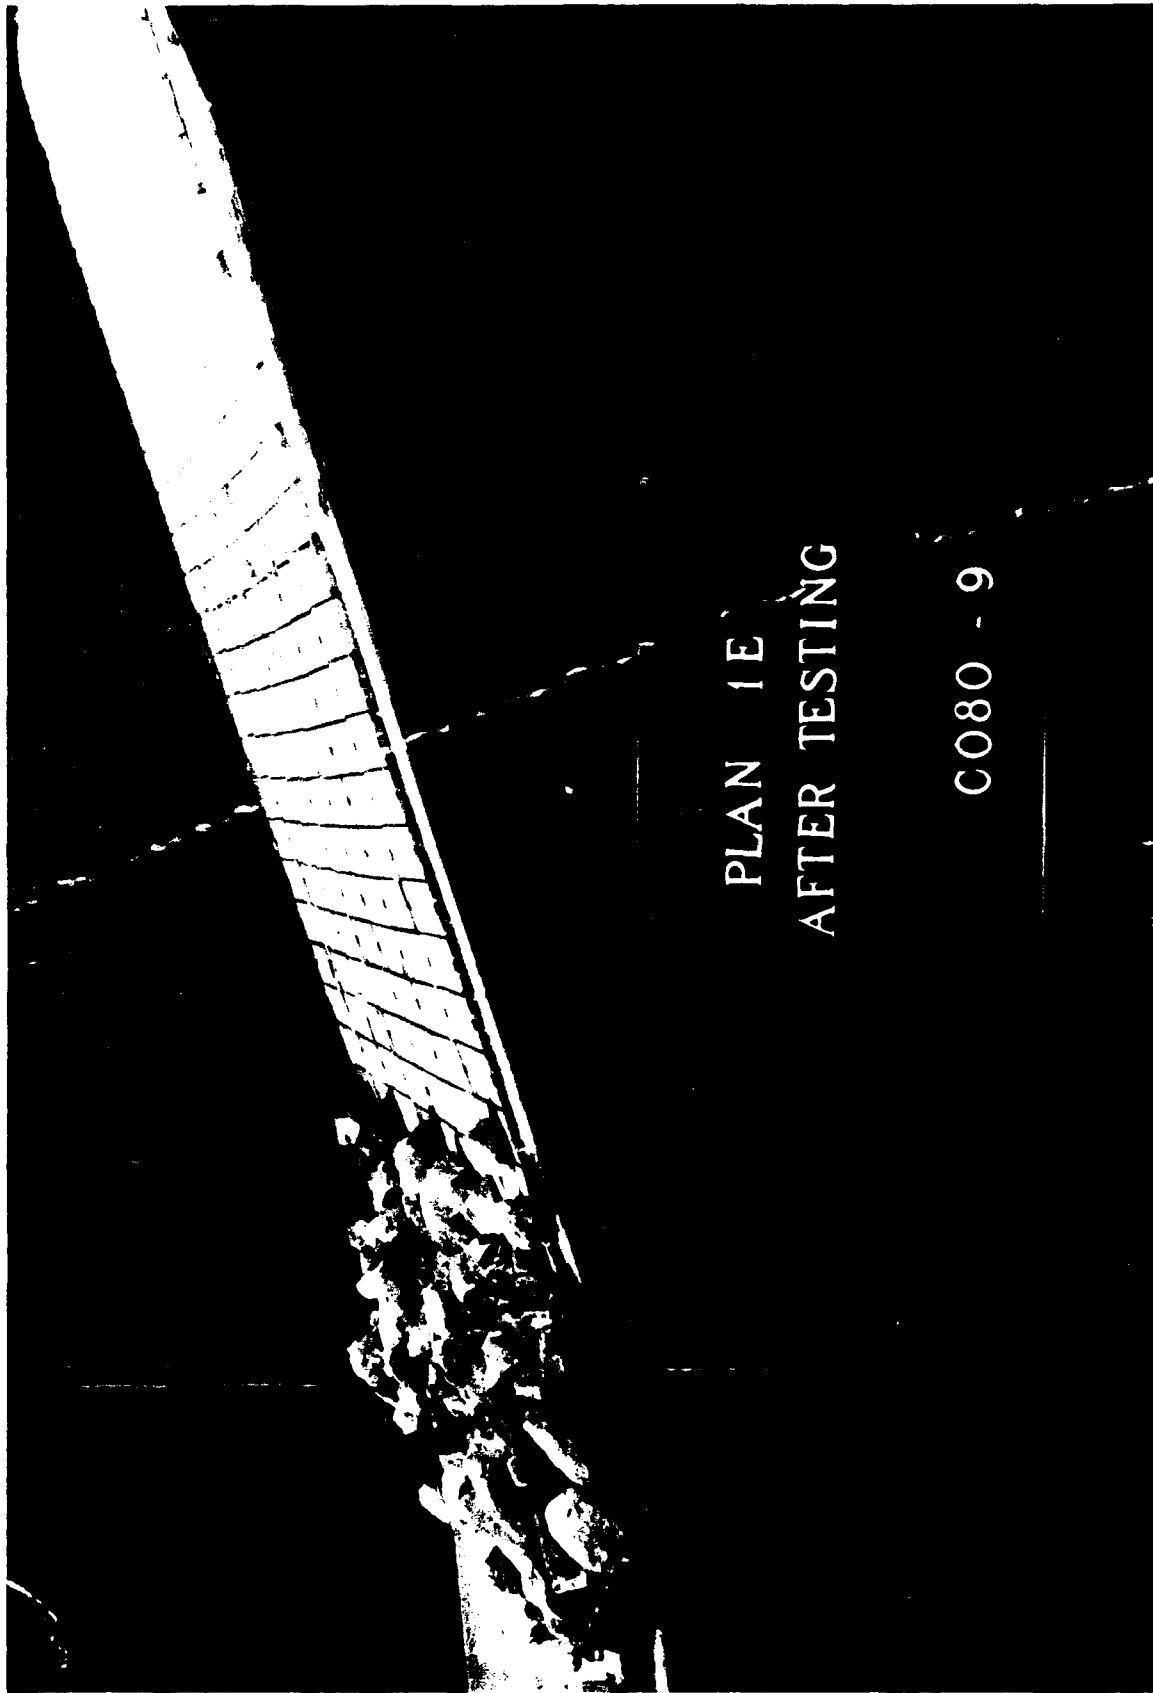
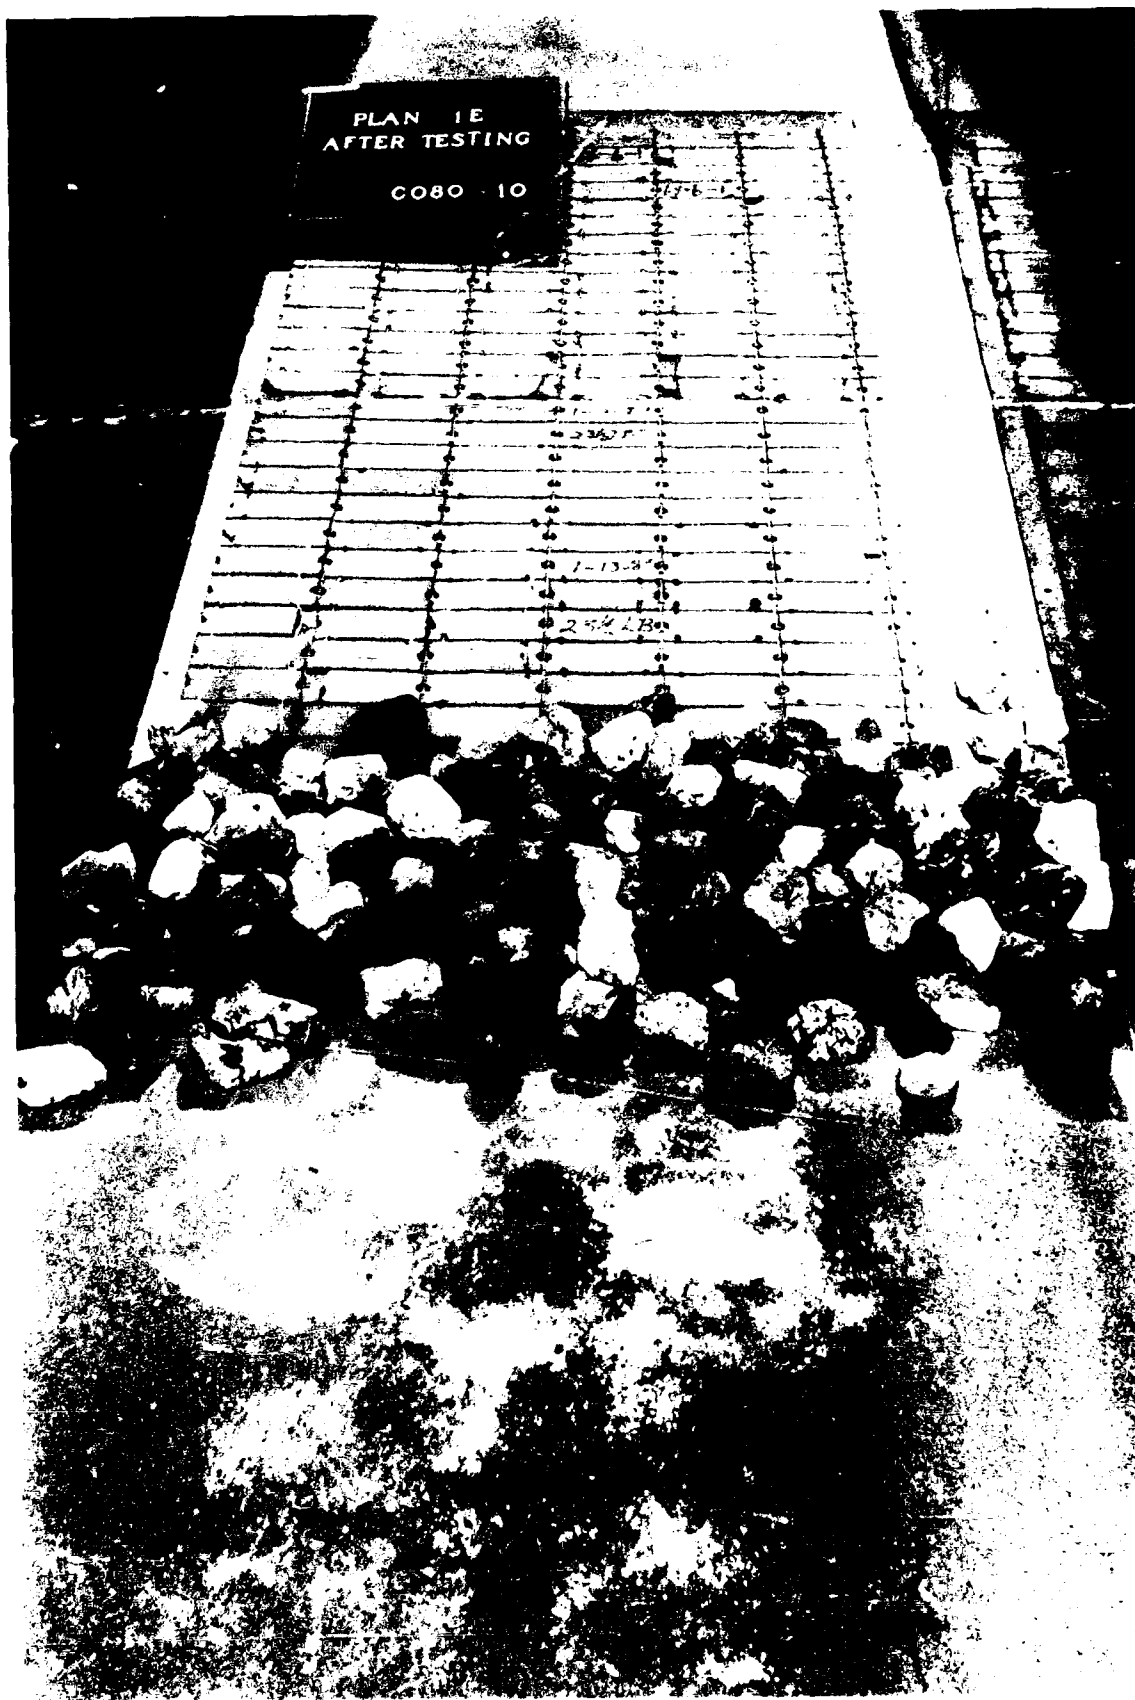
Photo 9. Side view of Plan 1E after wave attack

Photo 10. Sea-side view of Plan 1E after wave attack

18. Plan 1E was the same as Plan 1D except the toe stone weight was increased to 800 lb. Tests proved the plan to be stable for up to 4-ft waves; however, the 5- and 6-ft waves still caused excessive movement of toe stone upslope and downslope and produced significant lifting of the mat in the vicinity of the swl. Maximum runup was unchanged at +28.5.

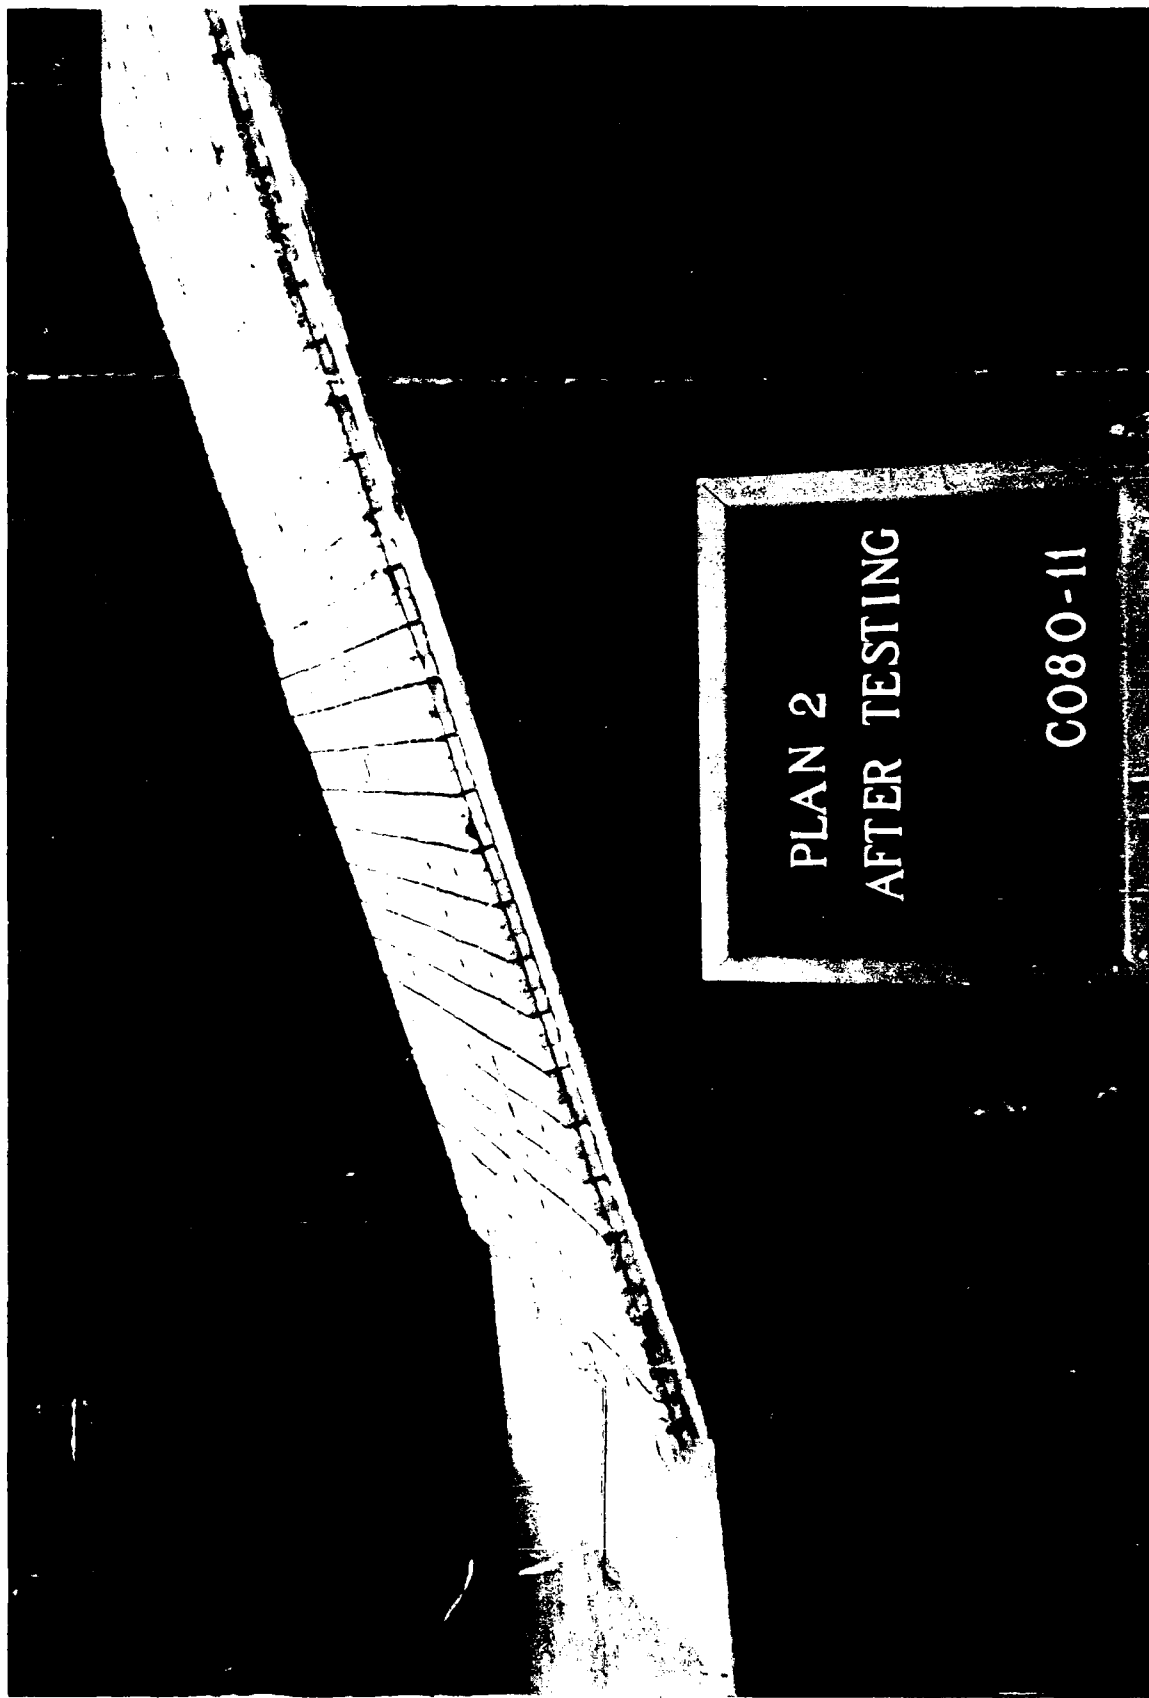
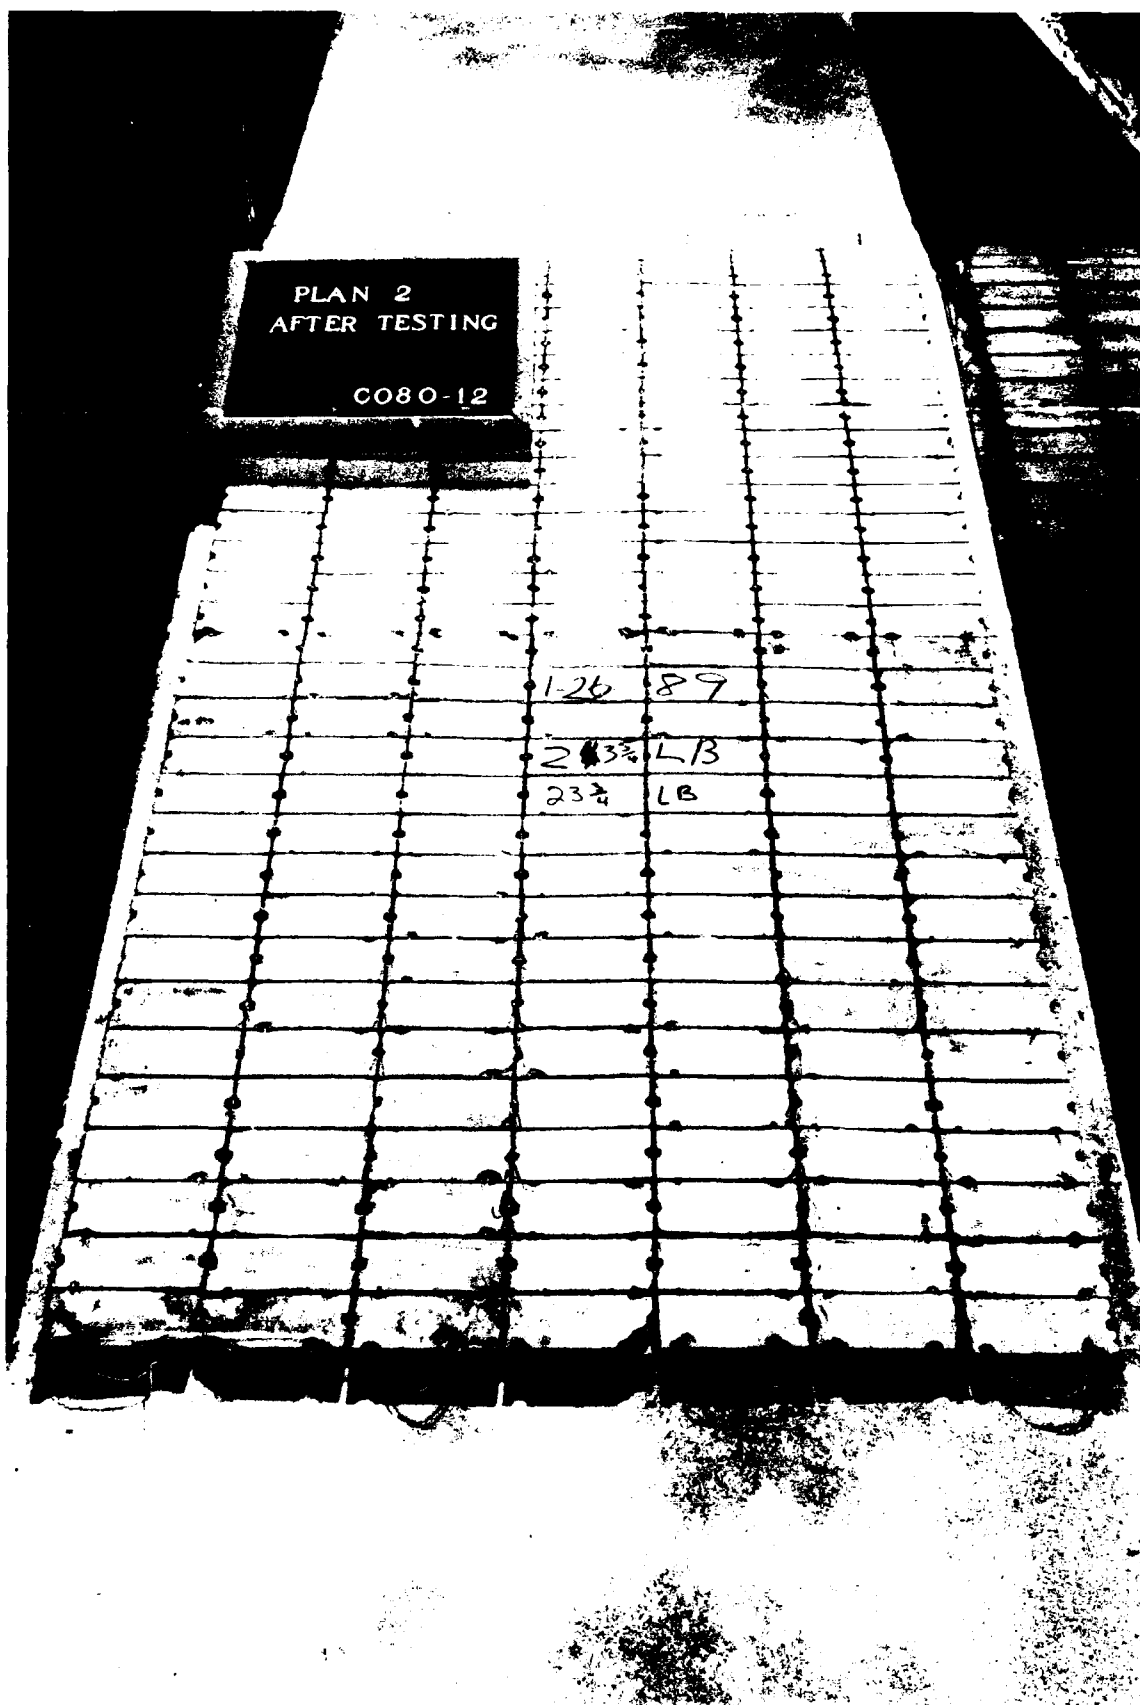
Photo 11. Side view of Plan 2 after wave attack

Photo 12. Sea-side view of Plan 2 after wave attack

19. Plan 2 consisted of two layers of mats laced together at intervals of every other block and every other row and secured by top anchors. This plan was stable for 2-, 3-, and 4-ft waves; however, both the 5- and 6-ft waves produced lifting of the toe. Maximum observed runup was the same as Plans 1 through 1C (+29).

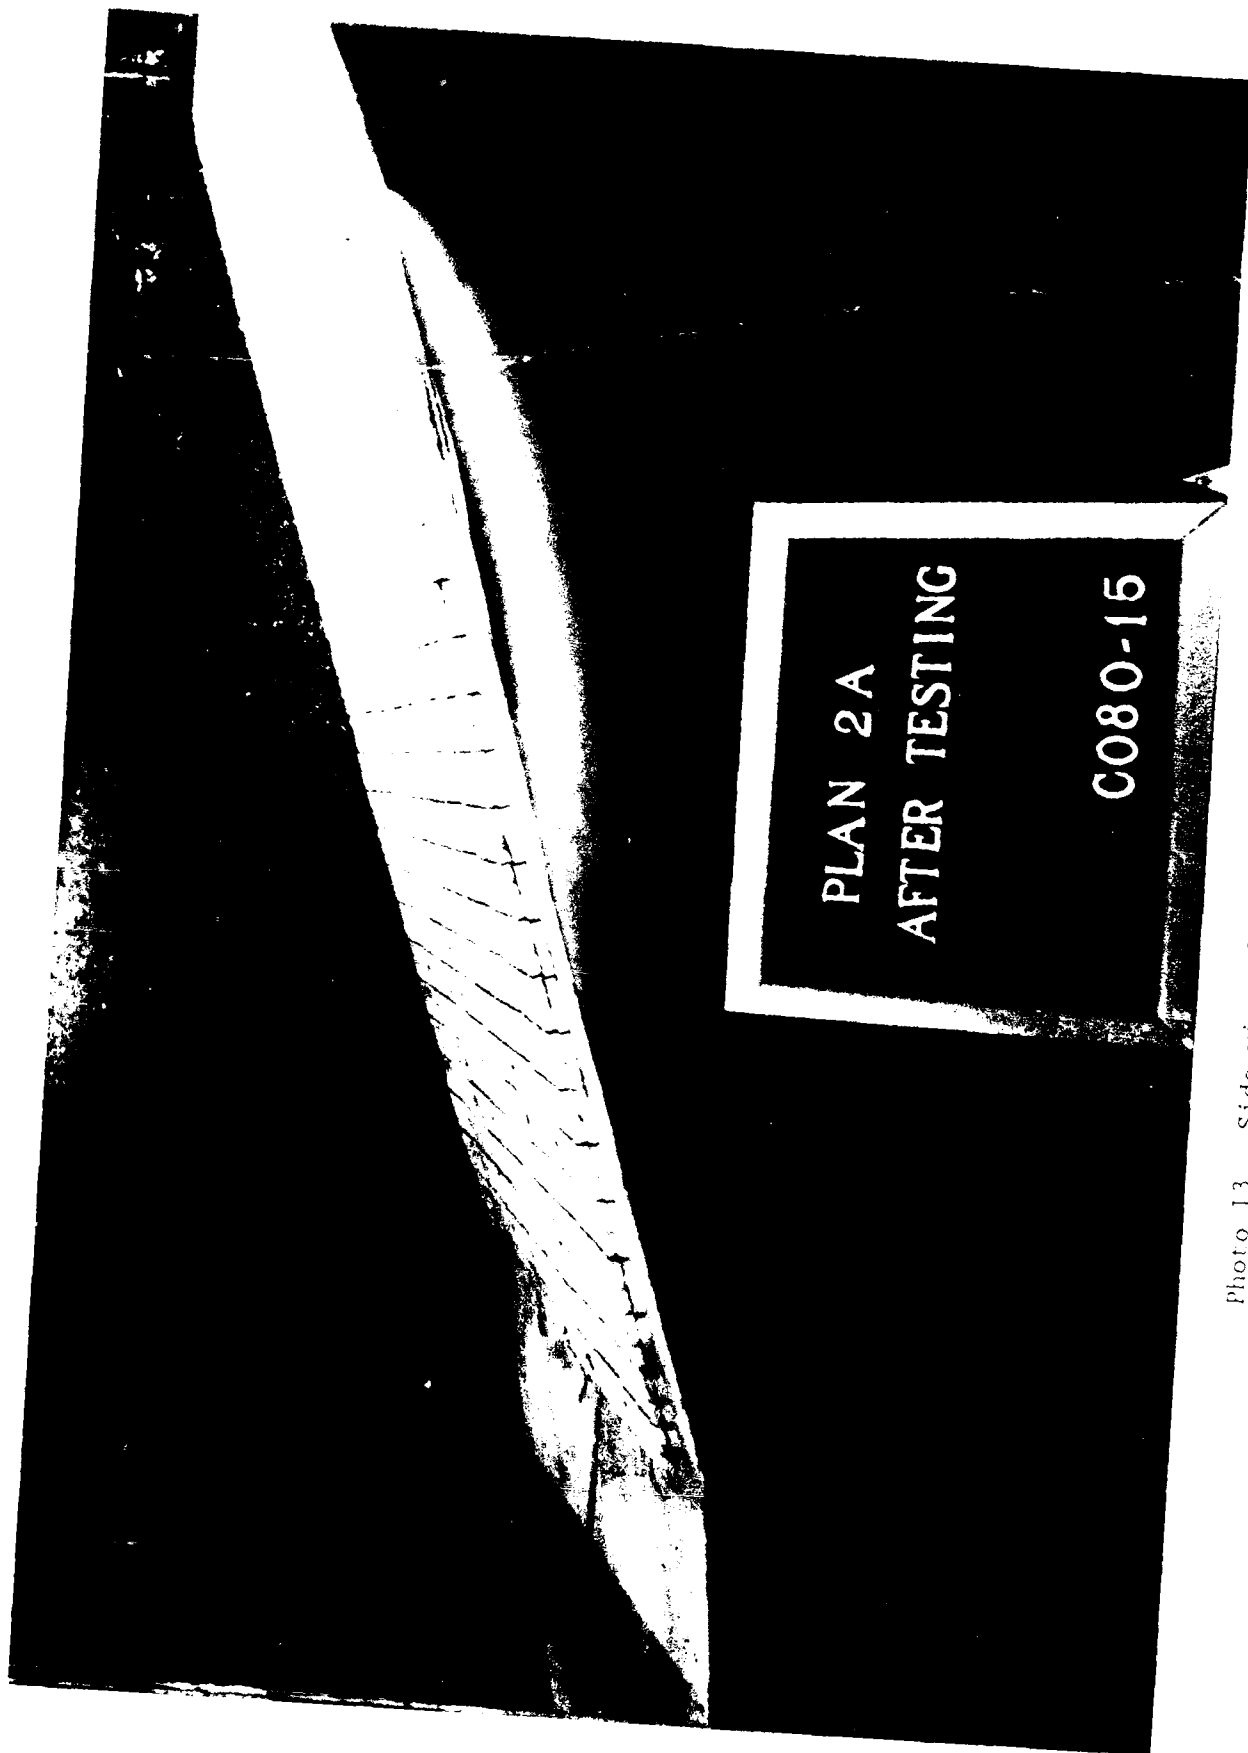
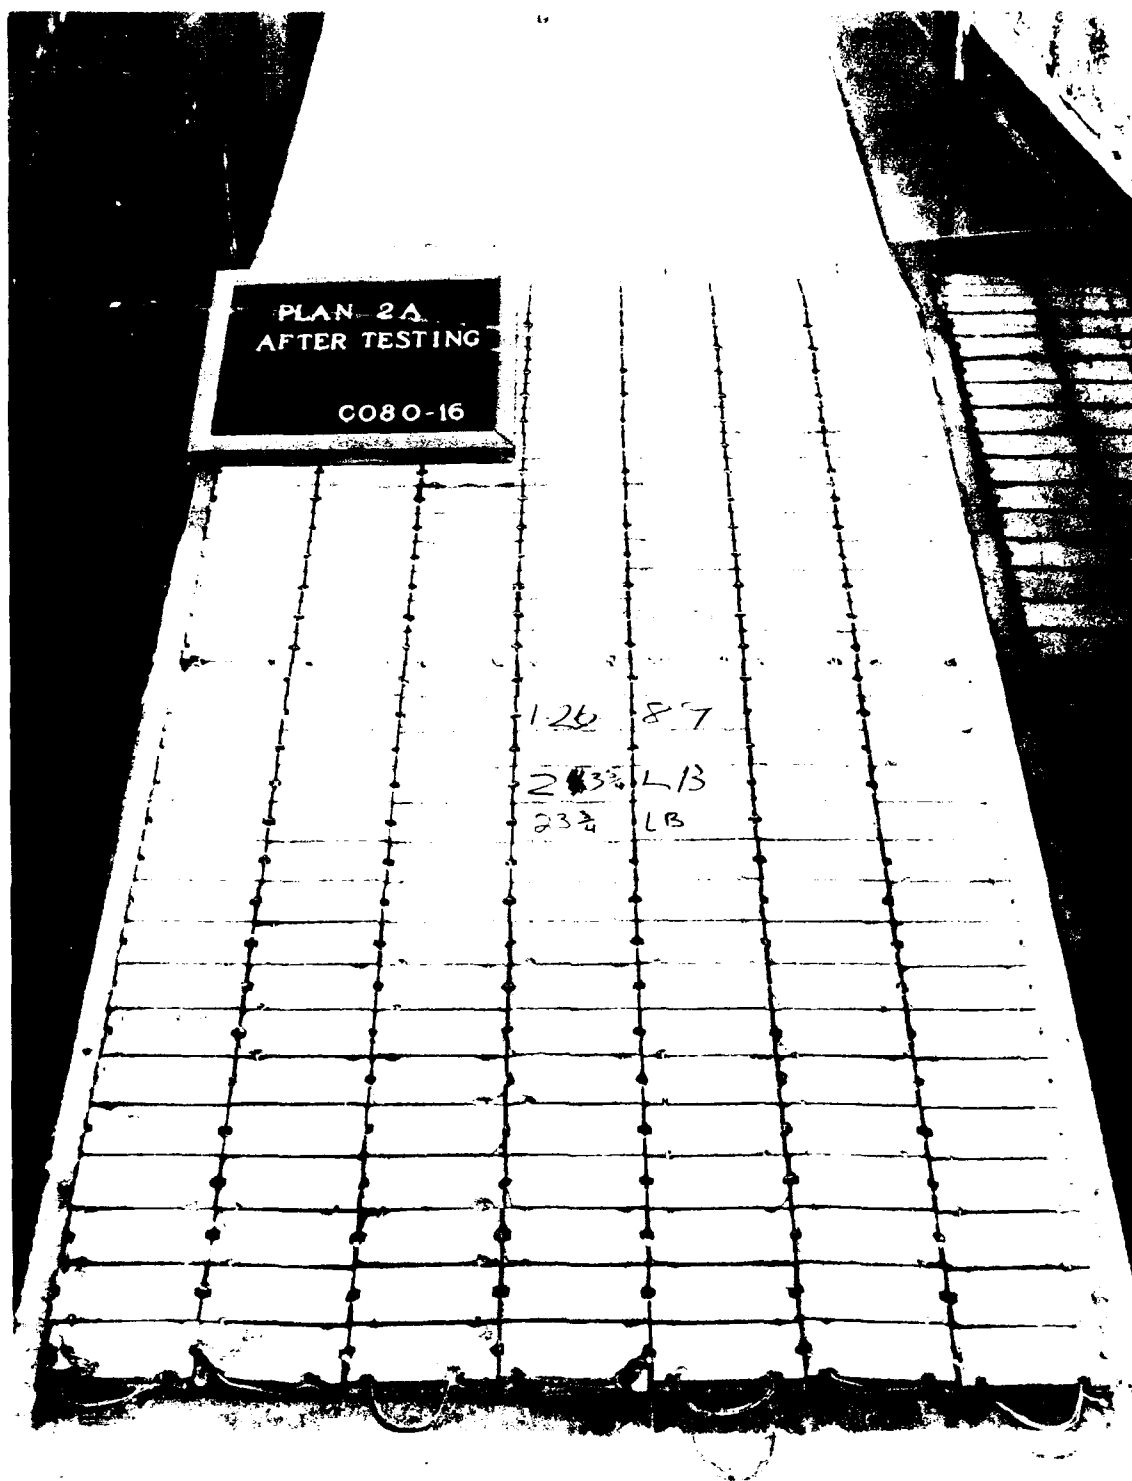
Photo 13. Side view of Plan 2A after wave attack

Photo 14. Sea-side view of Plan 2A after wave attack

20. Plan 2A was the same as Plan 2 except two rows of toe anchors were added. Stability improved; however, slight localized lifting of the mat was observed in the vicinity of the swl for the 5- and 6-ft waves. Maximum runup was unchanged at +29.

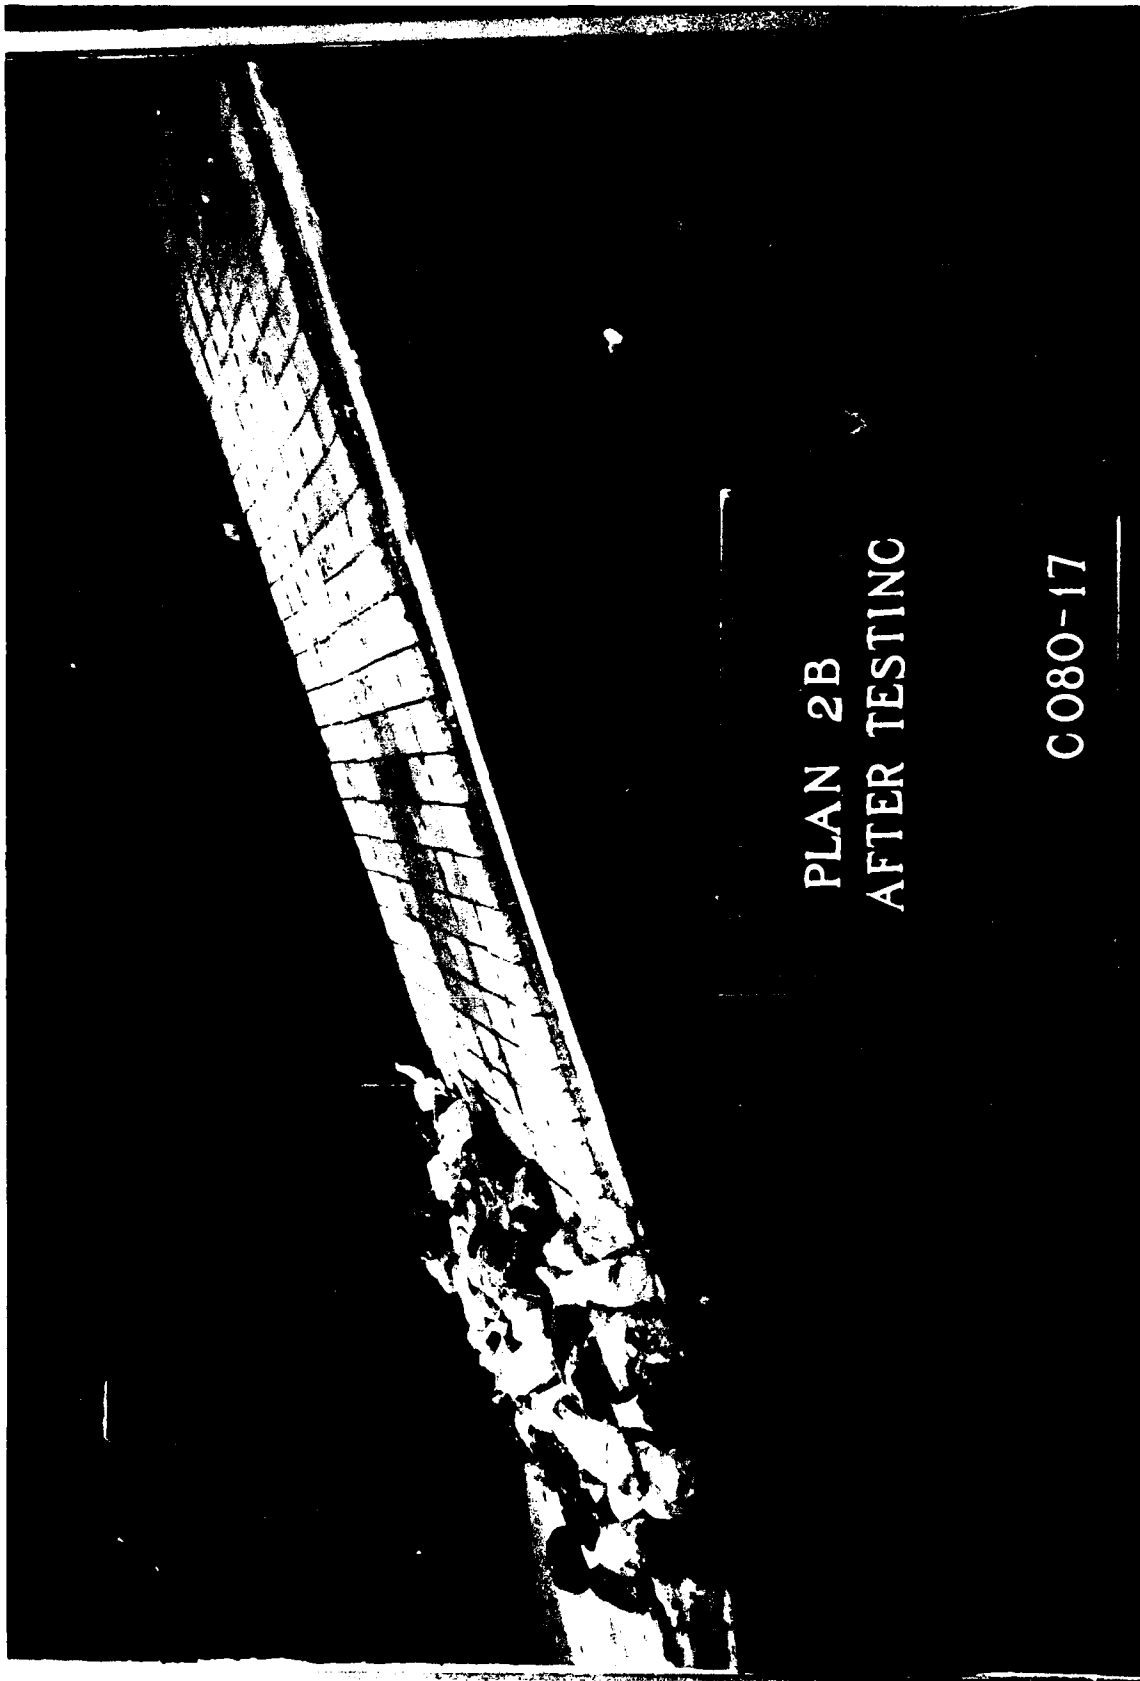
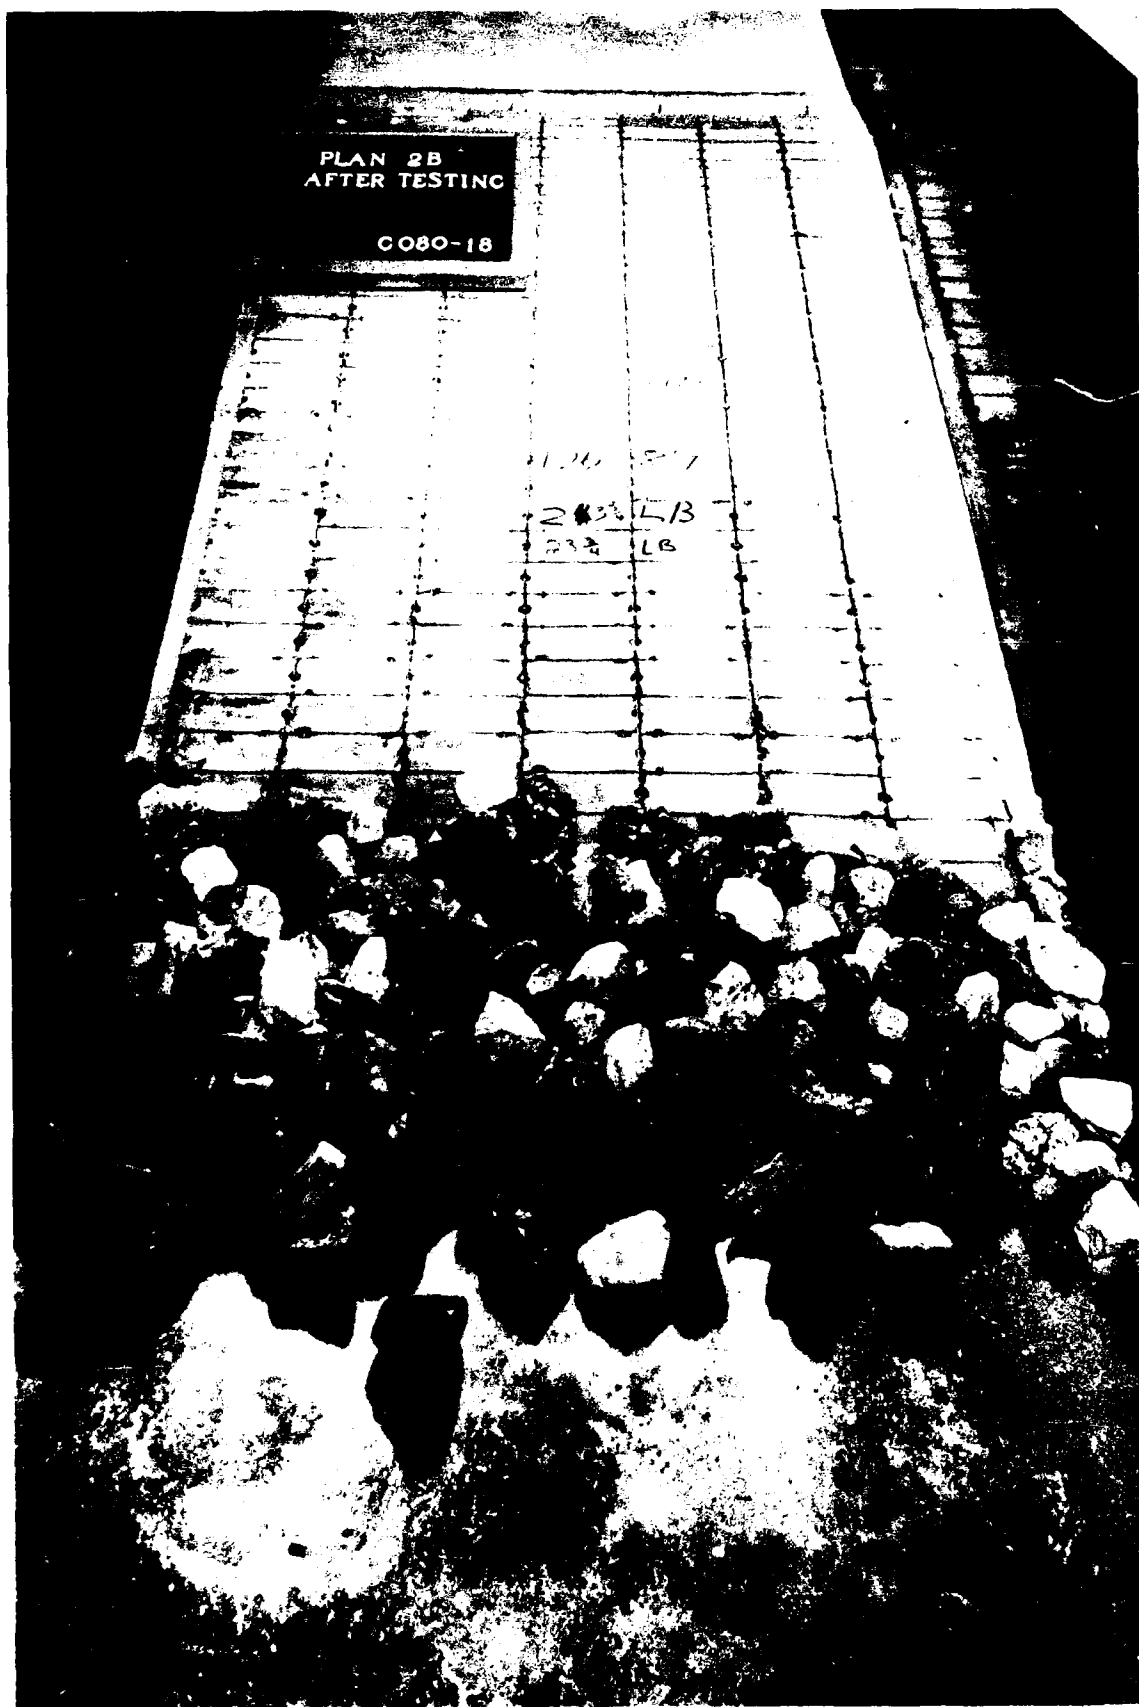
Photo 15. Side view of Plan 2B after wave attack

Photo 16. Sea-side view of Plan 2B after wave attack

21. Plan 2B was secured by top anchors and a 6-ft-wide, two-layer berm of 800-lb toe stone. This plan proved to be stable for 2-, 3-, and 4-ft waves; however, the 5- and 6-ft waves caused excessive movement of toe stone upslope and downslope. Very minor localized lifting of the mats in the

vicinity of the swl was observed during attack of the 5- and 6-ft waves. Maximum runup was reduced slightly to +28.5.

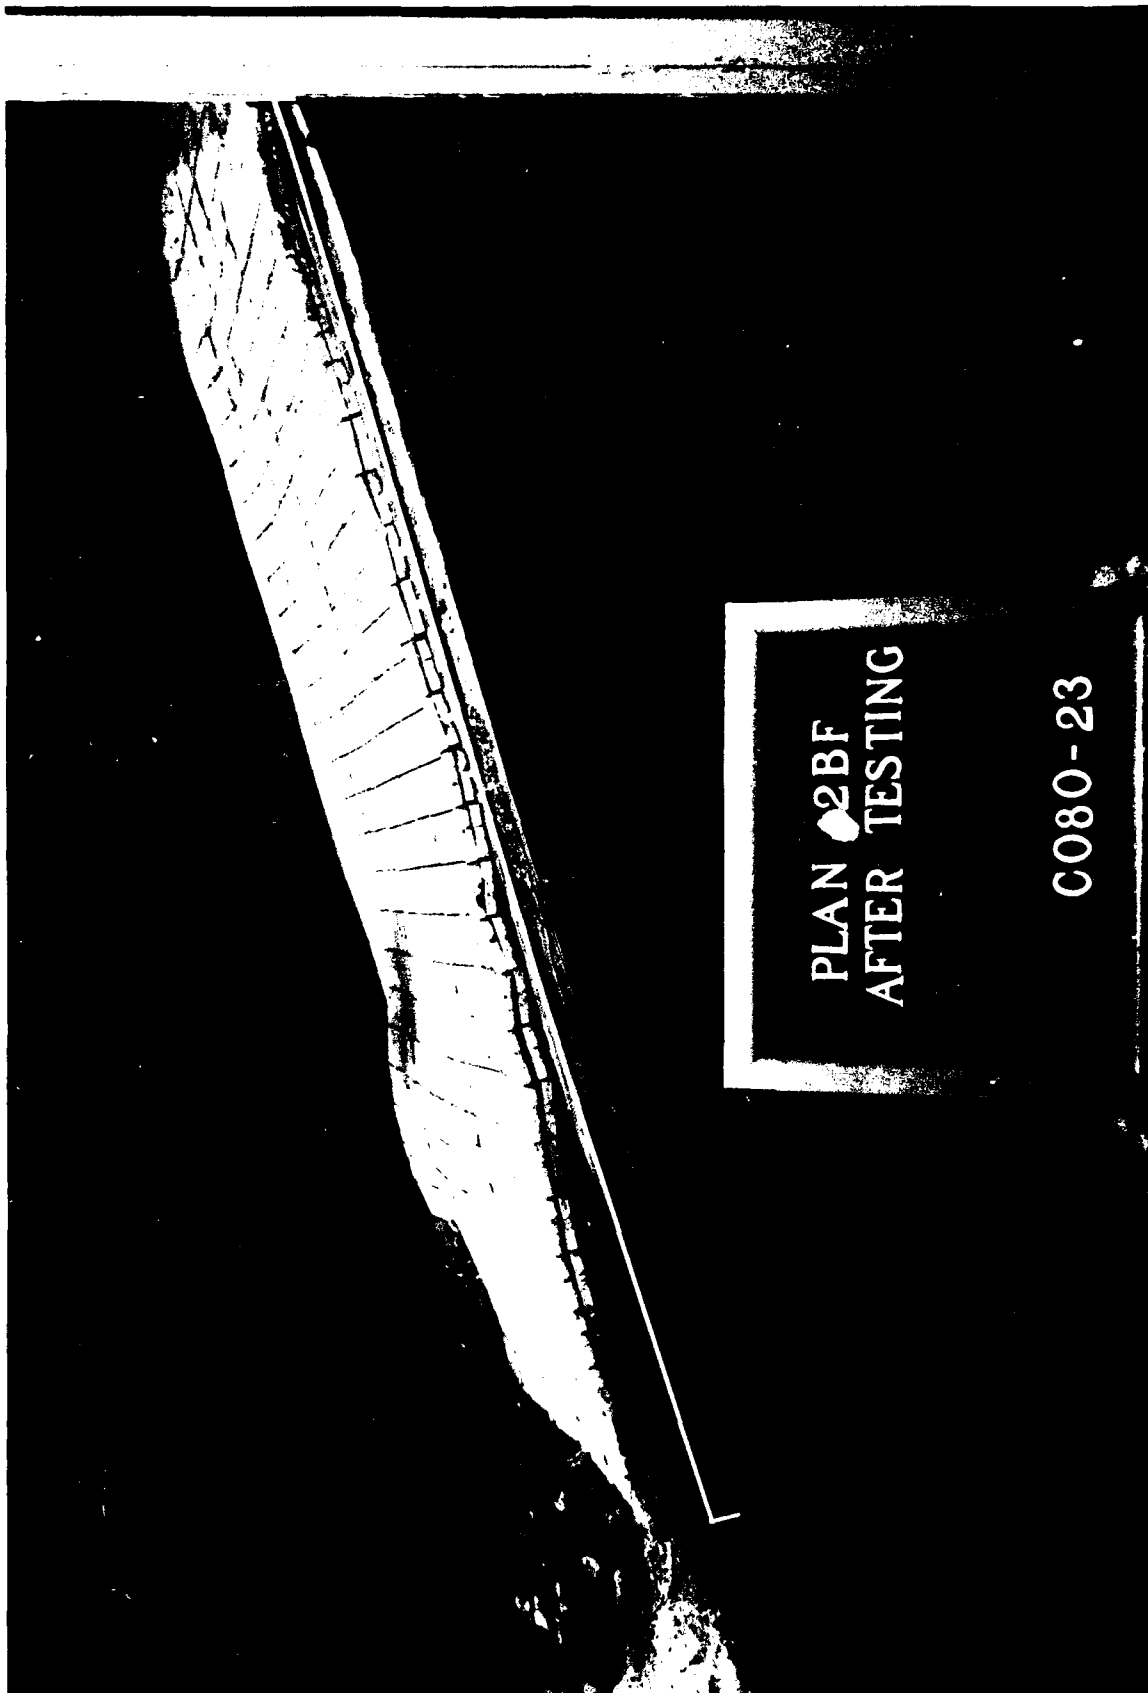
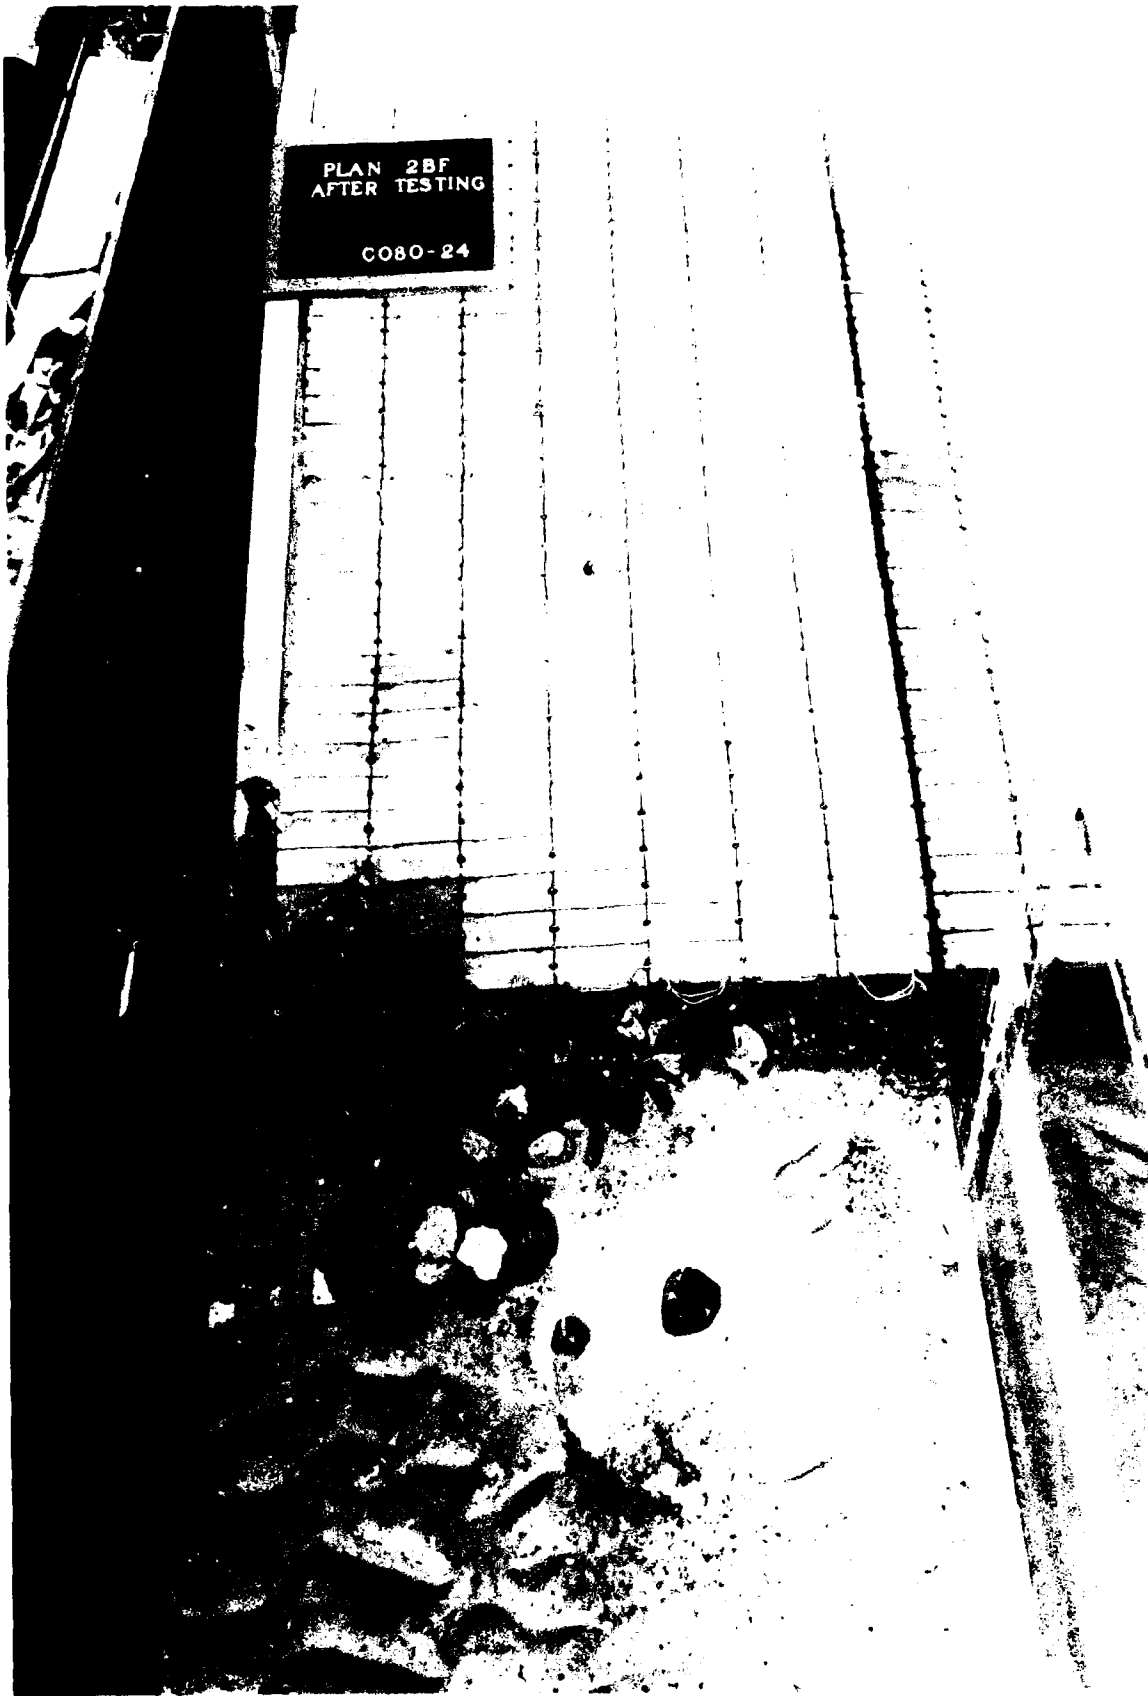
Photo 17. Side view of Plan 2BF after wave attack

Photo 18. Sea-side view of Plan 2BF after wave attack

22. Plan 2BF was the same as Plan 2B except a 1-ft-thick layer (prototype) of bedding stone was placed under the mats. As would be expected, the dynamic response of the mats and toe stone was the same as Plan 2B. The bedding stone proved to be stable for the 2-, 3-, and 4-ft waves; however, the 5-ft waves initiated downslope migration under the mats, and the 6-ft waves produced failure of the bedding stone.
