TECHNICAL REPORT CERC-89-12

# STABILITY OF ARTICULATED CONCRETE MATTRESSES FOR HERBERT HOOVER DIKE IMPROVEMENTS LAKE OKEECHOBEE, FLORIDA

Coastal Model Investigation

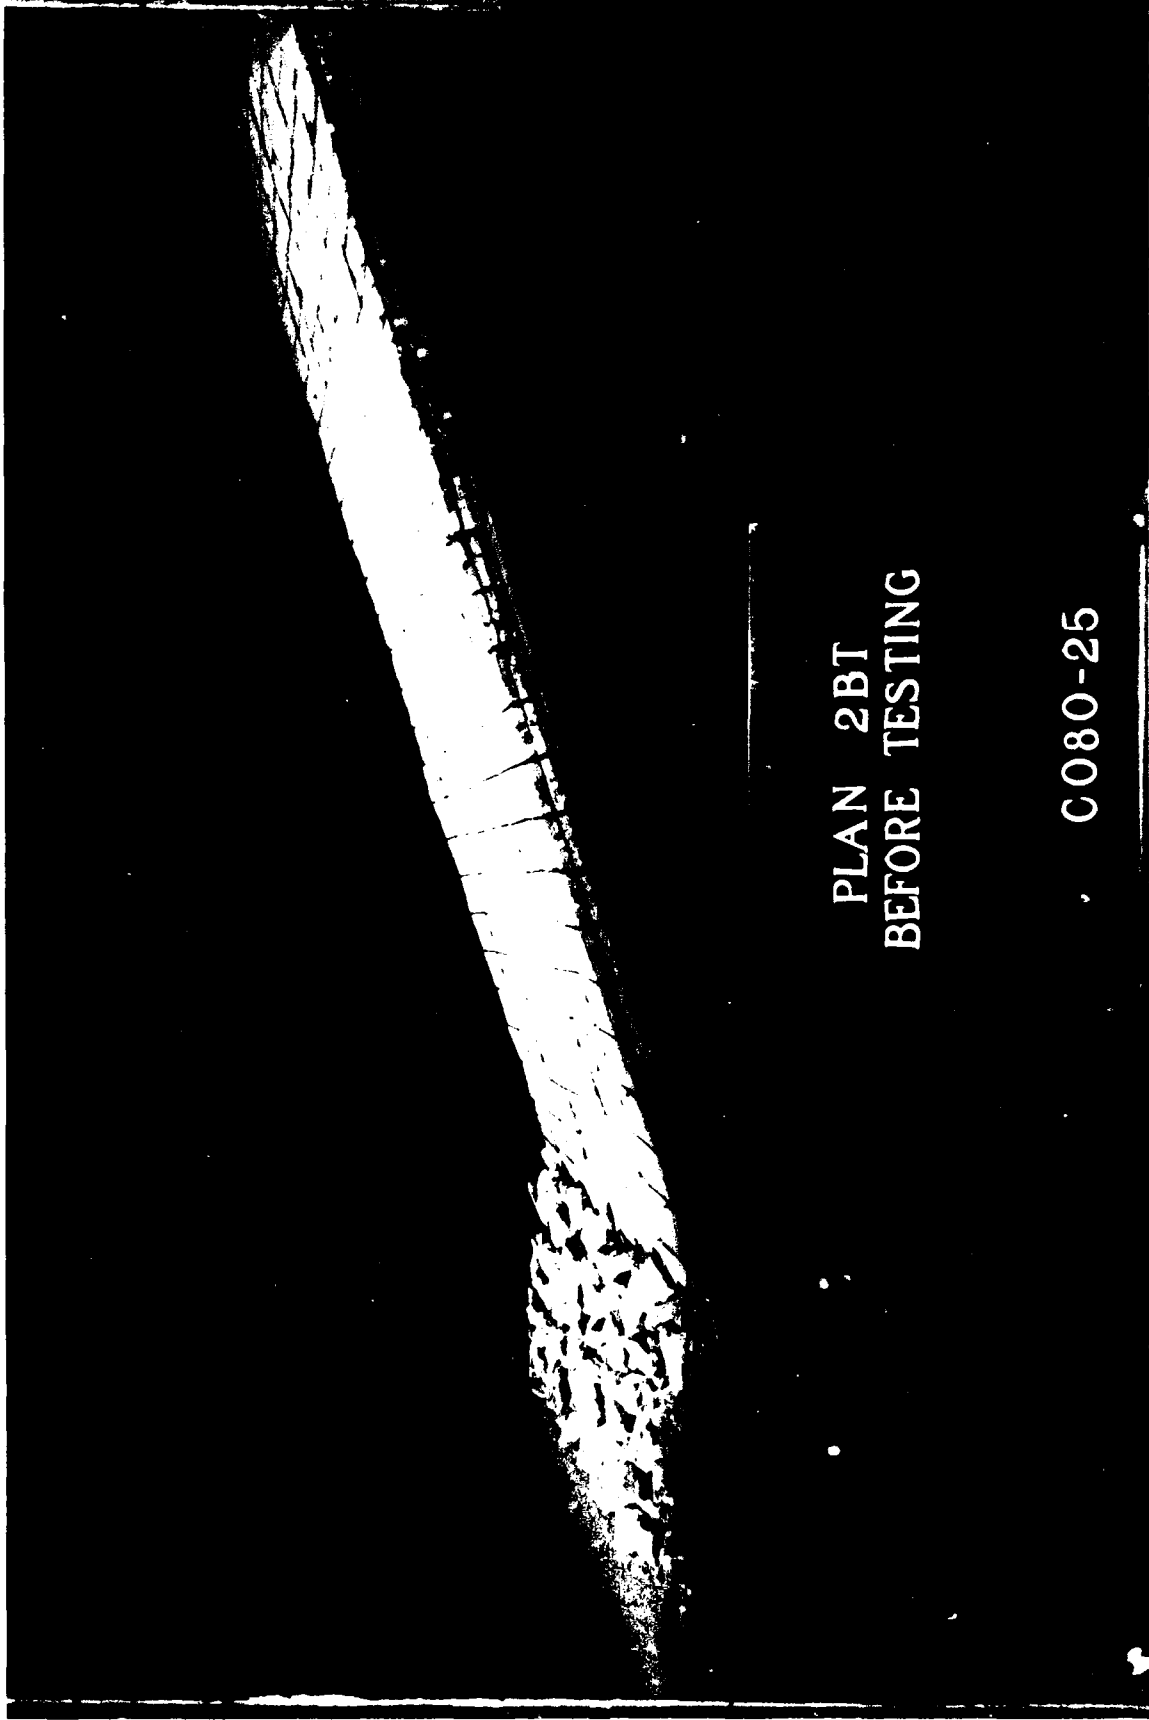
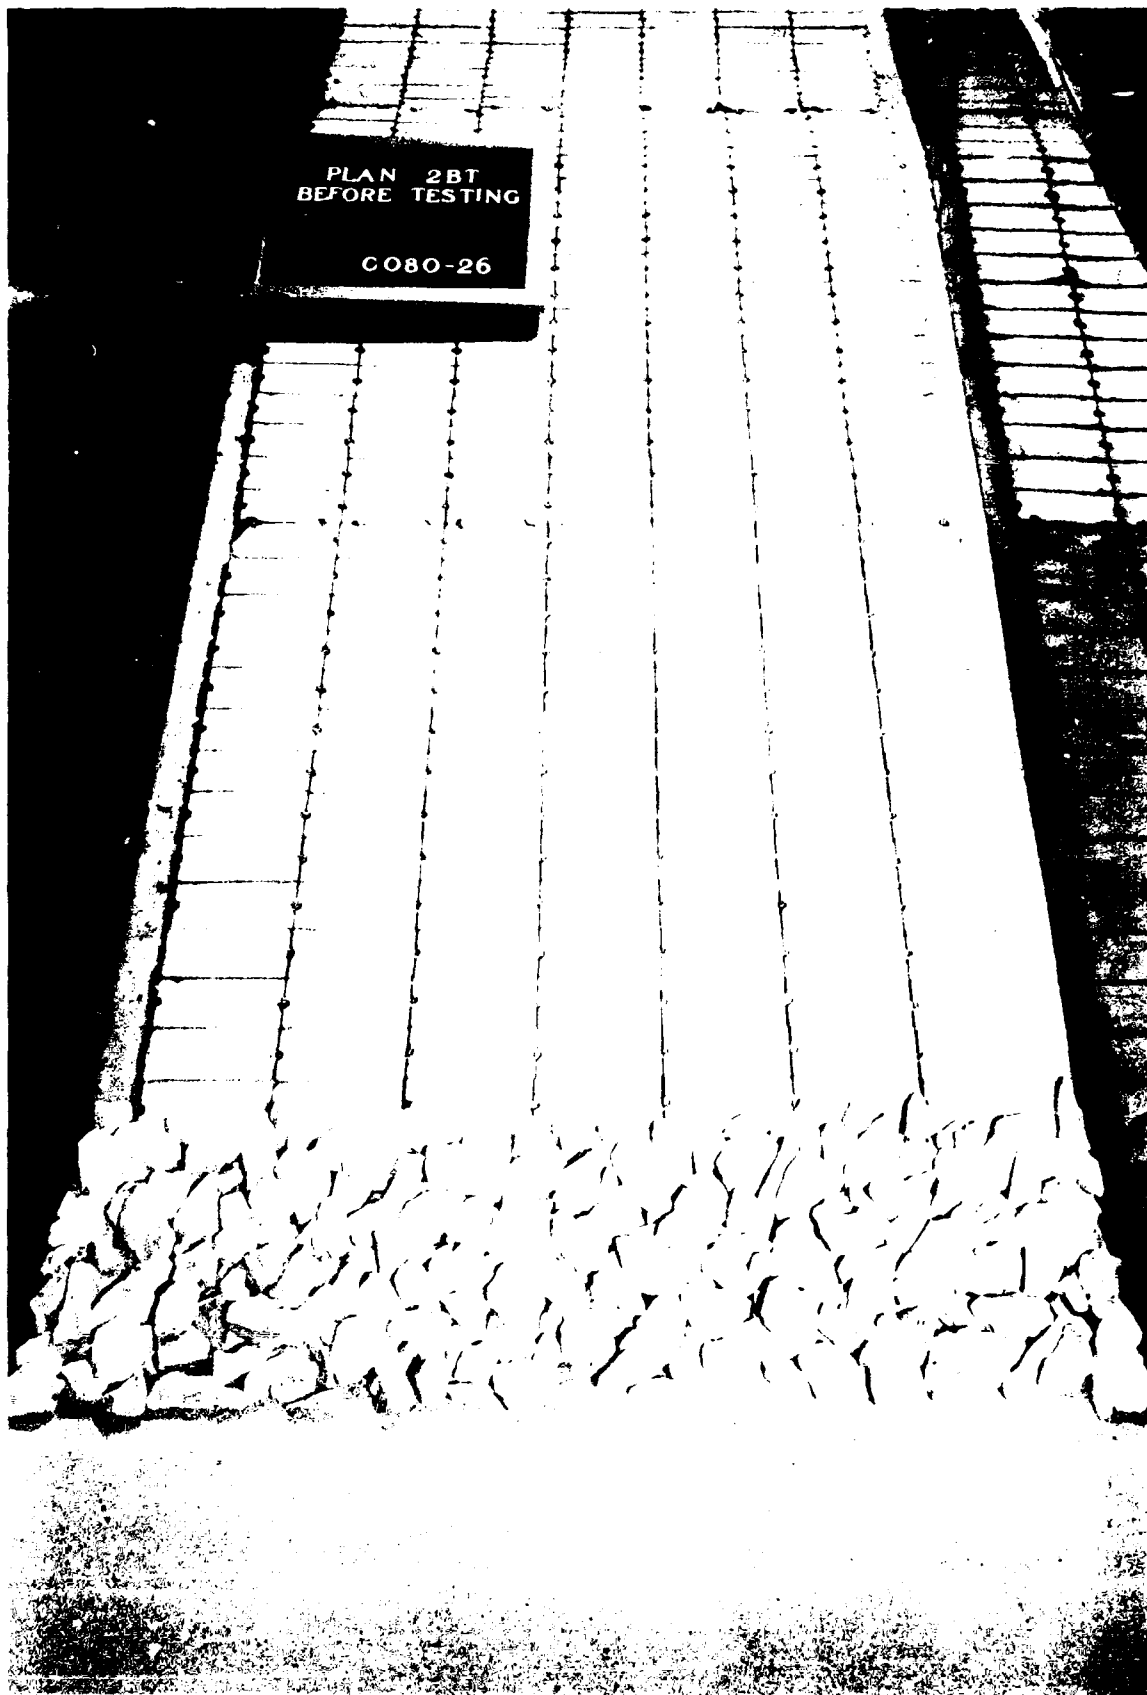
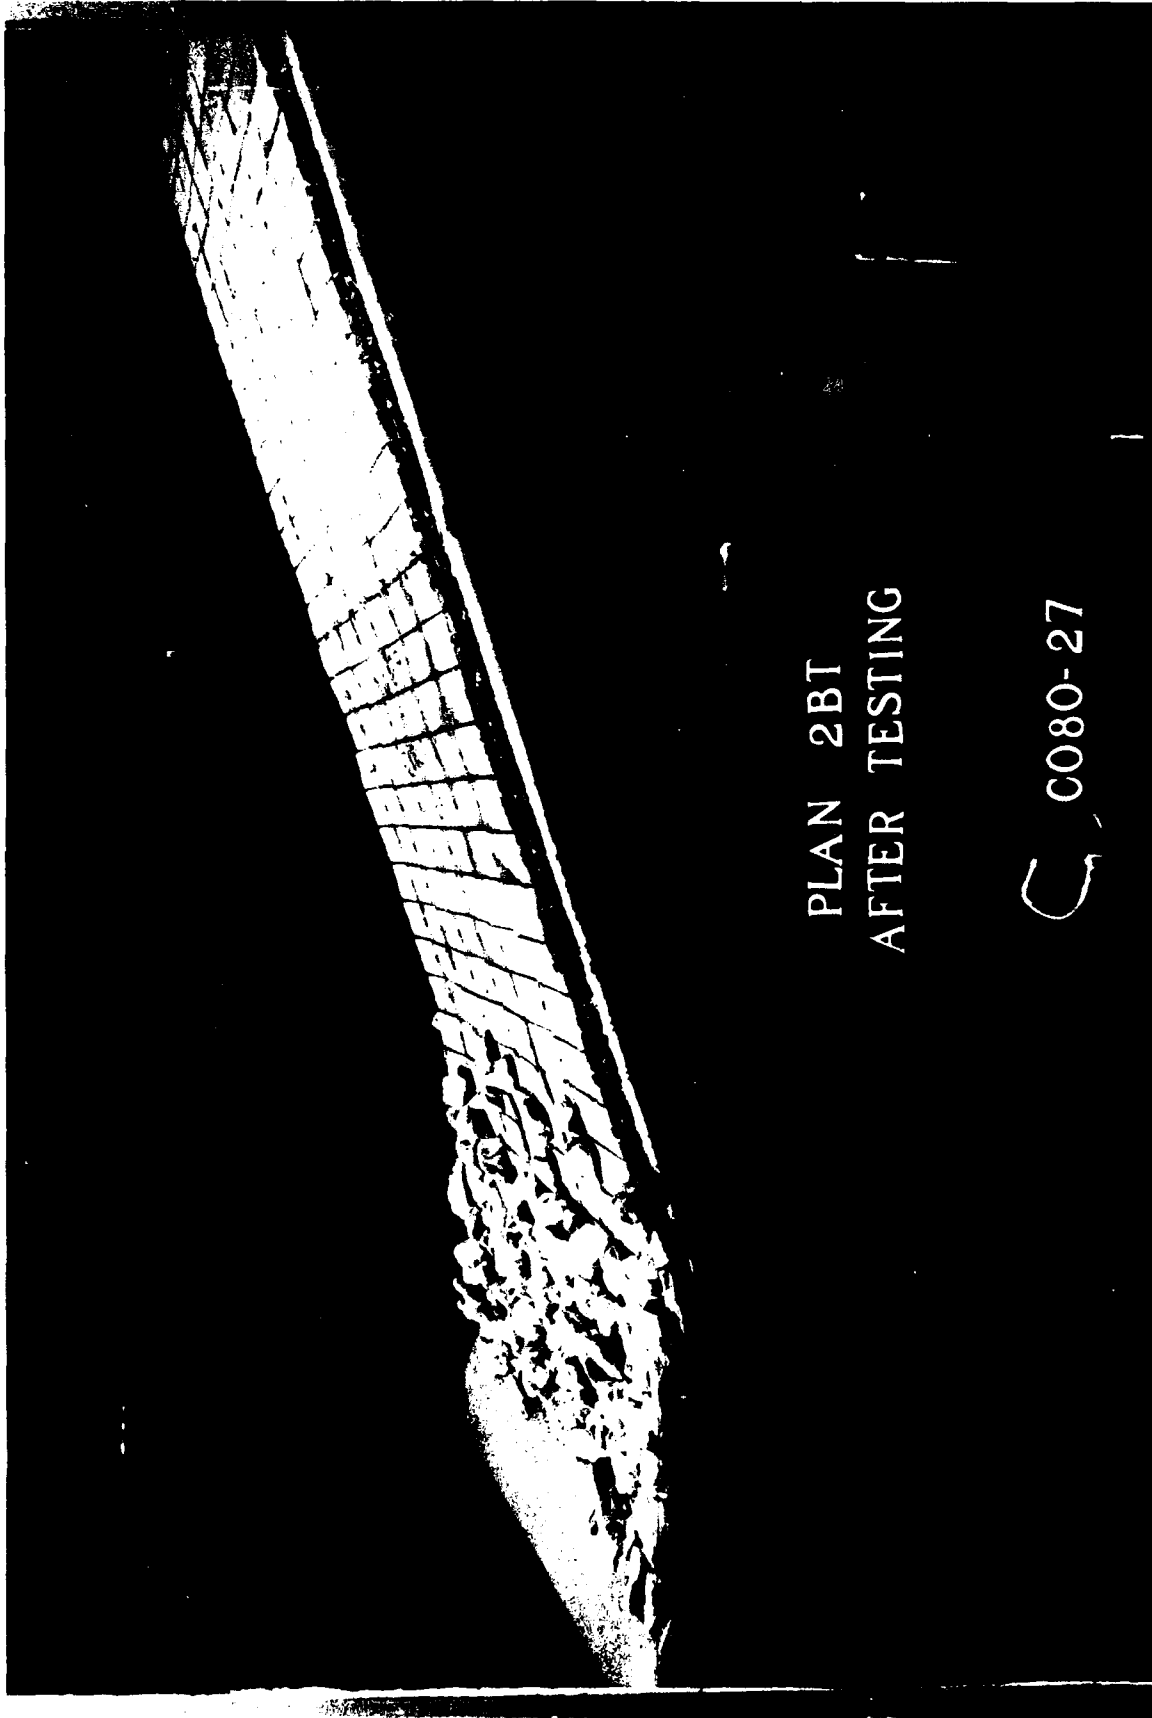
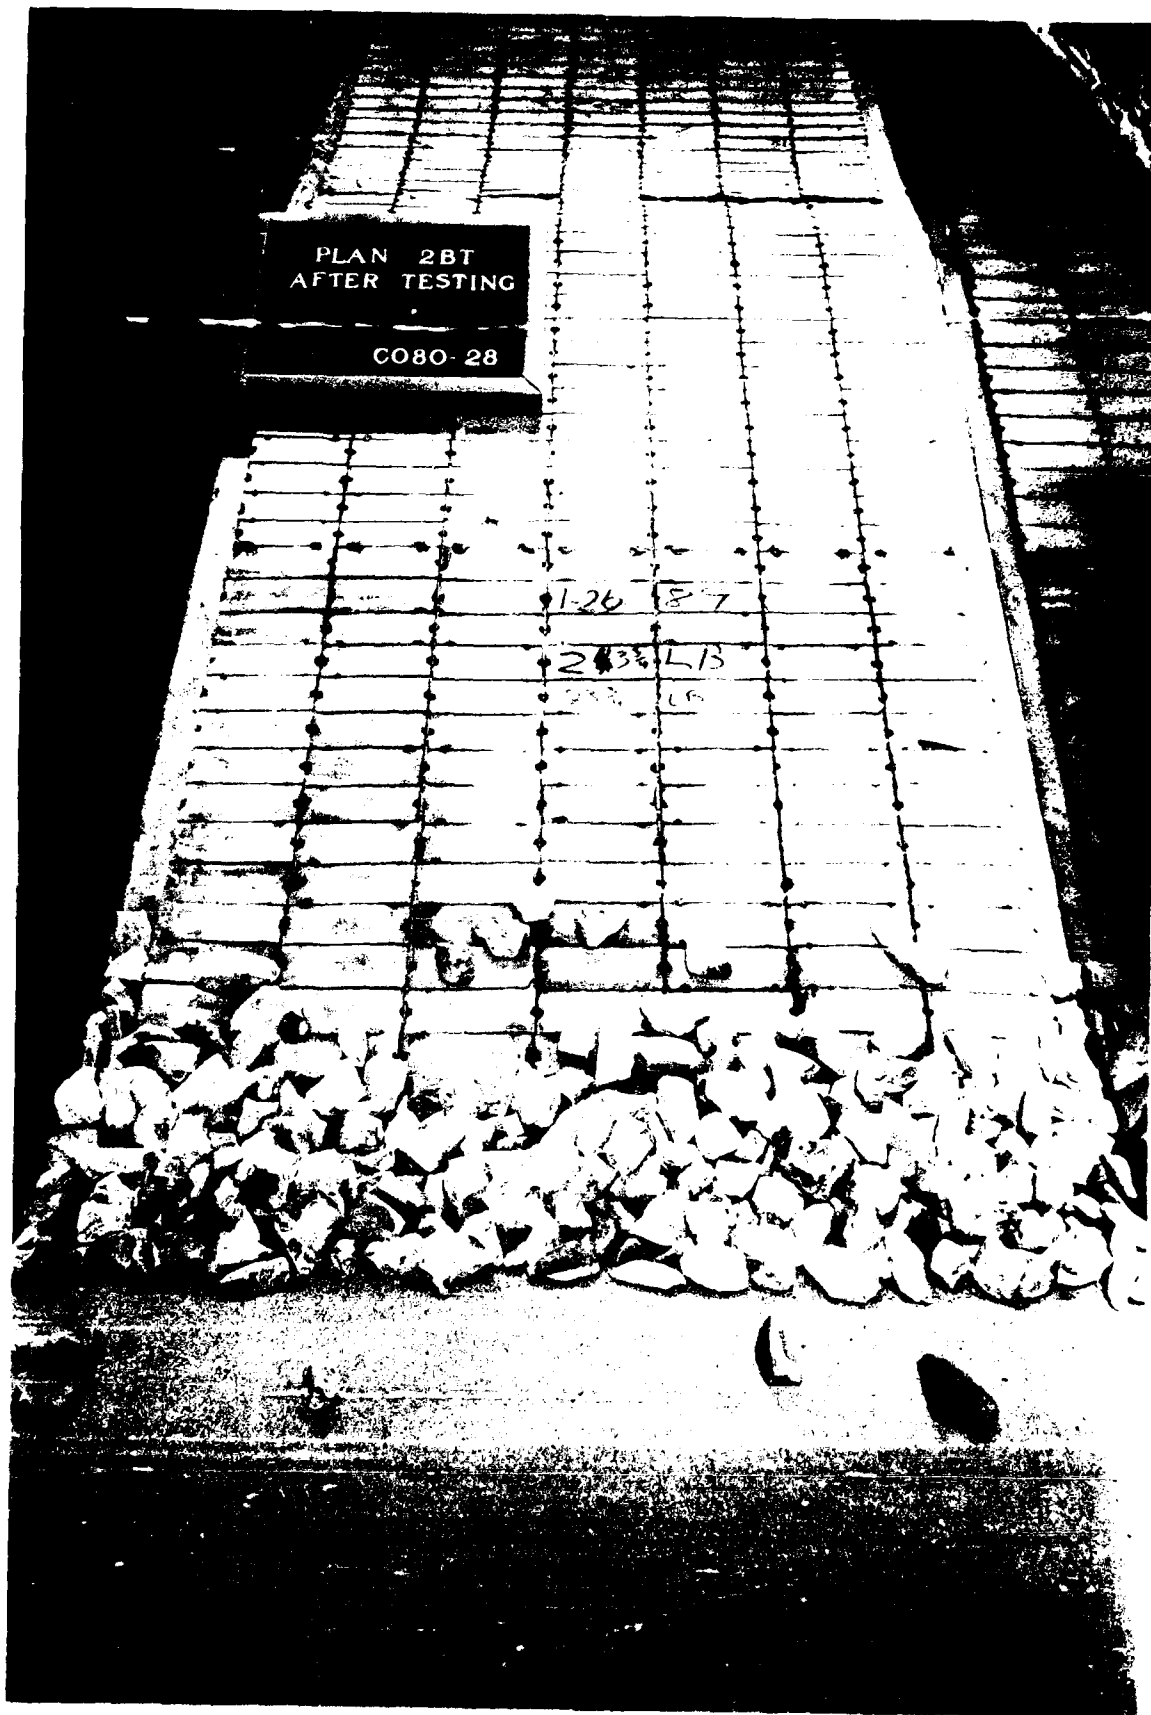
Photo 19. Side view of Plan 2BT before wave attack

Photo 20. Sea-side view of Plan 2BT before wave attack

Photo 21. Side view of Plan 2BT after wave attack

Photo 22. Sea-side view of Plan 2BT after wave attack

23. Plan 2BT was similar to Plan 2B except 500-lb toe stone was placed in a 3-ft-deep trench in an effort to improve stability. Also, a single mat was placed on the overbank above the existing two mats in an effort to reduce runup. Stability was achieved for 2-, 3-, and 4-ft waves; however, the 5- and 6-ft waves caused significant movement of toe stone upslope and downslope. The toe trench significantly improved stability in that the 500-lb stone exhibited a stability response similar to that observed for the 800-lb stone (tested in Plan 2B without a toe trench). Some localized lifting of the mats in the vicinity of the swl was observed during attack of the 5- and 6-ft waves. Maximum runup was reduced to +27.5.

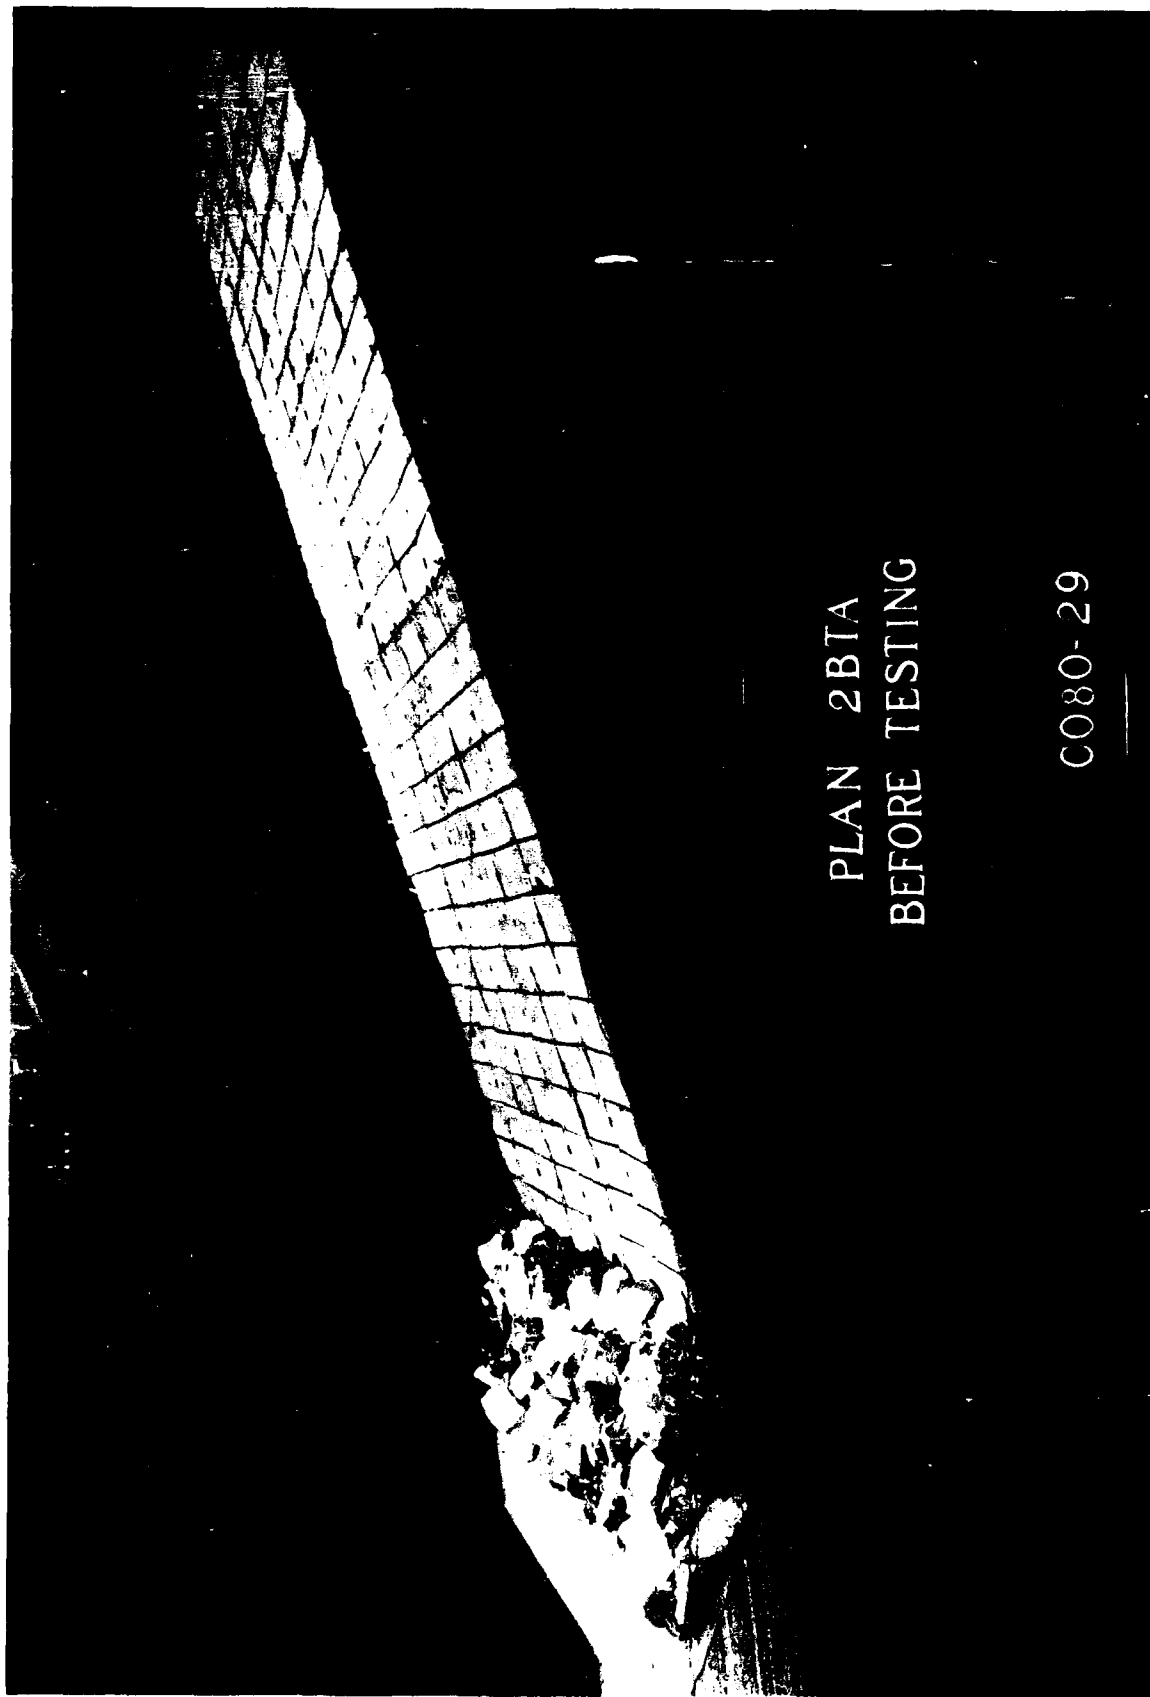
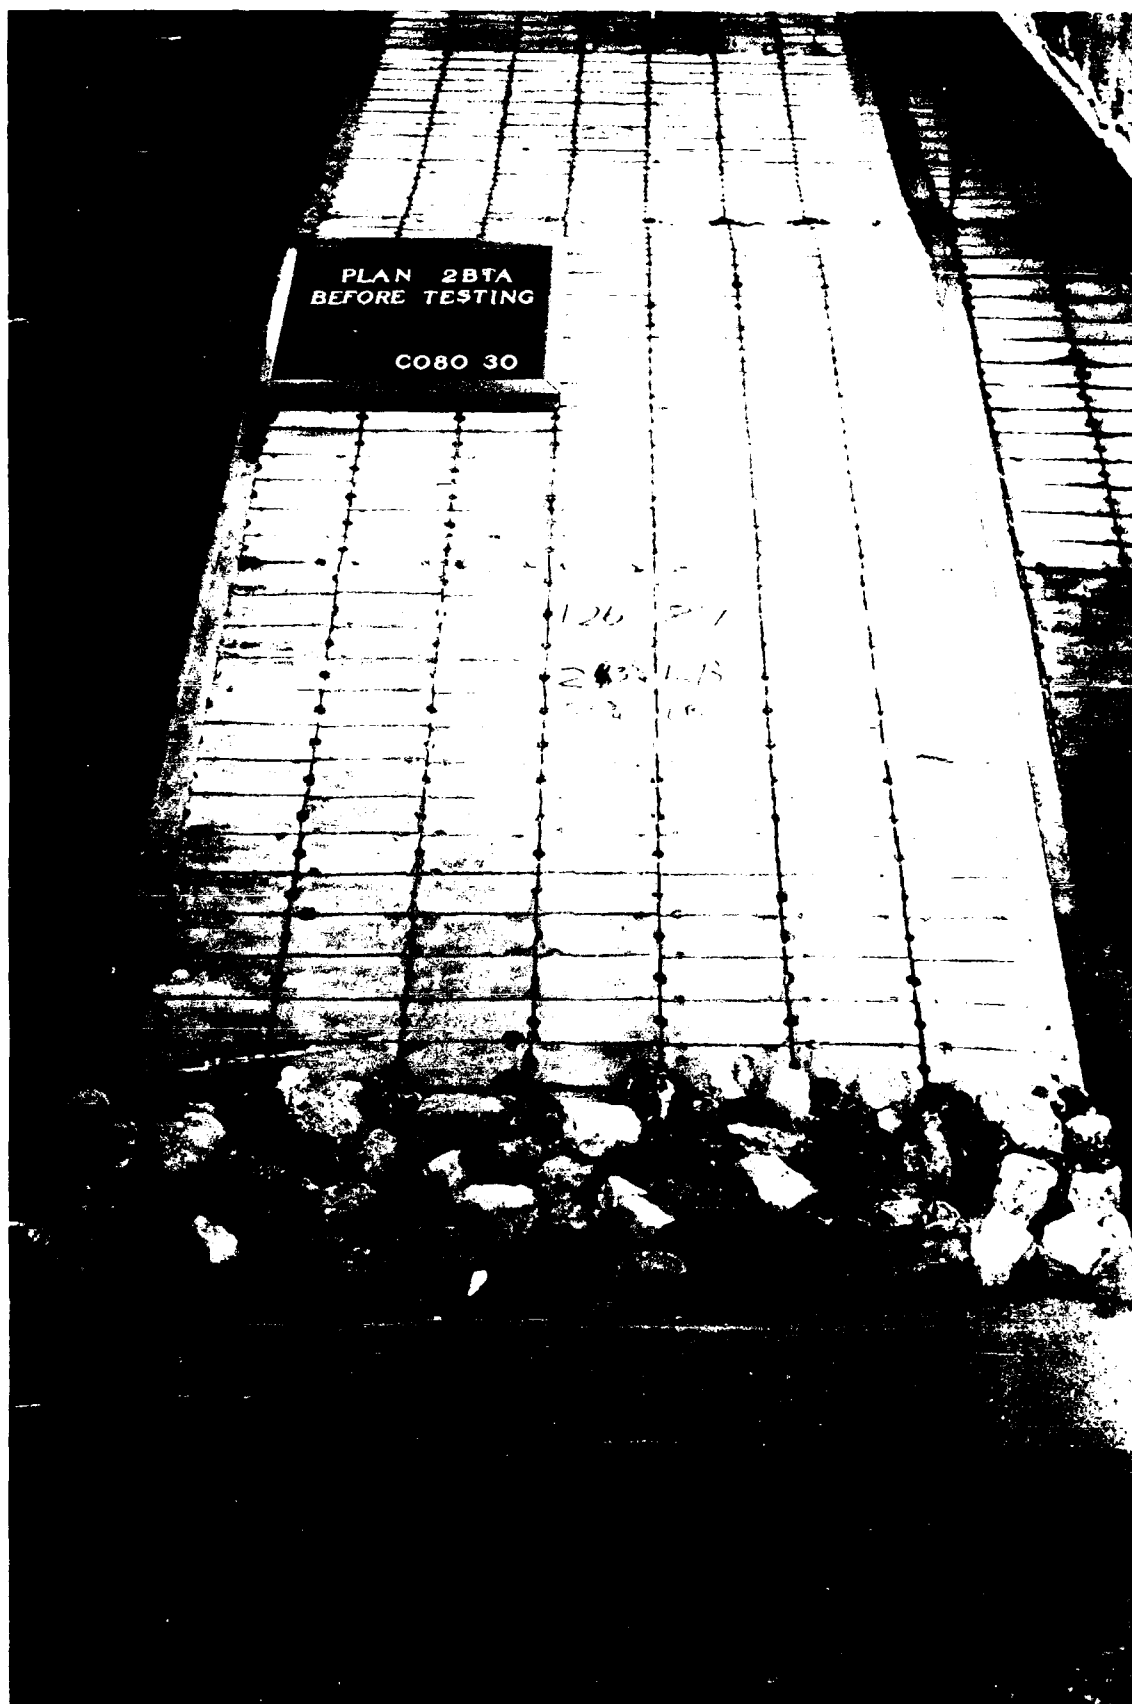
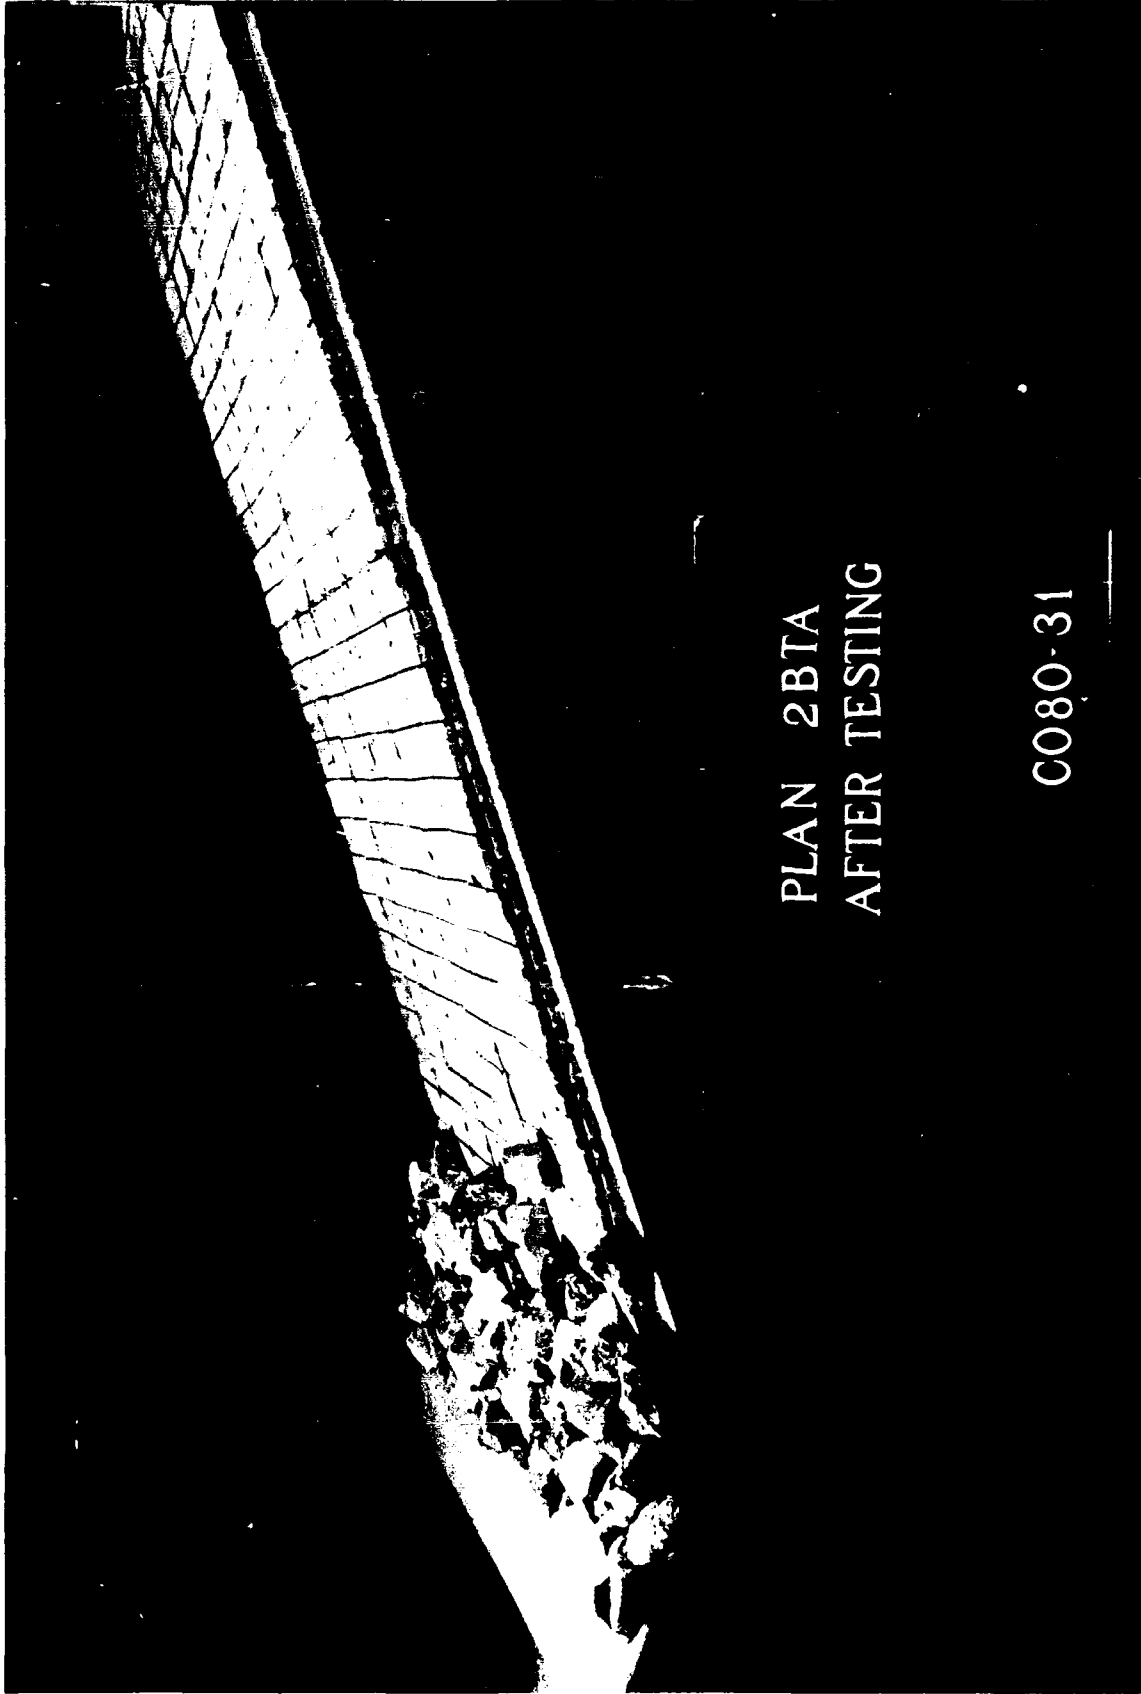
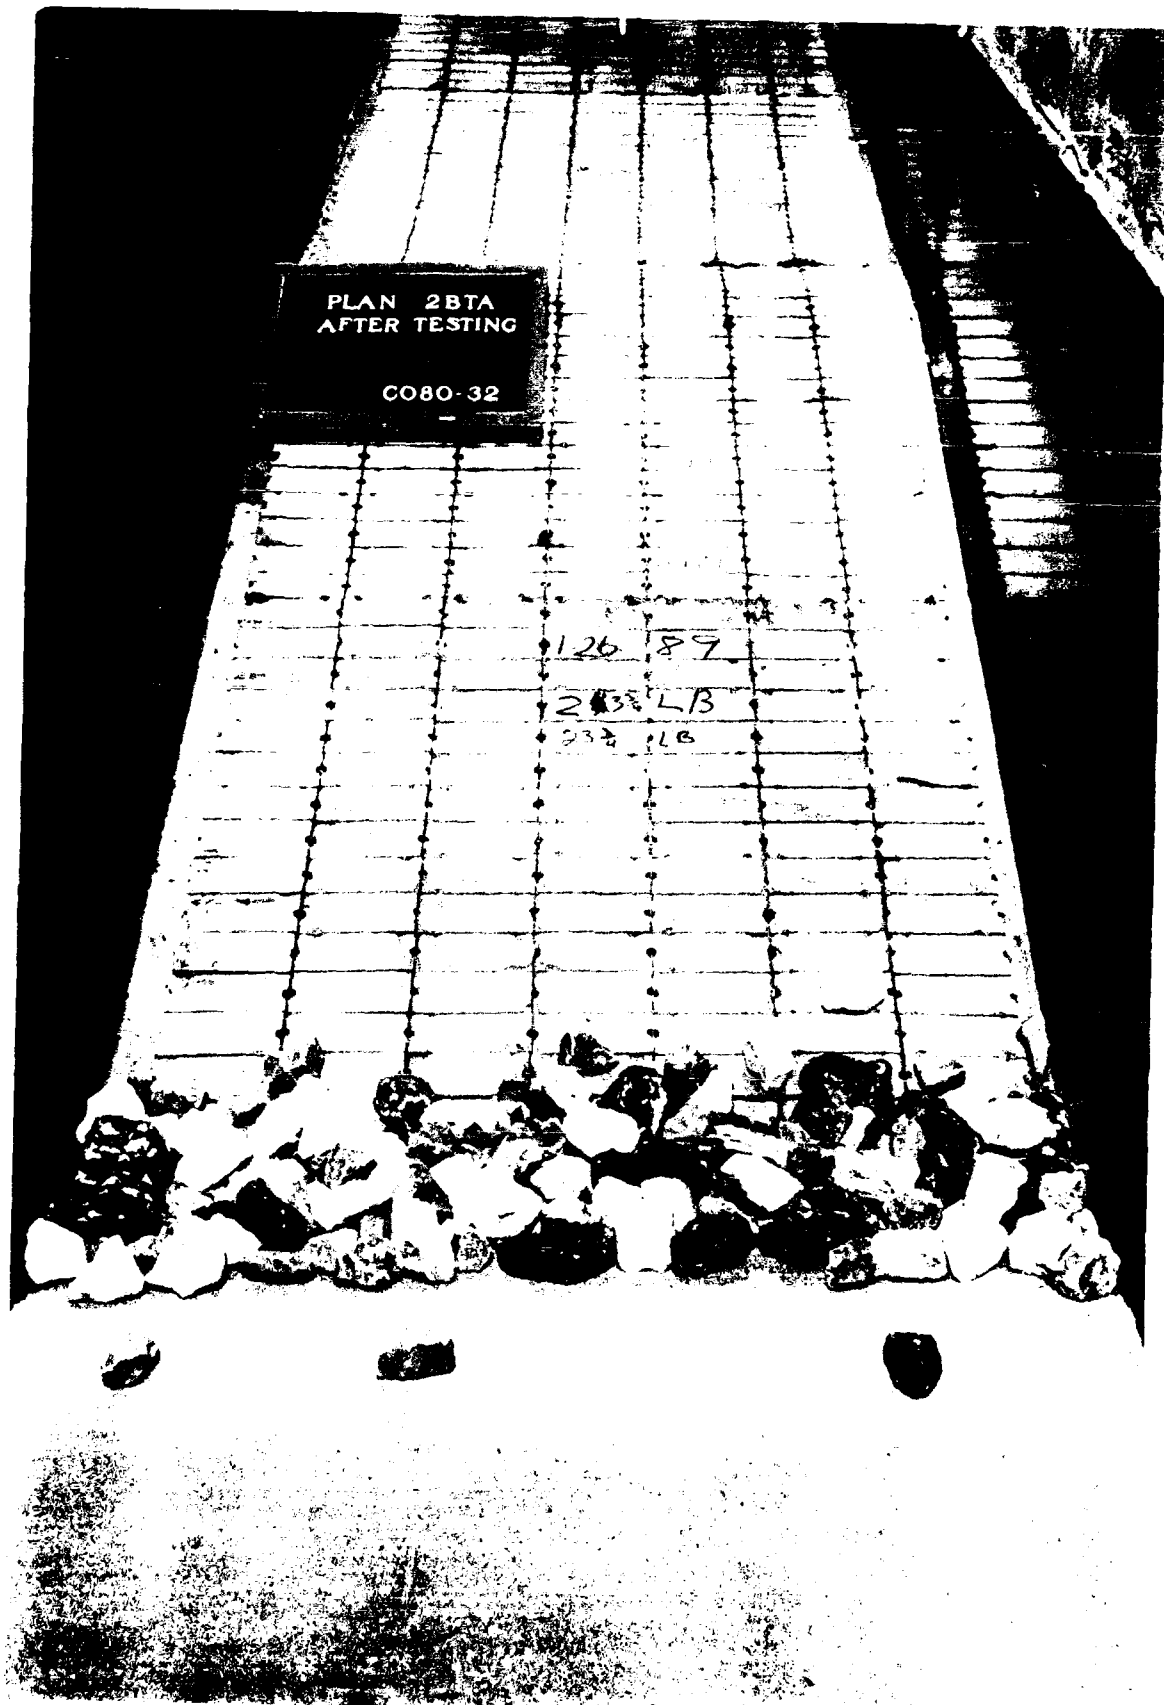
Photo 23. Side view of Plan 2BTA before wave attack

Photo 24. Sea-side view of Plan 2BTA before wave attack

Photo 25. Side view of Plan 2BTA after wave attack

Photo 26. Sea-side view of Plan 2BTA after wave attack

24. Plan 2BTA was the same as Plan 2BT except the toe stone weight was increased to 800 lb and three rows of anchors were added in the vicinity of the swl. As anticipated, toe-stone stability improved for the 5-ft waves; however, the 6-ft waves still caused significant movement of the toe stone upslope and downslope. Also, very minor localized lifting of the mats was observed between the areas secured by anchors and toe stone for the 5- and 6-ft waves. A check test at the +15.5 swl showed slightly greater stability than was observed at the +17.5 swl. Maximum observed runup was the same as Plan 2BT (+27.5).

28. During the course of testing, interest in the survivability (ability to withstand wave conditions in excess of the selected design conditions) of the two-layer plans arose. Plan 2BTA, one of the better alternatives tested, was exposed to 7-ft waves at an swl of +19.5 and movement of both the mats and toe stone was similar to that observed for the 6-ft waves.
