TECHNICAL REPORT CERC-89-12

# STABILITY OF ARTICULATED CONCRETE MATTRESSES FOR HERBERT HOOVER DIKE IMPROVEMENTS LAKE OKEECHOBEE, FLORIDA

Coastal Model Investigation

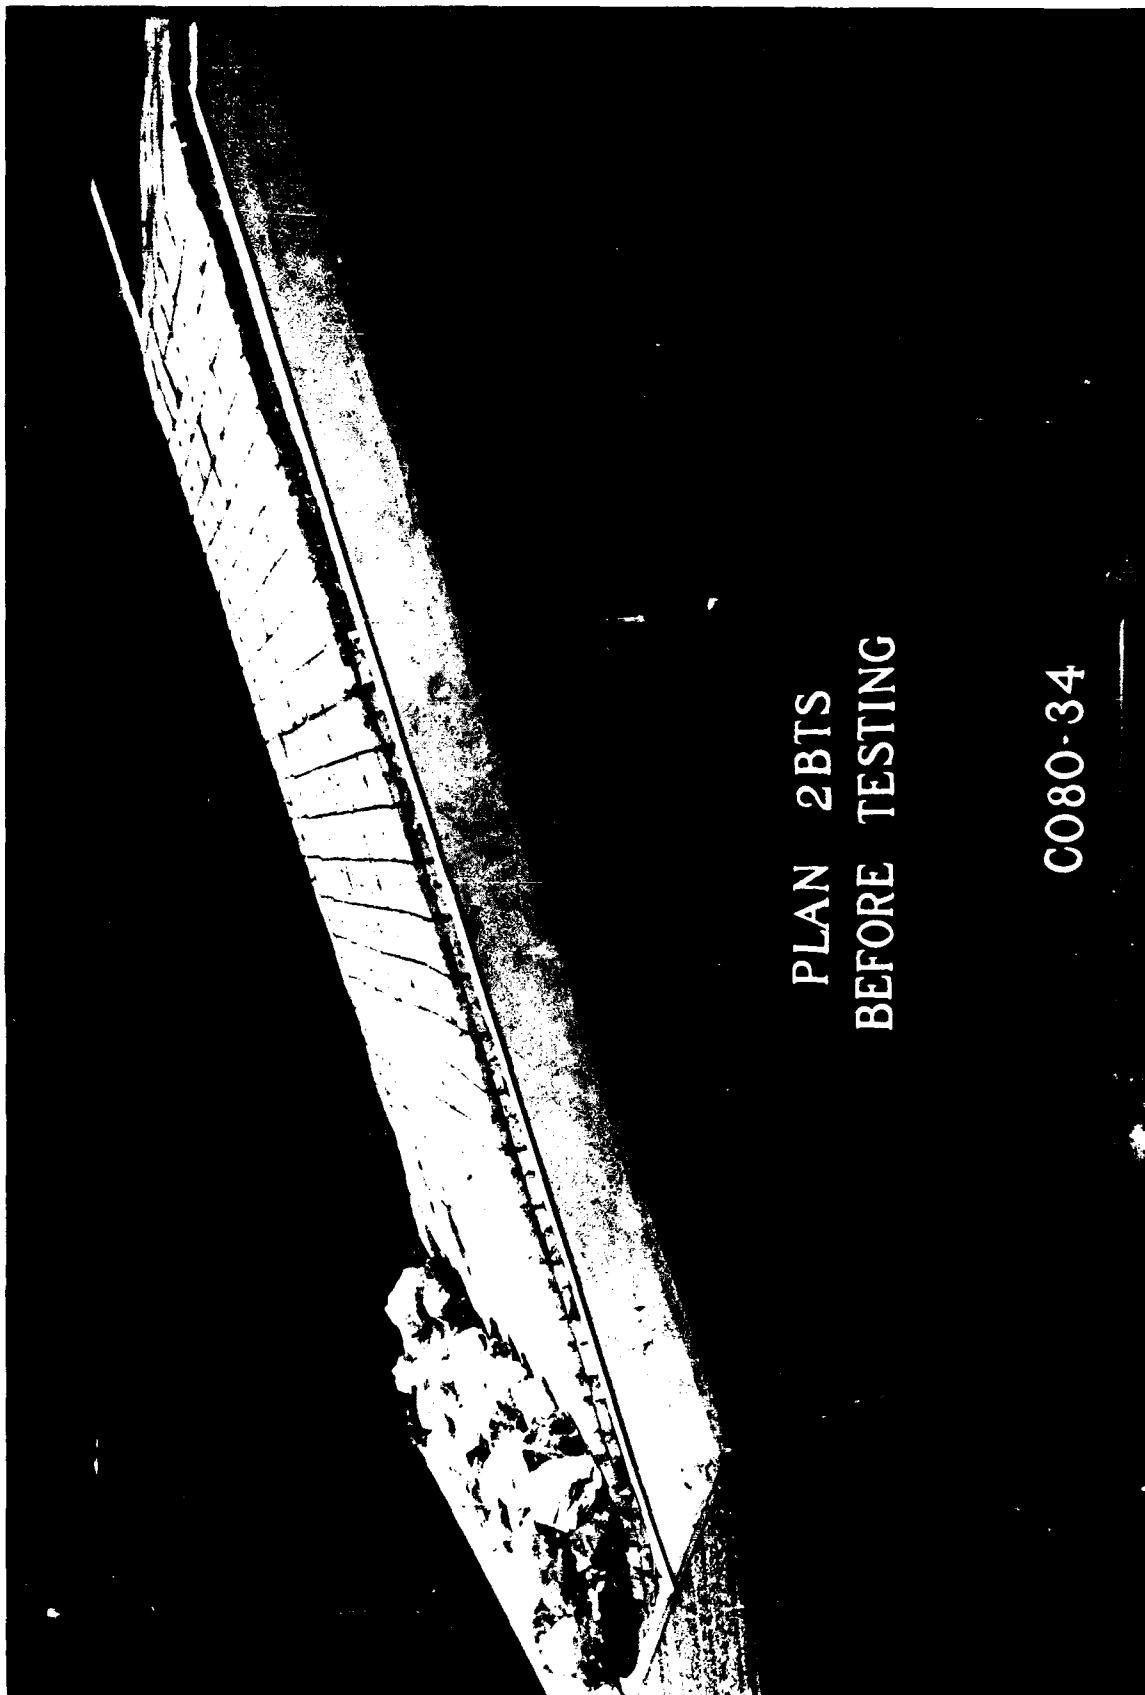
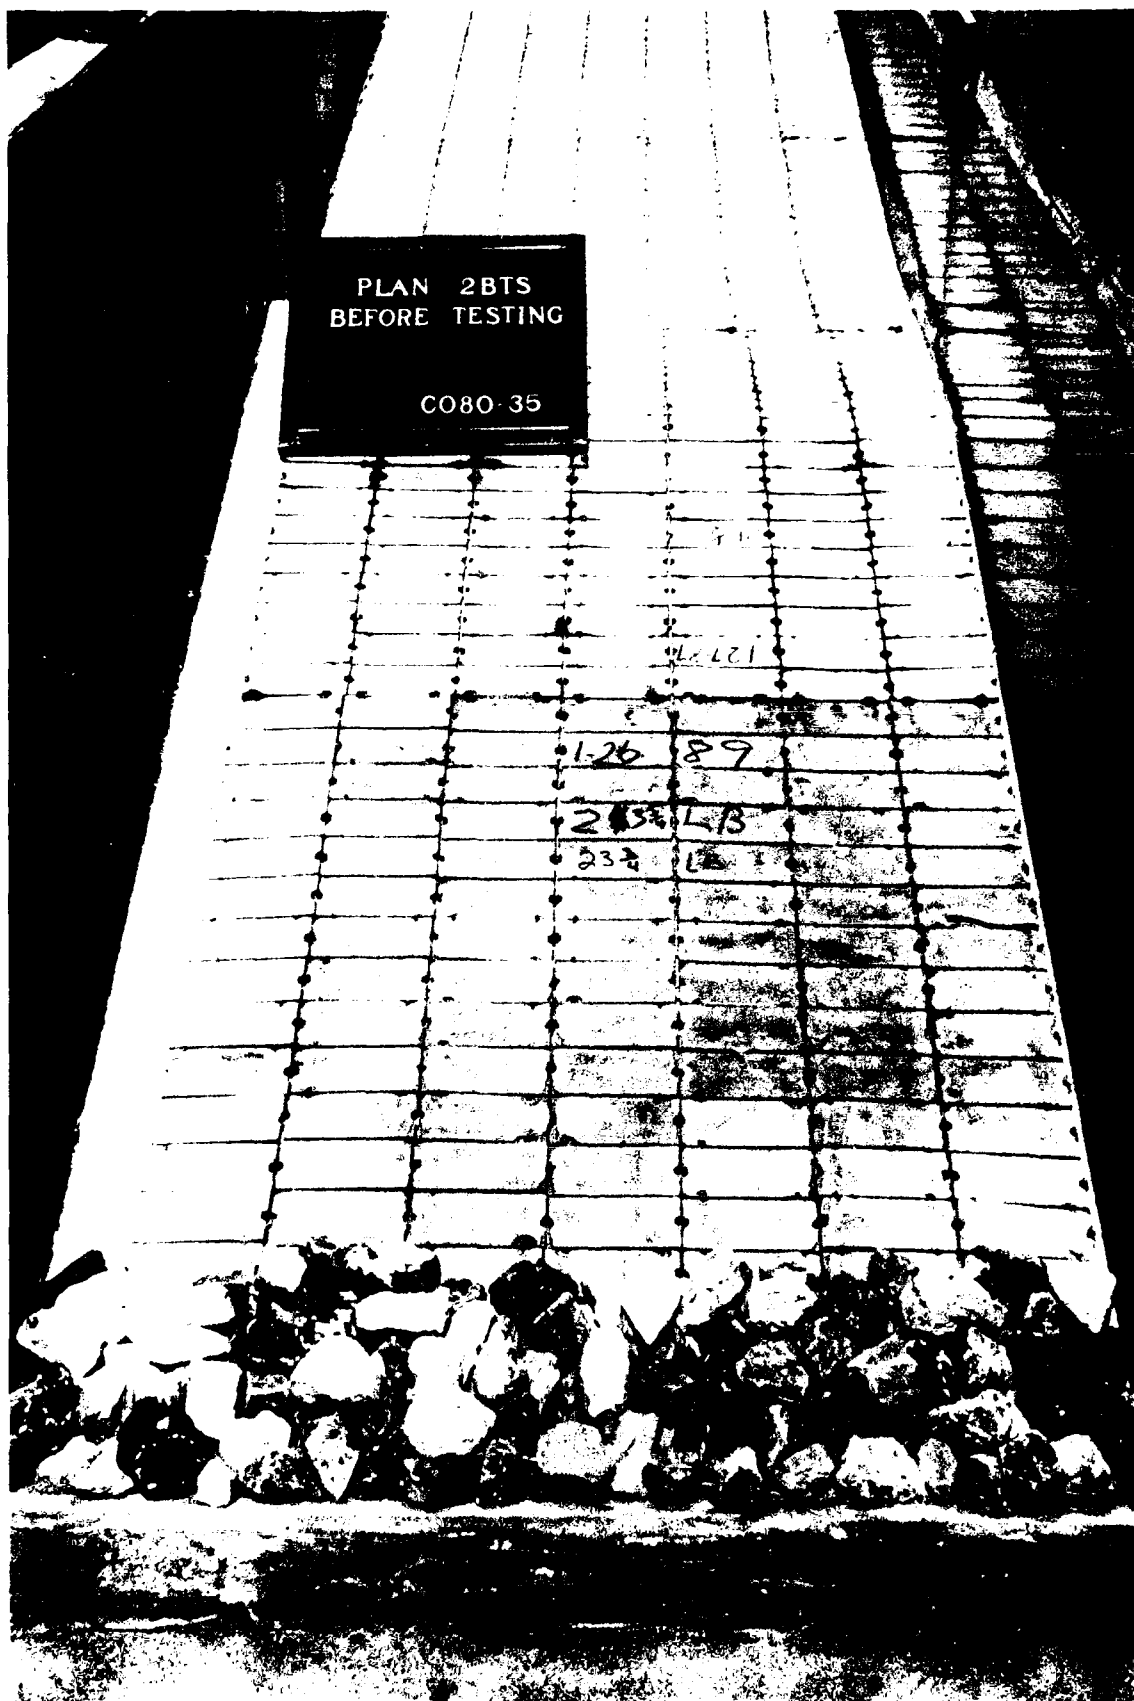
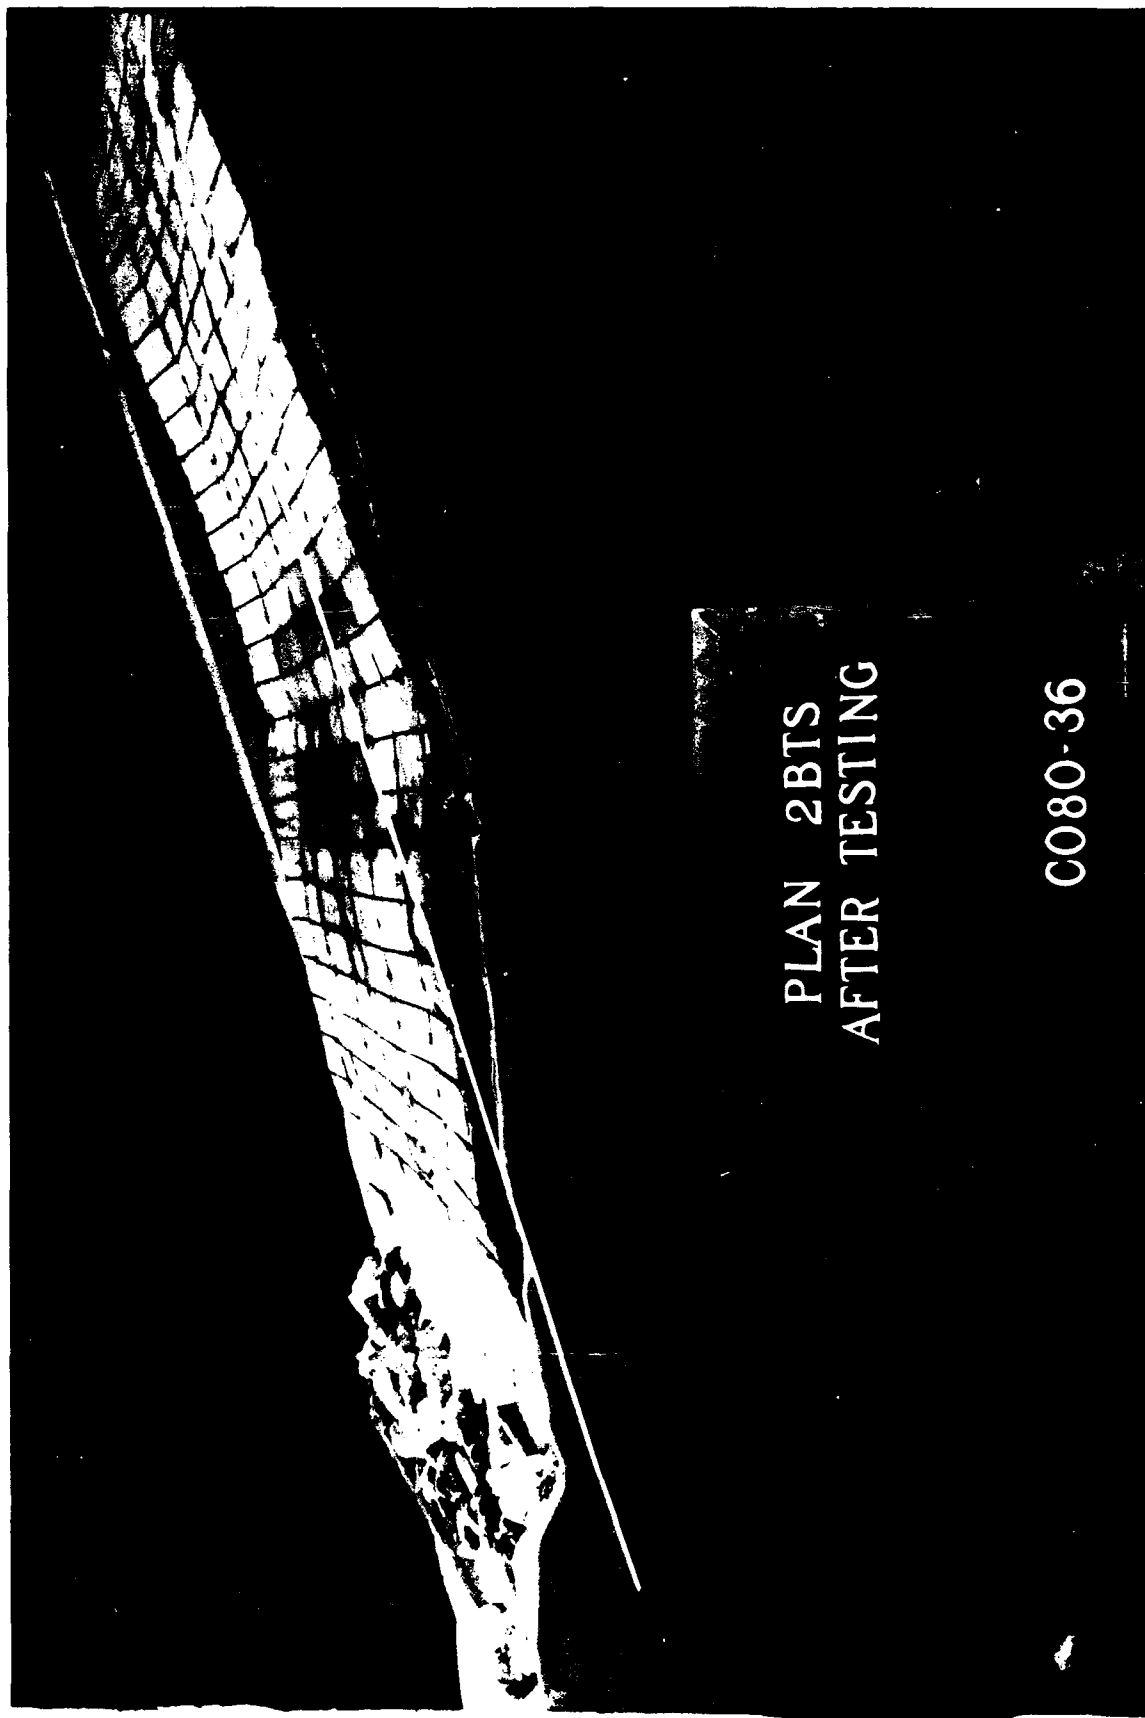
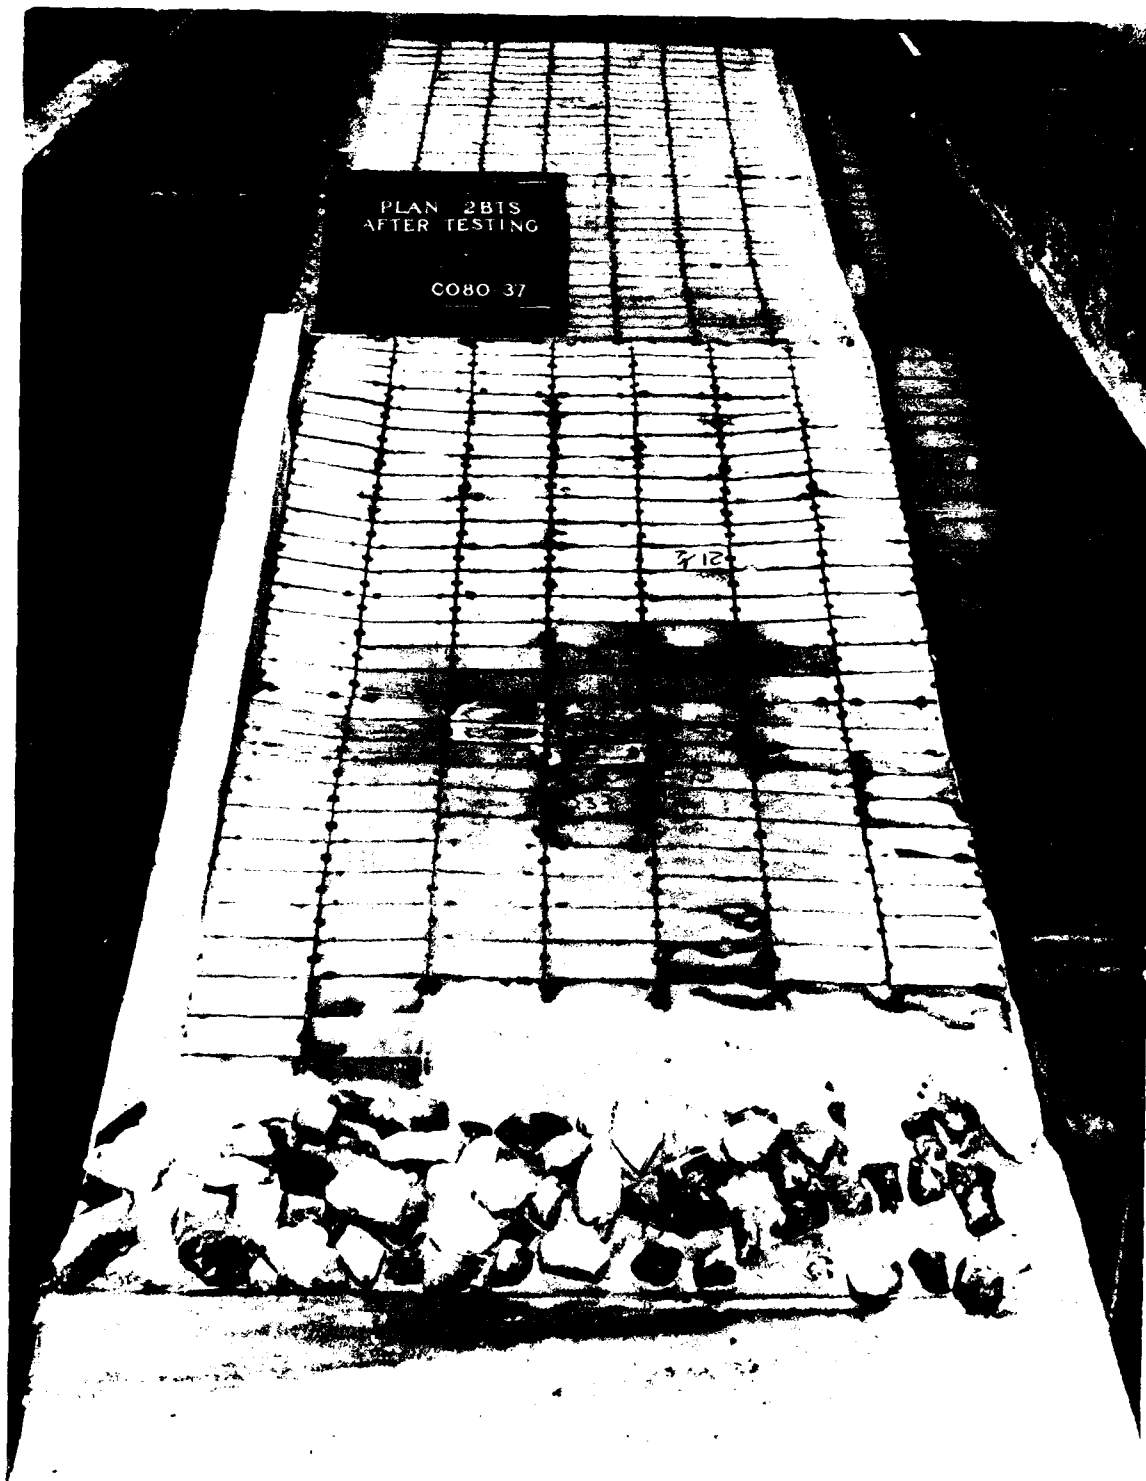
Photo 27. Side view of Plan 2BTS before wave attack

Photo 28. Sea-side view of Plan 2BTS before wave attack

Photo 29. Side view of Plan 2BTS after wave attack

Photo 30. Sea-side view of Plan 2BTS after wave attack

25. Plan 2BTS was the same as Plan 2BT except the toe-stone weight was 800 lb and the mats were placed over a 2.5-ft-thick layer of sand in an effort to obtain a qualitative indication of sand movement. Attack of the 2-ft waves caused about half of the sand layer to erode between the swl and +21. The 3-ft waves removed the sand layer between the swl and +22. Attack of 4-ft

waves produced complete removal of sand above the swl as evidenced in Photos 27 and 28.

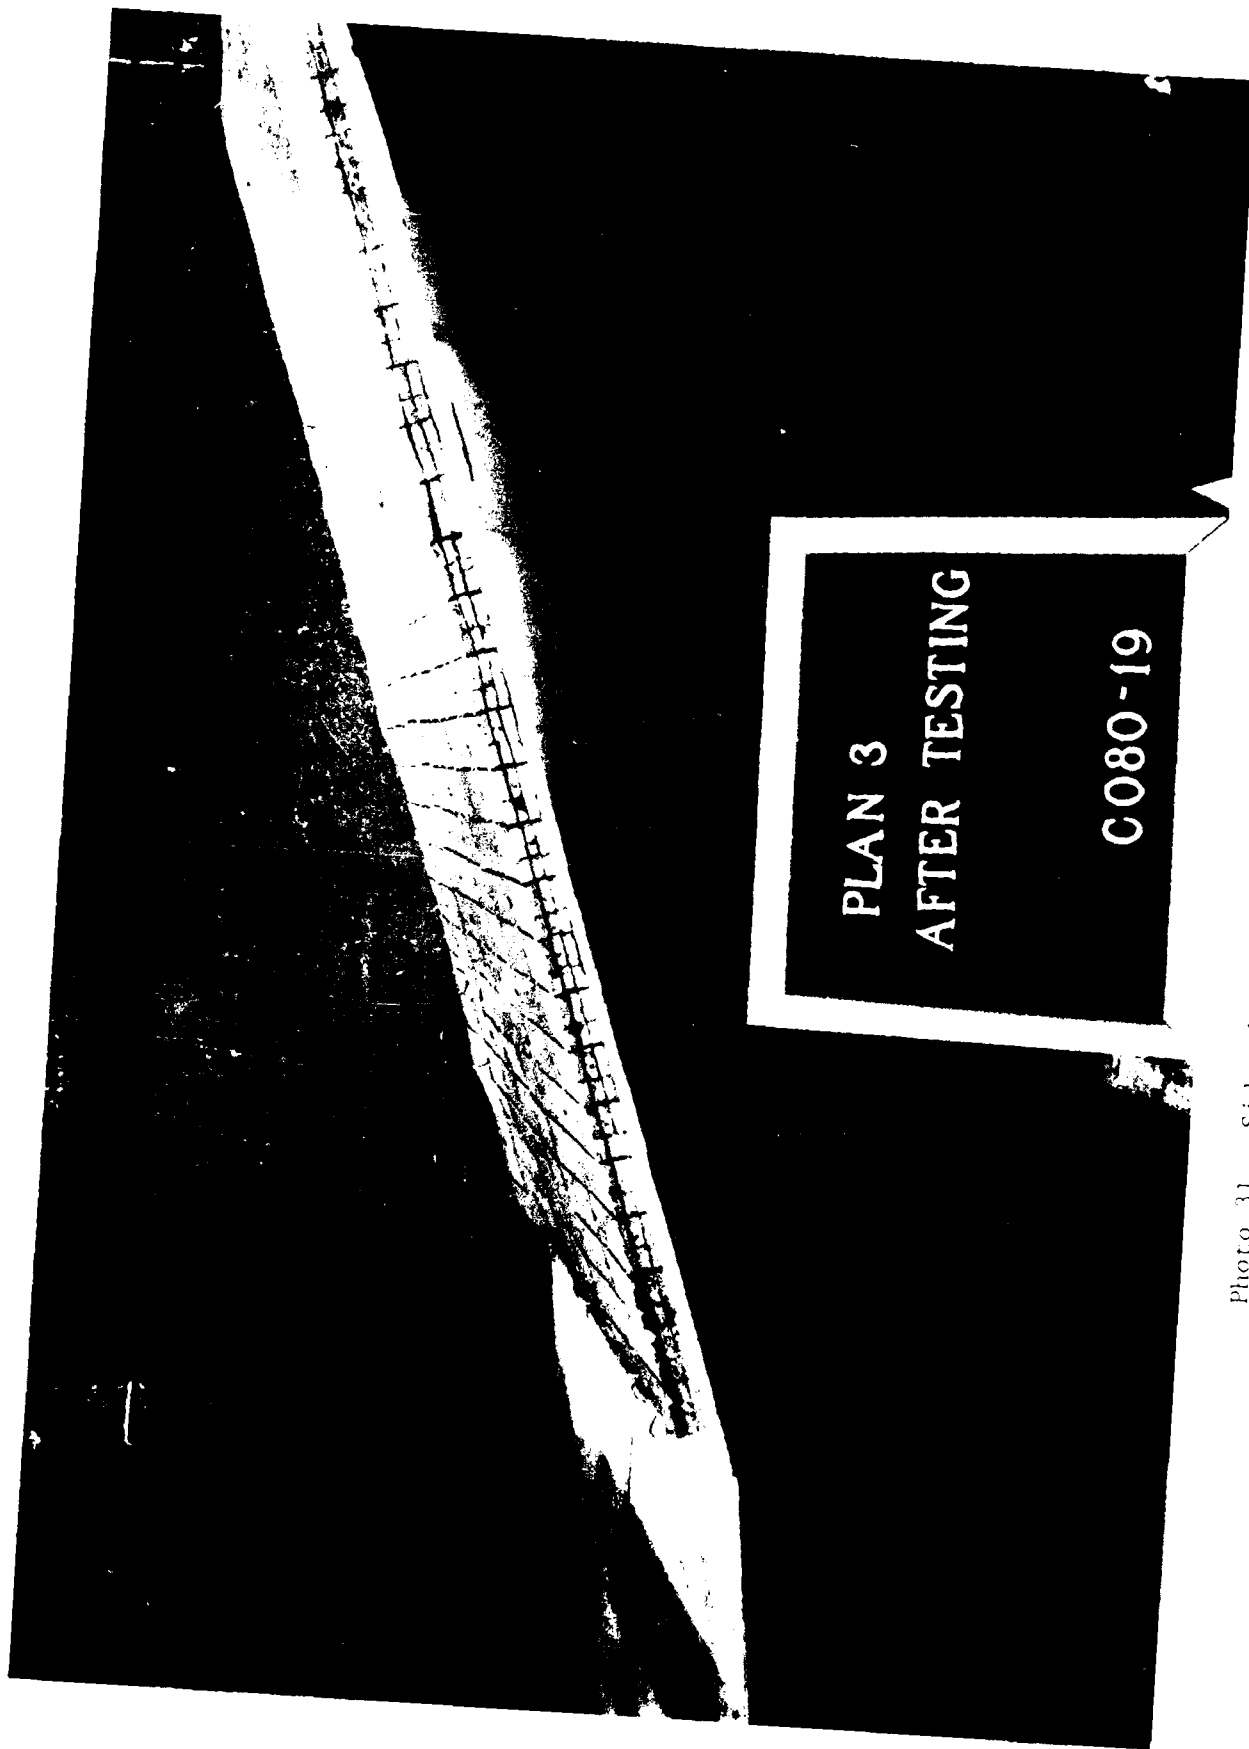
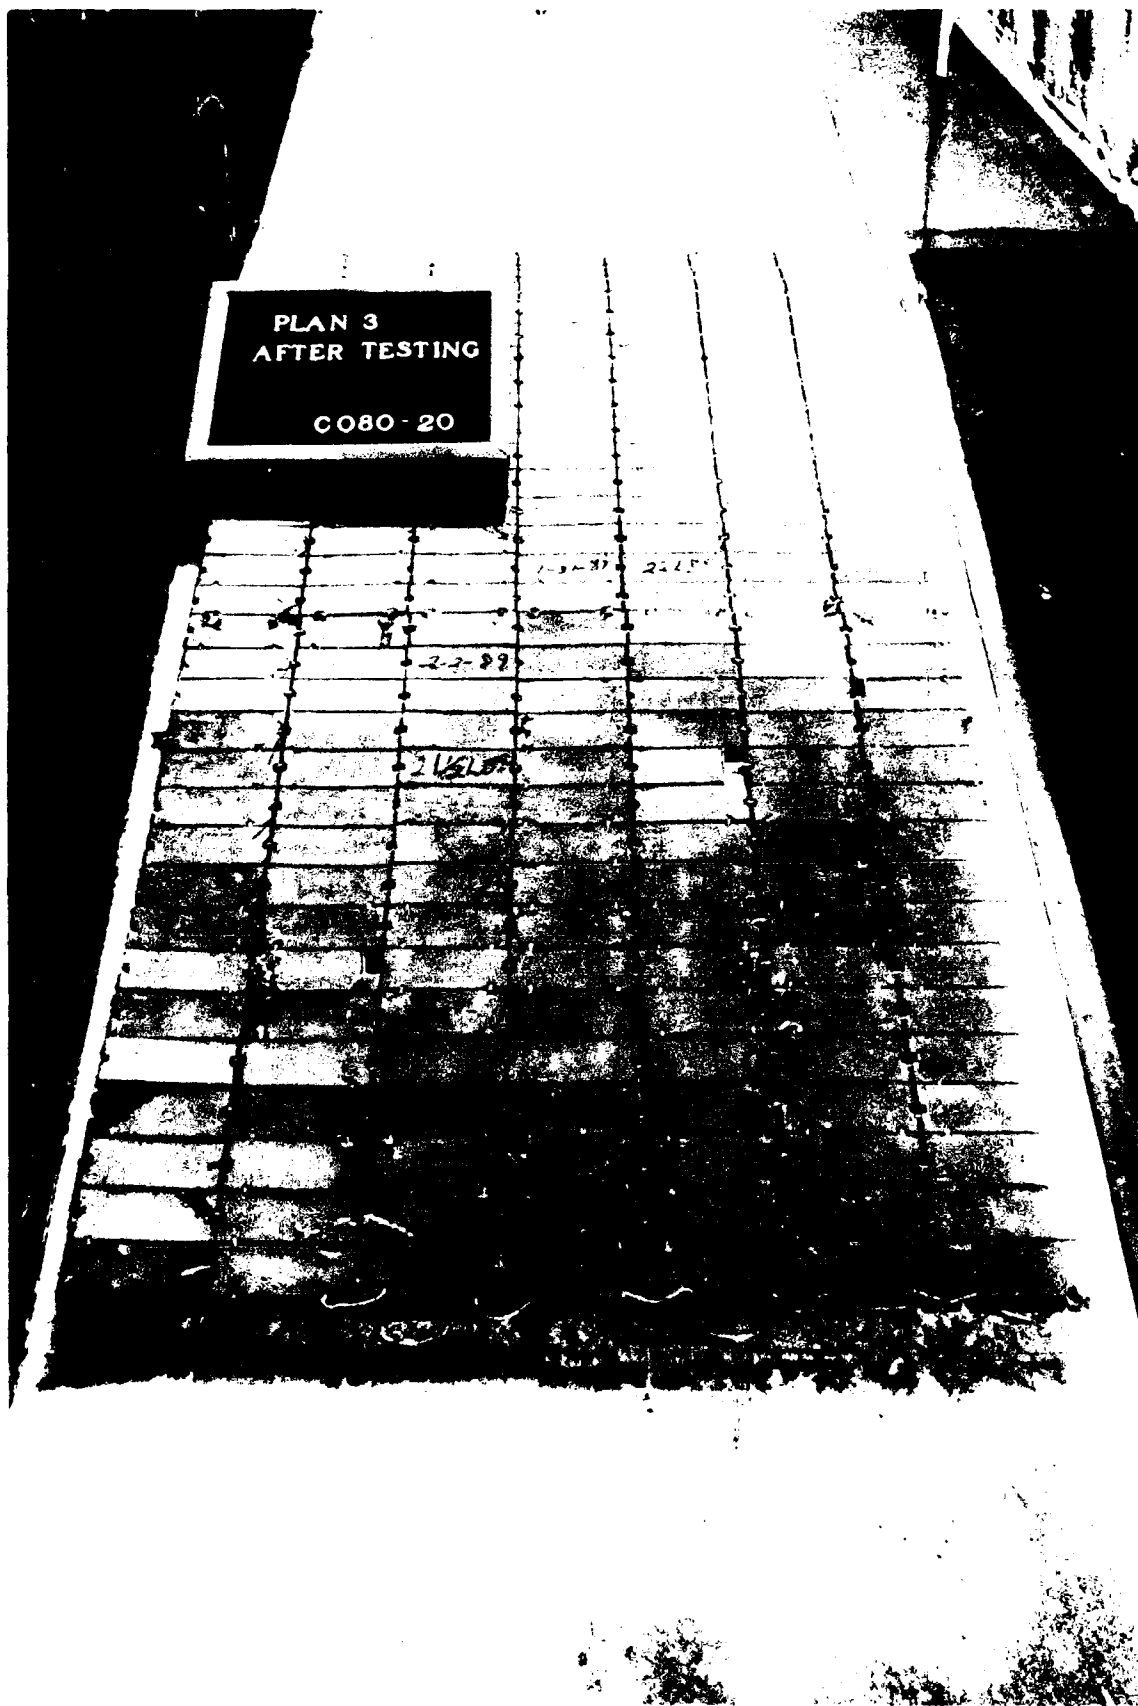
Photo 31. Side view of Plan 3 after wave attack

Photo 32. Sea-side view of Plan 3 after wave attack

26. Plan 3 consisted of three layers of mats laced together and secured by top anchors. This plan proved stable for 2-, 3-, and 4-ft waves; however, both the 5- and 6-ft waves caused minor lifting of the toe. Maximum runup was the same as Plan 2 (+29).
