DTIC FILE COPY TECHNICAL REPORT SL-89-18

# BACKFILL EFFECTS ON RESPONSE OF BURIED REINFORCED CONCRETE SLABS

Pamela G. Hayes

Structures Laboratory

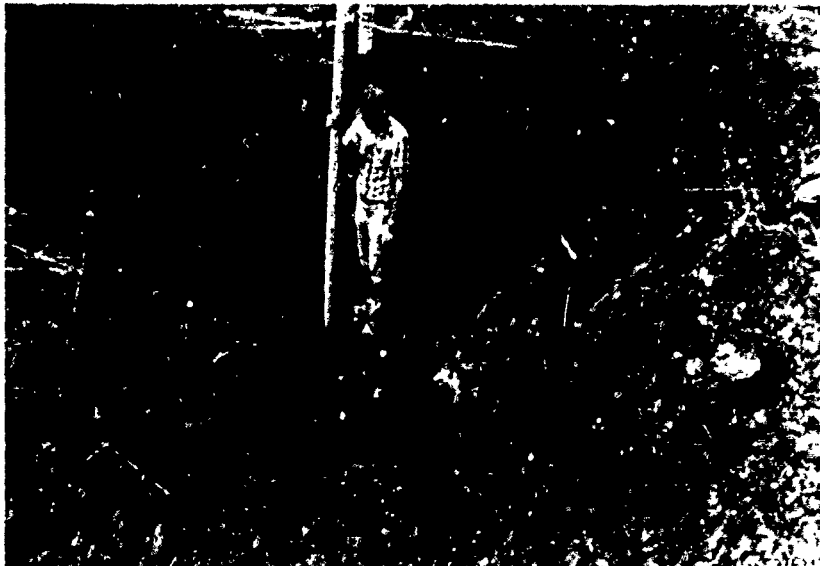
Figure 5.20. Crater formed in In-Situ Test 4.

the charge caused a crater which was 6.55 feet deep as shown in Figure 5.20. The crater had a 16 foot width parallel to the reaction structure and a 14.75 foot length perpendicular to the reaction structure.

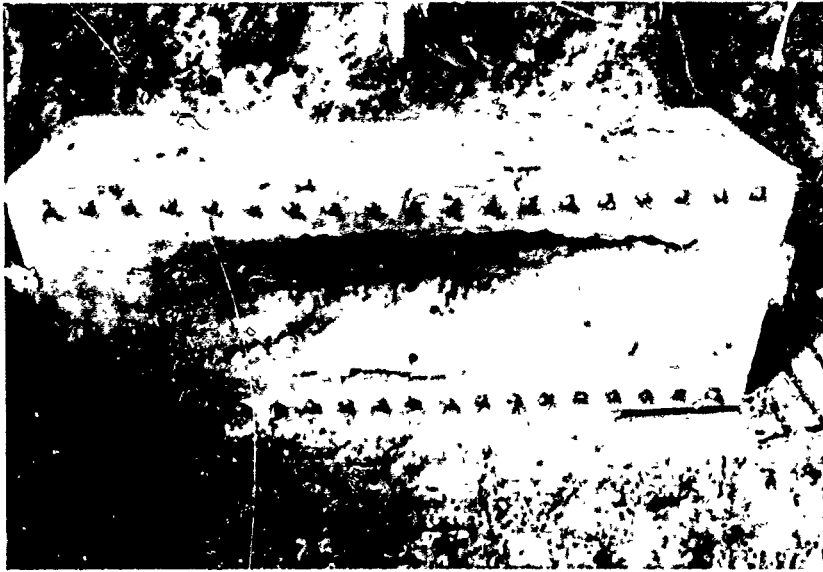
Figure 5.21. Damage to outside face of test slab,  
In-Situ Test 4.

The detonation of the 15.4-pound cased charge at a range of 5 feet from the front face of the test slab caused severe damage. Figure 5.21 shows damage to the front face of the test slab after excavation of the test bed. Principal steel was broken in the back layer of the reinforcing mat at the center of the slab and in the front layer of the mat just below the top supports and above the bottom supports. The rear face of the slab is shown in Figure 5.22. The passive deflection gage in the reaction structure showed a maximum deflection of 10.69 inches and a permanent deflection of 9.19 inches.
