INVESTIGATION OF FAILURE MODES  
IN A CERAMIC COMPOSITE  
UNDER OFF-AXIS LOADING

THESIS

Presented to the Faculty of the School of Engineering  
of the Air Force Institute of Technology  
Air University  
In Partial Fulfillment of the  
Requirements for the Degree of  
Master of Science in Aeronautical Engineering

December 1989

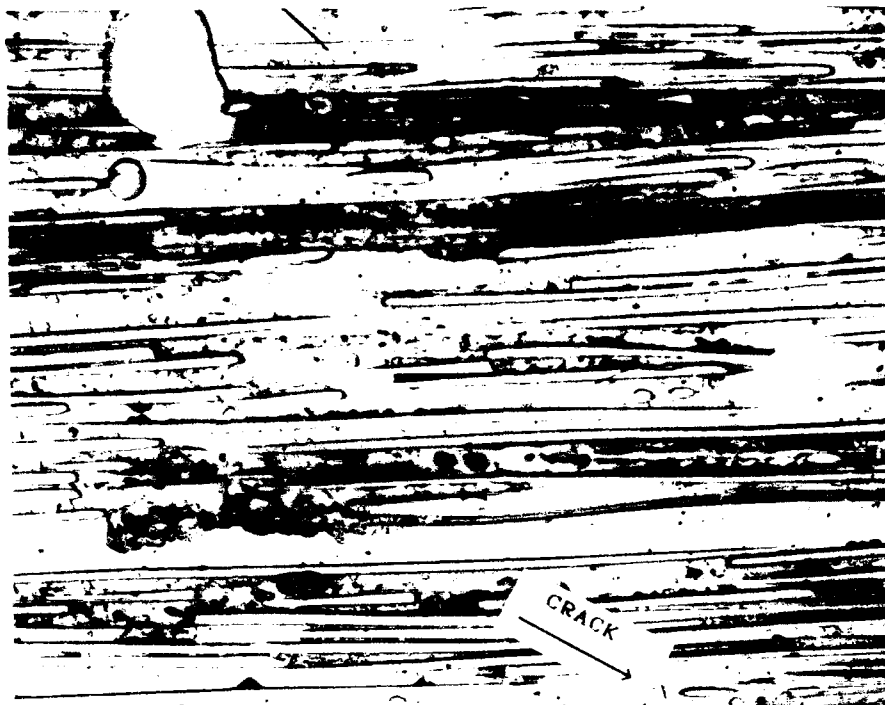
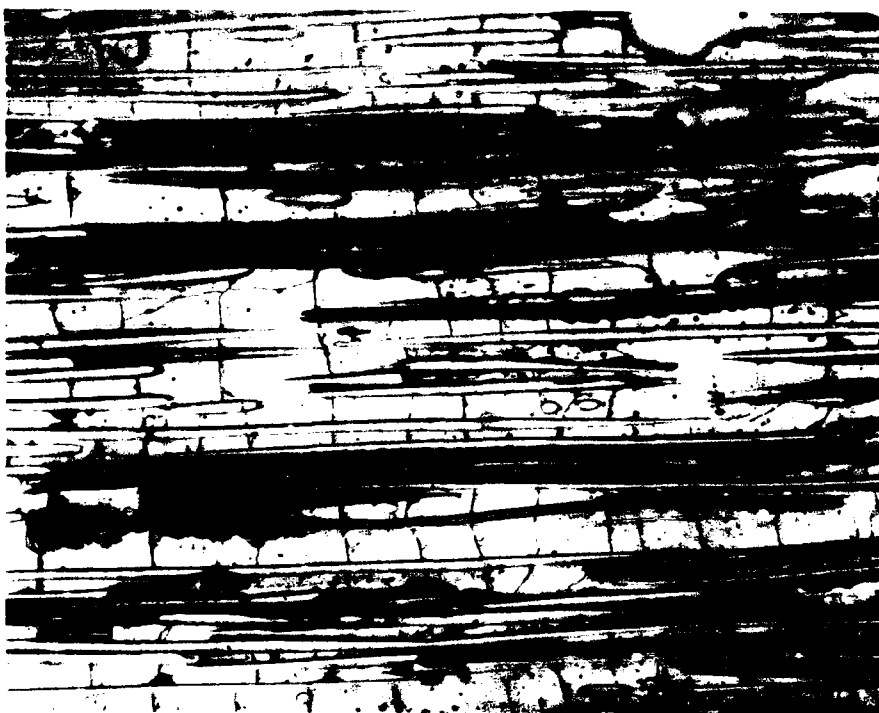
(a) Edge at 115 MPa (100x)

(b) Edge at 159 MPa (100x)

Figure 13 Crack Progression for 0 Degree Specimen (115-250 MPa)  
Specimen 0-2

(c) Edge at 218 MPa (100x)

(d) Edge at 250 MPa (100x)

(e) Edge at 254 MPa (Failure) (200x)

The initial cracking was randomly distributed at first, then became continuous across the edge with increase in load. Figures 13a-e shows how crack spacing changes from loads of 115 MPa to 250 MPa. These pictures were taken at the same spot on the specimen. Figure 13a shows an initial crack in the right hand corner when the stress was 115 MPa. Figure 13b shows two small cracks in the right hand corner when the stress was 160 MPa. Then the cracking becomes more continuous through the edge and crack spacing is more even, as seen in Figure 13c at 218 MPa. Figure 13d shows the crack spacing decreases further at 250 MPa. Finally, at failure Figure 13e shows the crack spacing is the same as seen in the previous picture. The matrix crack density will be further discussed in a later section of this chapter. Since the matrix cracking begins in the linear portion

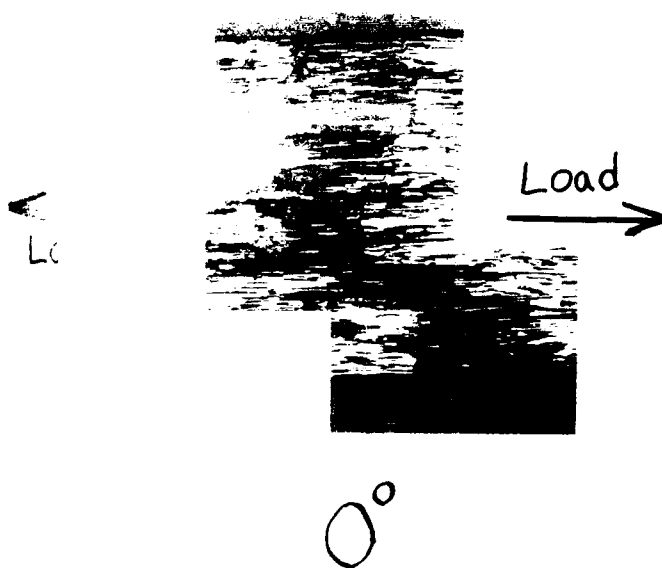
(a) Across Width (50x)

(b) Across Thickness (50x)

Figure 17 Fracture Surface across Width and Thickness for 0 Degree Specimen

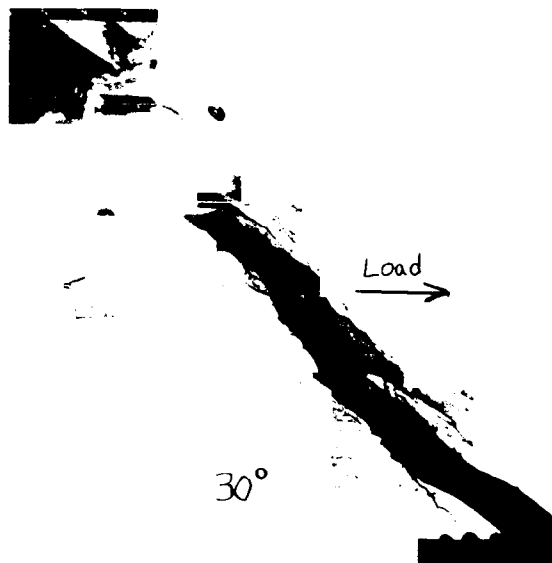
(a) Across Width (50x)

(b) Across Thickness (50x)

Figure 24 Fracture Surface across Width and Thickness for 30 Degree Specimen

The average ultimate stress and strain for this orientation was 72.1 MPa and 576  $\mu\epsilon$  respectively. The final failure through the width was in the direction of the fibers, 30 degrees off the direction of the load, see Figure 24 and 25. Figure 25 shows minimal fibers protruding from the edge of the final crack interface. This means the fiber did very little of the load carrying after the matrix started to fail.
