## Enhanced Preliminary Assessment Report:

Monroeville Army Housing Units  
Monroeville, Pennsylvania

October 1989

Environmental Research Division  
Argonne National Laboratory  
Argonne, Illinois 60439

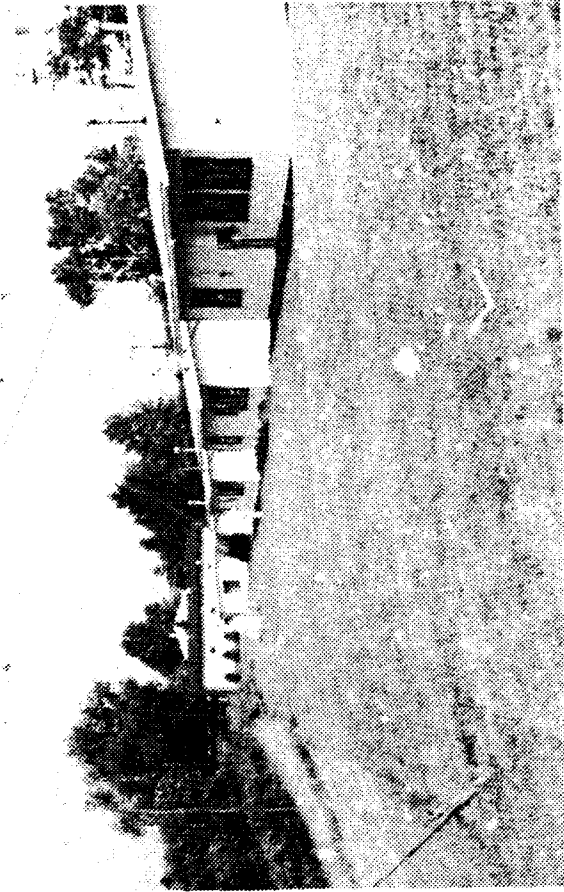
2

1. A row of houses on Lindsey Lane.
2. Grounds at the rear of the housing units.
3. Electrical transformer mounted near the top of the utility pole; the Portland Power Company is responsible for area transformers.
4. The sand-filter bed of the sewage treatment system.
5. Stagnant raw sewage on the top of another sand-filter bed; existing conditions at the sewage-treatment facility are to be corrected.
