MISCELLANEOUS PAPER GL-89-29

BLAST EFFECTS MONITORING STUDY AT HAZARDOUS WASTE SITE CLEANUP MEDDYBEMPS, MAINE

December 1989

Final Report

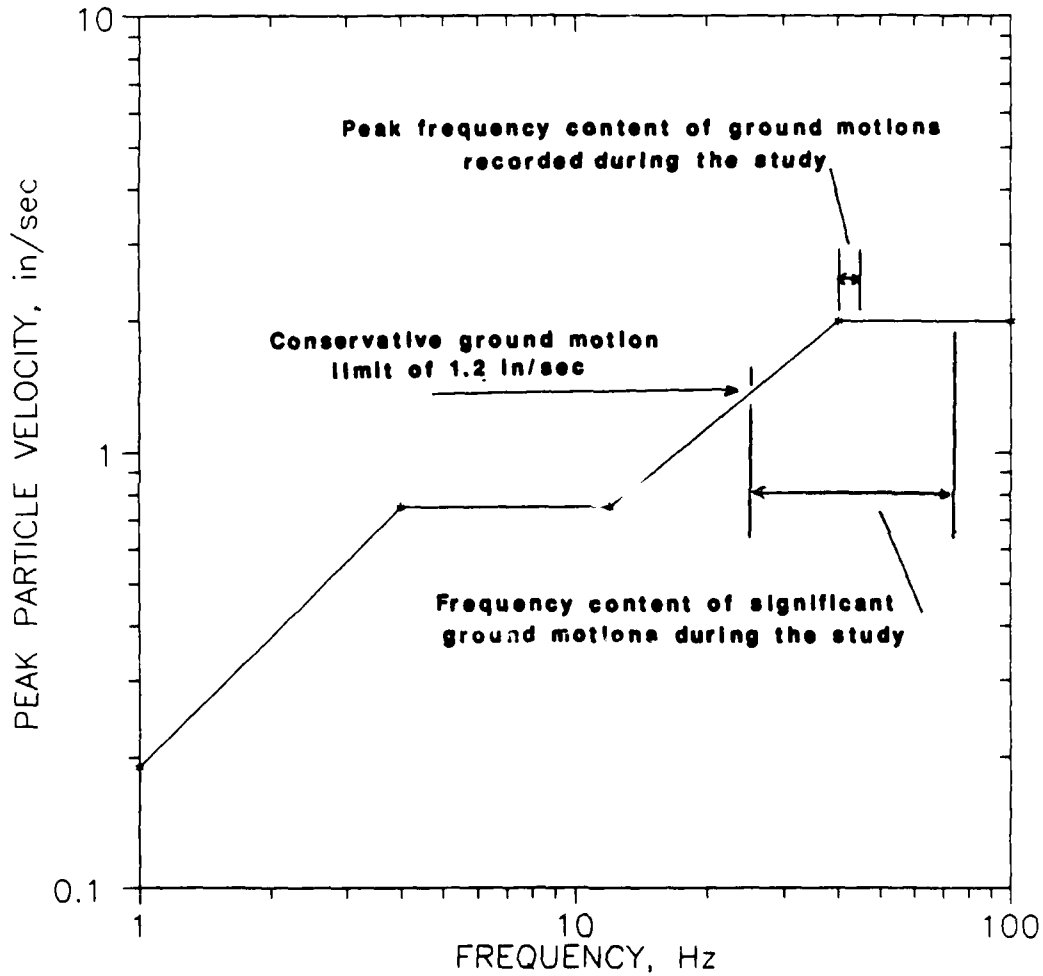
Figure 10. Determination of allowable ground vibration limit using the alternative blasting criteria.

Dept of Interior Office of Surface Mining 30 CFR part 715

14. The results of the ground motion and air overpressure monitoring during the demolition of the cylinders were that the PPV and PAO levels off site were below the PPV of 1.0 ips and near or below the PAO of 0.015 psi damage criteria established by the U.S. Dept. of Interior, Office of Surface Mining Reclamation and Enforcement. An alternative and more rigorous criteria adopted by this agency which takes into account the frequency of the blast vibrations also showed the ground vibrations were far below the damage criteria conservatively determined to be 1.2 in/sec (see figure 10). The recorded maximums were a PPV of 0.025 ips at Station 1, Shot 17 and a PAO of 0.043 psi at Station 1, Shot 2. These results were extrapolated to a range of 400 ft (distance to the nearest private residence) based on the recorded mean maximums at Station 1 for a 0.6 lb shot, with the calculated levels being a PPV of 0.007 ips and PAO of 0.017 psi.
