MTL TR 89-97

EVALUATION OF 2090-T8E48 ALUMINUM-LITHIUM PLATES

ERNEST S. C. CHIN
MATERIALS PRODUCIBILITY BRANCH

November 1989

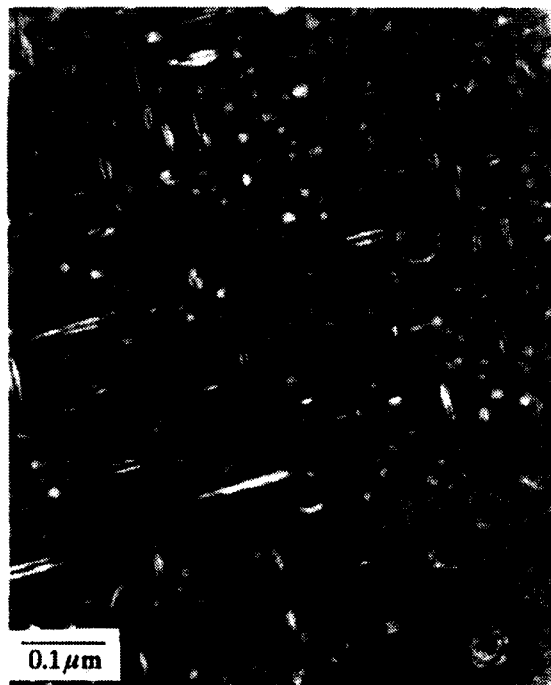
Figure 6. Superlattice dark field image of 2090 matrix revealing δ' , β'/δ' , θ' , and T_1 precipitates.

In addition to the coarse 1.8- μm -diameter grain boundary precipitates, several finer precipitates were also present and were observed via TEM. Figure 6 is a superlattice dark field image of the 2090 matrix which revealed several second-phase precipitates. Readily observed precipitates included the spherical coherent δ' (Al_3Li) phase, the spherical composite δ'/β' (Al_3Zr) precipitate, and the T_1 (Al_2CuLi) and θ' (Al_2Cu) plates. Both T_1 and θ' plates were visible in the bright field image of Figure 7. A superlattice dark field image using a centered δ'/θ' reflection revealed brightly imaged δ' and θ' precipitates (see Figure 8). The δ' precipitates were 200 \AA in diameter and precipitate-free zones were not observed along grain or sub-grain boundaries.

The precipitates identified by TEM, primarily δ' , T_1 , and θ' , are common to all Al-Li-Cu alloys.^{10,11} These are the main strengthening precipitates. In addition, partially incoherent T_1 and θ' phases act to reduce the extent of strain localization compared to the binary Al-Li alloy.⁹ Since the well-dispersed T_1 phase is anodic¹² with respect to the matrix, this would explain the pit nucleation observed throughout the specimen surface.

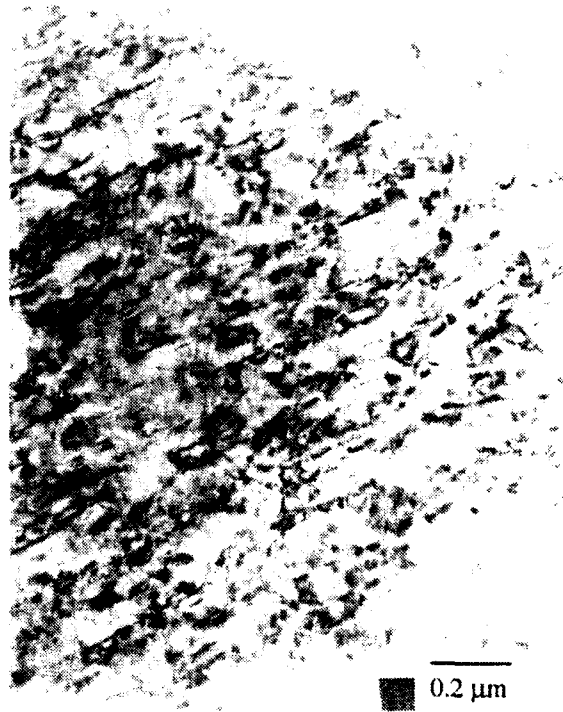
Figure 7. Bright field image showing T_1 and θ' plates.

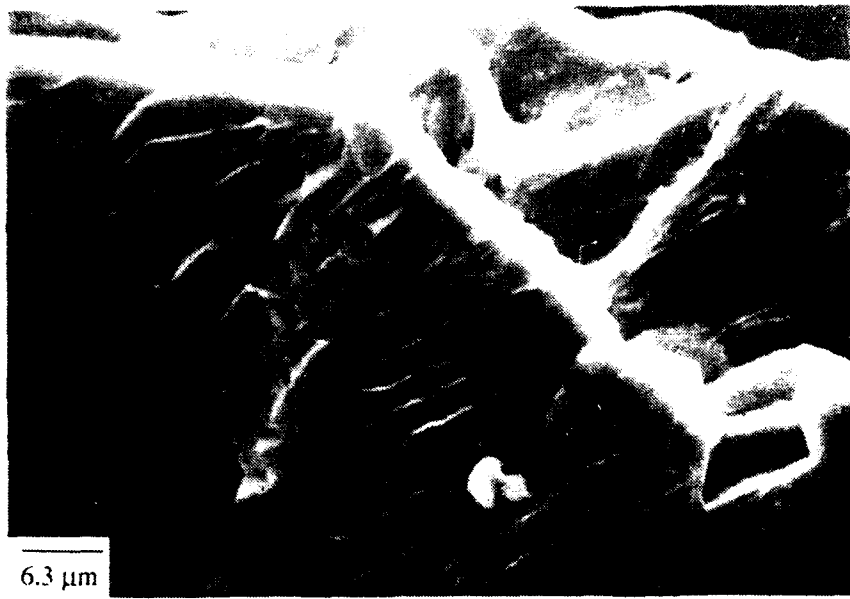
Figure 11. SEM micrograph of shear bands on fracture surface.

SEM analyses of the fracture surfaces of two tensile specimens were performed to determine mode of fracture. The two tensile specimens were of different gauge diameter, one being 0.113 inch and the other 0.505 inch. As is standard practice for specimens of varying size, the crosshead speed of 0.05 in./min for the larger specimen was lowered to 0.005 in./min for the 0.113-inch specimen. The fracture surfaces of the tensile specimens revealed two different modes of fracture. The smaller tensile specimen exhibited a mixed ductile/intergranular fracture with microvoid coalescence around Al-Cu-Fe intermetallics (see Figure 9). Conversely, the large specimen fractured by a brittle transgranular cleavage mechanism (see Figure 10). Shear bands were evident (see Figure 11) as well as rods corresponding to the T_1 phase (see Figure 12).
