AGARD REPORT No. 771

## Fuel Tank Technology

Papers presented at the 68th Meeting of the Structures and Materials Panel of AGARD in Ottawa,  
Canada, 23—28 April 1989.

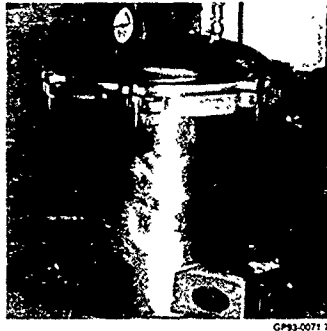
Figure 7. Hydrolytic Stability Screening in Steamclave

The second accelerated test is hydrolytic stability screening in the steamclave (Figure 7). This is a test in which material samples are placed in a pressure vessel at 103E + 01 Pa (15 psig), 121°C (250°F) and 100% relative humidity (RH). Standard tensile specimens are used and at intervals during the exposure, samples are withdrawn and tested (Figure 8).

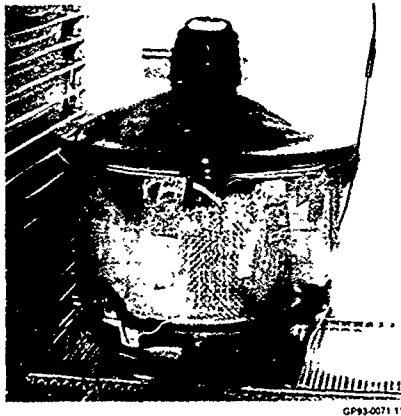
Figure 11 Long Term Humidity Exposure Desiccator Test

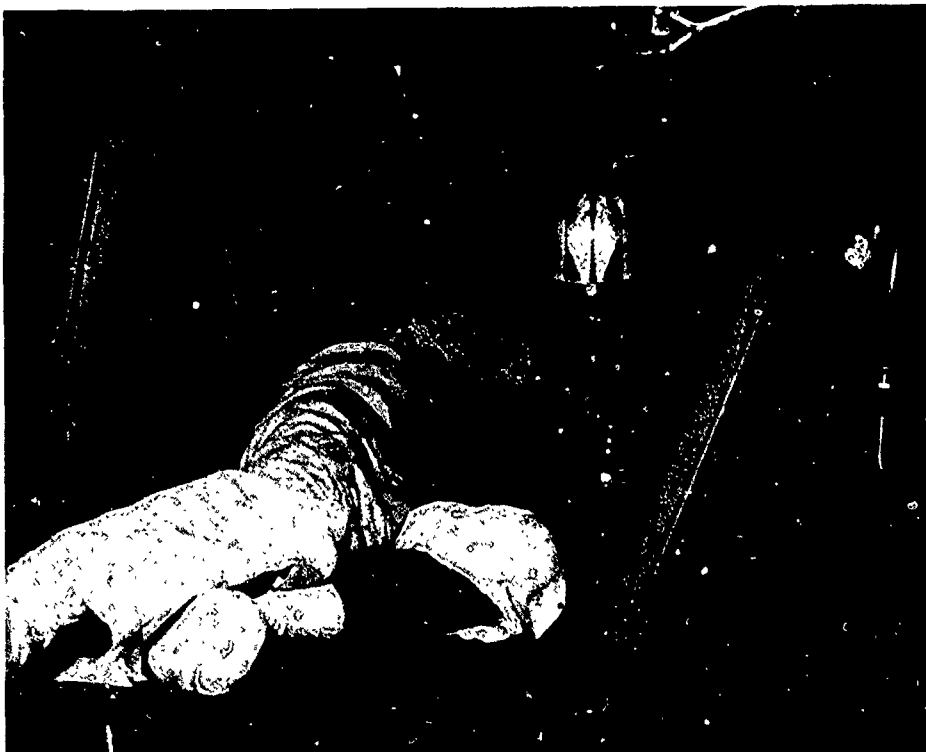
Figures 4 through 9 depict the blue foam applications to the C-130 wing and external fuel tanks.

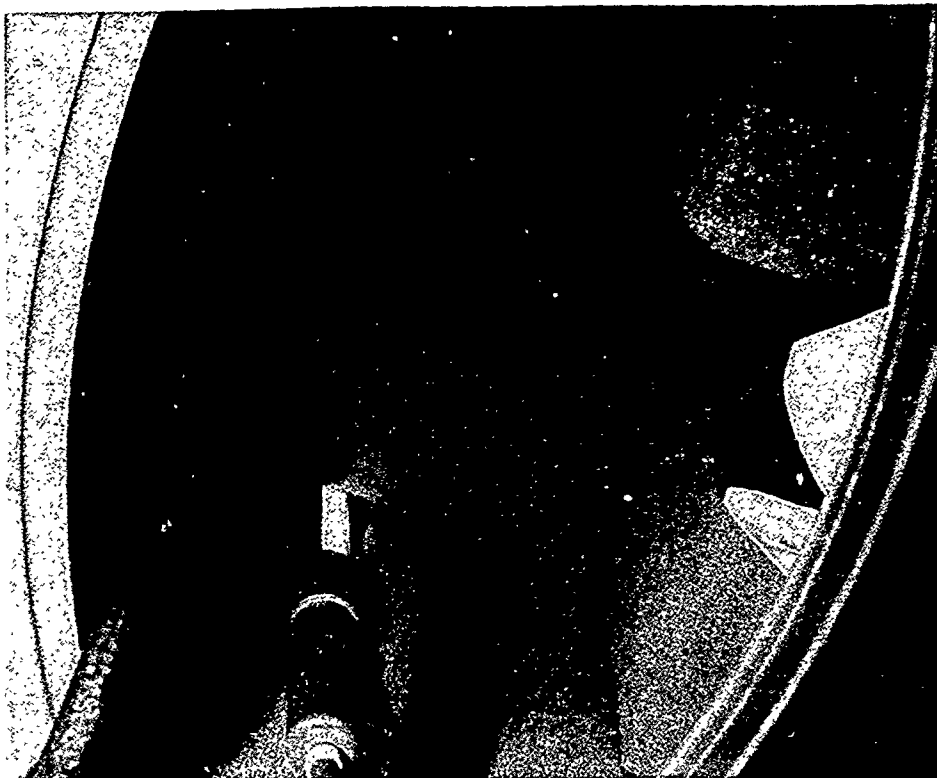
Figures 10 through 14 depict the shrouds and blue/yellow foam for installation around the FLCV and filler cap.
