THE RELATIONSHIPS OF CLIMATE AND TERRAIN  
TO MAINTENANCE OF WAY ON THE NORFOLK  
SOUTHERN RAILROAD BETWEEN NORFOLK,  
VIRGINIA, AND PORTSMOUTH, OHIO

A Dissertation  
Presented for the  
Doctor of Philosophy  
Degree  
The University of Tennessee, Knoxville

Thomas Brock Maertens, Jr.

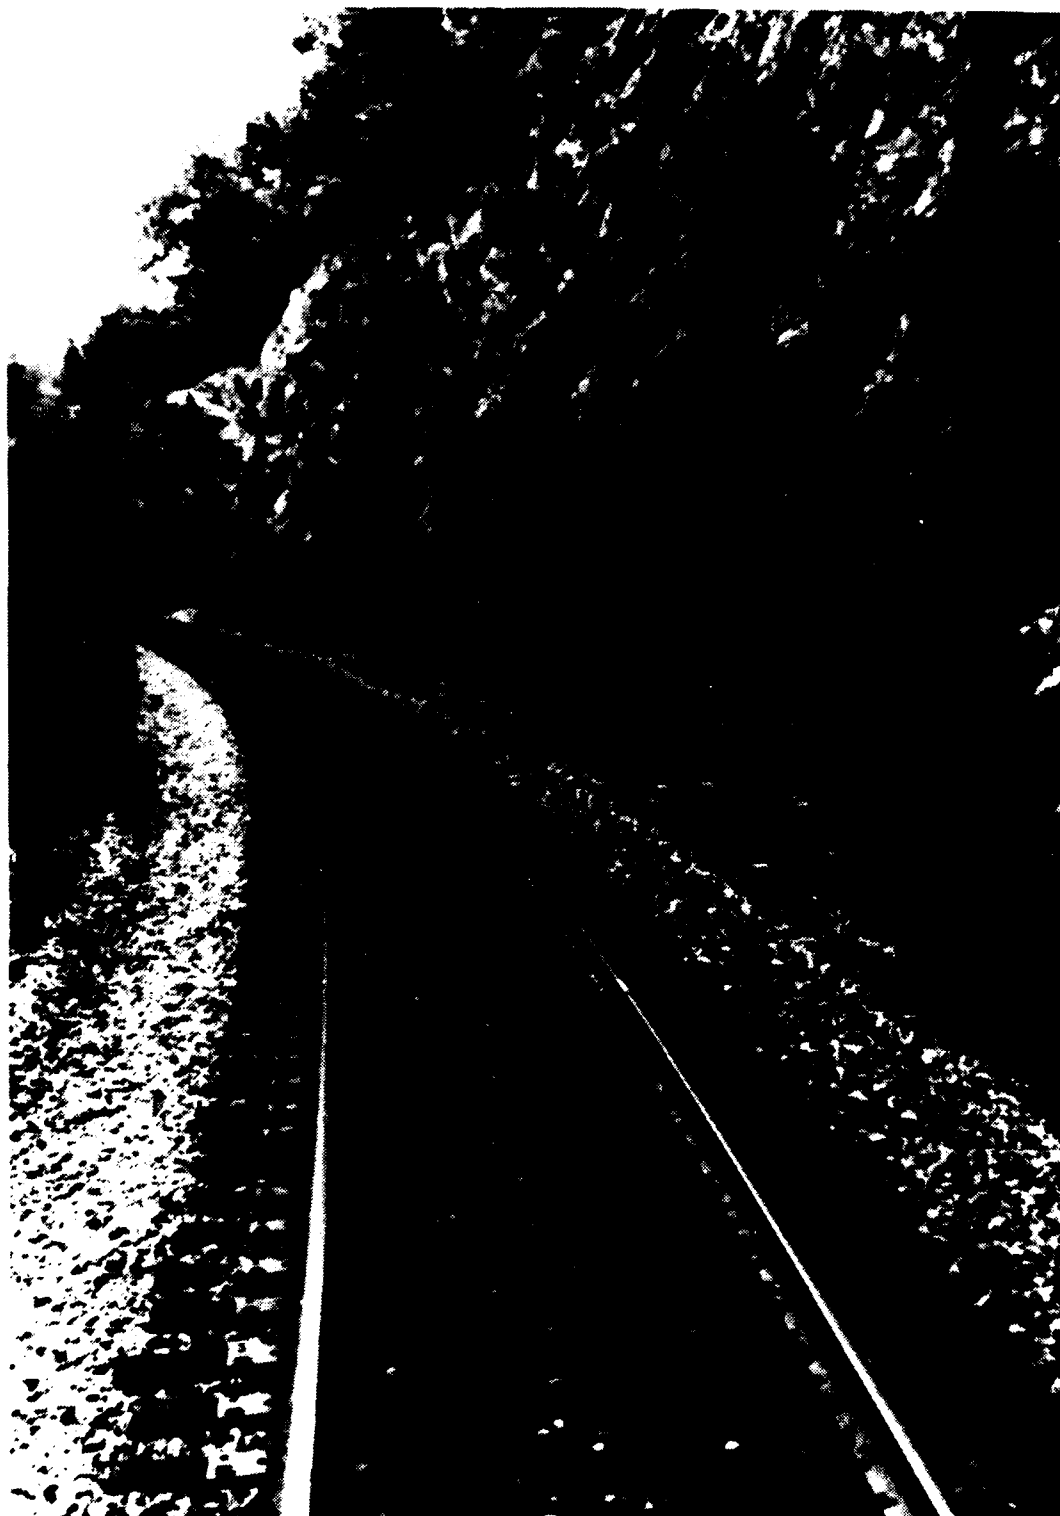
Figure 17. Electric Slide Fence in Service Along a  
Narrow Cut Two Miles East of the Merrimac Tunnel Near  
Blacksburg, Va.

Maintenance with respect to slides and falls involves frequent inspections to detect slow-moving failures before they become a hazard together with extensive knowledge of the maintenance history of particular track segments. Remedial measures for slides include: (1) strengthening of soils through lime and cement grouting, (2) reducing excess water through a system of drains and pumps, (3) modifying the geometry of the slope, (4) employing structural modifications such as retaining and gabion walls or pilings, (5) bridging over the slide area, and (6) relocating the track away from the base of the slope. Electric slide fences (see Figure 17) installed along the right of way in areas of cuts and steep slopes operate signals to warn trains that the fence has been struck by falling rocks. These fences open electric circuits when pulled apart by the pressure of impinging rocks. To summarize the discussion of maintenance of way along the right of way, many railroad maintenance engineers cite three basic factors--drainage, drainage, and drainage.<sup>64</sup>

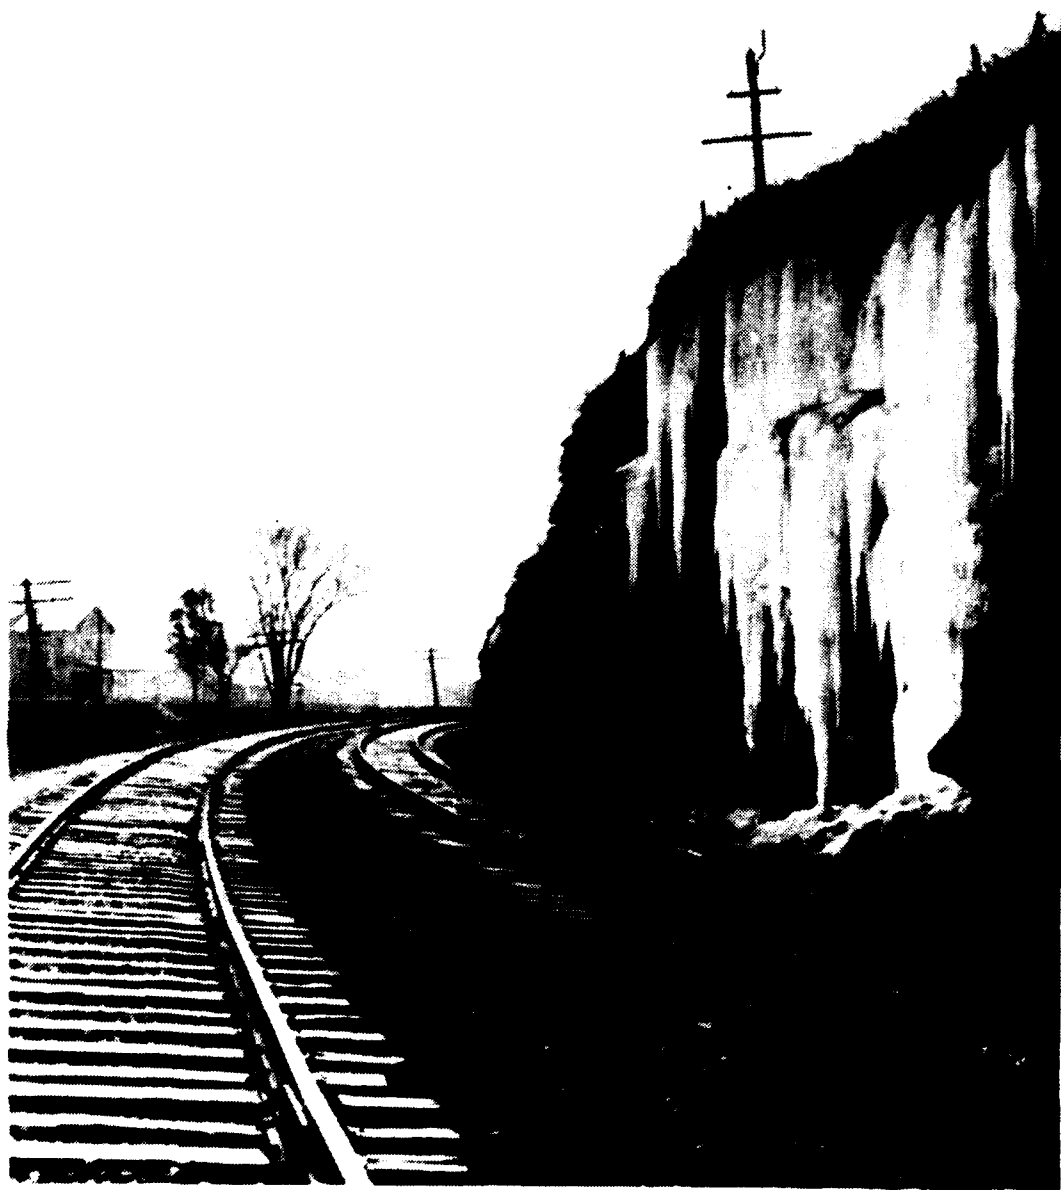
Figure 19. Ice Formation Along Curve West of  
Williamson, W.Va.

and inoperative at temperatures below freezing when combined with moisture from rain, sleet, or snow.<sup>69</sup>

Ice storms occur when supercooled rain or sleet falls and freezes on contact with frozen ground. Ice-laden wires, trees, and sections of pole lines snap and fall, interrupting communications and signal operation and sometimes blocking the track. While most of the Norfolk Southern system uses microwave and radio communications and buried communication and signal cables, above-ground lines and poles are still found throughout the Pocahontas Division. Ice storms also create difficult and hazardous working conditions for maintenance personnel, as tools, materials, walkways, and tracks become covered with ice.<sup>70</sup>
