**IRP RECORDS SEARCH DOBBINS AFB**  
DOCUMENT IDENTIFICATION  
**APR 1982**

# INSTALLATION RESTORATION PROGRAM RECORDS SEARCH

For  
Dobbins Air Force Base, Georgia

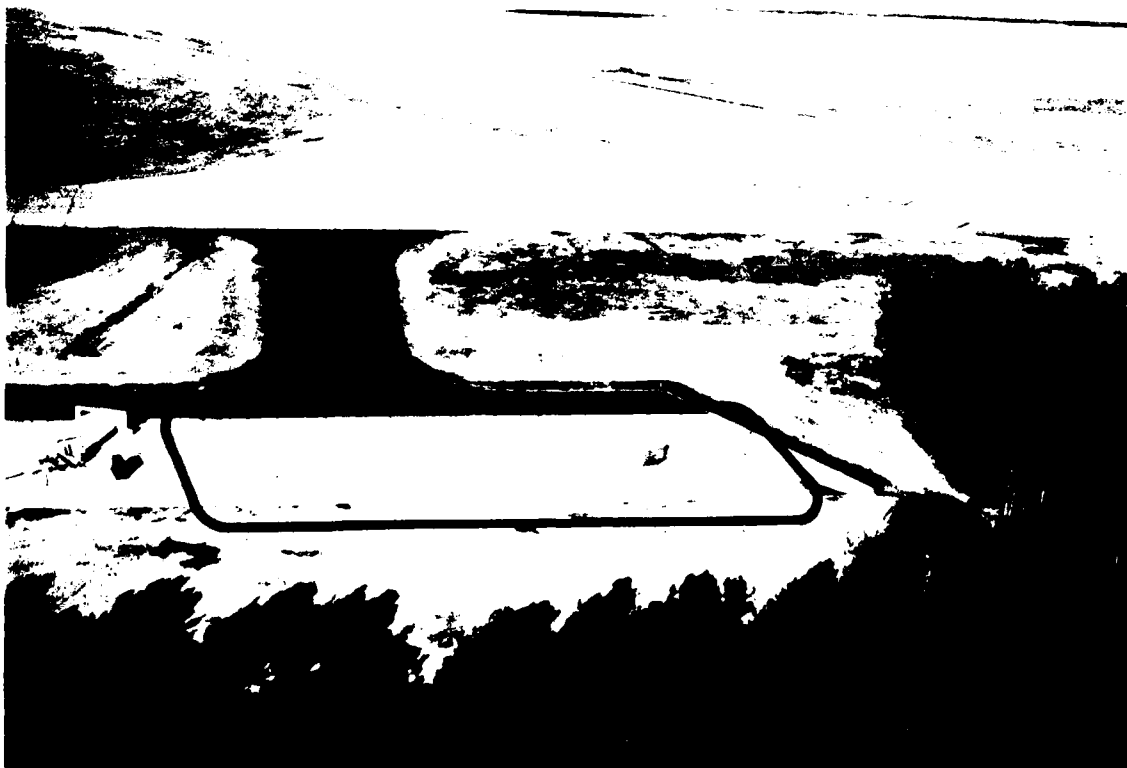
FIGURE I-2. Site No. 2, past fire training area.
