US Army Corps  
of Engineers  
Construction Engineering  
Research Laboratory

USACERL Technical Report M-91/10  
November 1990

## **Strong-Motion Records at Army Hospitals in California From the Loma Prieta Earthquake of 17 October 1989**

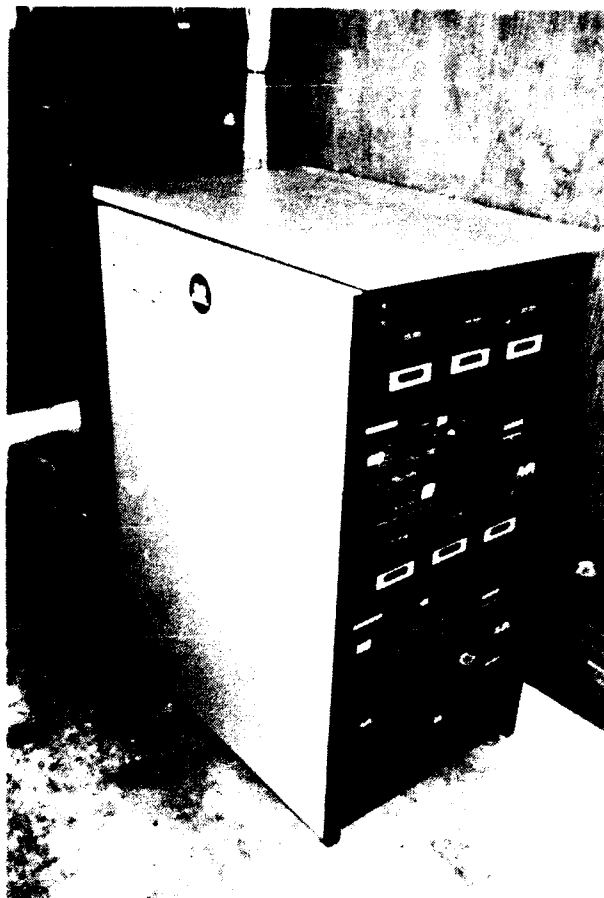
Figure 10. Digital central recording unit.

In 1982 USACERL instrumented both facilities with 18-channel strong motion digital cassette accelerograph systems manufactured by Terra Technology Corp. (see Figure 10). Each seismic instrumentation system (SIS) consists of a digital cassette accelerograph (DCA), a power supply with battery backup, and 18 servo accelerometers. A playback/plotter system is located at USACERL for processing data tapes, and data files may be transferred to USACERL computers for analysis.

The DCA contains six digital cassette tape decks, each of which records output signals from three accelerometers with a digital resolution of 12 bits per channel. The accelerometers have a full-scale peak range of  $\pm 2$  g. The signals are digitized and processed through a 0.64-second pre-event memory buffer before being recorded as a complete time history on tape at 100 samples per second per channel. The output signals from all accelerometers are continually monitored, digitized, and processed through the pre-event memory buffer, but are not recorded. When the system is triggered by the basement accelerometers, all of the tape decks begin recording data from the beginning of the pre-event buffers, so the resulting records include 0.64 seconds of information from before the trigger occurred. Recording continues for 15 seconds after the preset trigger level is last exceeded. Date, time (hours, minutes, seconds), DCA serial number, and event number are obtained from the unit's internal clock and recorded with the earthquake data. The battery backup assures continuous SIS operation for up to 30 hours if commercial power is interrupted or lost. Cables connect each accelerometer to the DCA, which supplies DC (direct current) power and calibration signals, and records the output signals from the accelerometers.
