ESL-TR-89-30

# RESPONSE OF SEMIHARDENED AIRCRAFT SHELTER FIRE PROTECTION SYSTEM TO BOMB BLAST LOADING

D.M. ZALLEN, J. MARQUIS

FINAL REPORT

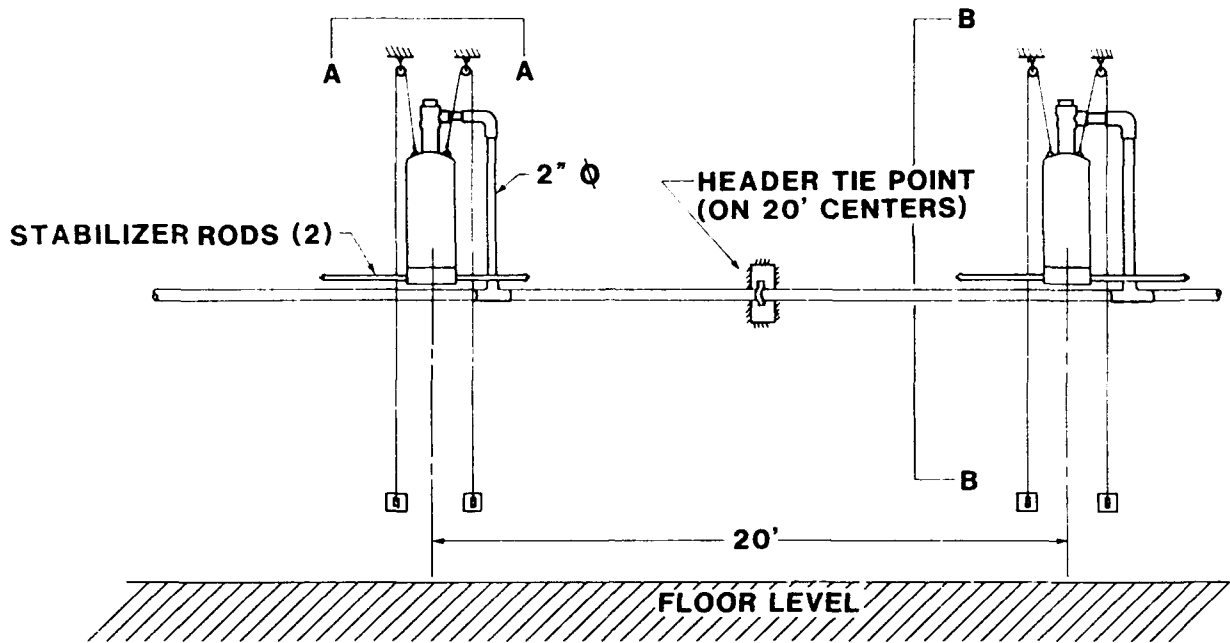
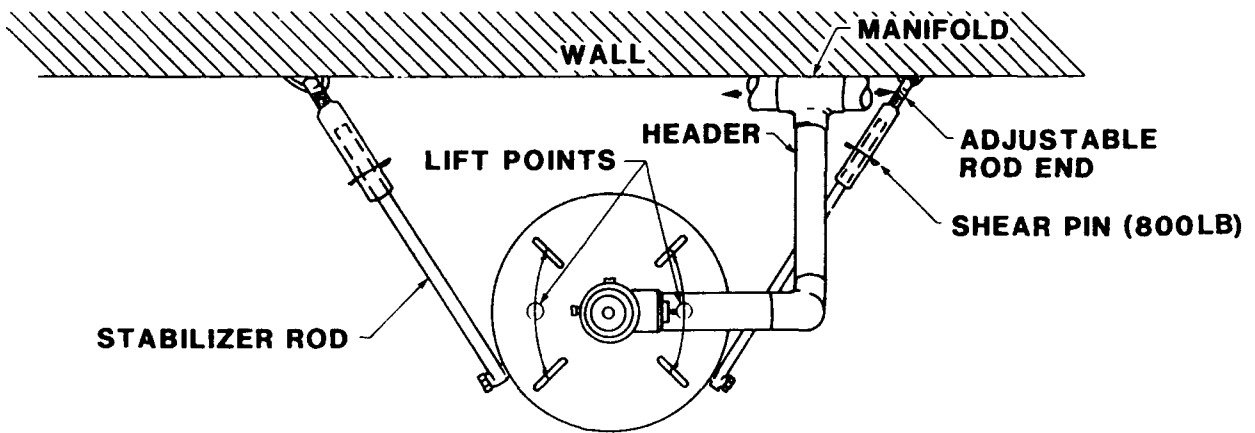
Figure 11. Company 'A' Cylinder Suspension Assembly.

- a. The assembly schematic, tray elevation schematic, and construction for the tray cylinder mount are presented in Figures 7, 8, and 9, respectively.
- b. The layout of the wire rope cylinder suspension mount is presented in Figure 10. Plan and elevation views of the suspension assembly are presented in Figure 11.
- c. The construction of the detector mount is presented in Figure 12.

**HAS CYLINDER MOUNTING - BLAST RESISTANT**

**ELEVATION VIEW - TYPICAL SECTION OF SYSTEM**

**SECTION A-A**

(1) The shock-mounted suspension basically isolates the cylinder from wall movement. The thin wall header, tied down only on 20-foot centers will flex (and rotate at V-Band couplings) to accommodate the differential movement from wall to cylinder.

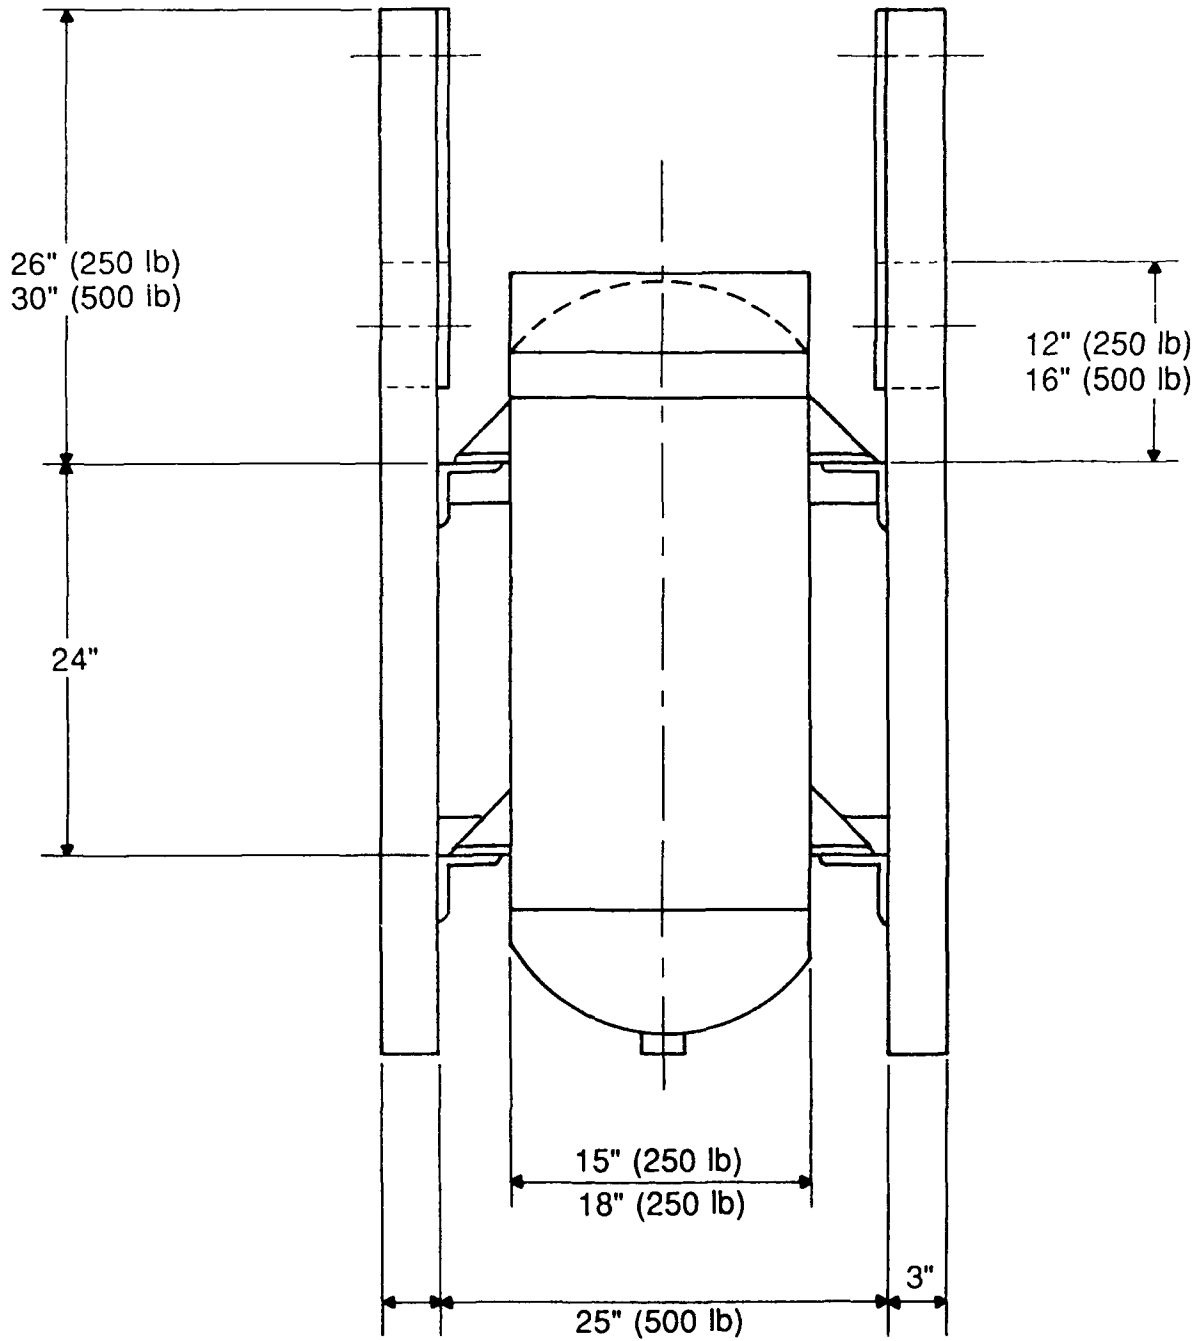
a. Figures 15, 16, and 17: ISK 150--The bracket arrangement originally supplied for the fire suppression tests of the 250 and 500 lb suppression cylinder supports.

Figure 15. Company 'C' Bracket for Tyndall Air Force Base.

Figure 16. Company 'C' Bracket for Tyndall Air Force Base.

Figure 17. Company 'C' Bracket for Tyndall Air Force Base.

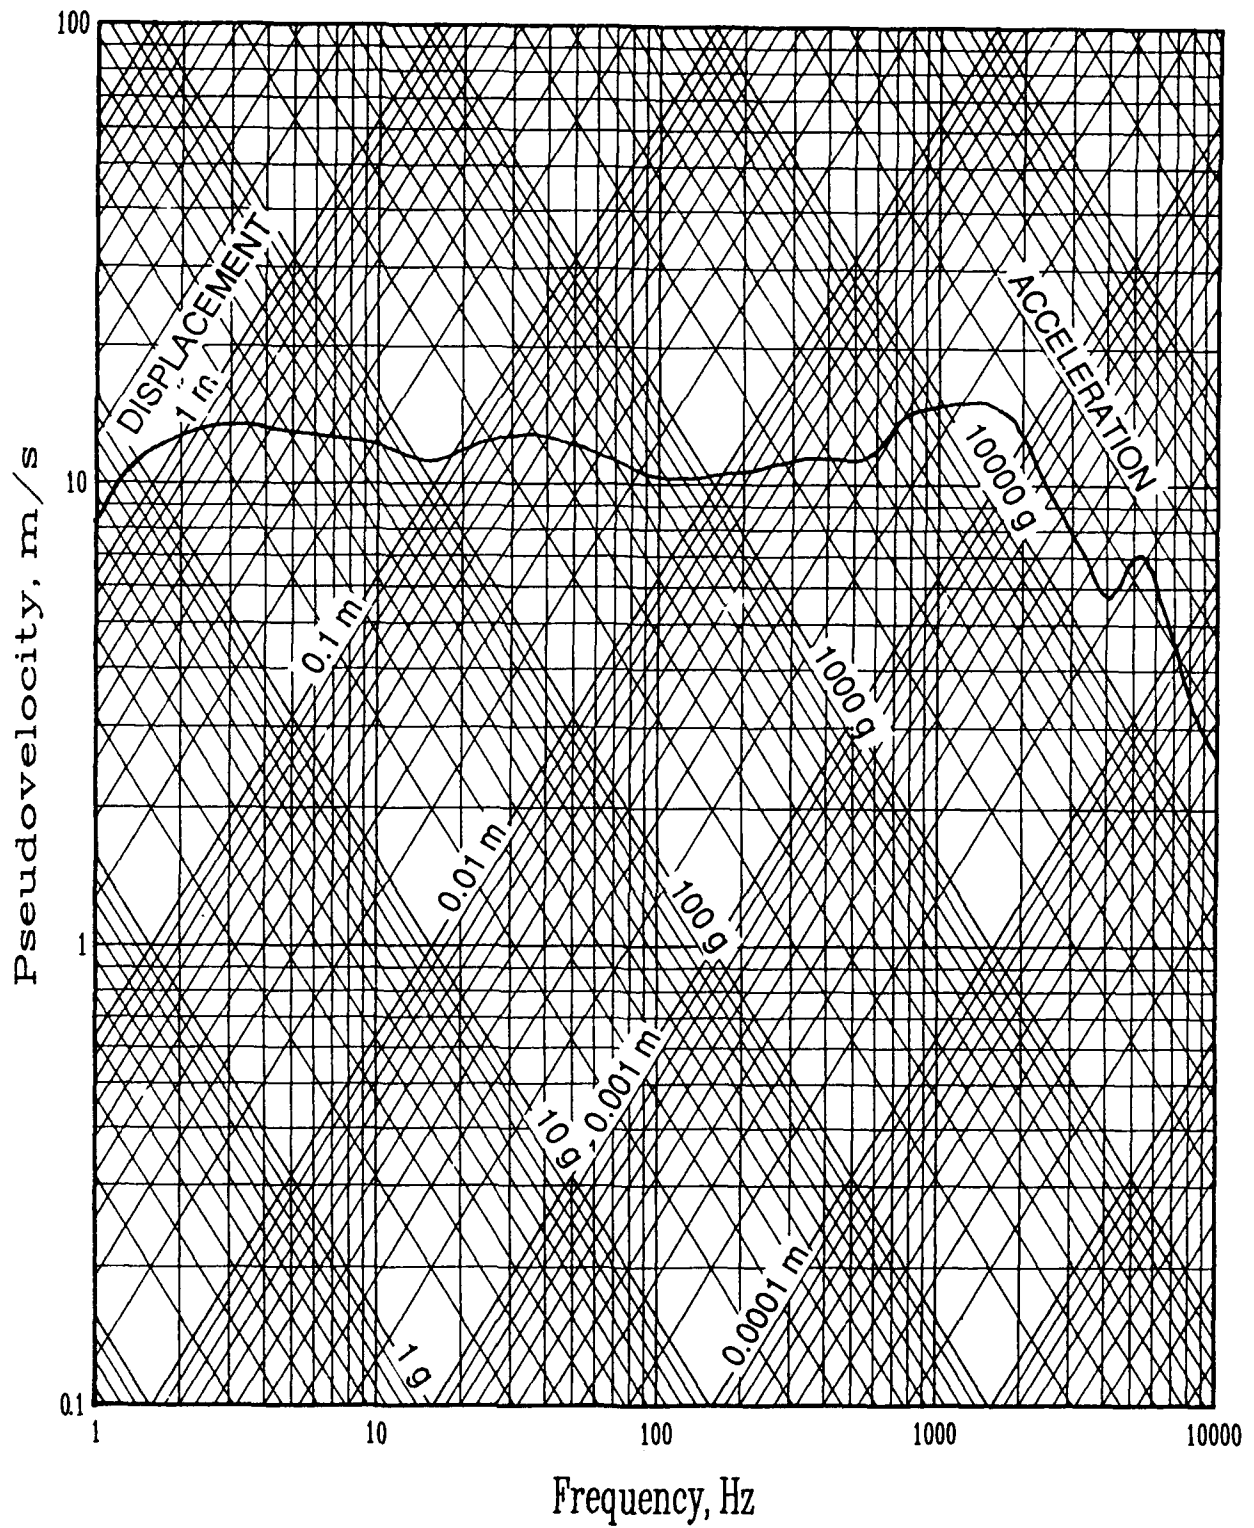
Figure 28. Pseudovelocity Shock Response Spectrum for HAS-FPS Equipment, 5 Percent Damped.

The required shock response spectrum for the HAS-FPS equipment to be mounted on the arch wall is the 5 percent damped spectrum given in Figure 28. The required spectrum applies to both the vertical and horizontal axes of the equipment as defined by the mounted configuration in the aircraft shelter. The test excitation shall be generated with multifrequency excitation inputs. The 5 percent damped test shock response spectrum, which is felt by the equipment mounts, shall envelop the 5 percent damped required shock response spectrum given in Figure 28. The amplitudes of the test excitation input shall be equal to or greater than the zero period acceleration of the required shock response spectrum, unless other amplitudes can be otherwise justified.

The required shock response spectrum in Figure 28 was developed by enveloping shock response spectra derived from acceleration measurements on the arch wall and those on the mounting fixture of FPS equipment. It would, of course, be desirable to have additional acceleration measurements on the arch wall to derive a more refined and perhaps less conservative required shock response spectrum. Further definition of the shock environment at the arch wall could reveal that there is sufficient difference in the severity of the shock motions to specify a different required shock response spectrum at low elevations on the wall versus higher elevations on the wall, or a different required spectrum for the horizontal and vertical directions.

It should be noted that the required spectrum in Figure 28 applies to the case of an unbermed arch wall. Therefore, a different required spectrum may be desirable for aircraft shelters whose walls are bermed. Finally, the required spectrum in Figure 28 was derived from shock response spectra that are based on the soil conditions at the test site. Different soil conditions could result in more severe shock motions at the arch wall than those measured at the Utah test site. It may be necessary to adjust the required shock response spectrum to account for different soil conditions.

The required shock response spectrum in Figure 28 applies to the case of an unbermed arch wall. Therefore, a different required spectrum may be desirable for aircraft shelters with bermed walls. Finally, the required spectrum in Figure 28 was derived from shock response spectra that are based on the soil conditions at the test site. Different soil conditions could result in more severe shock motions at the arch wall than those measured at the Utah test site. It may be necessary to adjust the required shock response spectrum to account for different soil conditions.
