LGTPM REPORT NO. 91-R-02  
AFPEA PROJECT NO. 89-P-148

EVALUATION OF MINE SAFETY APPLIANCE (MSA) PASSIVE  
FUEL VAPOR MONITOR, PROTOTYPES MSA 16-72,  
MSA 17-72, AND MSA 18-72.

HQ AFLC/LGTPM  
AIR FORCE PACKAGING EVALUATION AGENCY  
WRIGHT-PATTERSON AFB, OH 45433-5999  
March 1991

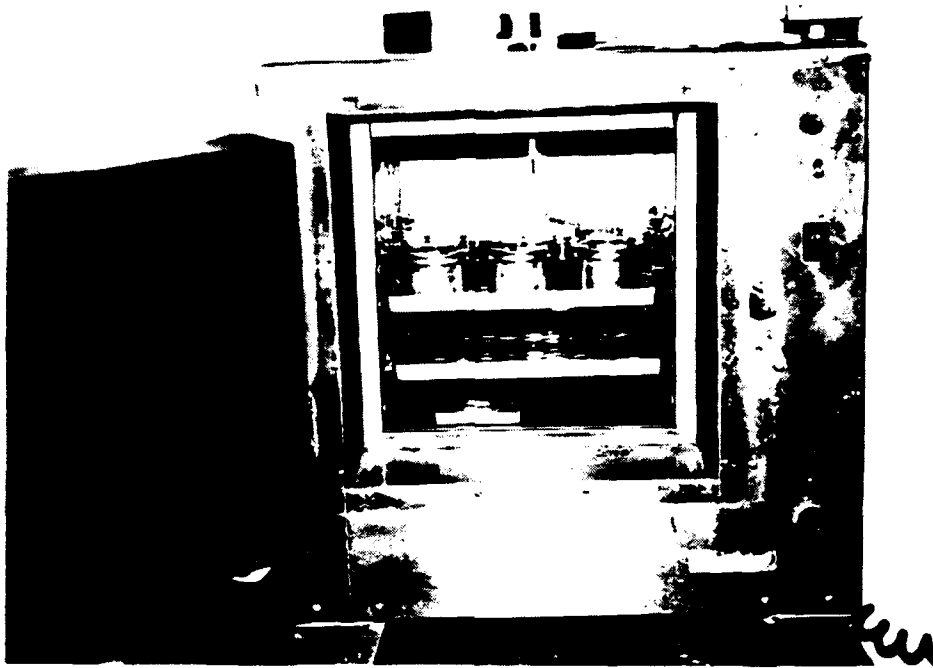
Figure 4. Low Temperature Test Chamber with Test Cups.

The indicator tubes were then mounted in the housings which were mounted in vented 3.5 inch I.D. x 2.14 inch depth aluminum cups with an aluminum adaptor plate. The cups were placed in a controlled temperature environmental chamber and allowed to come into thermal equilibrium at -17.7 C (0 F). At -17.7 C, 2.0 cc of JP-10 were injected into each cup. At -17.7 C, JP-10 vapor in equilibrium with liquid is estimated to have a vapor concentration
