# **USAF TESTING IN SUPPORT OF AIR CUSHION EQUIPMENT TRANSPORTER (ACET) TECHNOLOGY**

**GERALD R. WYEN  
AIRCRAFT LAUNCH & RECOVERY BRANCH  
VEHICLE SUBSYSTEMS DIVISION**

**MAY 1987**

**FINAL REPORT FOR PERIOD OCTOBER 1984 - DECEMBER 1986**

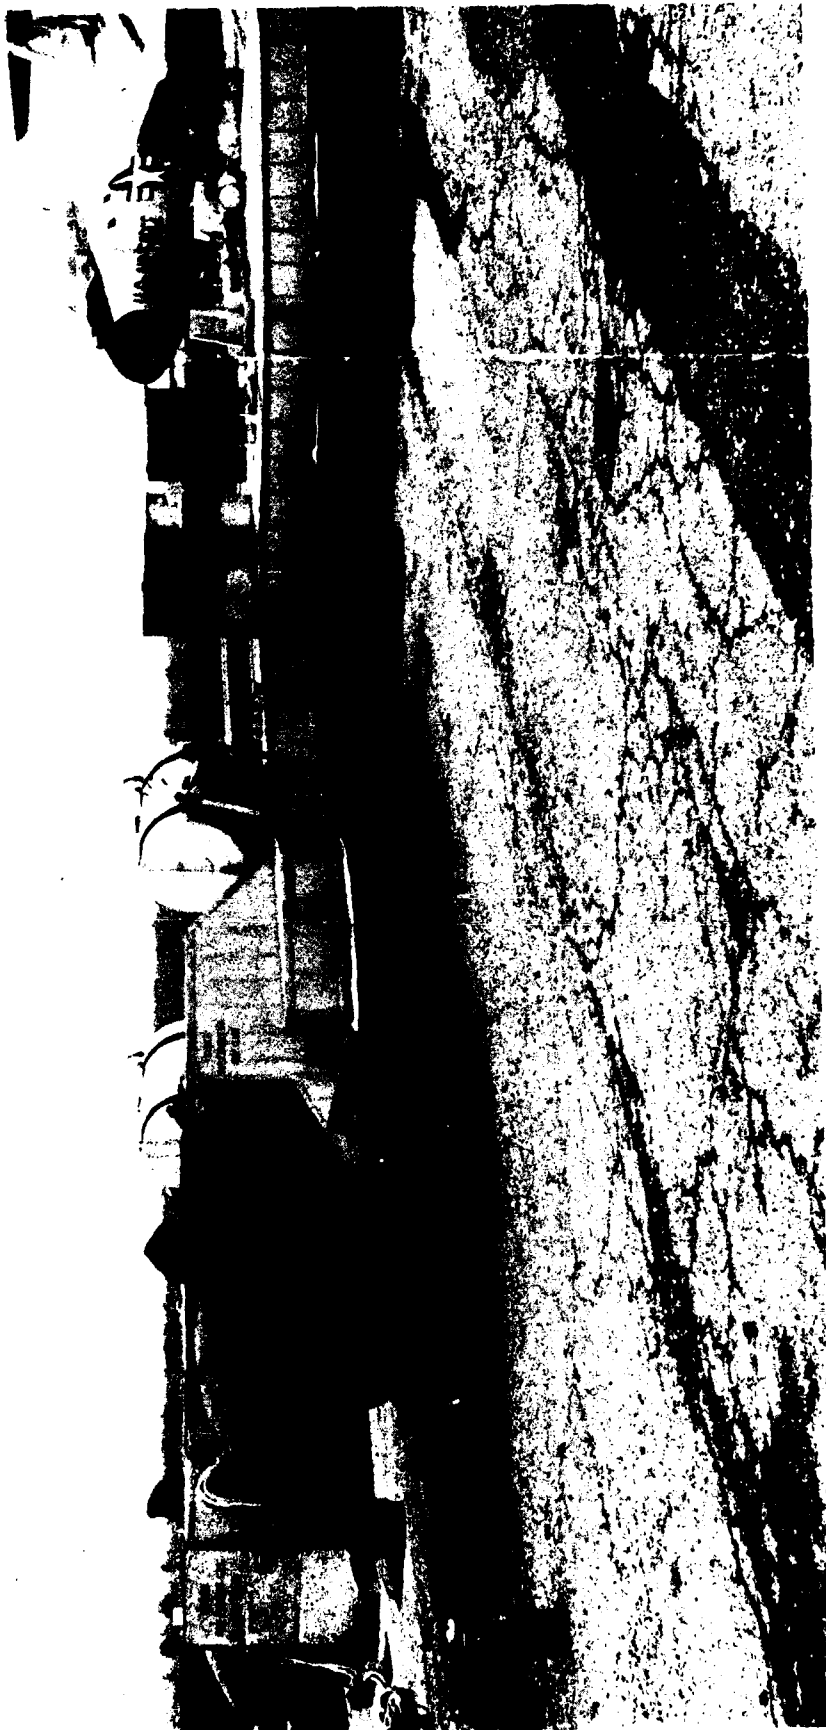
Figure 11. First Generation Protective Screen for F-10 Fan

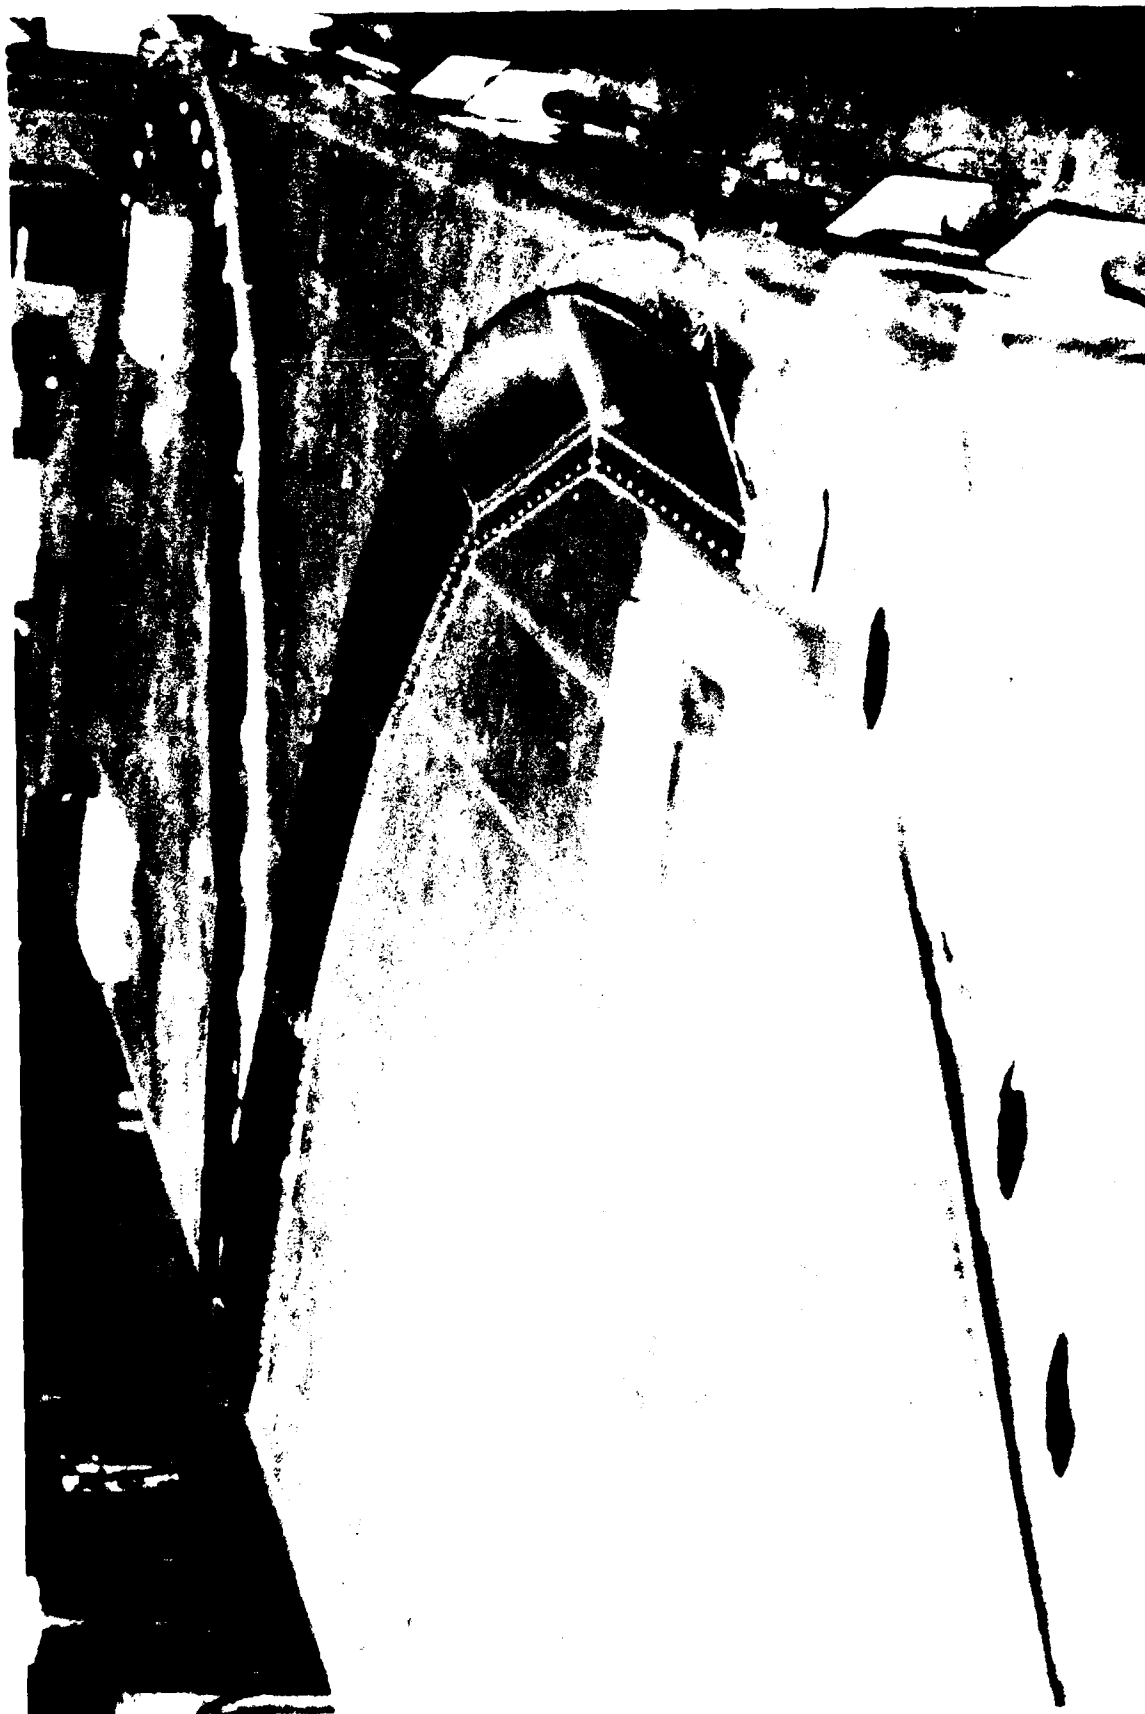
Figure 17. Installation of Cushion Air Deflectors

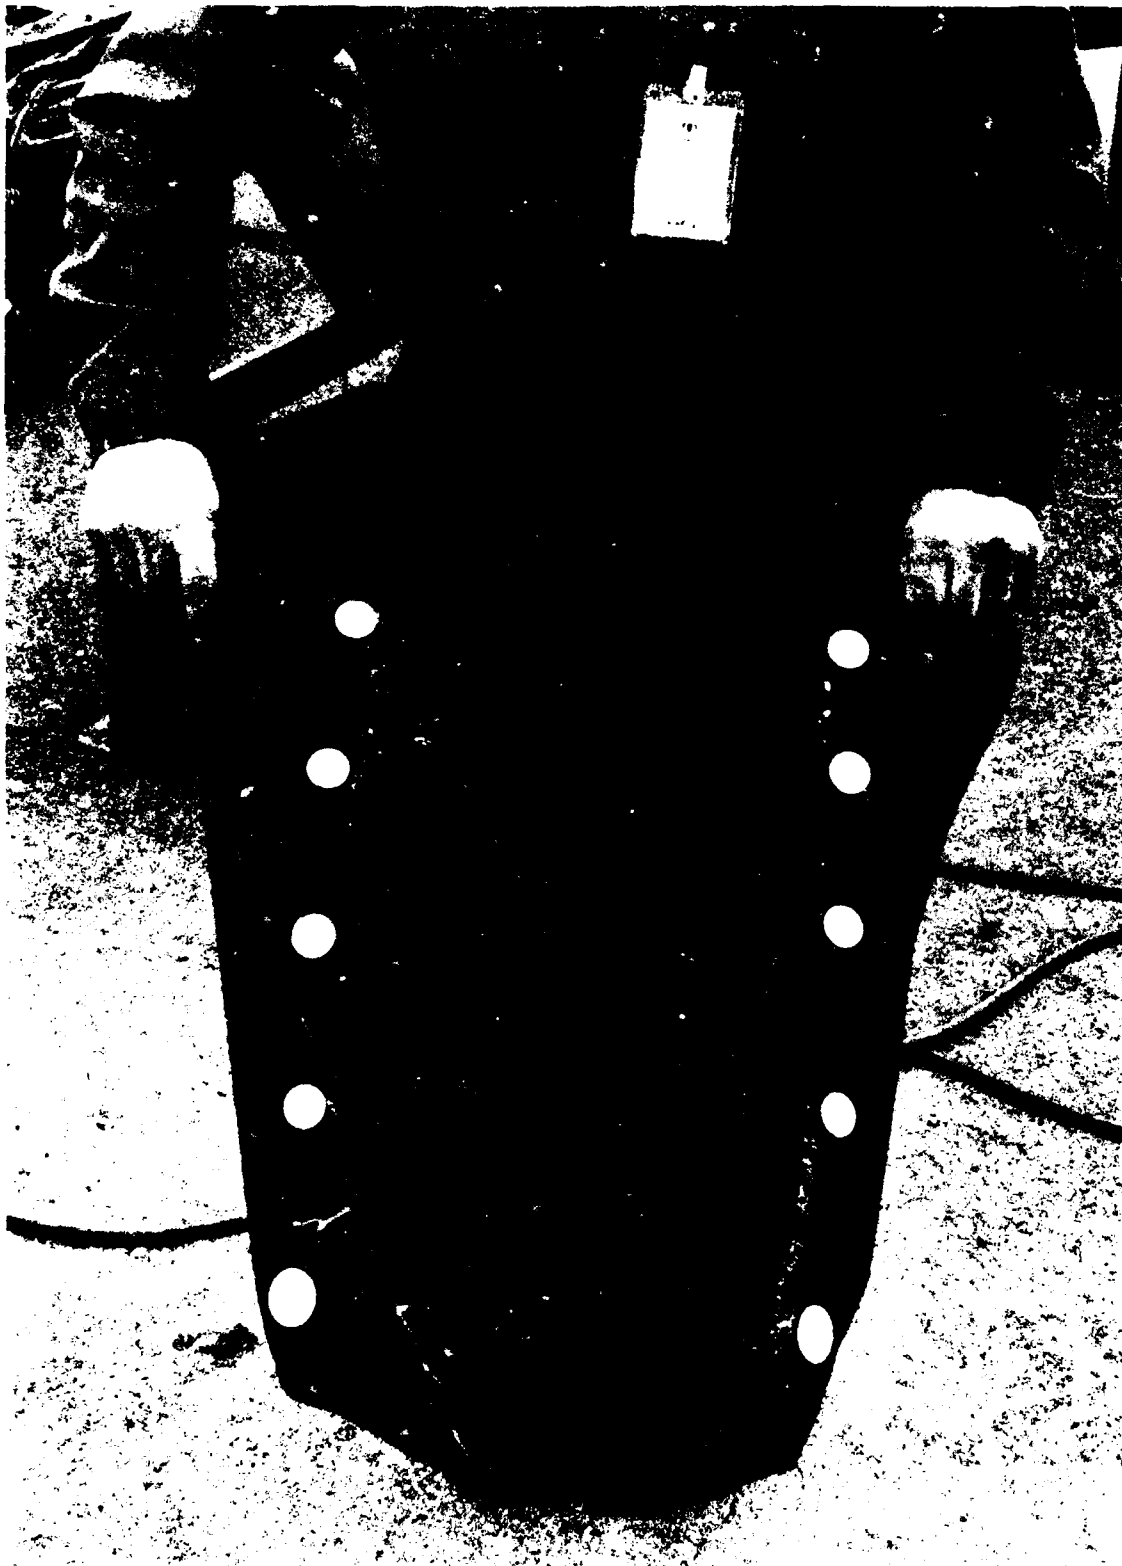
Figure 23. Obstacle Deflector Modification to Finger

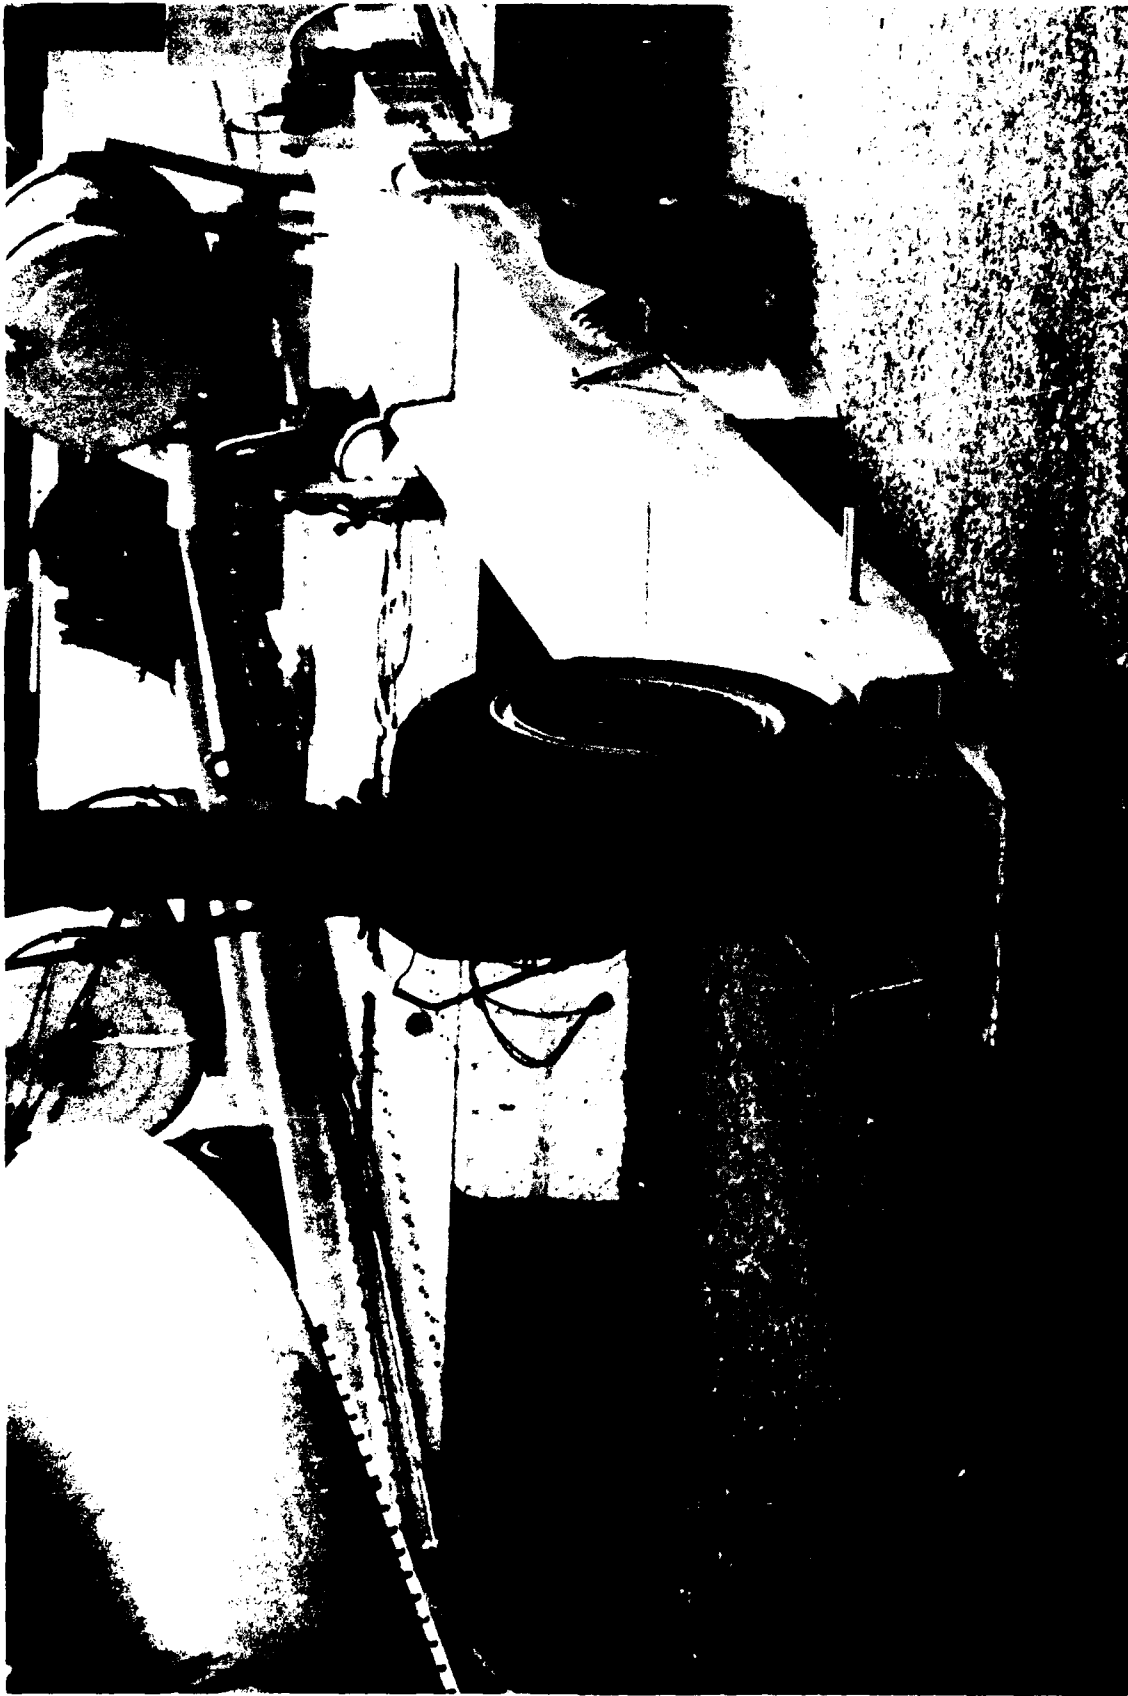
Figure 28. Main and Nose Wheel Ramp and Track Installation

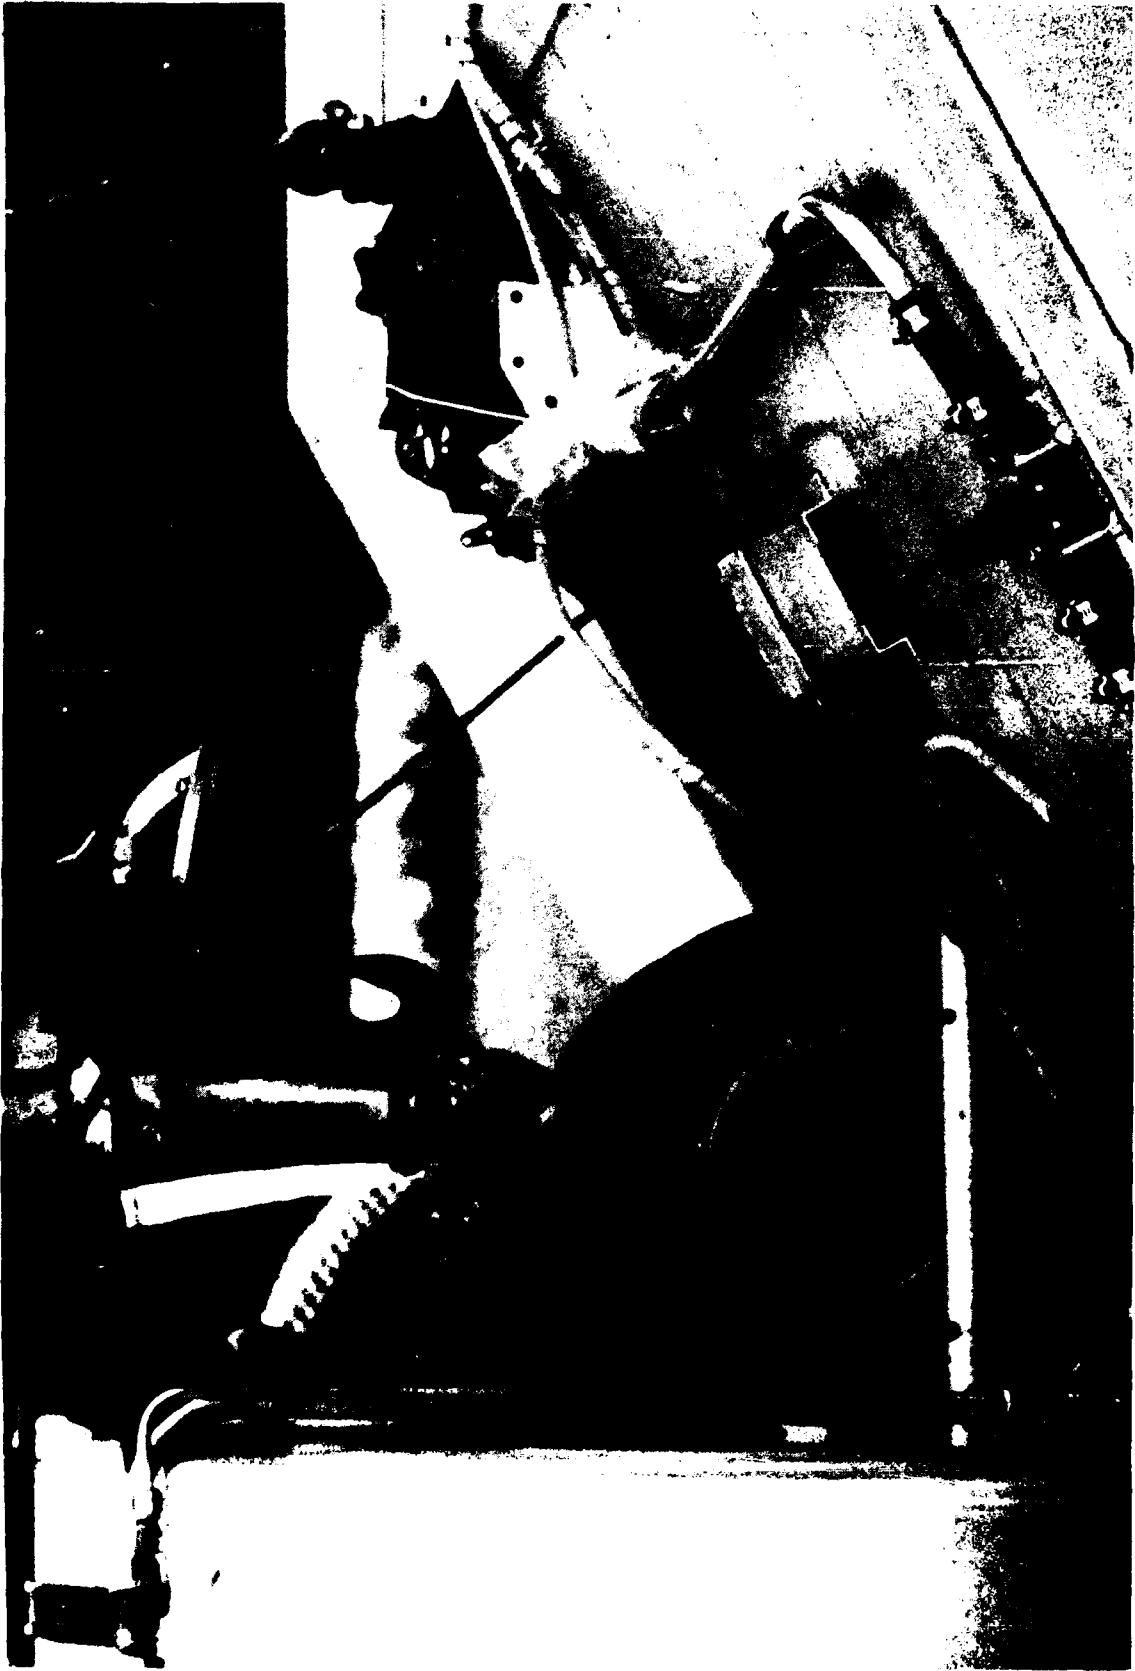
Figure 29. Winch Installation

The BACT Test Program was plagued by reoccurring failures of the winch. These failures were the result of a number of related factors. The calculated maximum load the winch would have to be capable of generating was determined to be 13,409 lbs. The selection of the winch was based on this figure and the physical space available to install the winch. From the initial selection, the winch was a compromise. The 2-HP unit was marginally acceptable. However, a unit in the 5 to 10 HP range would have provided more margin of safety and faster loading times. BACT attempted to find a winch in this range which would meet the space requirements of the installation but was unsuccessful. In order to use the 2-HP unit a single snatch block had to be used. This reduced the load by half but doubled the time required to load the aircraft. This load, 6,705 lbs, was within the manufacturer's published limits. What was not realized at the time of selection was that winches are rated on the basis of the first wrap of cable on the drum. The rated load capacity drops appreciably with each wrap of cable. The maximum loading on the winch occurred when the cable was on its second and third wrap of the drum. This left very little margin for error.

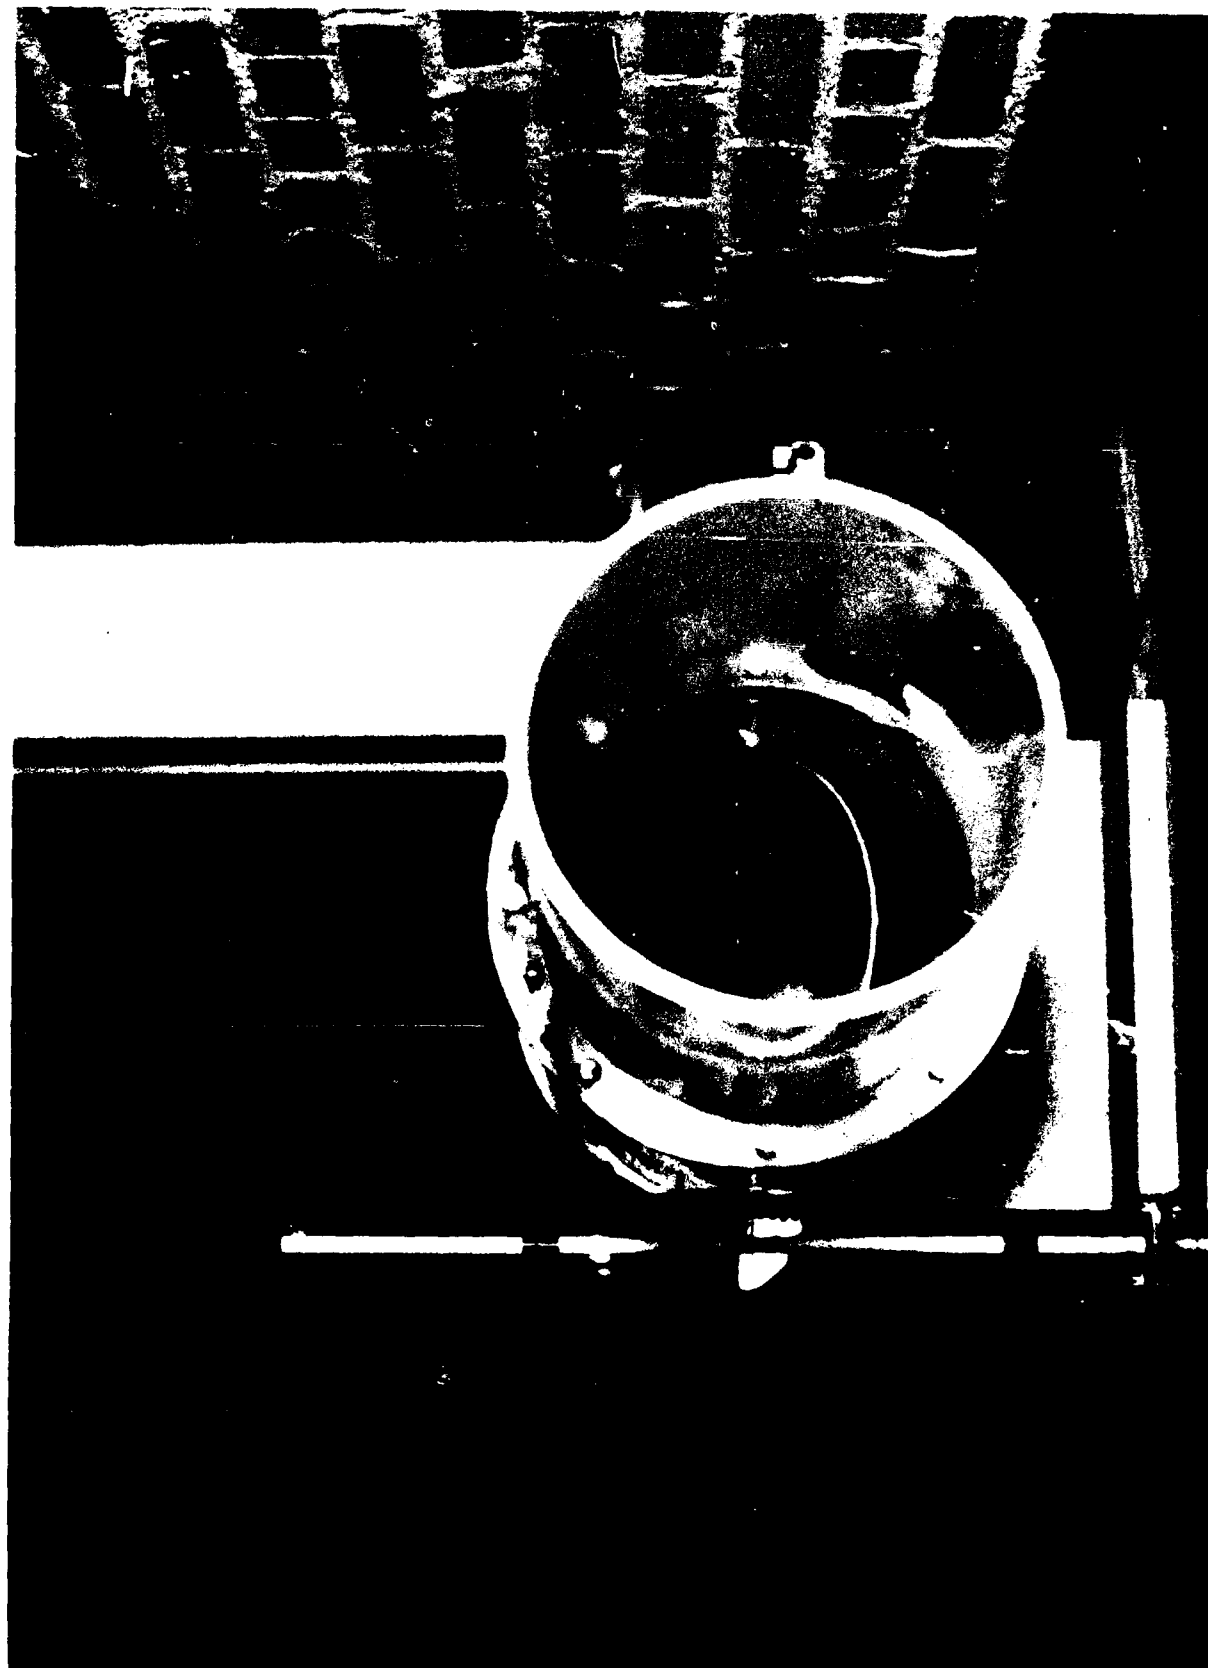
Figure 44. Exit Area Control Butterfly Valve

d. The Exit Area Control Section - This last section of the Calibration Rig is 23 inches long. A butterfly valve was installed in this section to regulate the exit area of the rig (Figure 44). The exit area can be varied by fixing the butterfly valve in any one of 10 positions between fully open and fully closed. The valve was constructed

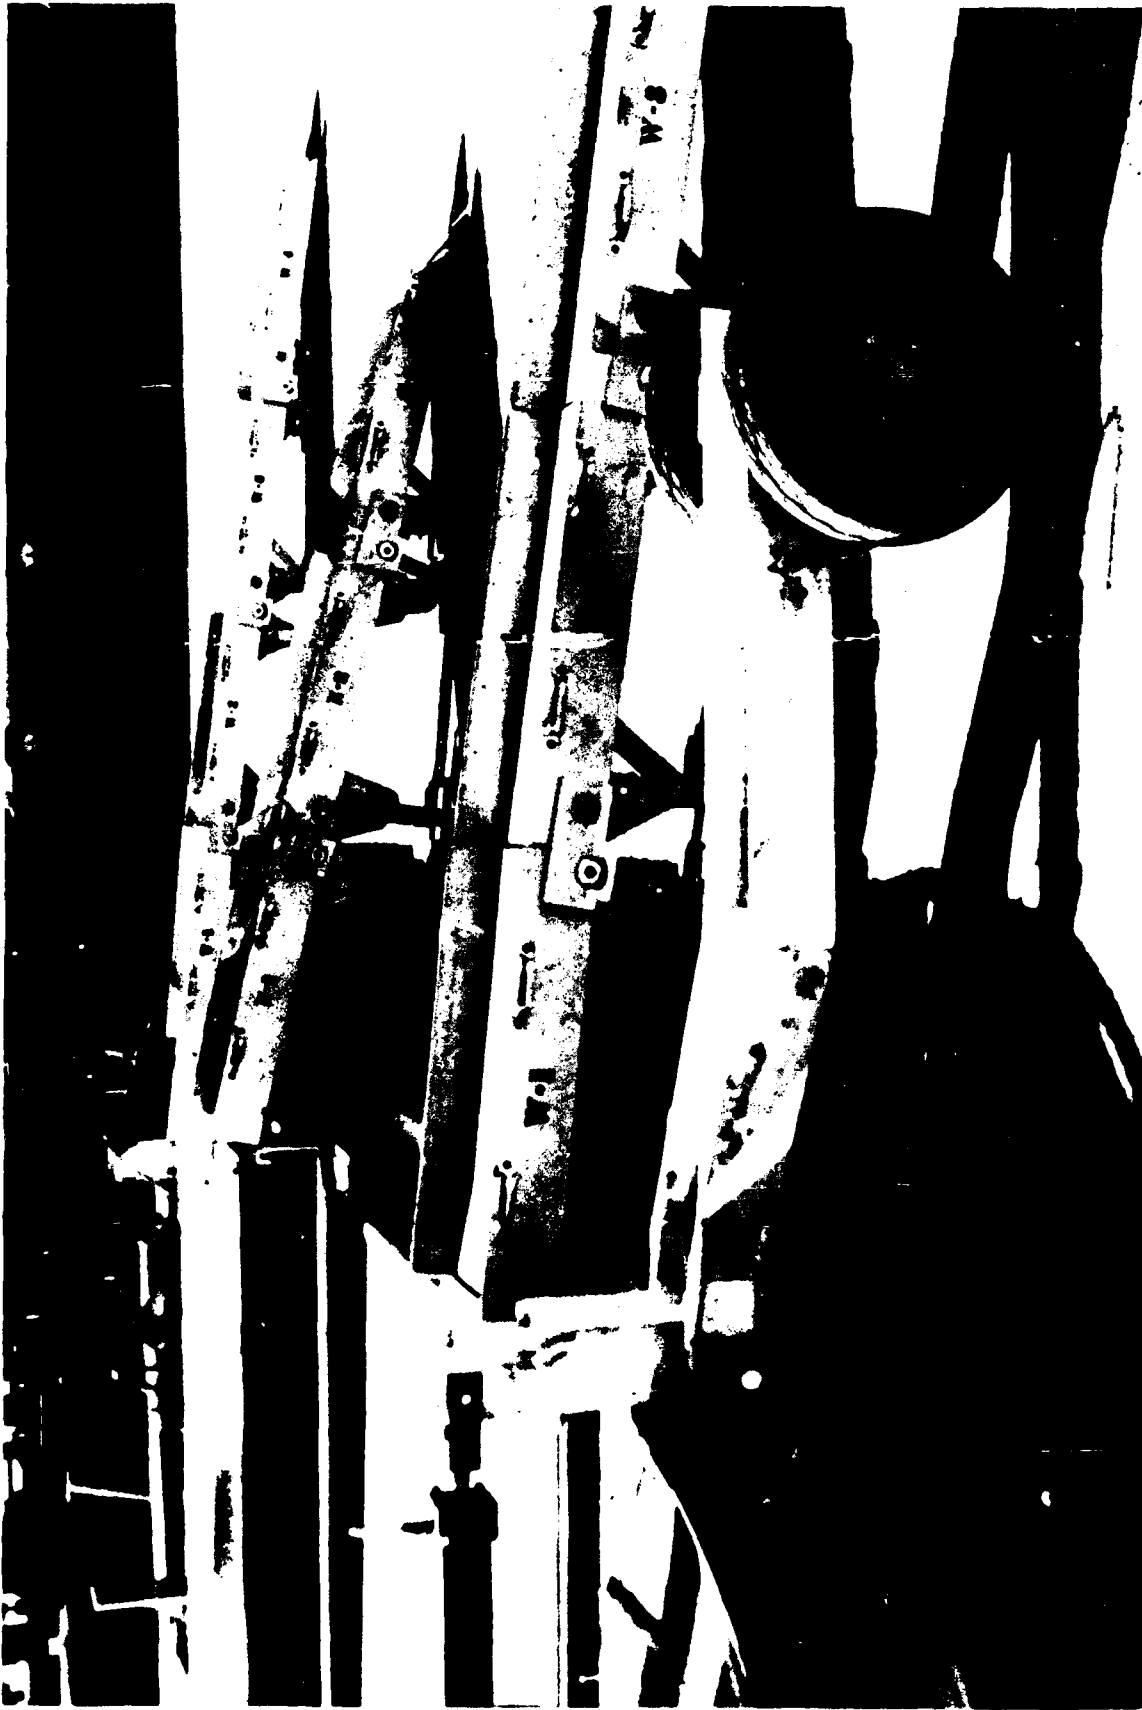
Figure 95. New Loading Ramp and Trailing Wheel Assemblies

The main landing gear ramps (Figure 95) were redesigned to meet these requirements. The new ramps were fabricated in four sections, with the load carrying member being AM-2 landing mat. The landing mat had the necessary strength capability and size to meet the requirements for both the main and nose wheel widths, as well as the maximum loading on the main and nose wheel tires. Each of the main landing gear ramps was redesigned from one continuous piece, to four interlocking sections. This was done to allow two people to move and position the ramps without the need for special handling equipment. Also, the angle of the main gear ramps was

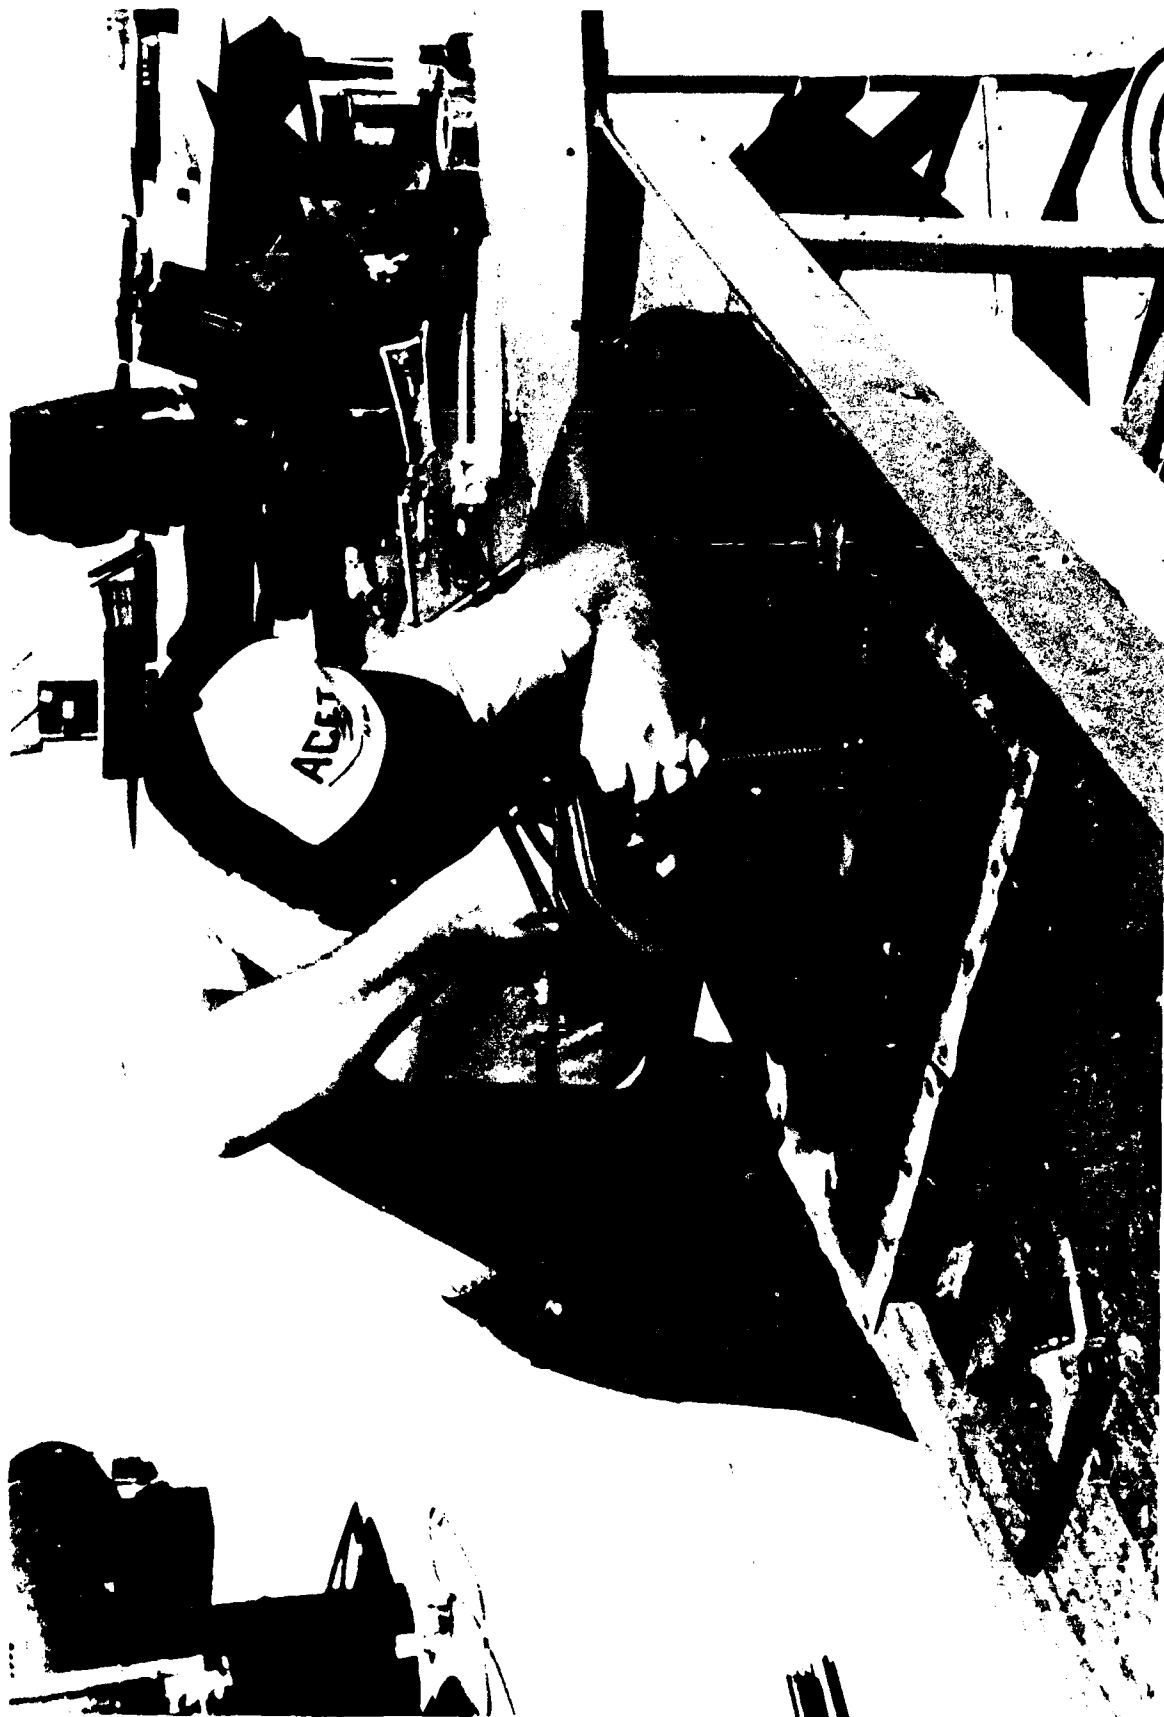
Figure 103. Repair of Lower ASP-10 Exhaust Stub

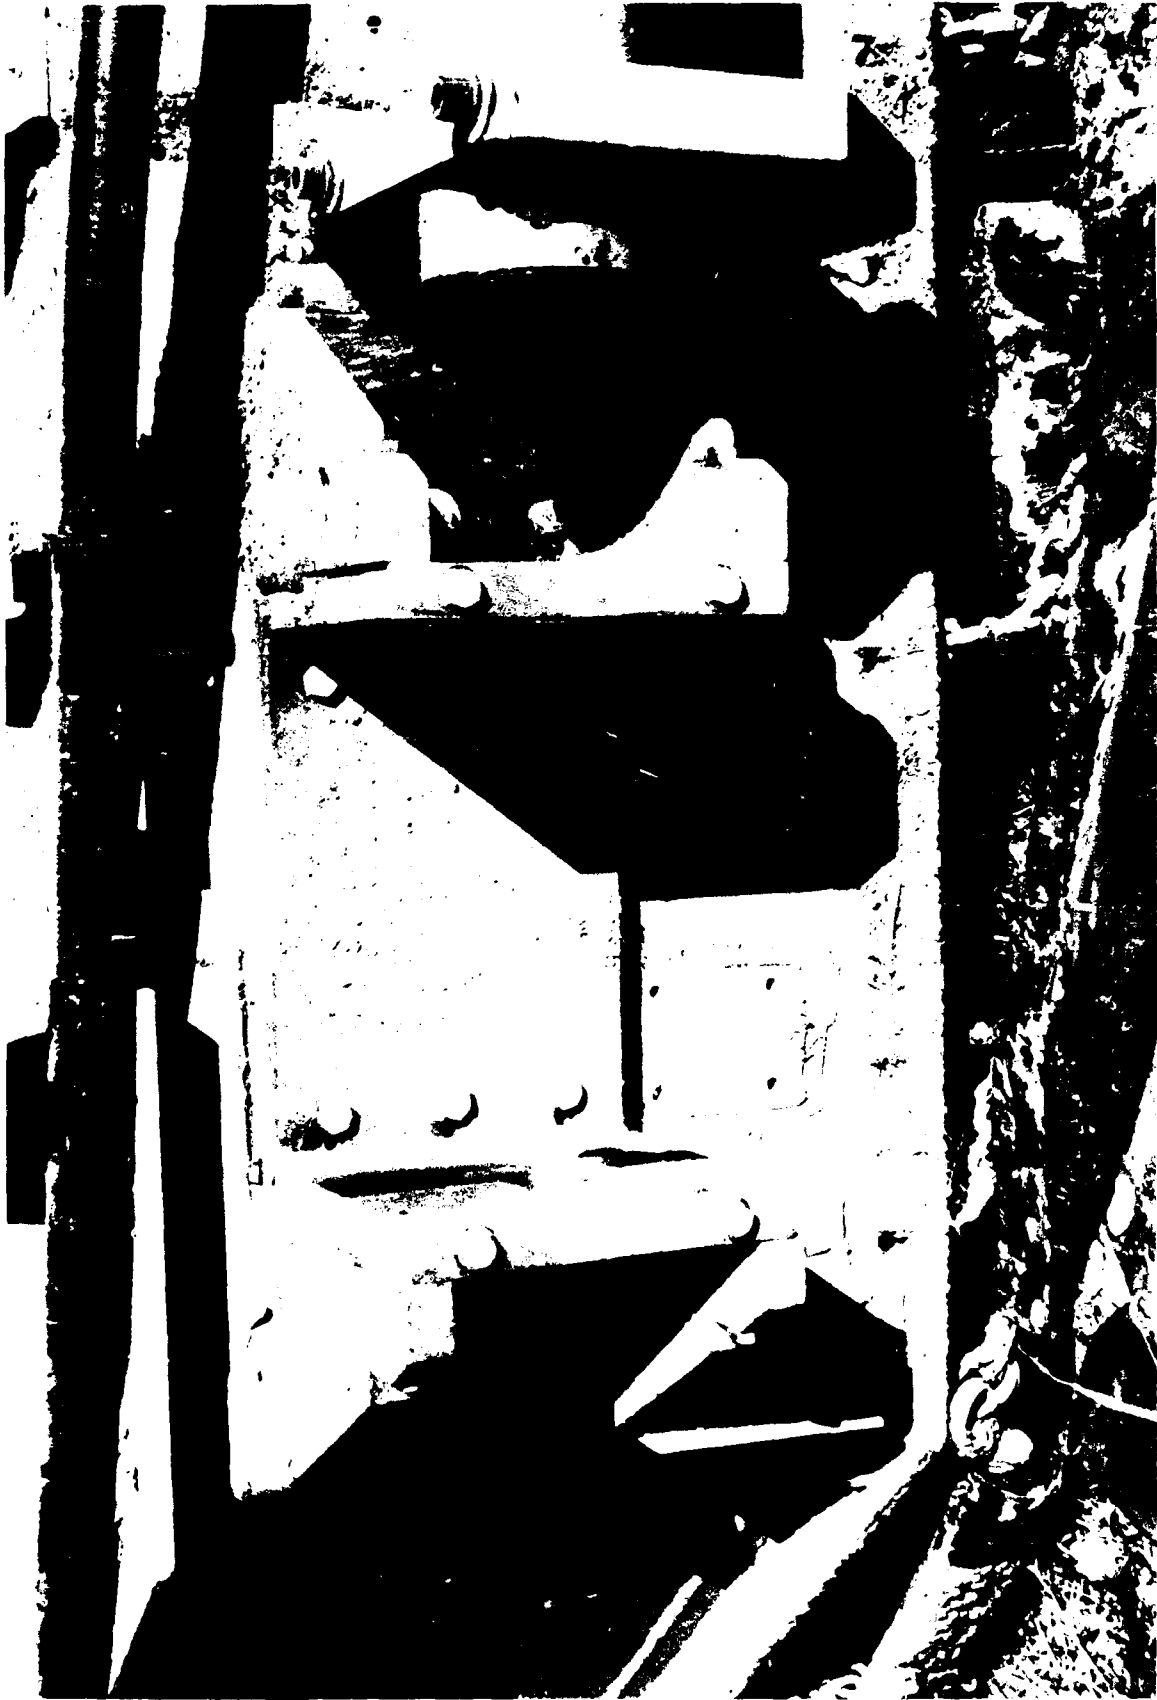
Figure 107. New Trailing Wheel Assembly Attachment Bracket
