**Technical Report 1434**  
**August 1991**

# **Environmental, Electrical, and Electromagnetic- Compatibility Testing of the TFCC—DTC-II**

# NAVAL OCEAN SYSTEMS CENTER

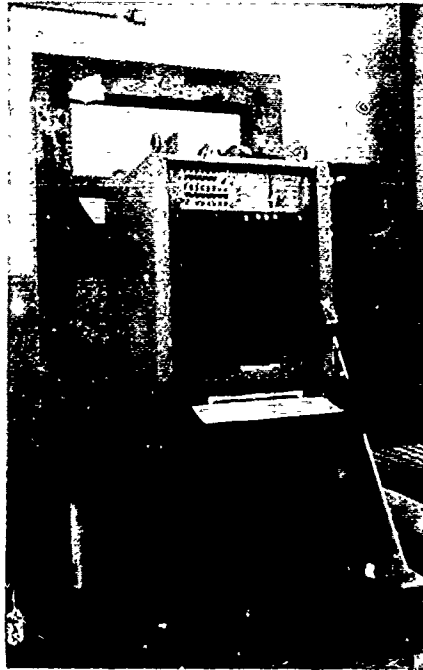
Figure 1. Unit 1 on the vibration tester.

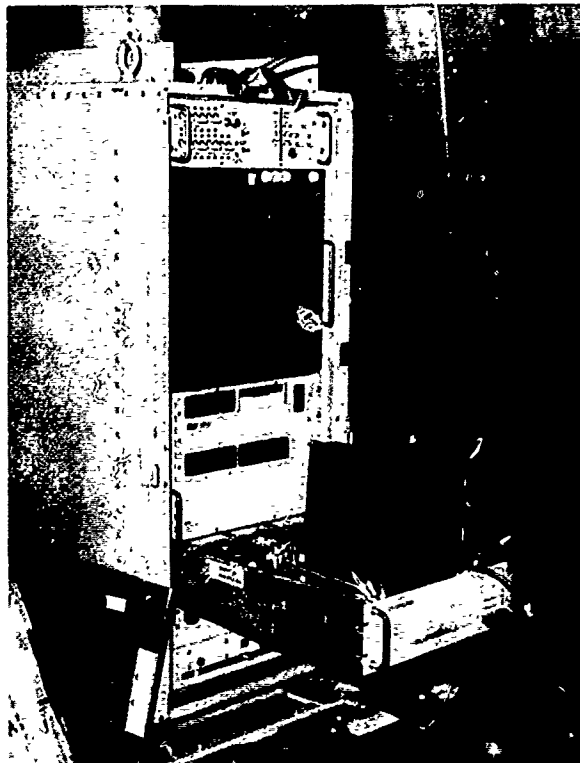
Figure 2. Unit 1 after the UPS failure.

Results. Unit 1 completed the full MIL-S-167-1 vibration-exposure test with failures of the trackball assembly and of two UPSs. The JOTS II software cannot continue operation in the event of failure of the trackball. As the trackball is necessary to the operation of the system, this is a critical failure. One UPS failure was clearly caused by improper assembly, the cause of the other failure is under investigation.

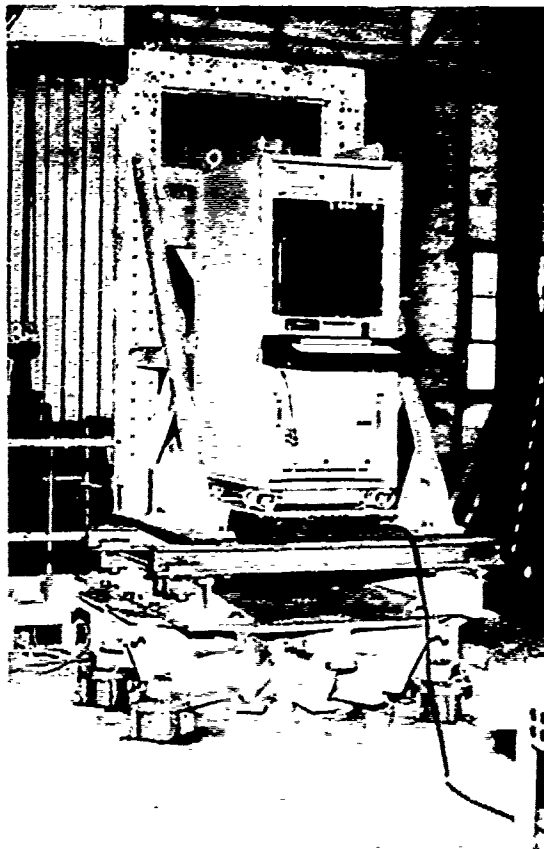
Figure 5. Unit 1 ready for shock in the vertical axis.

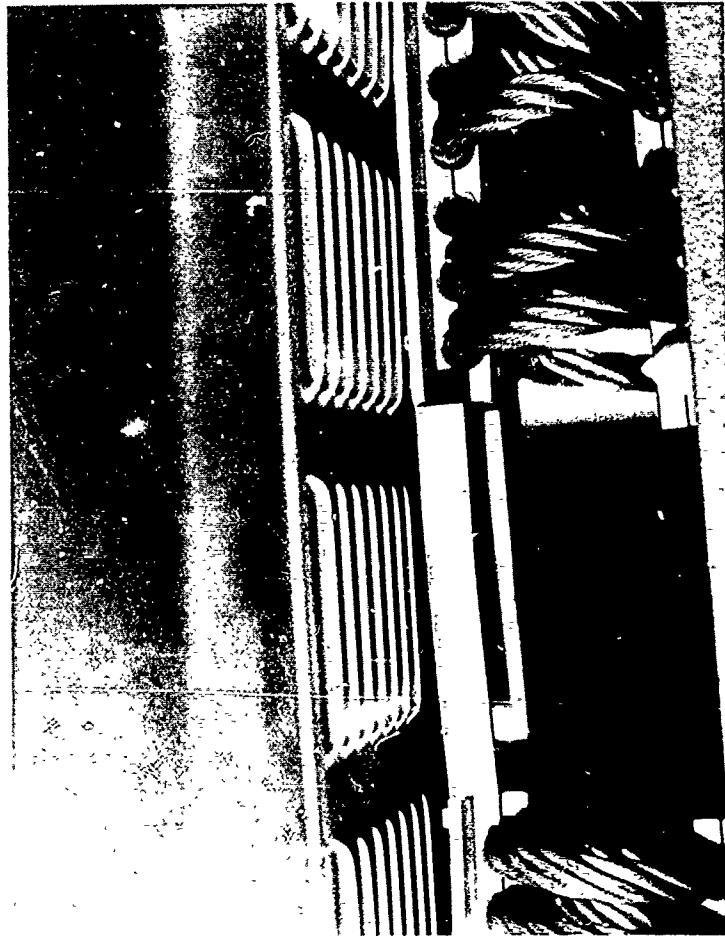
Results. Both units experienced failures of the screws holding the upper shock mount plate to the back of the cabinet. The plates also bowed away from the cabinet as shown in figure 10. The original 10-32 screws on unit 2 were replaced after blow 5 with 1/4-20 through bolts with nuts and washers on the outside of the cabinet. These bolts survived the rest of the blows. During blow 8 on unit 2, the top of the inner rack collided with the top of the outer rack with enough force to bend the top plate of the outer rack and shear one of the screws holding the top on. Unit 1 reported problems with drive "SDOa" after blow 5 and had to be rebooted. No other operational problems were encountered with either unit.

Figure 10. Looking up at the upper shock mount plate showing bowed metal after the shock tests.
