US Army Corps  
of Engineers

MISCELLANEOUS PAPER EL-91-21

# VEGETATION AS AN AGRONOMIC METHOD OF DUST CONTROL ON HELICOPTER TRAINING AREAS AT FORT RUCKER, ALABAMA

Final Report

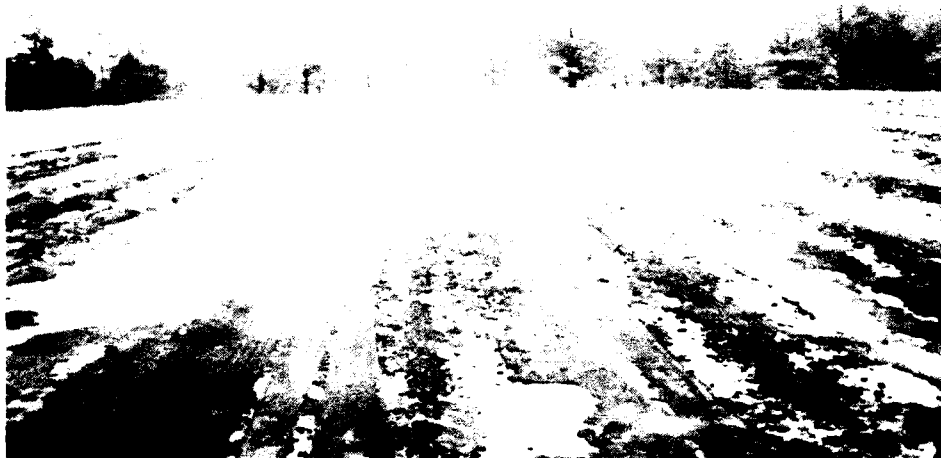
Figure 2. Unsuccessful use of Penepime surface penetration dust control method

Some of the above-mentioned methods have been used at Fort Rucker in the past and have not demonstrated long-term effectiveness. The methods used include mostly the surface penetration and surface blanket types. Penepime, a liquid cutback asphalt, was used extensively on eroded areas with only short-term erosion control. Cracks in the material, resulting from vehicular traffic or environmental stress, allowed the uplifting of thin sheets by rotorwash, exposing the bare soil surface (Figure 2). Also, Penepime has been shown to totally retard seed germination on sandy soil, resulting in little if any vegetative recovery (Zhordania et al. 1983). Tests were conducted in the 1960's using membranes and mesh. These surface blanket materials were discontinued for helicopter areas after torn pieces of the materials were drawn into the rotary wings.

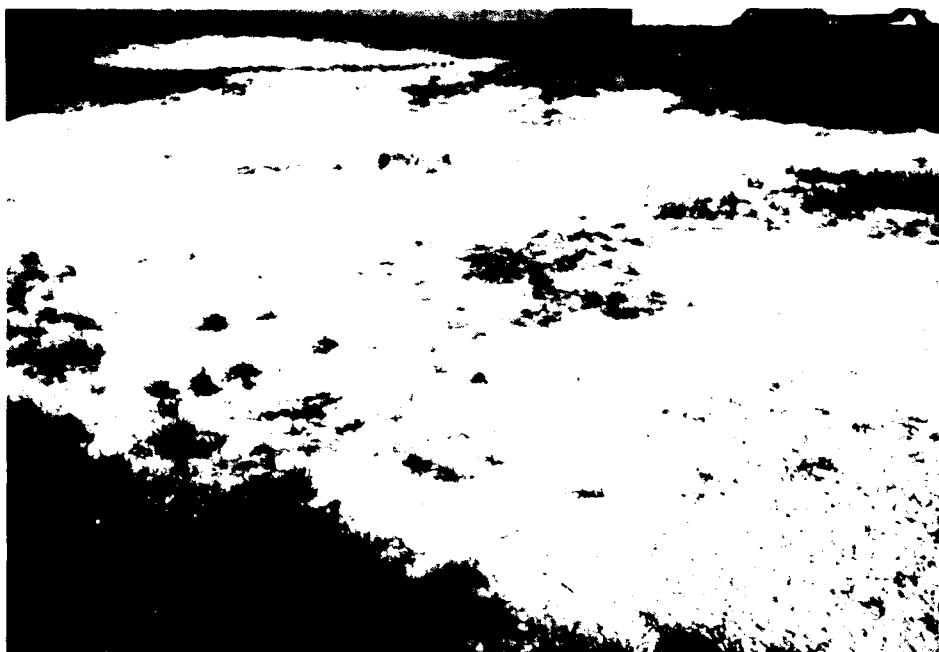
Figure 3. Surface blanket method using 2-in. aggregate

Two-inch-diameter aggregate was recently applied to severely eroded areas at Fort Rucker. This surface blanket method can provide not only a long-term solution, but also a quick solution (Figure 3). The initial high cost, however, limits its use over large areas.

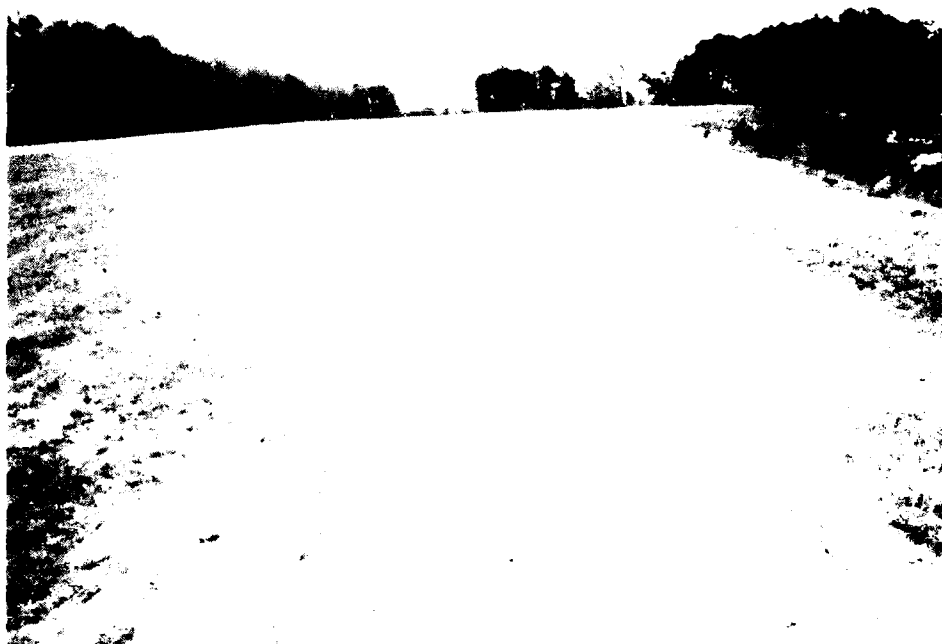
Figure 6. Tire ruts on remote helicopter training area

Some of the worst damage observed had occurred on RT sites used for weekend training by National Guard/Reserve units (Figure 6). Vehicles that are driven on the grassed areas during these training exercises cause damage to the soil surface and vegetative cover, especially during periods of wet weather.

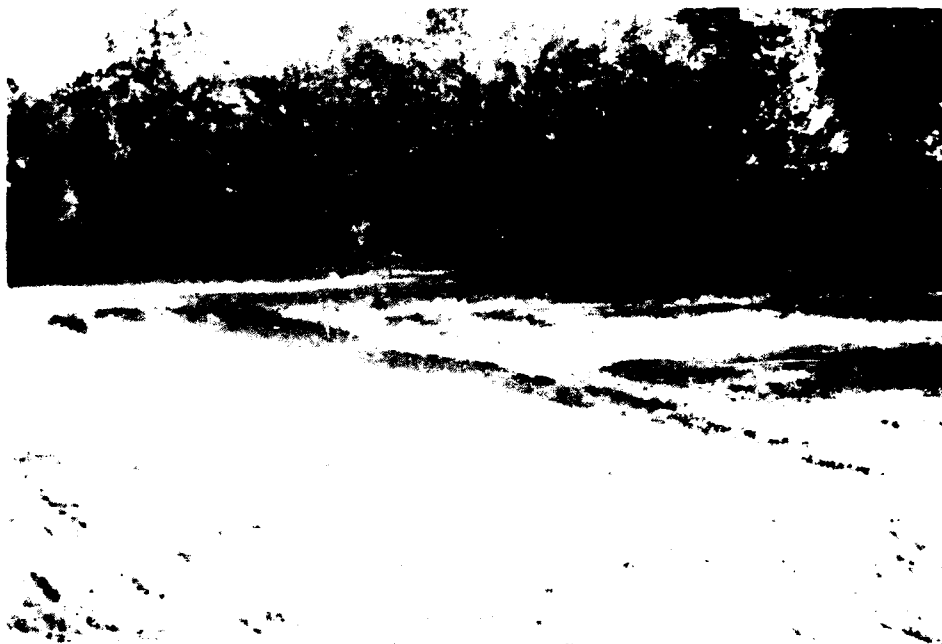
Figure 7. Pit caused by rotorwash on skid impact damage

Landing points on these sites are generally pinpointed to a small designated area, and the site is usually remote and unimproved. Repeated landings on these sites deteriorate the vegetative cover and loosen the soil surface, which is quickly eroded by rotorwash. A pit is eventually created in the ground (Figure 7), and the site has to be closed down.

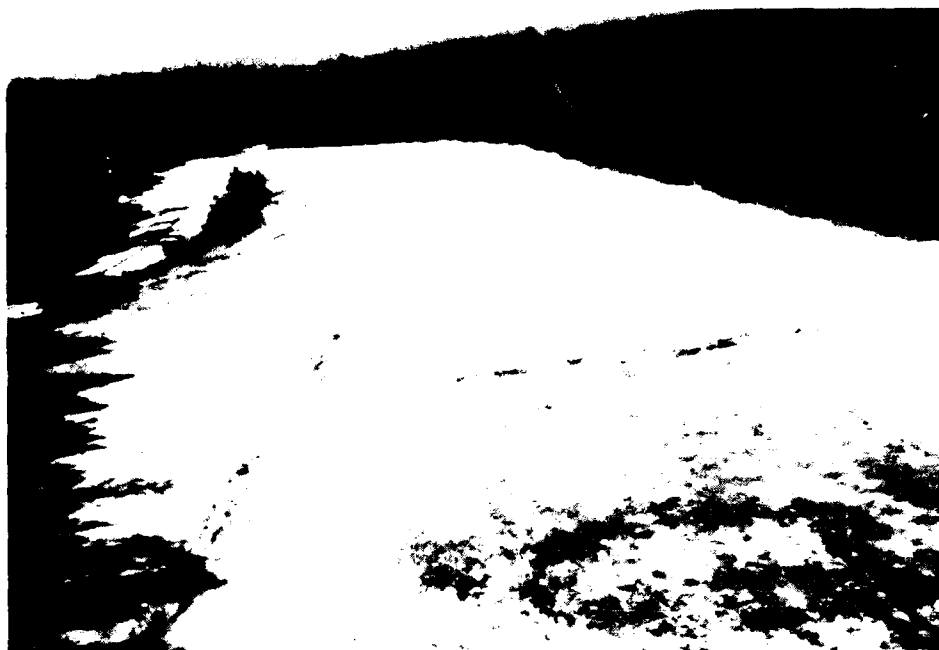
Figure 8. Training area RT14 prior to demonstration

For all practical purposes, vegetation was nonexistent at the site, and severe dust generation occurred during helicopter operations. As much as 12 in. of topsoil had been removed from the site by rotorwash and stormwater runoff.

Figures 8 and 9 show area RT14 prior to establishment of test plots. The site was to remain closed until establishment of new vegetation (estimated at 6 weeks after planting). The objective at RT14 was to evaluate methods of restoring the site with a vegetative cover capable of reducing the dust generation by rotorwash from Apache aircraft. Methods would include various species of vegetation and soil amendments.

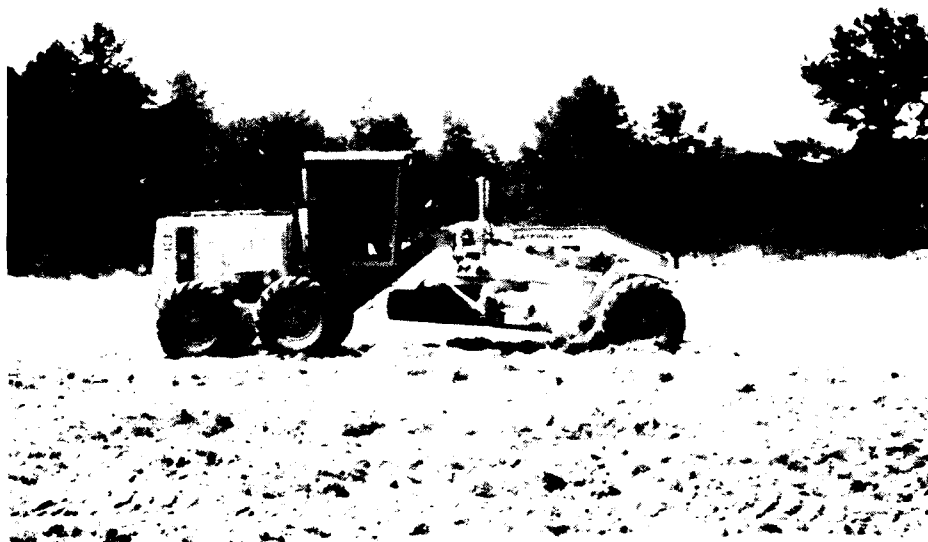
Figure 12. Ripping soil with teeth on a roadgrader

Soil preparation and seeding were conducted in June 1989. All test plots were ripped, using the chisel teeth on a roadgrader (Figure 12), to fracture the hardpan caused by excessive construction traffic and to allow for greater root penetration. After three passes with a disk, lime was applied to all plots at the rate of 2,000 lb/acre. A spreader truck was used to apply chicken litter at the rate of 20,000 lb/acre to designated plots (Figure 13). The lime and chicken litter were then incorporated with one pass of the disk. Nitrogen, phosphorus and potassium fertilizers were applied by hand equipment to designated plots, and then incorporated with a disk. A heavy section of chain-link fencing was dragged behind a tractor to level the soil surface.

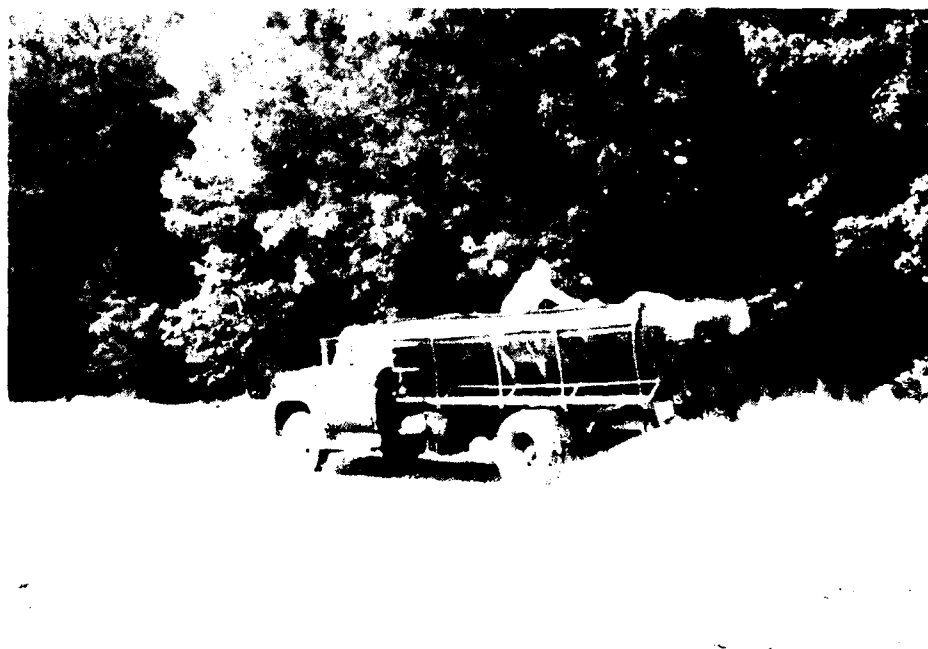
Figure 13. Applying chicken litter by spreader truck

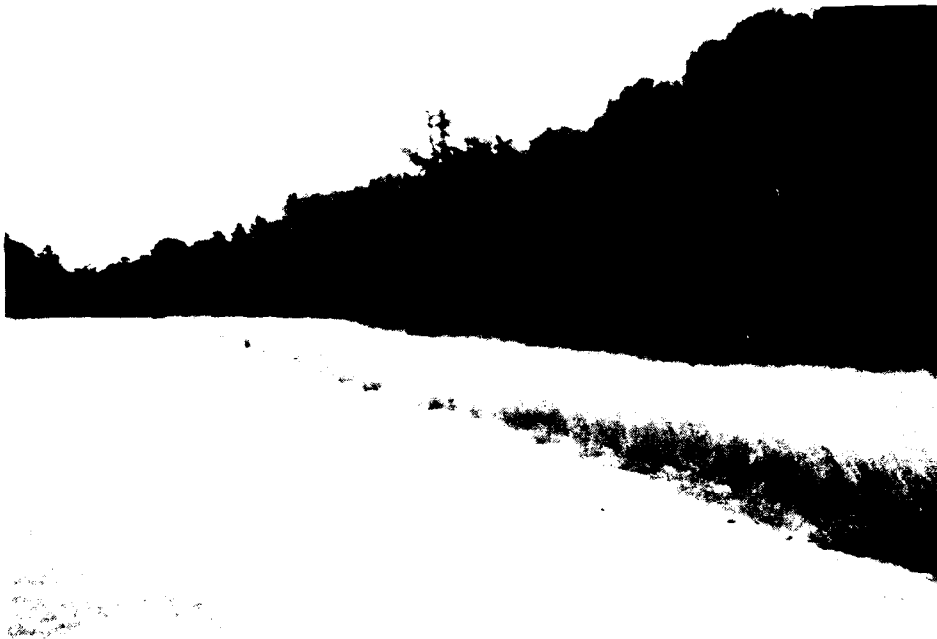
**Figure 15. Cochise lovegrass on recommended fertilizer rate (1X) plot**

The Fort Rucker area began receiving normal rainfall in July 1988. By August, significant growth of the above-mentioned species, especially Cochise lovegrass, had occurred in the fertilized plots (Figure 15). Unfertilized plots had little if any vegetation.

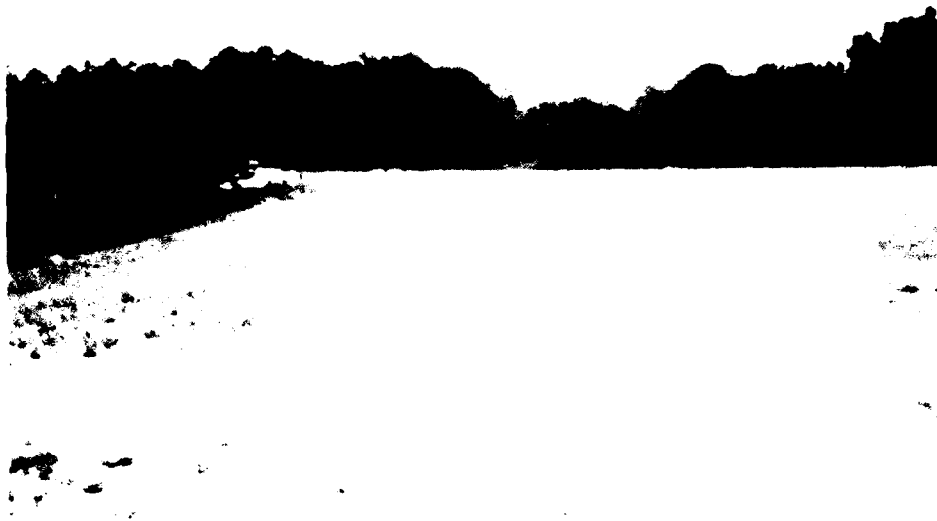
Figure 16. Lime (foreground) versus lime + fertilizer + wood mulch + chicken litter (beyond foreground), May 1990

The lime and lime + fertilizer + wood mulch + chicken litter plots shown in Figure 16 are shown 4 months later (September 1990) in Figure 19. Notice the severe erosion caused by surface water runoff in addition

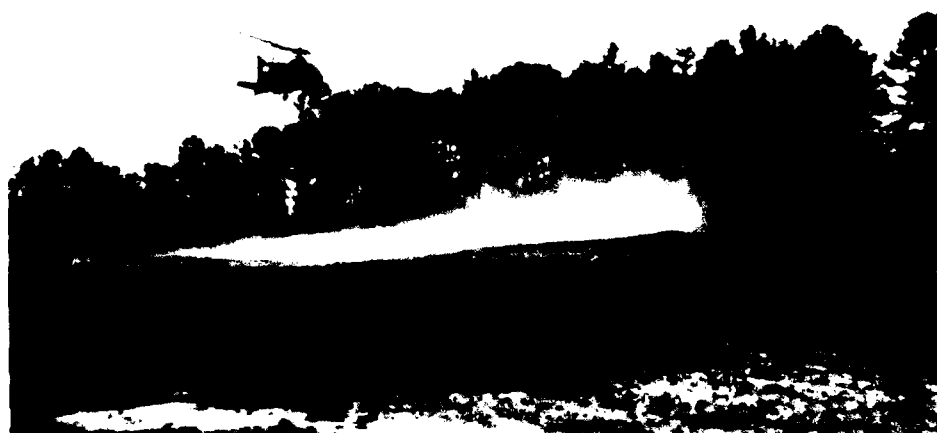
Figure 17. AH-64 Apache generating dust over a lime-only plot

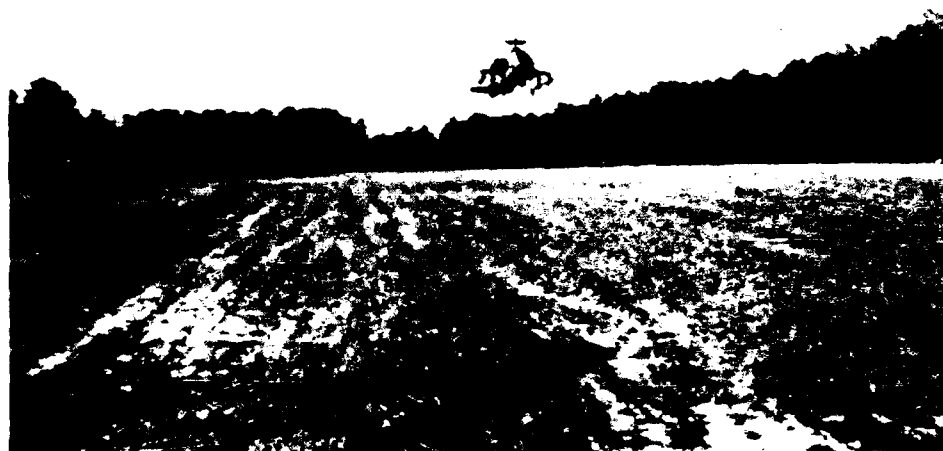
Figure 18. AH-64 Apache over lime + fertilizer + wood mulch + chicken litter plot with no dust generation

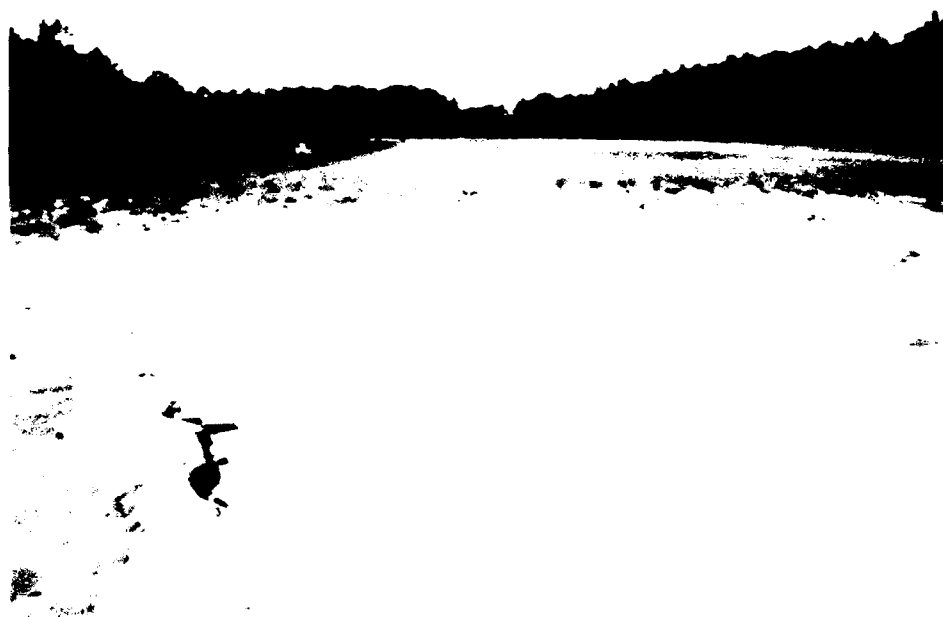
Figure 19. Lime versus lime + fertilizer + wood mulch + chicken litter, September 1990

to rotorwash. As much as 12 in. of topsoil was lost to erosion. Comparisons of September 1990 biomass showed statistically higher biomass in lime + fertilizer and lime + fertilizer + wood mulch versus the lime-only plots for all vegetation. Plots with chicken litter were statistically higher in biomass than those without, for all vegetation. A summary of September 1990 biomass is presented in Figure 20.

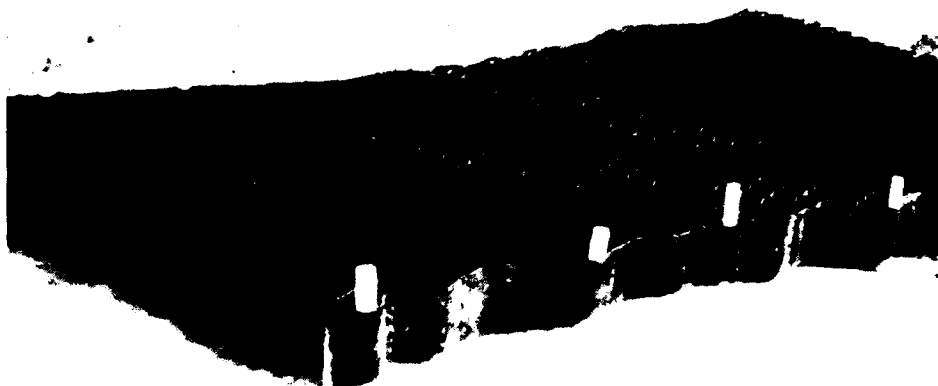
Figure 22. Sand grids placed on steep eroded slope

The sand grids that were installed on the slope, in combination with the seeded vegetation, provided sufficient erosion control during the 3-year period. Very little erosion occurred over the sand grids; however, below the sand grids, erosion was more evident. More extensive soil amendments to increase vegetative growth may have prevented erosion altogether.

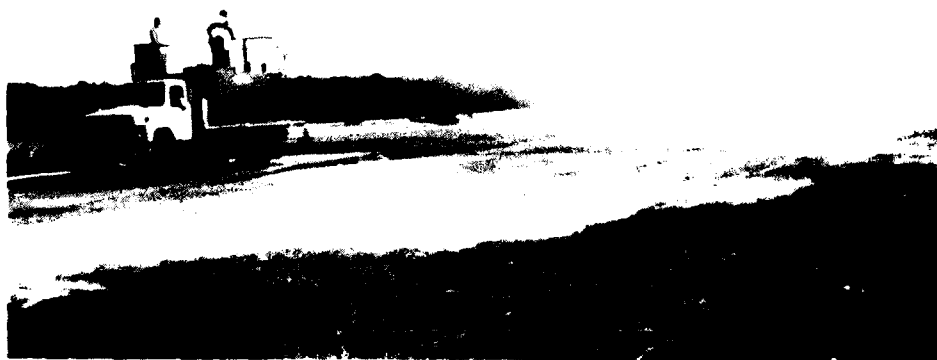
Figure 24. Applying Soil Seal to barren areas after seeding

A chemical soil stabilizer (Soil Seal) was applied to the disturbed soil using a 1,500-gal hydromulcher (Figure 24). Ninety gallons of Soil Seal concentrate was applied per acre at a ratio of 1 gal of concentrate in 30 gal of water. This rate was the manufacturer's highest labeled rate.

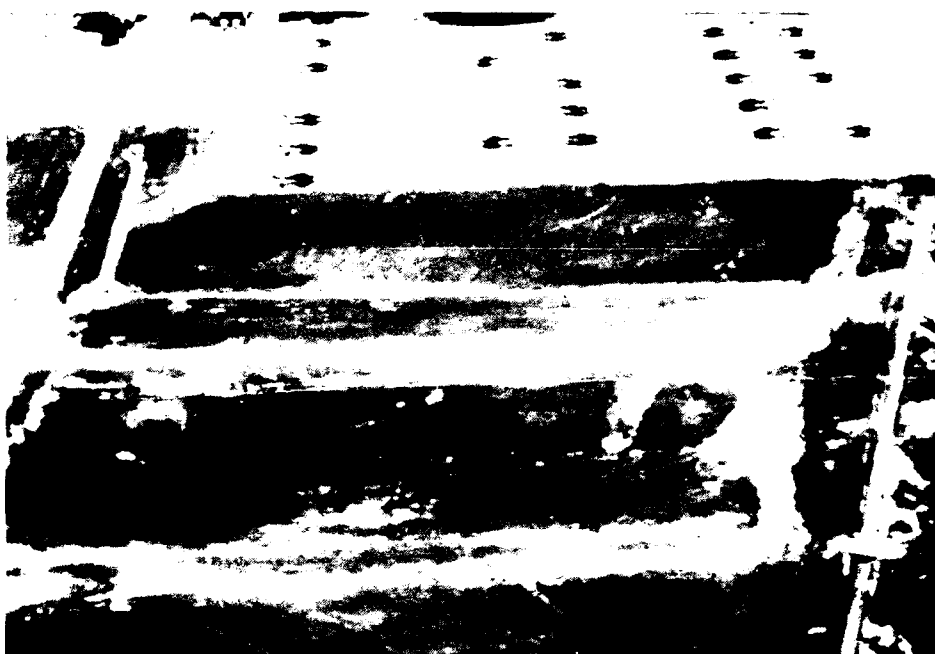
Figure 25. Lowe test plots in the approach zone, May 1988

As a result of the drought in the spring of 1988, very little planted vegetation was surviving on Lowe Army Heliport by early May (Figures 25 and 26). Seedlings that had emerged (mostly subterranean clover) were dead from lack of soil moisture. Existing bahiagrass was water stressed and exhibited no visible differences between treatments. Further fertilizer applications were discontinued due to the obvious loss of benefit.

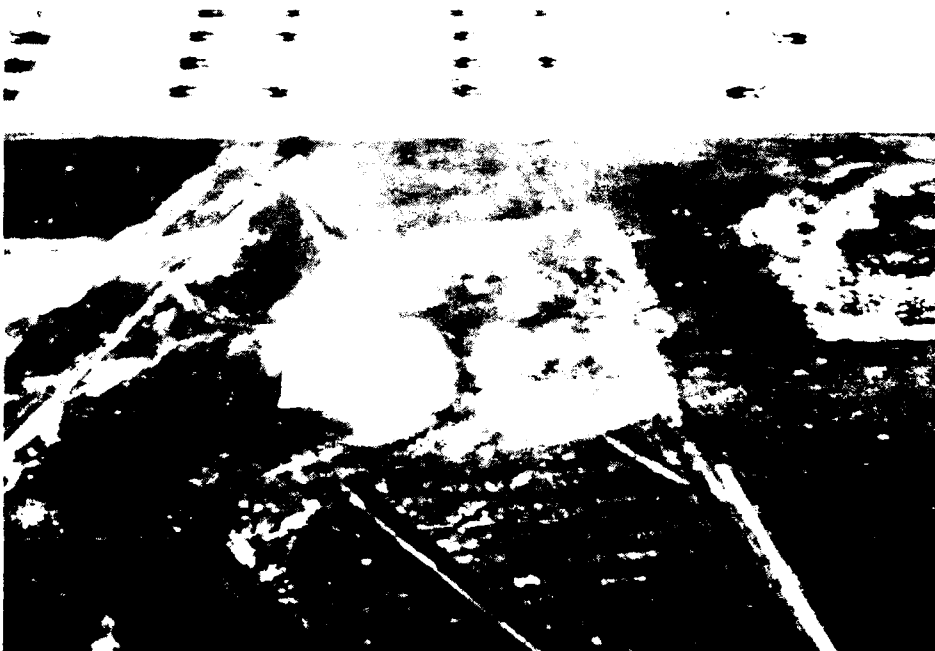
Figure 26. Lowe test plots around landing/departure pads, May 1988

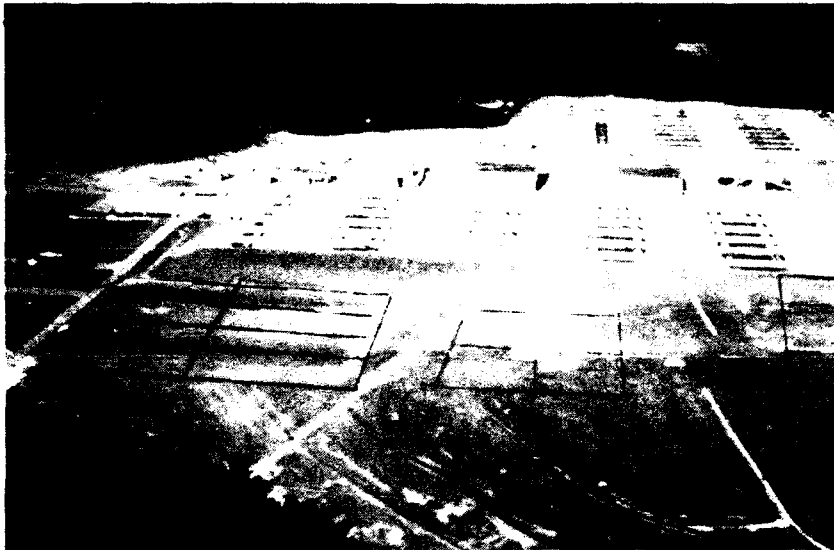
Figure 27. Approach zone and landing/departure pads, September 1990

yields in Rate 1 versus control plots and in the Rate 2 and Rate 3 versus Rate 1 plots (Table C3). This indicates that vegetative response to the third application of Rate 3 is not seen until the last part of the growing season. Also, the significantly higher yields in the fertilized plots versus unfertilized (control) plots means that helicopter activity is not reducing vegetative cover in vegetated areas. Significant improvement in all but the most severely damaged areas where Soil Seal was applied was noted in September 1990 (Figure 27).

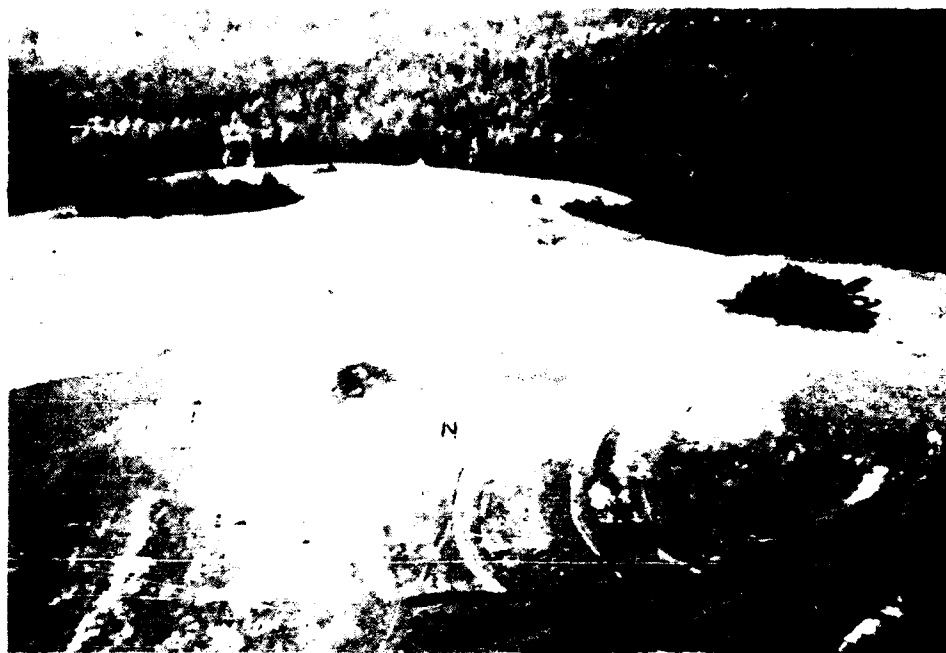
Figure 31. Area RT333 prior to test plot establishment

Area RT333 is a Government-owned tract of land located in the middle of a privately owned pasture. This training area is a good example of construction techniques having major impact on erosion. Soil was scraped from the ground surface and pushed into a pile to form a pinnacle, on which a concrete landing pad was constructed. Training helicopters land on the elevated landing pad as part of their training mission. The site was also used to practice lifting of army vehicles. This results in soil surface damage from the vehicle dragged or dropped during training exercises.

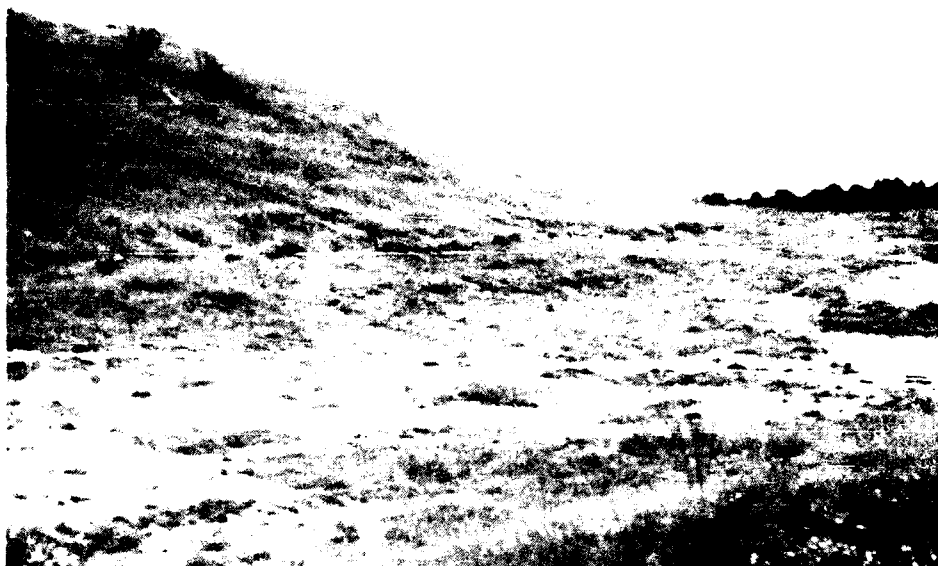
Figure 33. Area RT333, August 1988

Results of the 1988 demonstration at RT333 were similar to the results of the other two demonstration plots. Low rainfall resulted in poor germination of planted vegetation by May 1988. By August 1988, some bahiagrass had germinated and was growing well; however, coverage was not adequate (Figure 33). Analysis of soil samples taken in February 1989 indicated a need for increased fertilizer application rates.

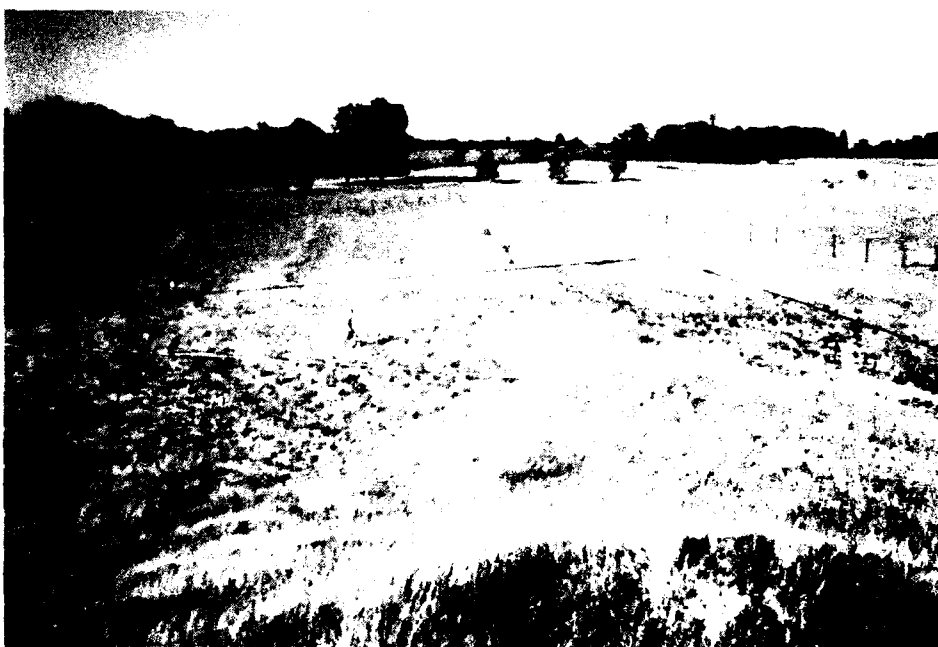
Figure 35. Lime + fertilizer + chicken litter plot, May 1990

Even with the destructive grazing in the fertilized plots, total biomass yields were still statistically higher in fertilizer versus no-fertilizer treatments (Table C4). Figure 34 shows the lime + fertilizer plot on the left half of the slope and the lime plot on the right half. Notice also the tire marks from a mowing operation. The lime + fertilizer + chicken litter plot (the most heavily damaged plot prior to demonstration) in May 1990 is shown in Figure 35.
