US Army Corps  
of Engineers  
Seattle District

18 JULY 1991

# FLOOD SUMMARY REPORT NOOKSACK, SKAGIT AND SNOHOMISH RIVER BASINS NOVEMBER 1990 EVENTS

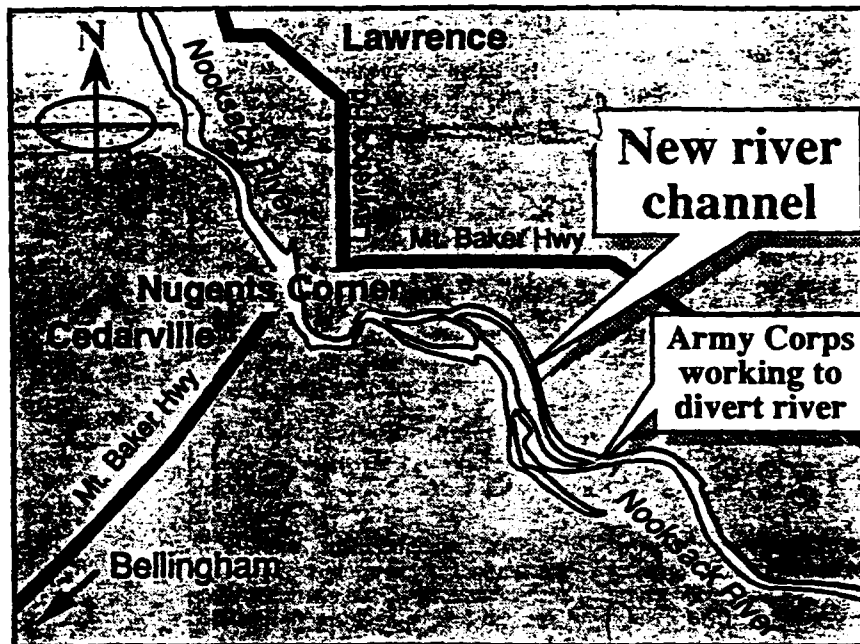
Map shows where the flooded Nooksack River has cut a new channel.

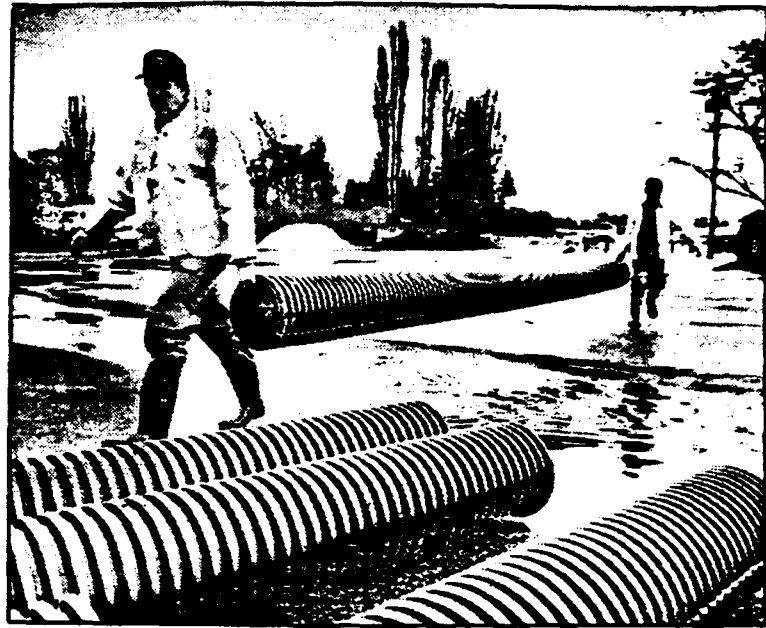
Jerry Pelland (left) and Ken Smiley carry a section of 18-inch pipe in west Mount Vernon. The pipe and a pump were used to remove water from a flood-created pond next to the KBRC radio station to nearby storm drains. The pump's capacity is about 5,000 gallons per minute.

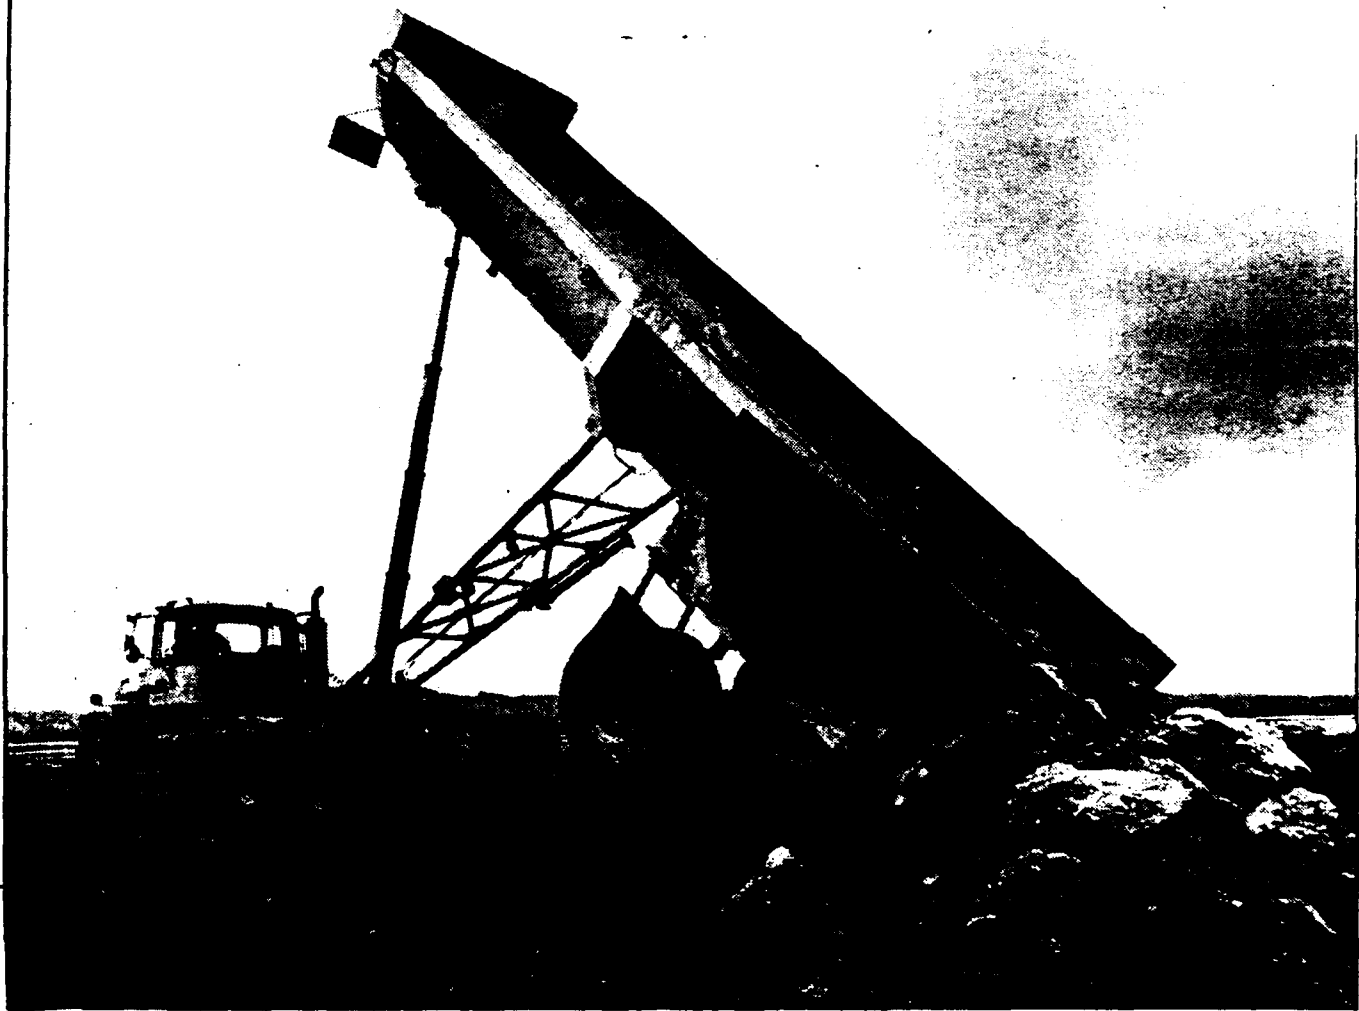
A truck dumps rock for a roadway to a break in Fir Island's saltwater dike near Brown's Slough about a mile south of Fir Island Road. Strider Construction Co. of Bellingham was one of three companies awarded contracts for some repair work this week. According to Steve Bentley, superintendent, crews will work 15 hours a day in an effort to have the road to break finished by this weekend. They hope to have the break completed by Christmas, he said.
