Submitted in Partial Satisfaction of the Requirements for  
the Degree of Master of Engineering

REPAIRS TO CONCRETE  
PORT AND HARBOR STRUCTURES

MAX D. RODGERS  
and  
JAMES M. SCHOFIELD

Hydraulic and Coastal Engineering  
Department of Civil Engineering  
University of California  
Berkeley, California

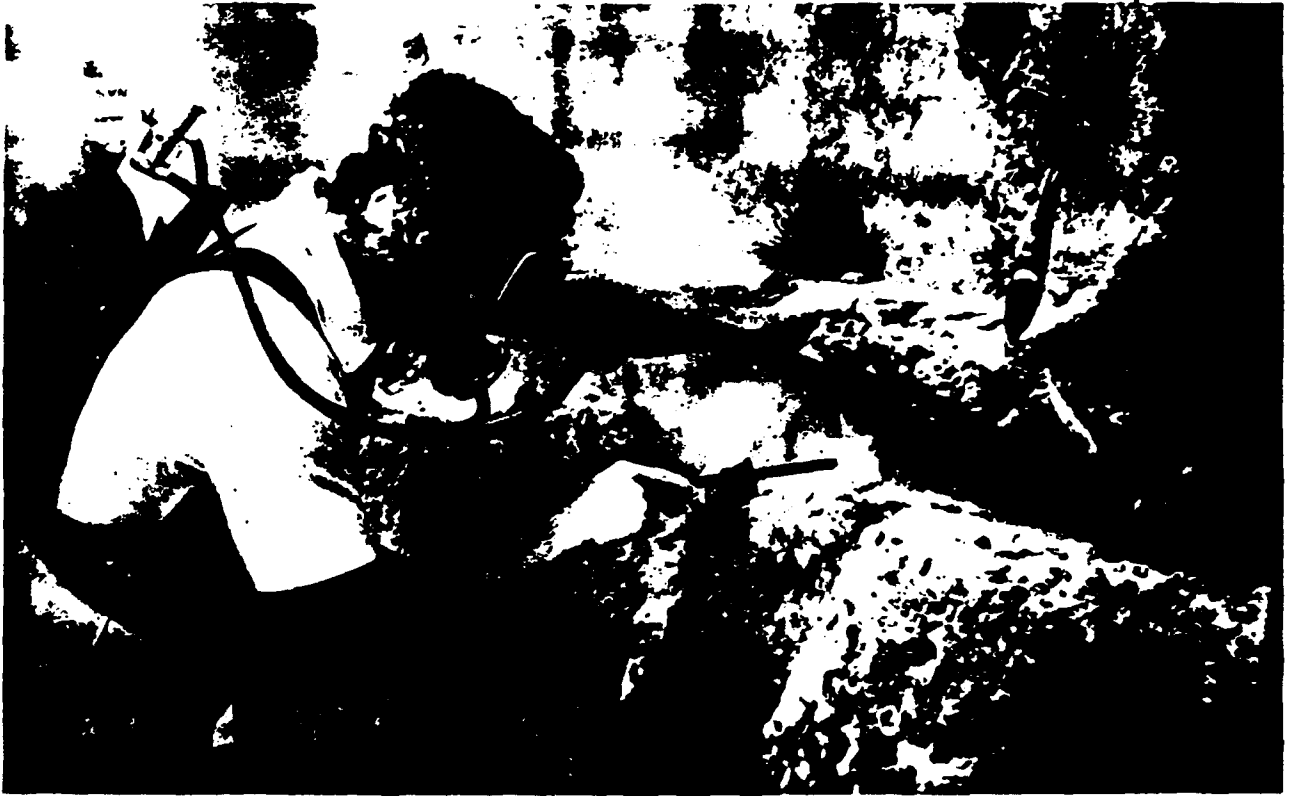
Figure III.2 Diver Engaged in Underwater Visual Inspection [47]

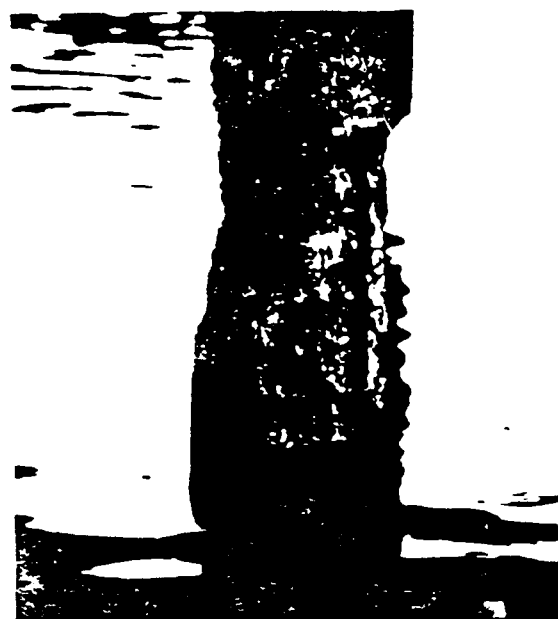
<p style="margin-top: 10px;">Typical condition where Types I and III jacket should be used.</p> </div> </div> |                                                                                                                                                                                                                                                                             |                           |            |                                                                                                                                                                                                                                                                             |

**FIGURE IV.12 Encasement of Concrete Pile Using Fiberglass Form**

Type I, III and V are used when deterioration terminates at the water line or no more than one or two feet below.

Type II, IV and VI are used when deterioration runs the full length of the pile.

Typical condition where Types II and IV jacket should be used.

Typical condition where Types V or VI jacket should be used.

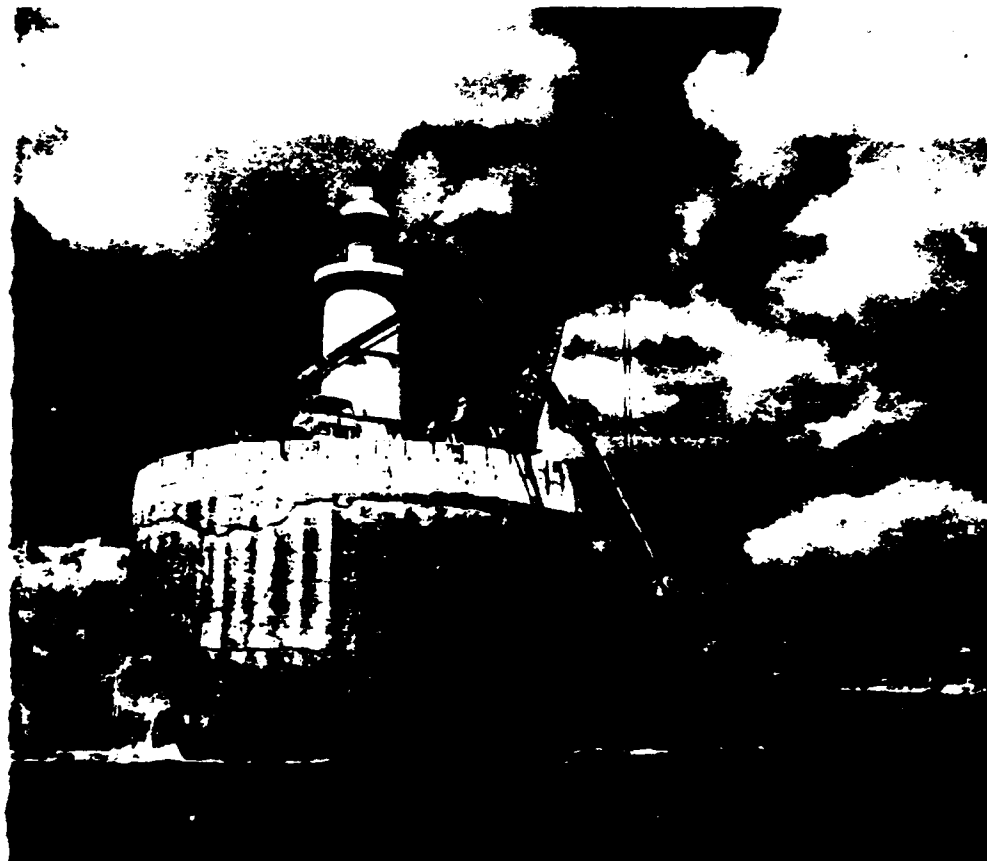
FIGURE IV.25 Pumped Placement of Underwater Concrete at a  
Harbor Entrance [55]

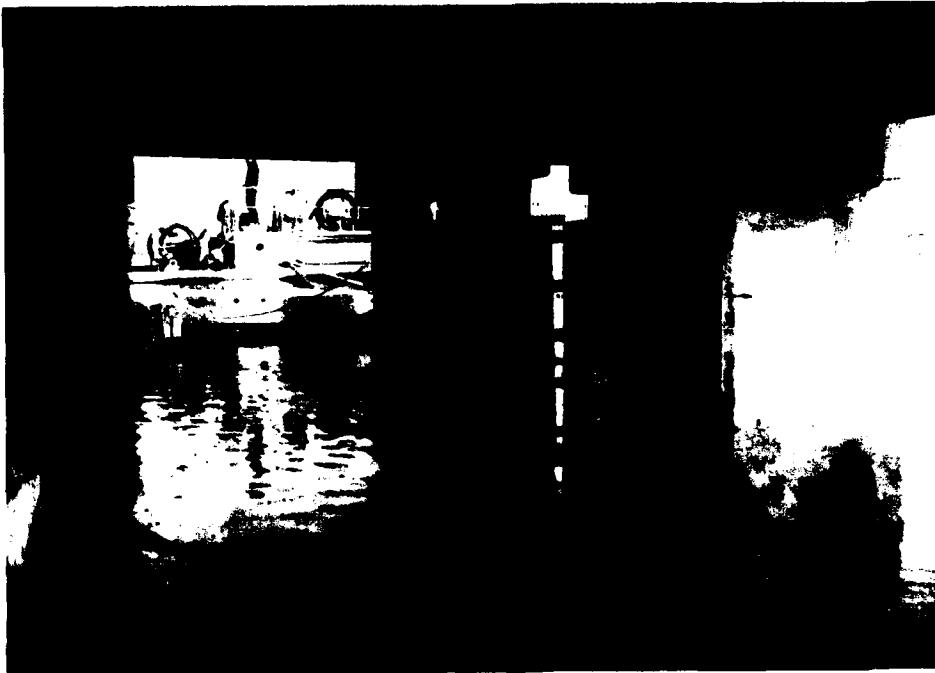
Photo V.10 WWF installed on piles A3, form installed on Piles B3  
and completed repair on piles C3
