MISCELLANEOUS PAPER GL-92-5

# GEOPHYSICAL INVESTIGATION AT SOLID WASTE MANAGEMENT UNIT NO. 3 FORT BUCHANAN, PUERTO RICO

February 1992

Final Report

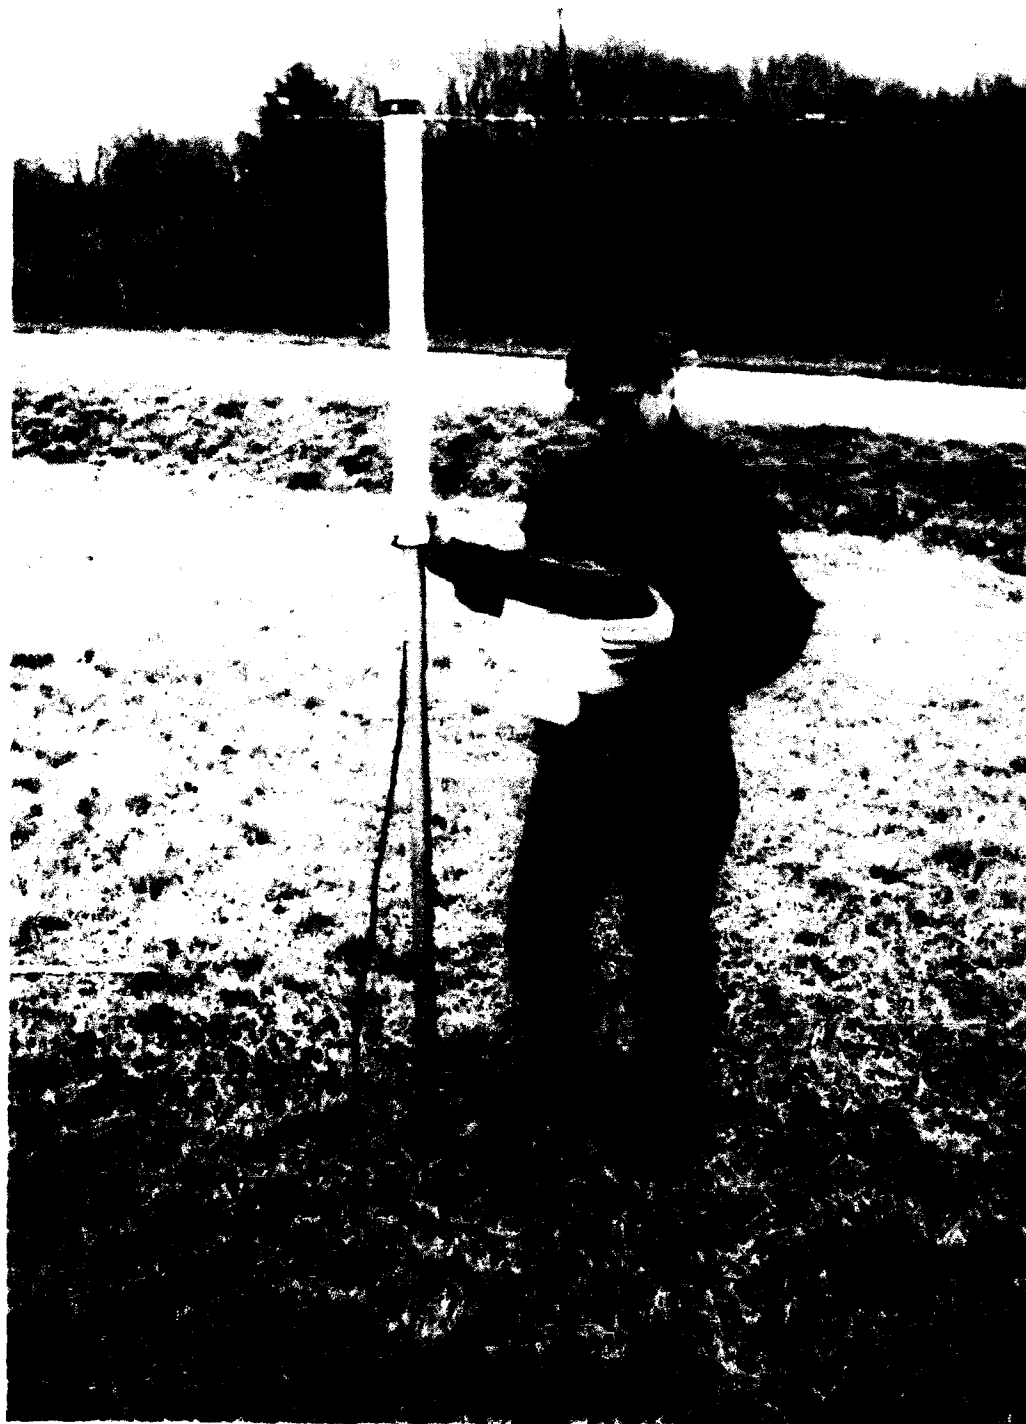
Figure 9. EDA OMNI-IV proton-precession magnetometer

17. An EDA OMNI IV proton-precession magnetometer, as shown in Figure 9, was used to measure the total field intensity of the local magnetic field. The local magnetic field is the vector sum of the field of the local magnetized materials (local disturbance) and the ambient (undisturbed) magnetic field. Figure 10 shows the ambient earth's field as 50,000 nanoteslas (nT) with a local disturbance of 10 nT. Figure 10 shows that the quantity measured with the magnetometer is the resultant total field with a value of 50,006 nT. The magnetometer was also used with dual sensors thereby allowing the gradient of the total magnetic field to be measured. The gradient is taken by measuring the total field at the two sensors which are fixed a small distance apart. The difference in values between the two sensors divided by their separation approximates the gradient measured at the midpoint of the sensor spacing. Two advantages of using the magnetic gradient are that 1. the regional magnetic gradient is filtered out thus local anomalies are better defined and 2. since the two readings are taken a short time apart magnetic storm effects and diurnal magnetic variations are essentially removed (Breiner, 1973). The magnetometer used in this survey has an absolute

accuracy of approximately  $\pm 1$  nT. For reference, the earth's magnetic field varies from approximately 60,000 nT at the poles to 30,000 nT at the equator (the nominal field strength at FTB is 45,000 nT).
