# Technical Report

IMPROVED RECOVERY VEHICLE (IRV)

M88A1E1 HYDRAULIC SYSTEM ANALYSIS

September 1991

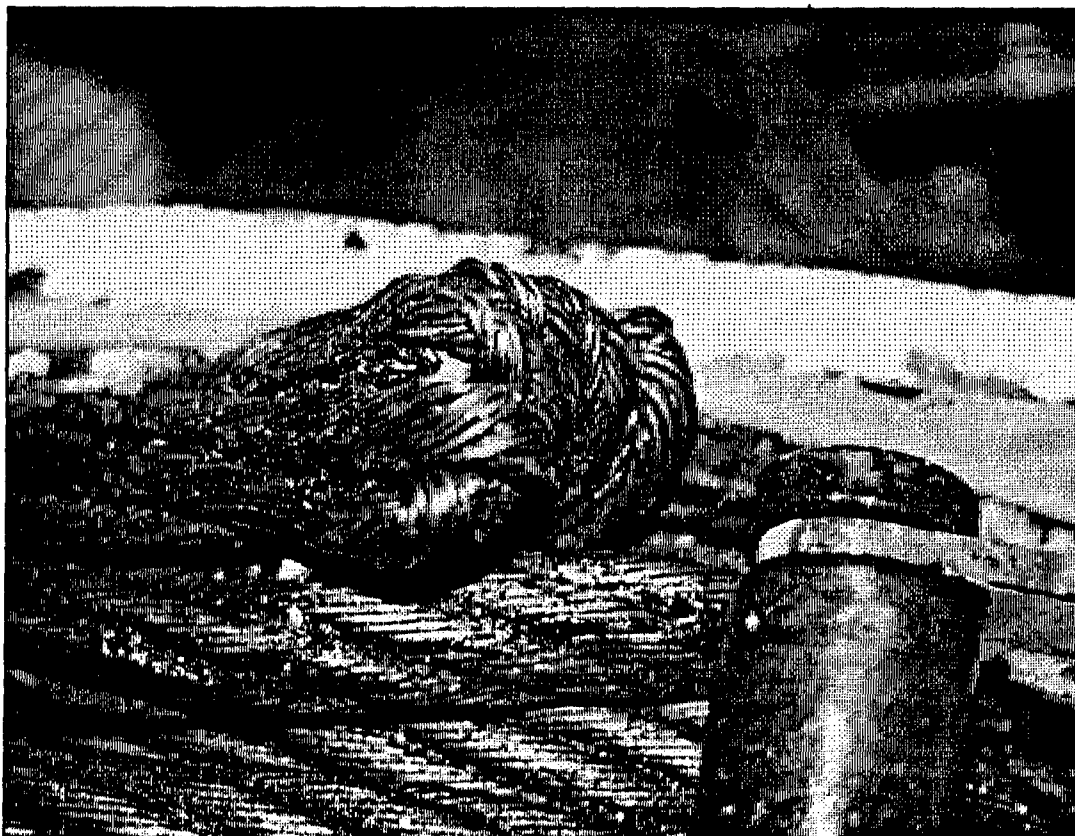
Cable birds-nesting continues to be a potential problem for the M88A1E1. Although it was an operator failure, the overriding of the warning signal is a situation that could arise in the field. Should this situation occur, the potential for damage must be minimized. The addition of breakaway bearing caps for the tie rods is a possible solution. Future winch design should consider a fail-safe design for the main winch housing and tie rods.

**Figure 16 - Birds-Nested and Kinked Cable**

d. A fail-safe system should be incorporated in the cable miswrap linkage to prevent main winch housing failure. A "break-away" bearing cap for the housing tie-rod should be studied as a possible solution.

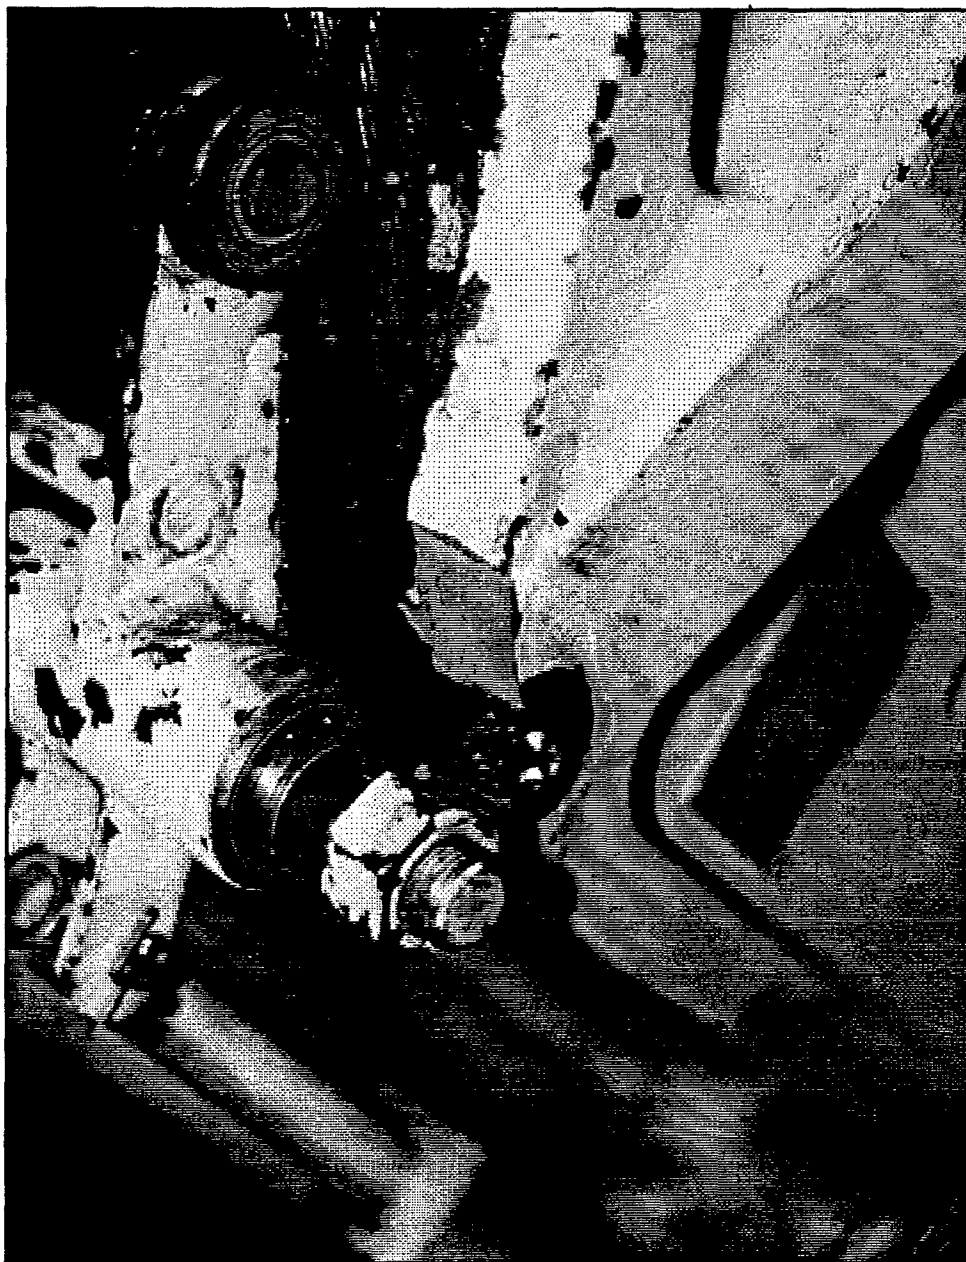
**Figure 17 - Housing Fracture**
