AGARD REPORT 785

## The Utilization of Advanced Composites in Military Aircraft

*Papers presented at the 73rd Meeting of the AGARD Structures and Materials Panel,  
held in San Diego, CA, United States, 7th-11th October 1991.*

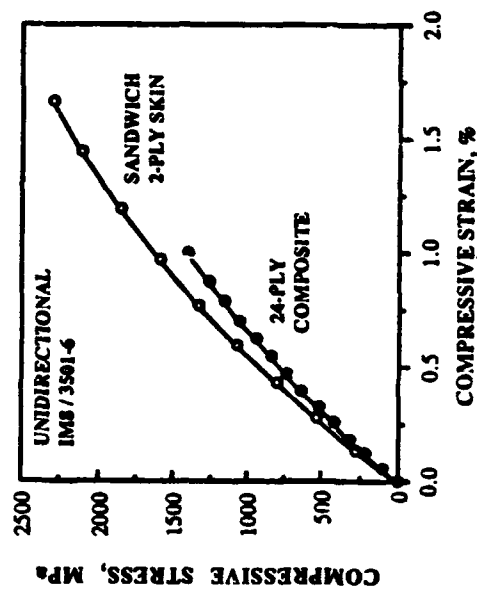
FIGURE 9. Stress-strain curves for a unidirectional IM8/3501-6 composite tested in a miniature sandwich specimen and as an all-composite 24-ply coupon.

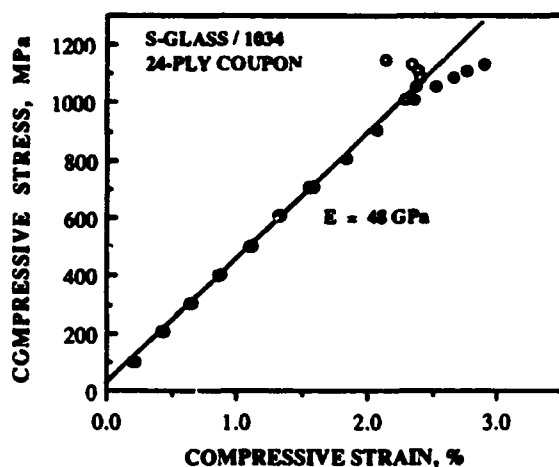
FIGURE 14. Typical stress-strain curves for unidirectional S-Glass/1034 composites tested in axial compression: 24-ply all-composite coupon (LEFT); sandwich specimen with 4-ply skins (RIGHT).

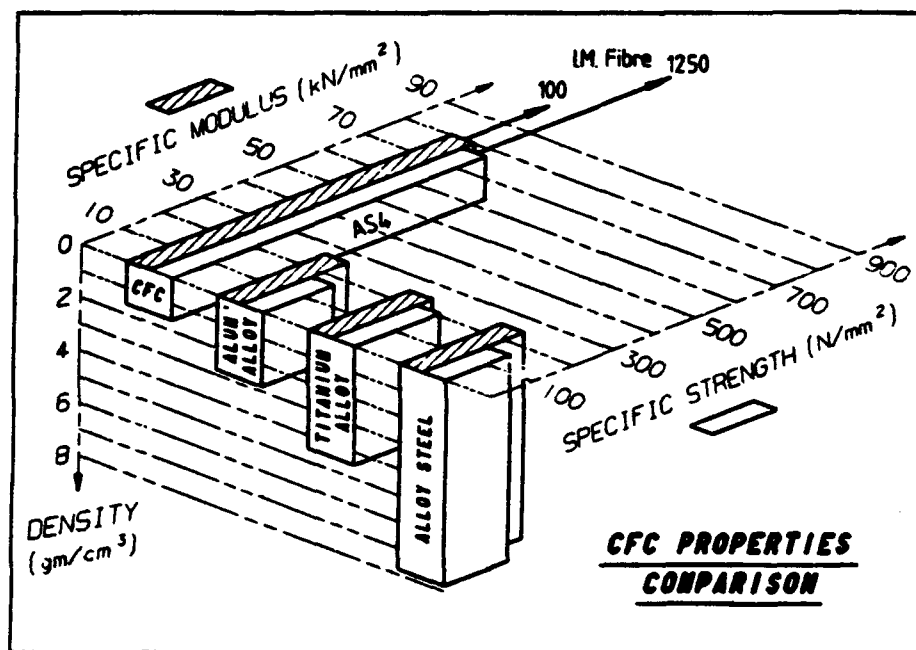
Fig 1. Properties comparison for a number of common aerospace materials. The CFC data relate to a unidirectional laminate.

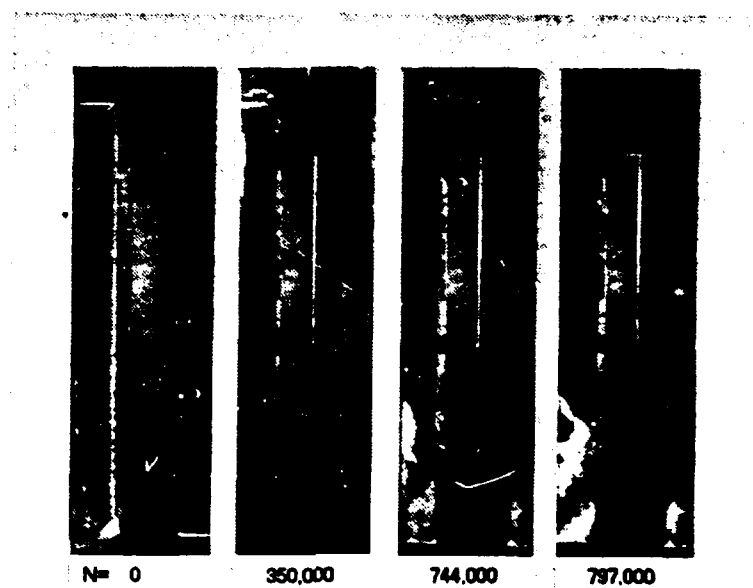
Figure 5. Laminate 2 specimen with photoelastic coating. Center of specimen is obscured by antibuckling guides. Specimen failed after 797,794 cycles so the images represent 0, 0.44, 0.94 and 0.999 life time (LT). The white area in the lower left corner of specimen seen at 0.94 and 0.999 LT indicates damaged zone.

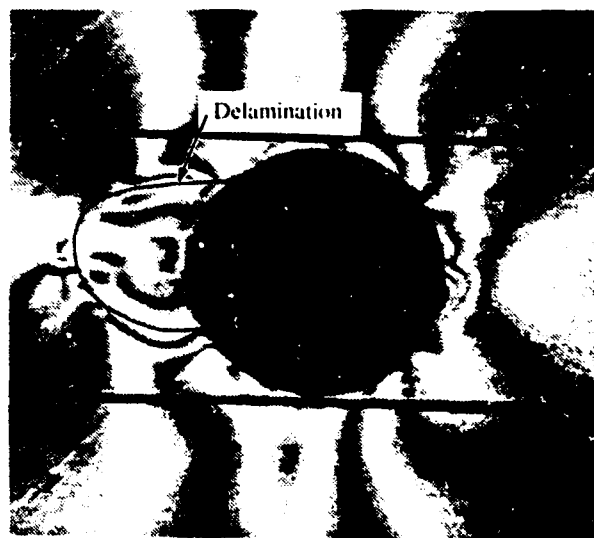
Figure 8: Photoelastic image of initial damage.

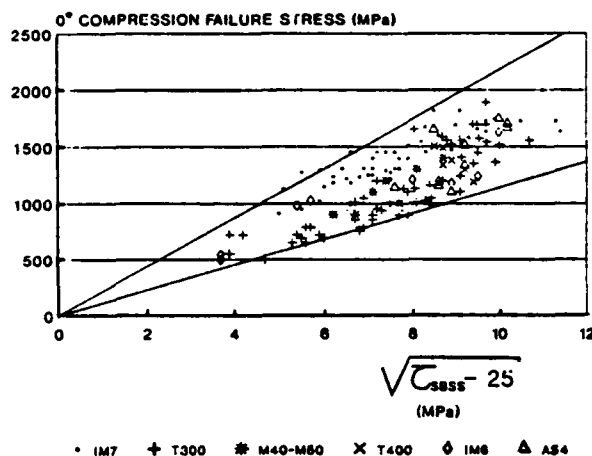
Figure 11 - Litterature experimental data report of  $E_n^c$  and  $\sqrt{\tau_{shear} - 25}$  value of various carbon/resin systems in different hot/wet conditionings.

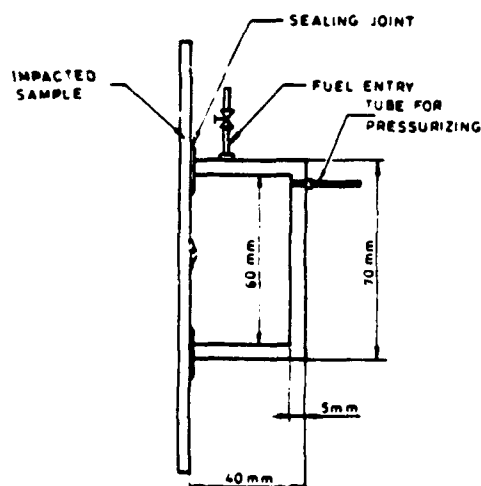
Figure-2: Pressurizing fixture for fuel leakage tests.

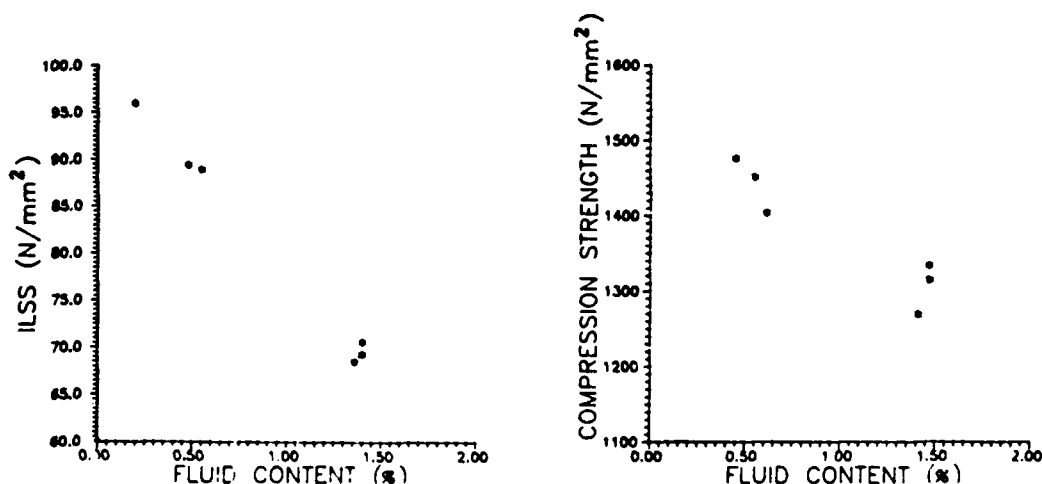
**Figure-3:** Variation of ILSS and compression strength values of Hercules AS-4/8552 as a function of the fluid content of the specimens.

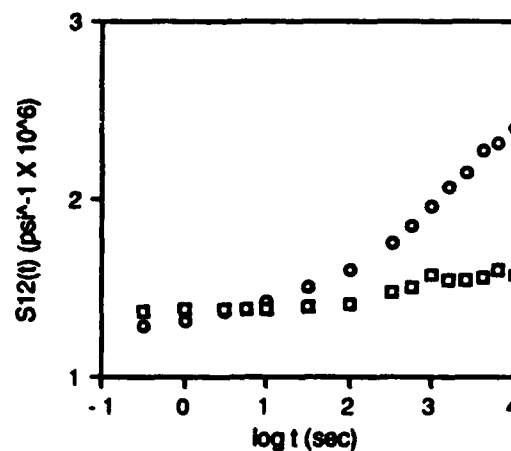
Figure 6. Creep Compliance for APC-2  $\pm 45$  after exposure JP-4, at 100°C.

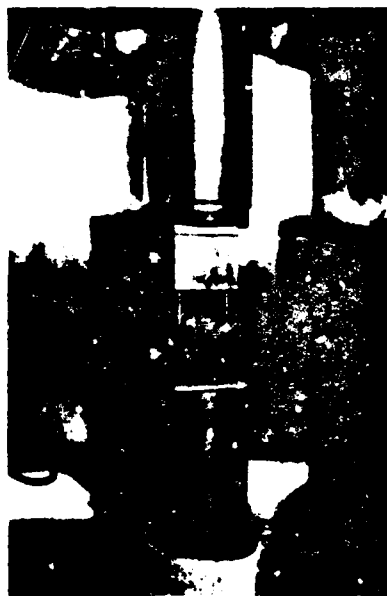
Figure 4. A Typical Set-Up for Hot-Wet Compression Test

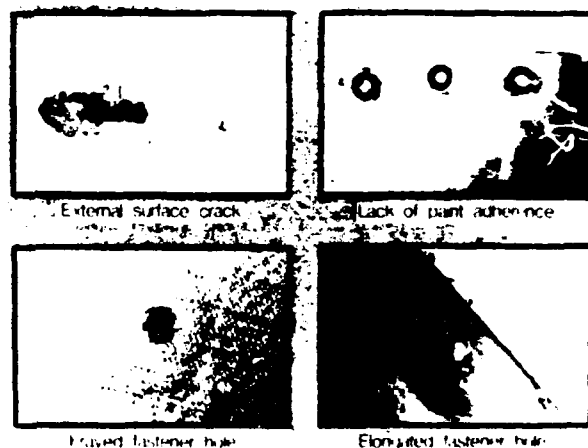
Figure 6. Typical in-service conditions of L-1011 Kevlar/epoxy fairings.
