Technical Report HL-93-1  
March 1993

## **St. Stephen Powerhouse Fish Lift, Cooper River Rediversion Project, South Carolina**

### **Hydraulic Model Investigation**

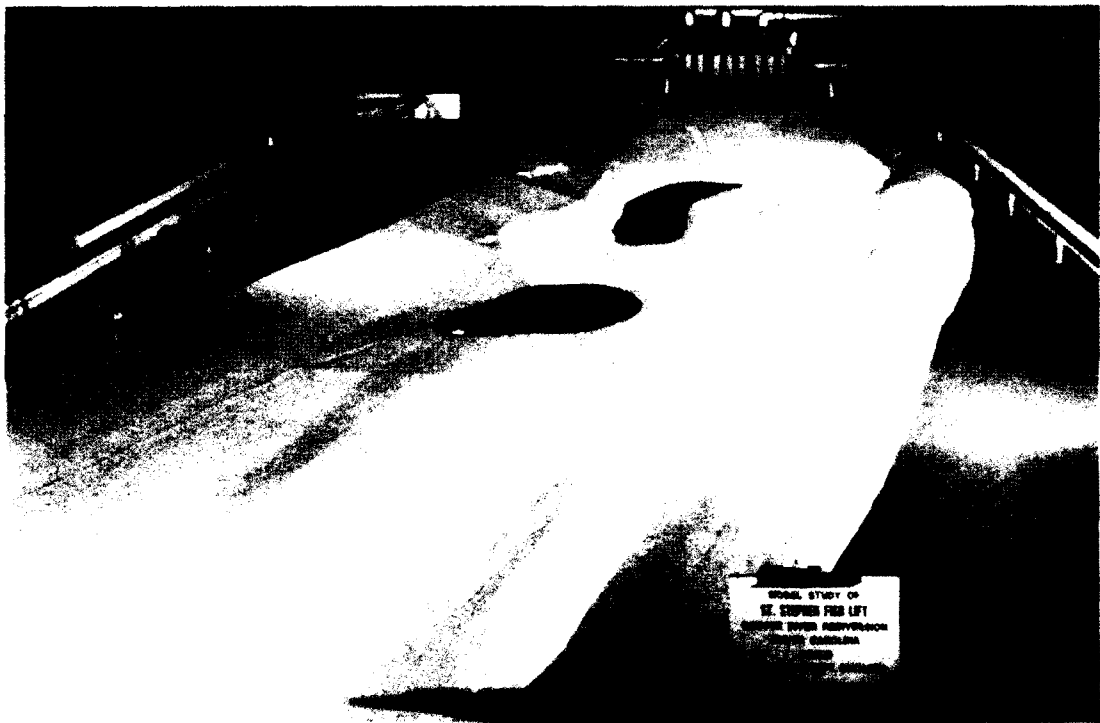
Figure 2. 1:25-scale model of St. Stephen  
Powerhouse tailrace (Continued)

c. Looking upstream toward powerhouse and fish lift entrances

d. Side view looking toward north wing wall and fish lift entrances

Figure 2. (Concluded)

4. The model was constructed to an undistorted scale of 1:25 and reproduced about 1,700 ft of the tailrace topography, the downstream face of the powerhouse, intake piers, spiral cases, draft tubes, and the existing fish lift entrances. The tailrace walls, tailrace slab, downstream face of the powerhouse, and portions of the fish lift were constructed of plastic-coated plywood. The spiral cases, draft tubes, and fish lift entrance piers were constructed of smooth Plexiglas. The downstream topography was constructed of sand and cement mortar molded to sheet metal templates. Plate 1 is a layout of the model. Figure 2 shows the model. Figure 3 is a side view of an intake, spiral case, and draft tube for a powerhouse unit.

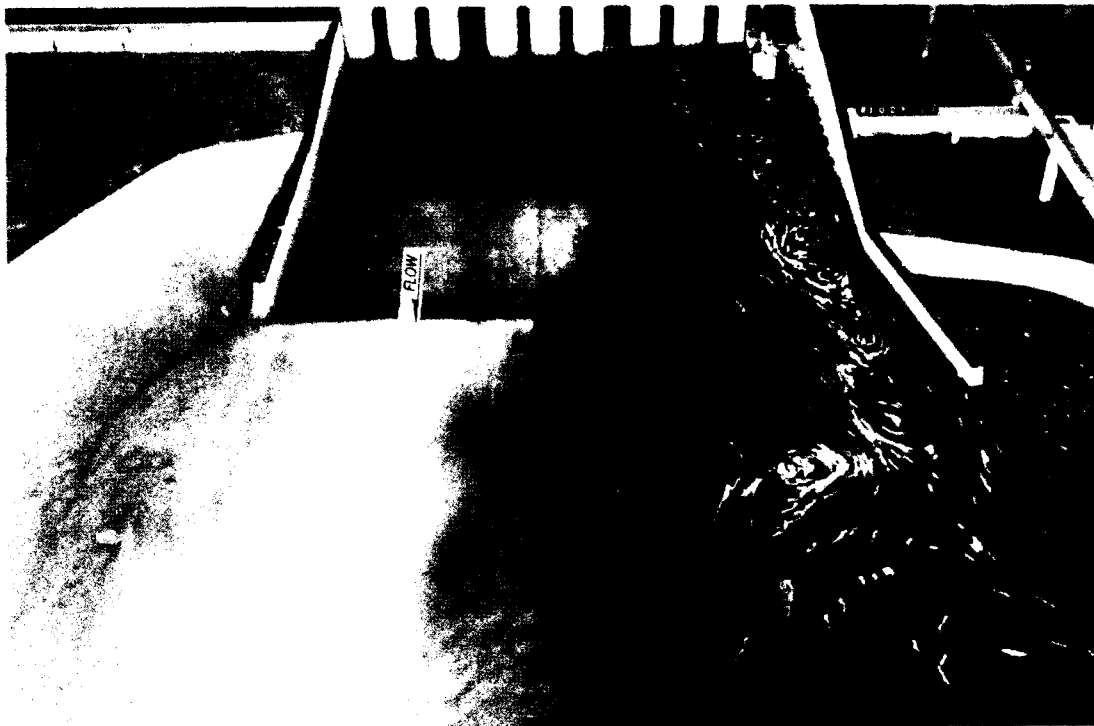
Photo 5. Surface flow patterns, original design, discharge 16,400 cfs, tailwater el 20.8, fish attraction flow 500 cfs (downstream fish entrance only), units 1 and 2 operating

15. Surface flow patterns with units 1 and 2 operating and a fish attraction discharge of 500 cfs (Photo 5) indicate eddy patterns similar to those observed with a fish attraction discharge of 240 cfs (Photo 2). Velocities measured with units 1 and 2 operating and a discharge of 500 cfs are shown in Plates 10 and 11. Velocities greater than 4.5 ft/sec were measured near the center of the downstream fish entrance, but no velocities in the downstream direction were measured over the fish slab at distances of 50 and 125 ft downstream from the fish lift entrance. The surface flow patterns and velocity measurements indicate that an attraction flow of 500 cfs does not result in downstream flow along the left training wall with units 1 and 2 operating.

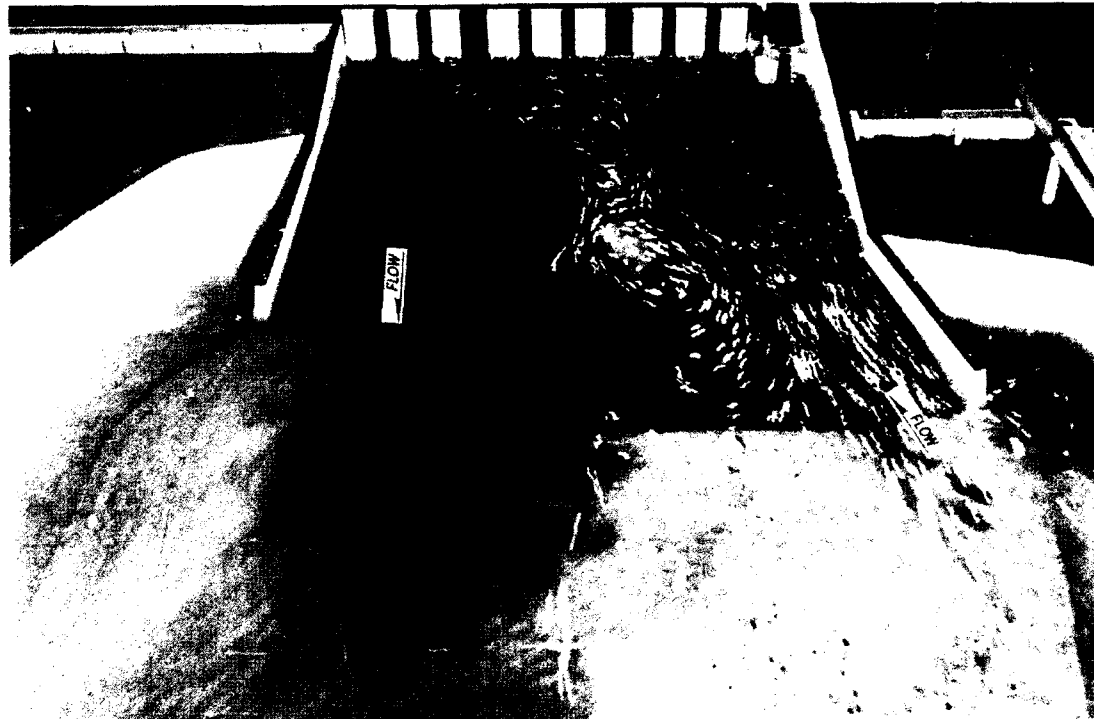
Photo 6. Surface flow patterns, original design, discharge 8,200 cfs, tailwater el 16.6, fish attraction flow 500 cfs (downstream fish entrance only), unit 1 operating

16. Surface flow patterns with unit 1 operating with a fish attraction discharge of 500 cfs are shown in Photo 6. Large eddies formed in the tailrace area downstream from units 2 and 3, and flow was observed in the downstream direction along the left training wall. Velocities measured along the fish slab are shown in Plates 12 and 13. Velocities measured near the center of the downstream fish entrance were as high as 8.4 ft/sec, and velocities were in the downstream direction 50 and 125 ft downstream from the fish entrance near the training wall. This type of flow pattern along the left training wall should be favorable for fish attraction; however, the velocities at the entrance may be too high for the fish to enter the lift.

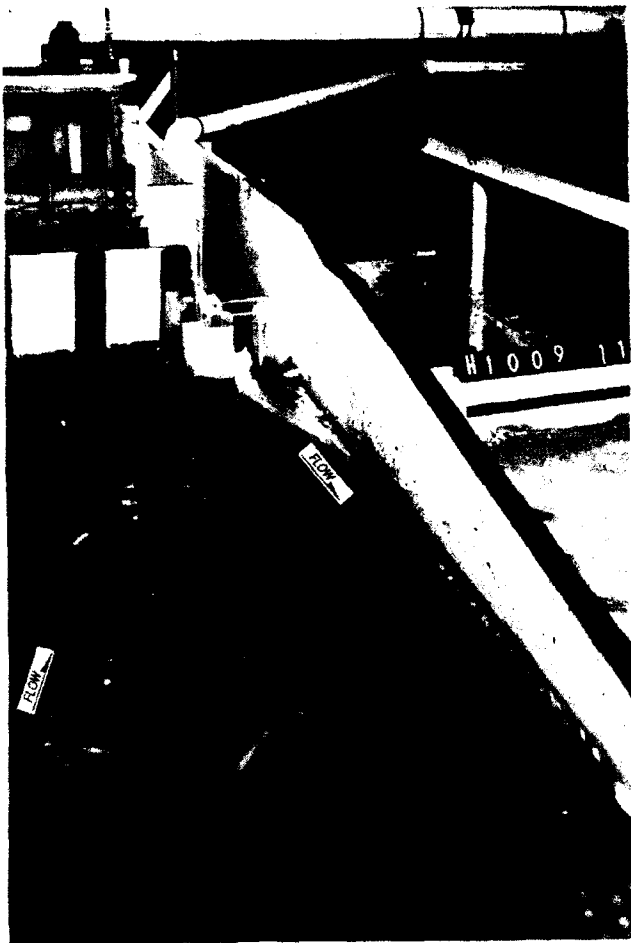
Photo 7. Close-up view of surface flow patterns, original design, discharge 8,200 cfs, tailwater el 16.6, fish attraction flow 500 cfs (downstream fish entrance only), unit 1 operating

17. Photos 7 and 8 show a close-up of flow conditions near the fish lift entrance with unit 1 operating at 8,200 cfs, a tailwater elevation of

16.6, and a fish attraction flow of 500 cfs. In Photo 7, only the downstream fish entrance is open, whereas in Photo 8 both entrances are open. Photo 7 shows the eddy downstream of the fish entrance to be less concentrated and further away from the training wall.

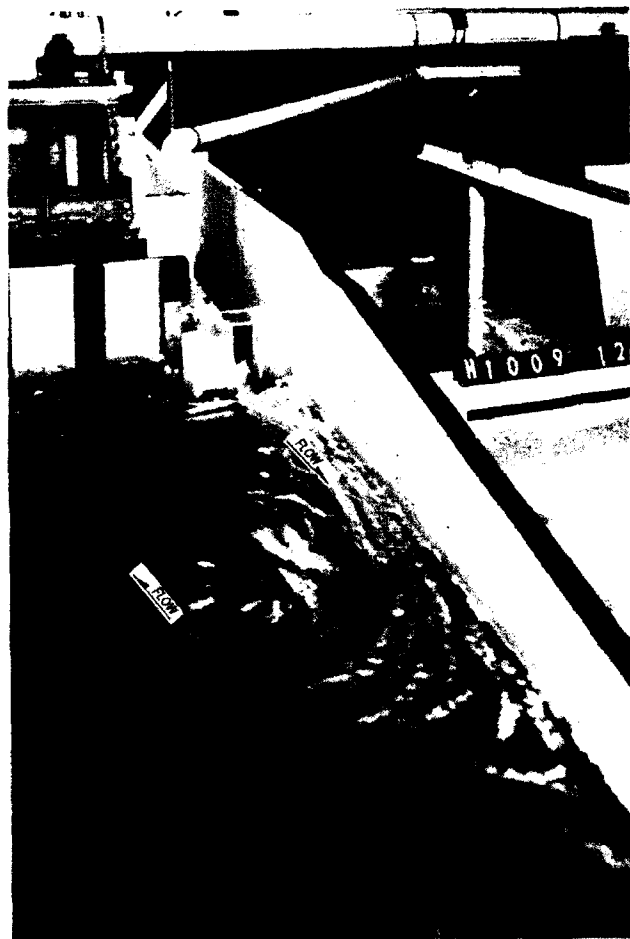
Photo 8. Close-up view of surface flow patterns, original design, discharge 8,200 cfs, tailwater el 16.6, fish attraction flow 500 cfs (both fish entrances open), unit 1 operating

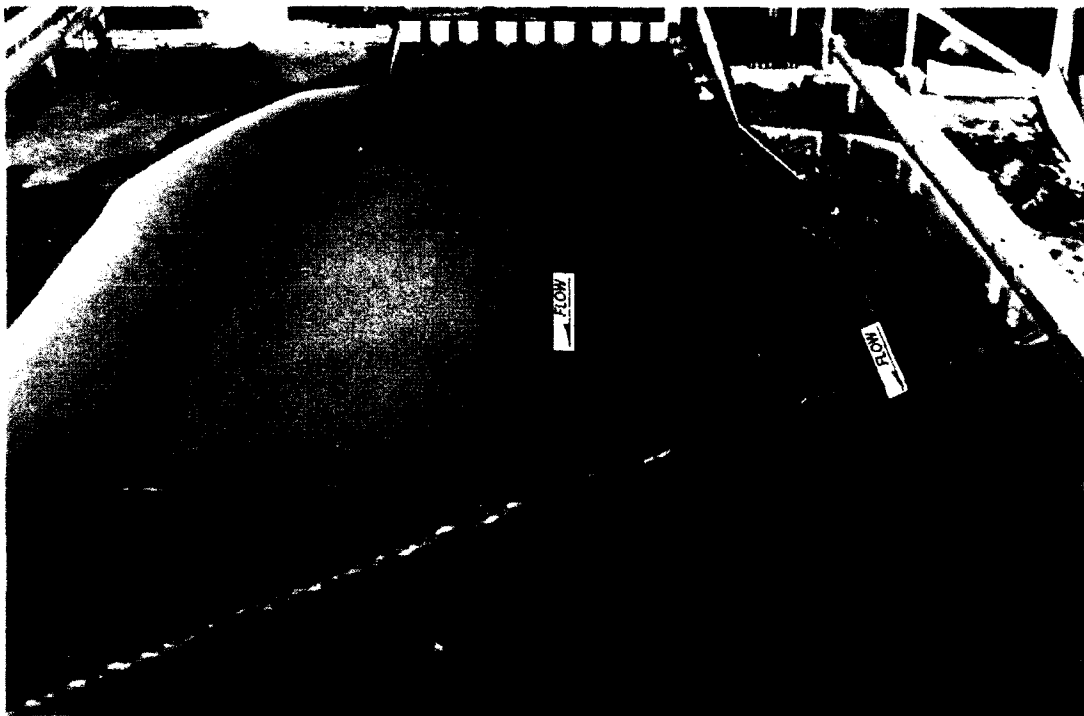
Photo 9. Surface flow patterns, type 8 entrance modification, discharge 7,100 cfs per unit, tailwater el 26.0, fish attraction flow 500 cfs, units 1, 2, and 3 operating

26. The type 8 entrance modification (Plate 29) was a refined version of the type 1 entrance modification. The downstream fish entrance was extended approximately 88 ft downstream to a point just beyond the area in the tailrace where the flow from the boil caused by the unit 3 discharge travels in a downstream direction along the north training wall. This modification provided flow along the training wall and could also be beneficial to fish traveling up the right side of the channel and across the tailrace. The top of the entrance weir was at el 13.5. Velocities measured with the type 8 entrance modification are shown in Plates 30 and 31. Photo 9 shows the

surface flow conditions with the type 8 entrance modification in place. Flow patterns and velocities measured at various depths inside the north wing wall were in a downstream direction.
