USAARL 93-15

## Basic Principles of Helicopter Crashworthiness

Impact, Tolerance, and Protection Division

February 1993

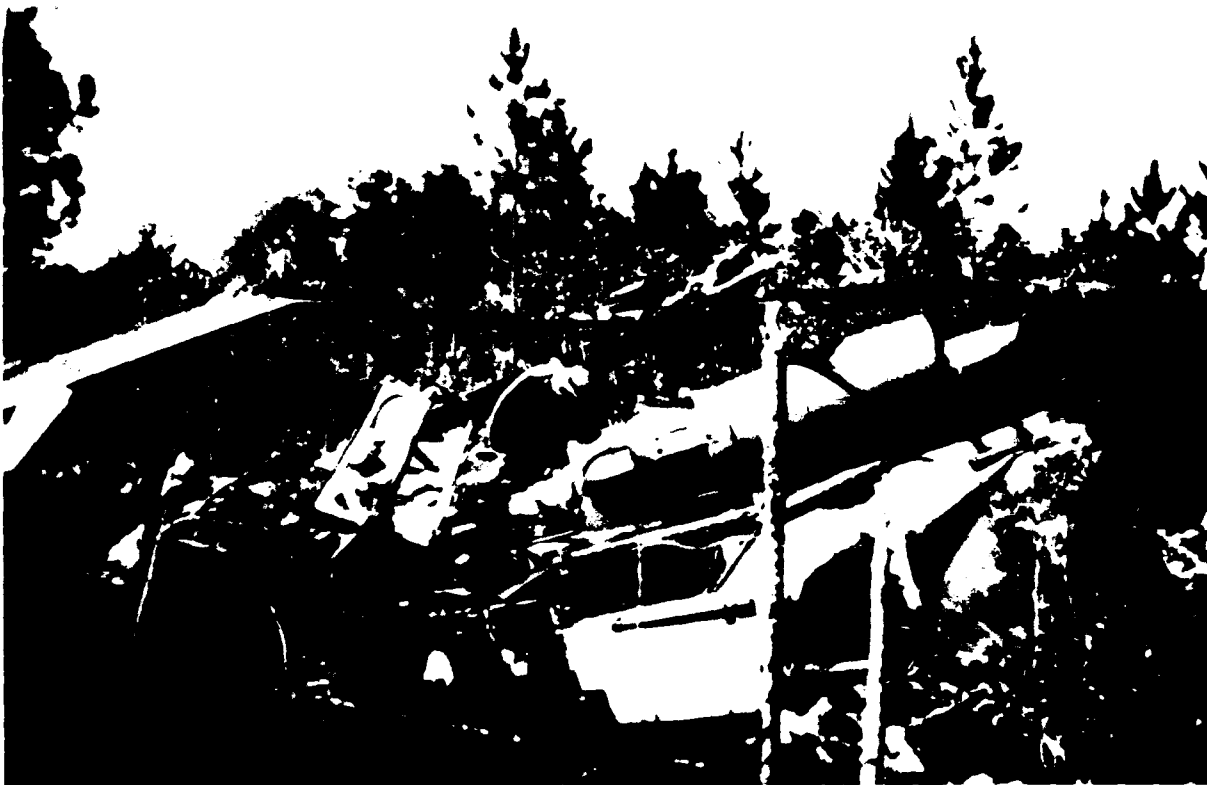
Figure 1. A crash where the roof completely collapsed, crushing the two rear cabin occupants. Surprisingly, one survived due to excellent restraint and a roof mounted, energy absorbing seat that collapsed with the roof.

The container is the occupiable portion of the helicopter -- the cockpit and cabin. It should possess sufficient strength to prevent intrusion of structure into occupied spaces during a survivable crash, thus maintaining a protective shell around all occupants. Since structural collapse causing severe contact injury is one of the most frequent injury hazards encountered in helicopter crashes, this point cannot be overemphasized (Figure 1). The container must also be designed to prevent penetration of external objects into occupied spaces. Another consideration

related to the container is high mass item retention. Transmissions, rotor systems, and engines should have sufficient tie-down strength to ensure that they do not break away and enter occupied spaces in survivable crashes. Finally, the floor and the nose of the helicopter should possess sufficient structural strength and be shaped so as to prevent plowing or scooping of earth during crashes with significant longitudinal velocity since plowing decreases stopping distances and results in higher decelerative loads. In general, cockpit/cabin designs should allow for no more than 15 percent dynamic deformation when subjected to the design crash pulse.

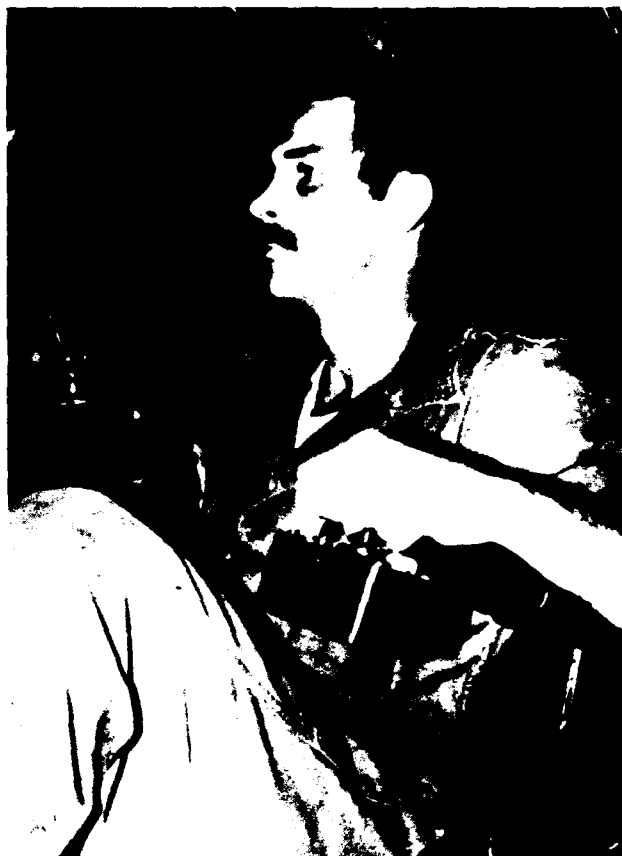
Figure 6. The proximity of the cyclic and collective controls to the pilot is accentuated in stroking (energy absorbing) seats as shown in this demonstration of a UH-60 pilot seat after a severe crash.

In designing an aircraft interior, it is extremely important to consider the local environment of the occupants at all potential seating locations (Figure 6). A person's local environment refers to the space that any portion of his body may occupy during dynamic crash conditions. Any object within that space

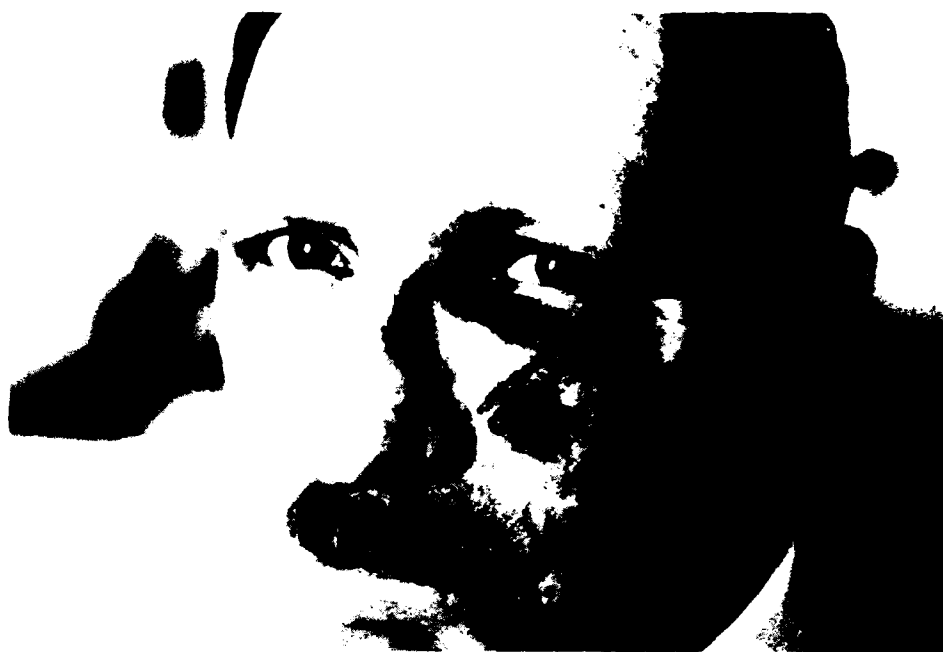
Figure 7a. Note the shapes and location of the abrasions and lacerations on the left side of the face of the pilot.

may be considered an injury hazard (Figures 7 and 8). As an example, the cyclic and collective controls can pose a significant injury hazard to pilots during a crash, particularly when the visor on the flight helmet is not worn in the down position. The volume of that space will vary depending on the type restraint system anticipated and, to a lesser extent, on the anthropometry of the expected occupants. The maximum head strike distance is reduced by about 50 percent when upper torso restraint is utilized. Clearly, the primary concern must be for hazards within the strike zone of the head and upper torso, but objects within the strike zone of the extremities also should be considered.

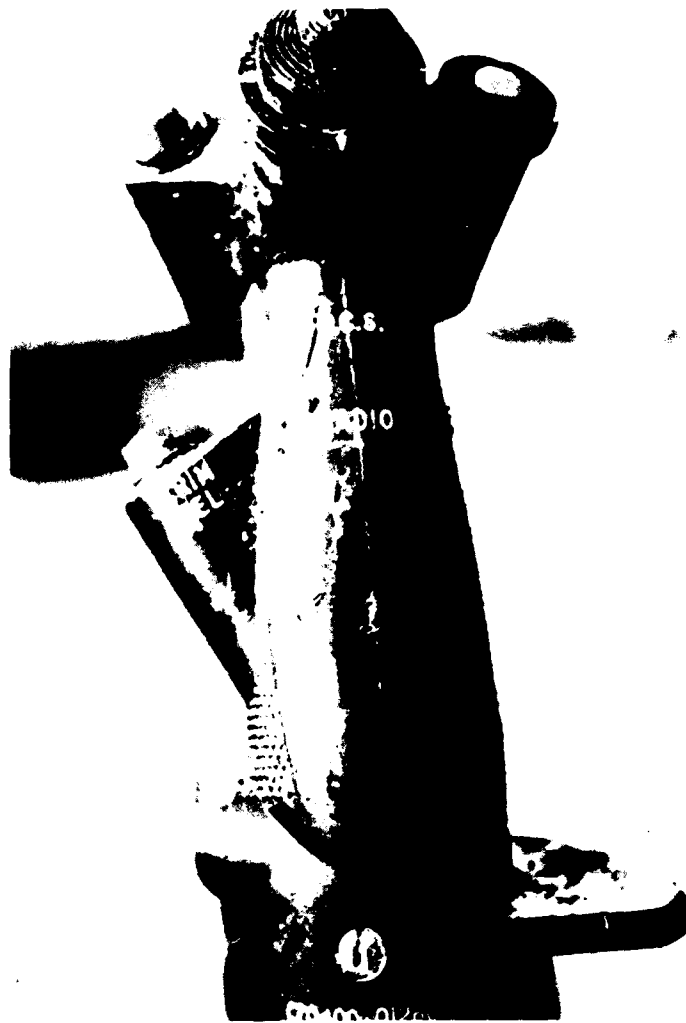
Figure 8. Cyclic control recovered from a UH-60 crash shows longitudinal gouges made by the pilot's teeth. The pilot lost several anterior teeth in the crash, but received no other serious injury.
