Paper No.  
**525**

The NACE Annual Conference and Corrosion Show

## THE INTERRELATIONSHIP BETWEEN MARINE BIOFOULING AND CATHODIC PROTECTION

Brenda J. Little and Patricia A. Wagner  
Naval Research Laboratory  
Stennis Space Center, MS 39529-5004

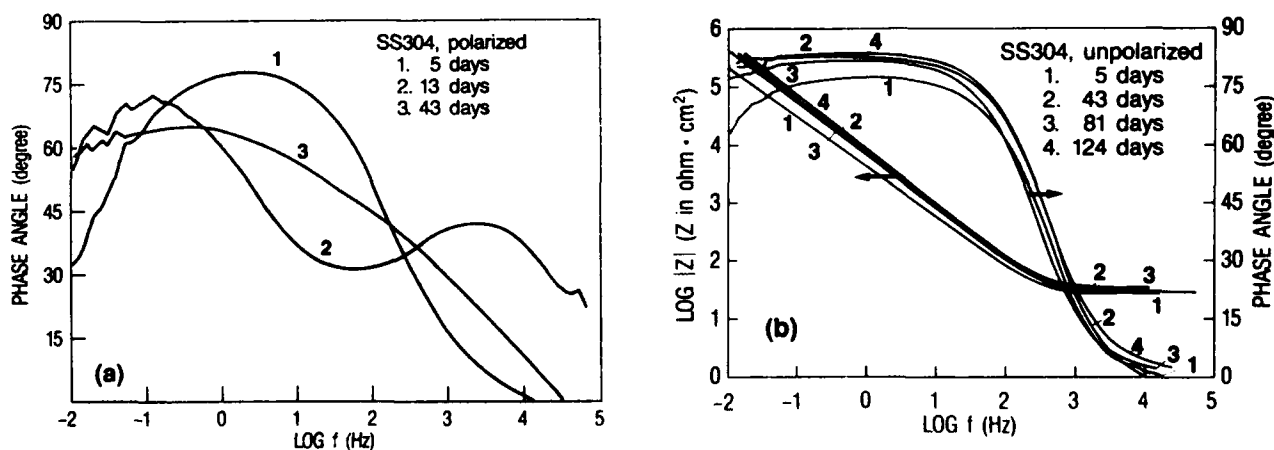
FIGURE 1 – (a) Impedance spectra for polarized 304 stainless steel (EIS data measured at  $E_{\text{corr}}$ ) and (b) impedance spectra for unpolarized 304 stainless steel

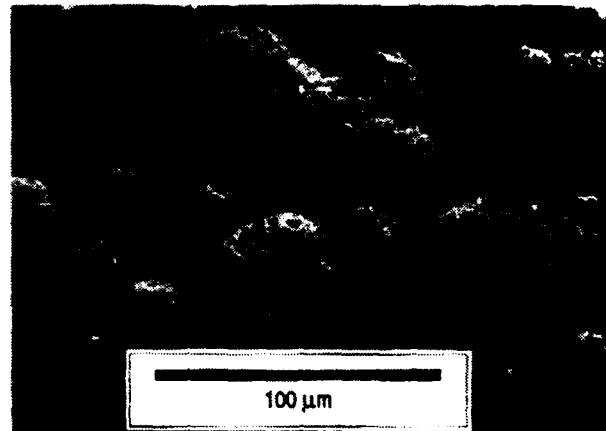
FIGURE 2 – Calcareous deposits on polarized 304 stainless steel after 43 days

In the following discussion all potentials have been reported in reference to a saturated calomel electrode (SCE). It has been reported that CP retards microbial growth because of the alkaline pH generated at the surface by reactions (1) and (2). Littauer and Jennings retarded biofouling in seawater using pulsed cathodic polarization of steel.<sup>6</sup> Dhar demonstrated that a potential more negative than -1024 mV was effective in decreasing bacterial content on titanium in seawater by 1 to 2 orders of magnitude.<sup>7</sup> The author concluded that in some systems it would be possible to prevent fouling and corrosion simultaneously by proper manipulation of the cathodic potential. However, numerous investigators have demonstrated a relationship between marine fouling and calcareous deposits on cathodically protected surfaces. For example, Mansfeld et al. polarized three stainless steels and titanium to -850 mV in natural Pacific seawater and followed the formation of surface layers using electrochemical impedance spectroscopy (EIS) and environmental scanning electron microscopy.<sup>8</sup> The applied potential was removed the day before EIS measurements, so that EIS data were collected at  $E_{\text{corr}}$  in a frequency range between 65 kHz and 10 or 1 mHz with a signal amplitude of 10 mV. Calcareous deposits and bacteria were evident on the surface after 5 days. Areal coverage of the surfaces could be followed with EIS (Figure 1a). For an exposure time of 5 days EIS data were similar for polarized and unpolarized samples (Figure 1b) despite the occurrence of scattered calcareous deposits on the polarized surface. After 13 days there were two time constants in EIS spectra of polarized samples indicating two surface conditions i.e., covered and uncovered. The occurrence of two time constants corresponding to calcareous deposits and uncovered surface is evident in the frequency dependence of the phase angle. After 43 days the time constants were no longer well defined due to complete coverage of polarized surfaces with calcareous deposits (Figure 2). In all cases bacterial cells could be imaged between and on top of calcareous deposits (Figure 3). It is noteworthy that the size and shape of calcareous deposits on polarized titanium differed from those on polarized stainless steel.

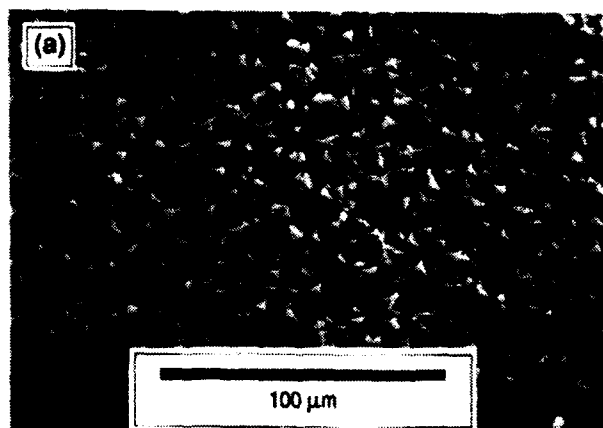
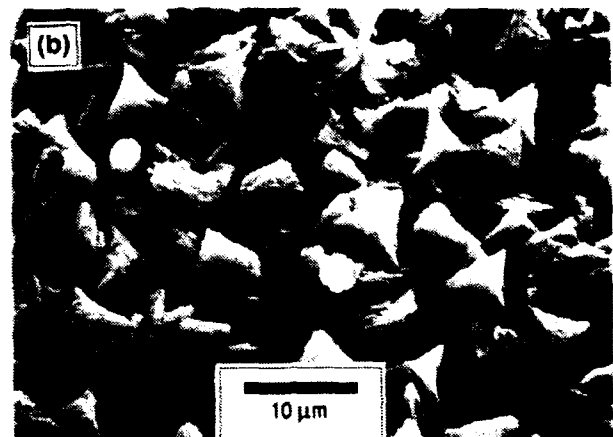
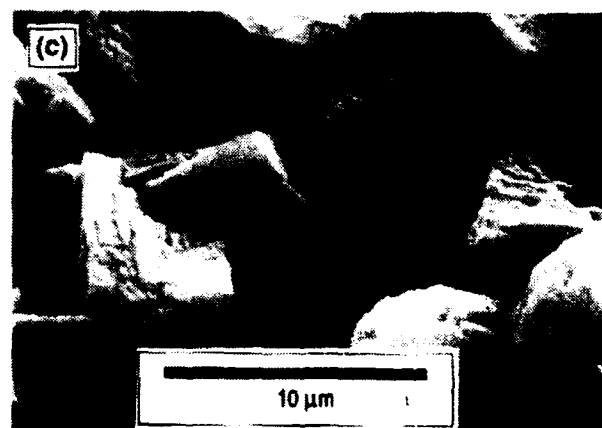
FIGURE 3 – (a), (b) calcareous deposits on polarized titanium (grade 2) after 43 days, and (c) bacteria between calcareous deposits

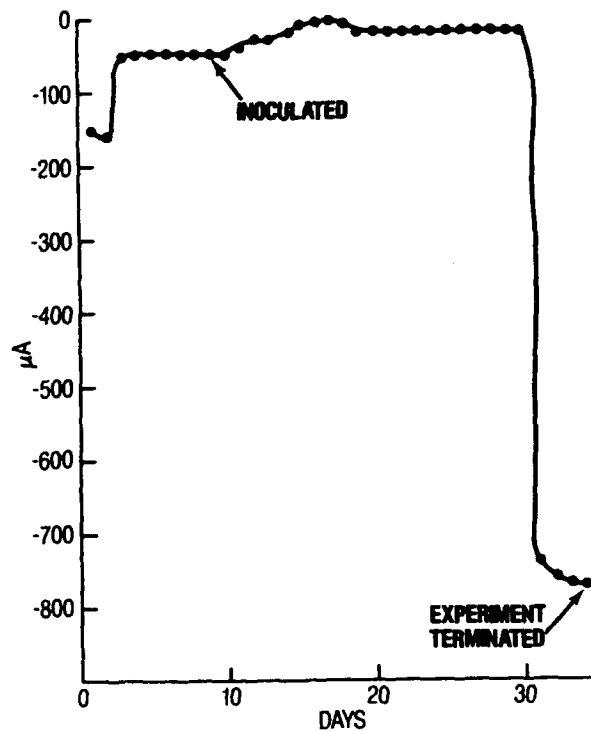
FIGURE 4 – Current density required to maintain  $-900$  mV (SCE) vs time

Little et al. showed that cathodically protected stainless steel surfaces in artificial seawater can become colonized by aerobic, acid-producing bacteria.<sup>23</sup> Formation of calcareous deposits and initial settlement of microorganisms resulted in decreased current density required to maintain a protection potential. Subsequent colonization and pH changes destabilized the calcareous deposits and dramatically increased current density required to maintain the imposed potential (Figures 4, 5). Ulanovski and Ledenev imposed cathodic protection on steel surfaces actively corroding in cultures of SRB and concluded that cathodic protection in the presence of SRB decreased corrosion by a factor of eight or nine.<sup>24</sup>

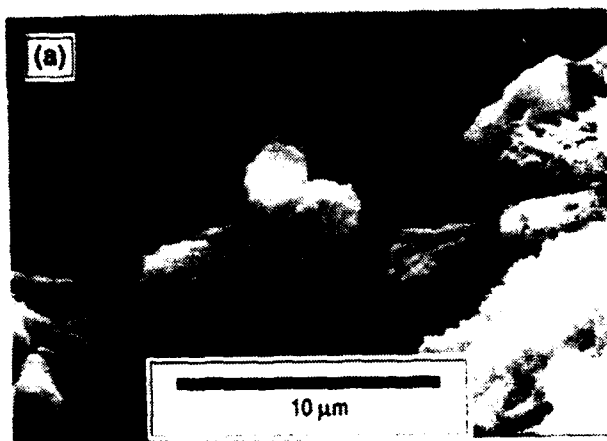
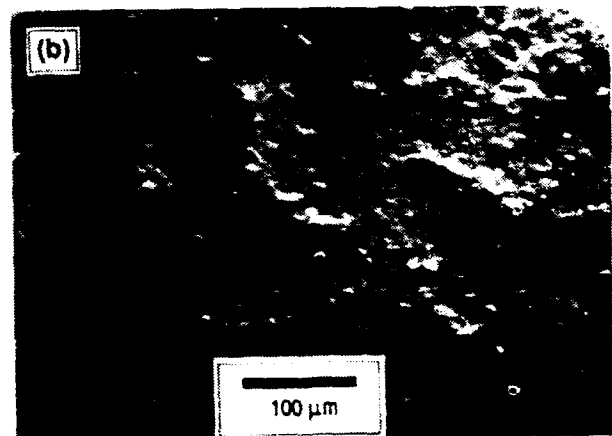
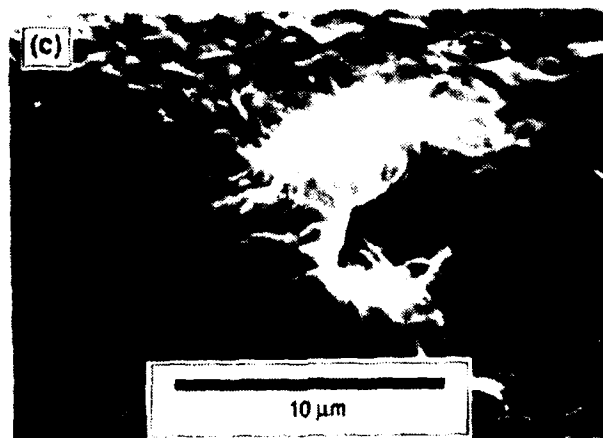
FIGURE 5 – Stainless steel polarized  $-900$  mv (SCE): (a) colonized electrode surface, (b) colonized pitted electrode, and (c) pits and associated bacteria
