Technical Report 1607
October 1993

**Effect of Different Axial Bearing
Supports on the Fatigue Life of
Ceramic Pressure Housings**

**NAVAL COMMAND, CONTROL AND
OCEAN SURVEILLANCE CENTER
RDT&E DIVISION
San Diego, California 92152-5001**

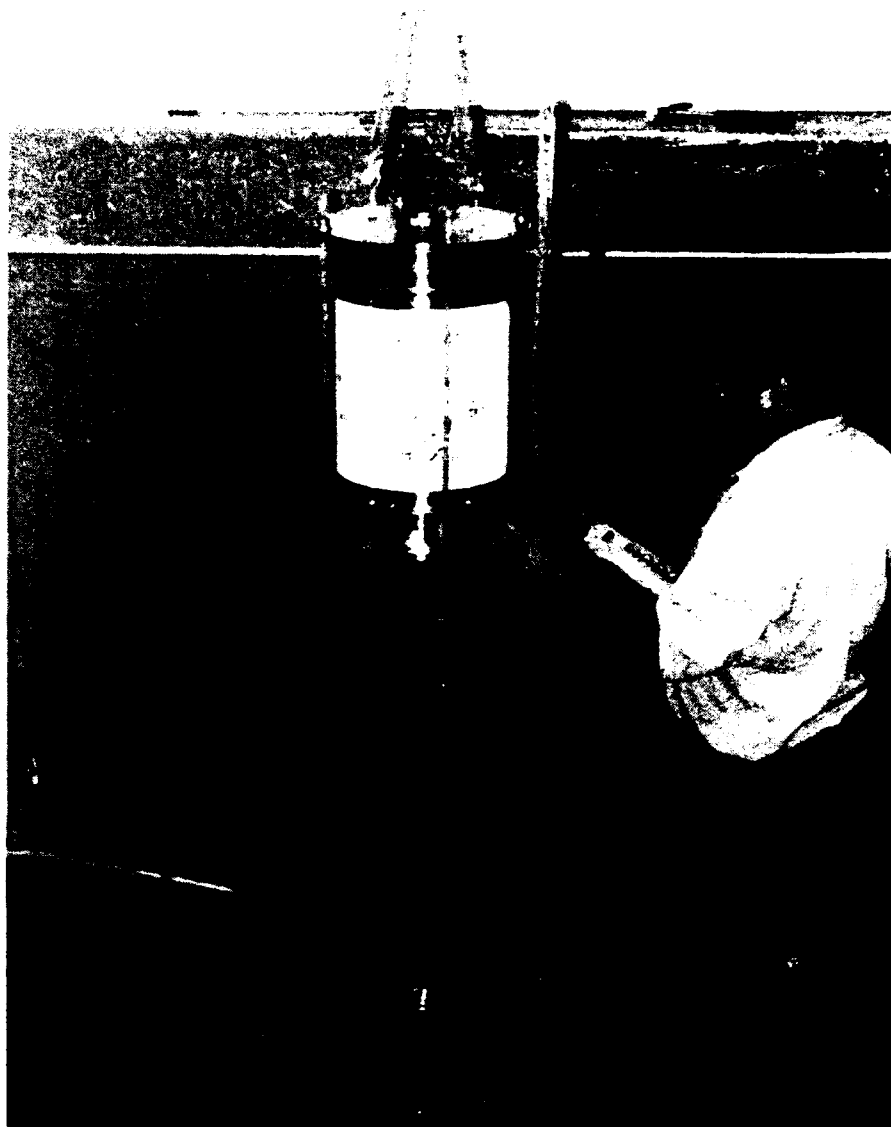
Figure 16. Placement of Test Configuration D into pressure-testing vessel.

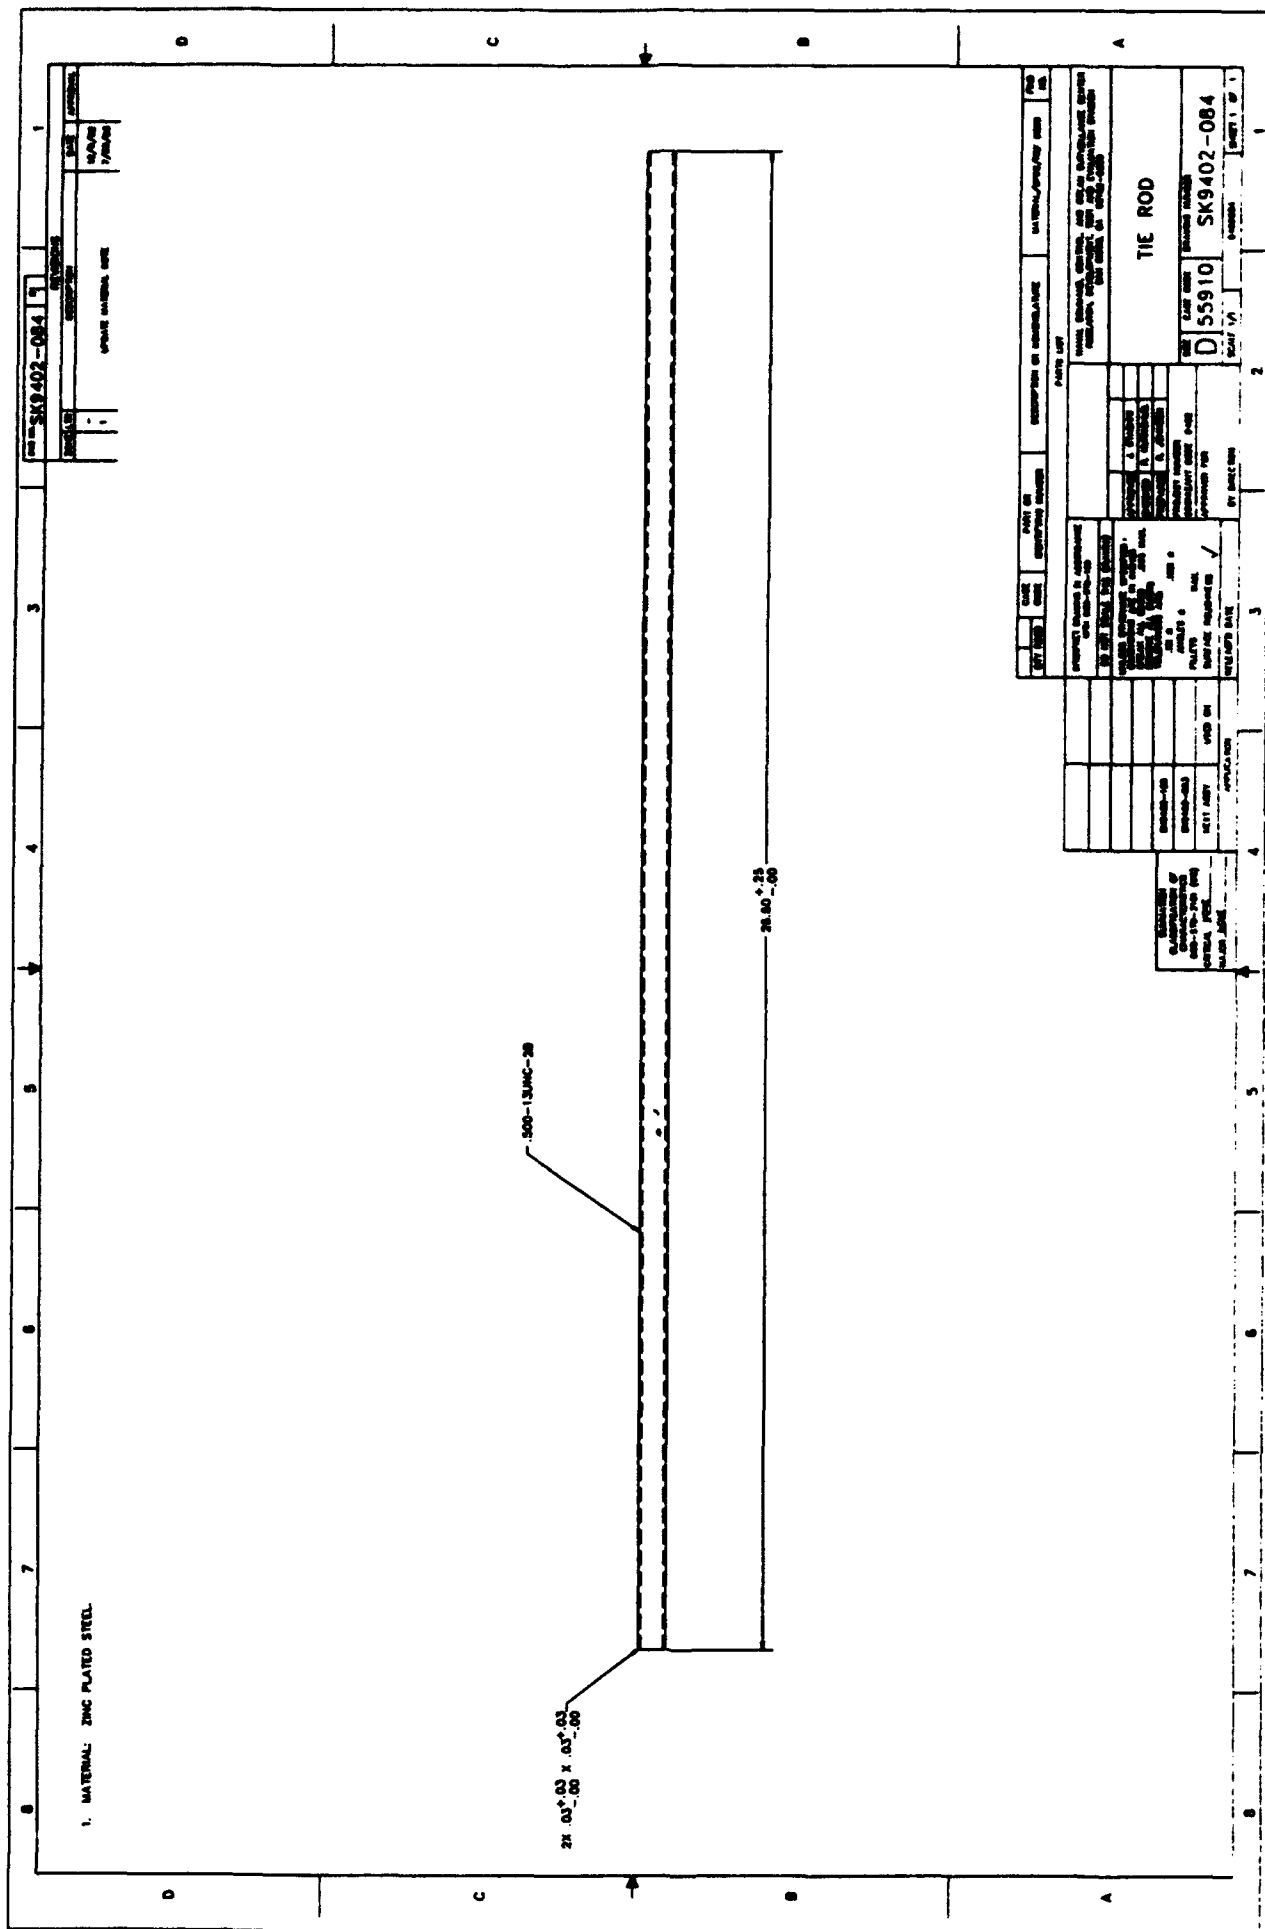
Figure 19. Tie rod.

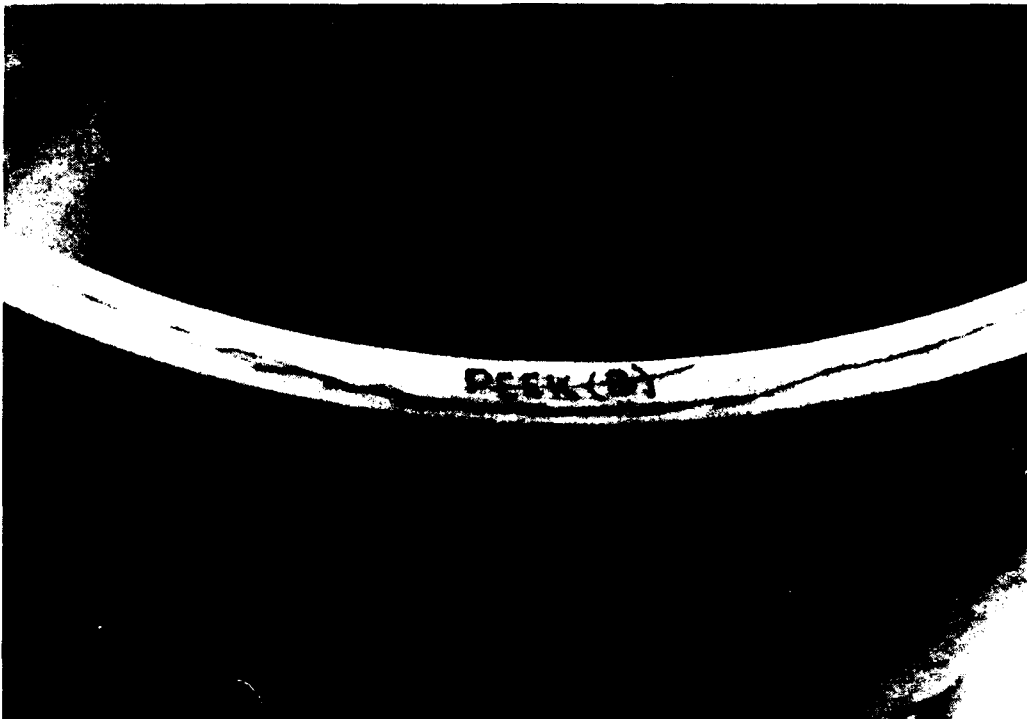
Figure 21. Bearing surface cracks at the top end of the Test Configuration B cylinder.

In general, most circumferential cracks that were detected with dye penetrant were located at the mid-plane of the bearing surface. The two primary exceptions to this pattern were the cracks detected at the top end of Test Configuration B where the GFR PEEK gasket was used, and at the top end of Test Configuration C where the dry-paper gasket was used between the sacrificial ceramic ring and the ceramic cylinder. As seen in figure 21, the

cracks that formed with the GFR PEEK gasket tended to wander between mid-plane of the bearing surface and the OD of the bearing surface. Figure 23 shows the extensive cracking detected at the top end of Test Configuration C where numerous short-circumferential cracks ran parallel to one another throughout the bearing-surface thickness. In both of these cases, the bearing surface of the cylinder was free of epoxy.

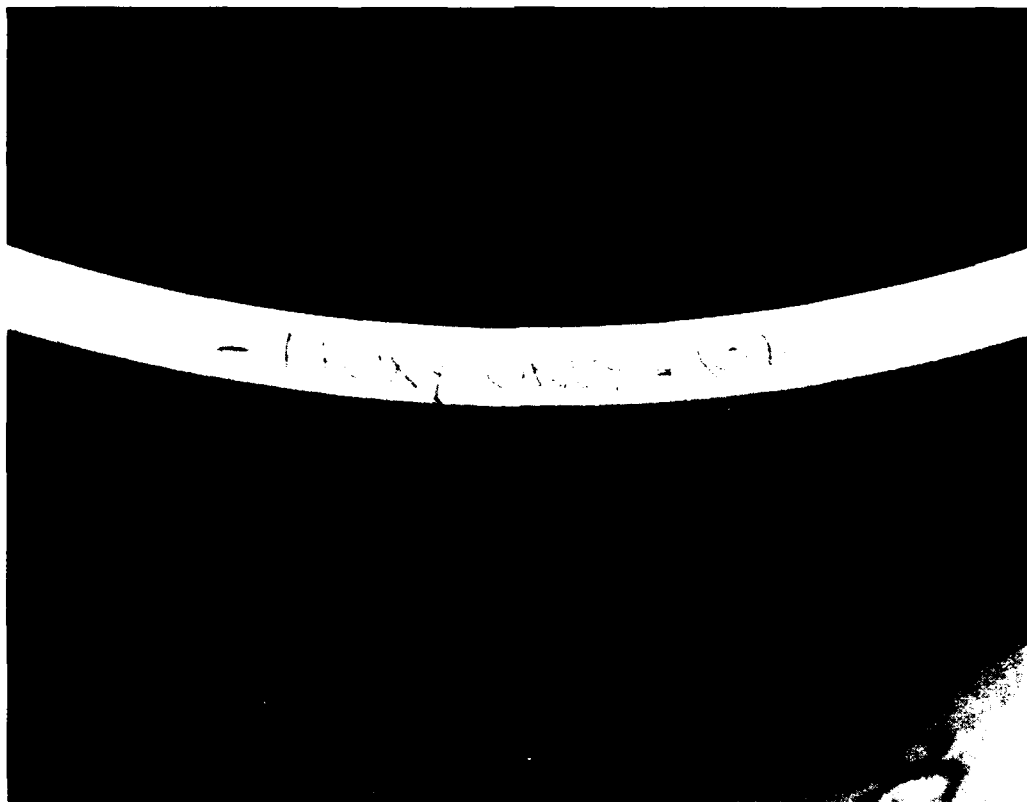
Figure 22. Crack-free bearing surface at the bottom end of the Test Configuration B cylinder.
