TECHNICAL REPORT ARCCB-TR-94010

**NOTCH-TIP DAMAGE AND TRANSLAMINAR
FRACTURE TOUGHNESS MEASUREMENTS
FROM CARBON/EPOXY LAMINATES**

J.H. UNDERWOOD
M.T. KORTSCHOT

MARCH 1994

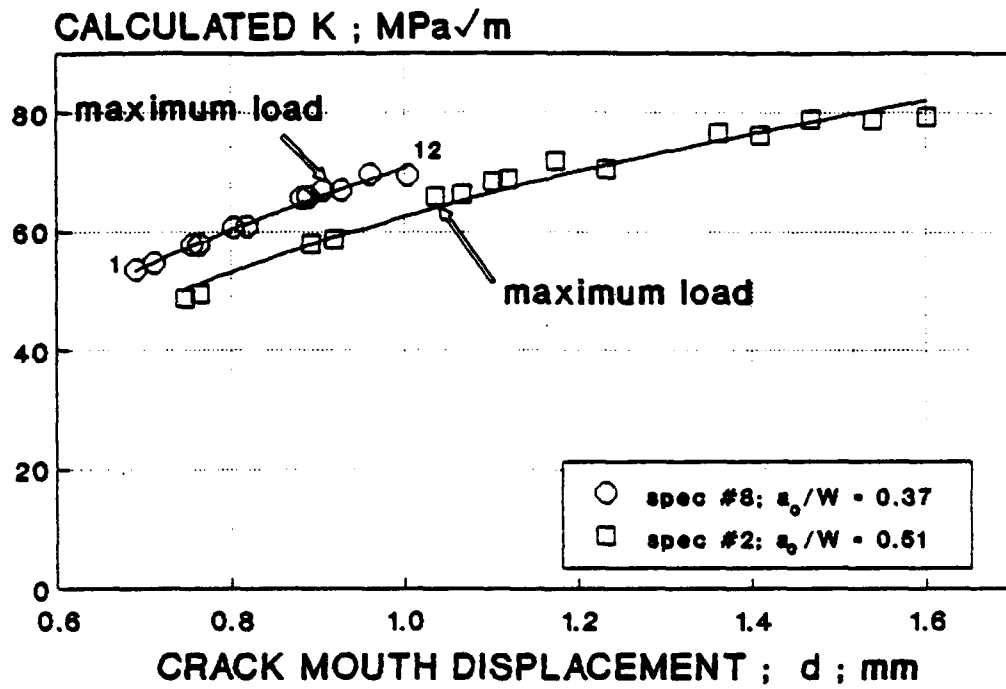
Figure 7. Calculated K from P-d plot versus crack-mouth displacement.

A description of notch-tip damage and crack growth over a considerable range of applied load and crack-mouth displacement is presented in Figures 6 through 8. First, in Figure 6, the upper portions of the P-d plot of specimen #8 is shown, which is representative of the step-like pop-in behavior observed in this study. The points of significant change in the plot were numbered 1 through 12 and plotted as applied K versus d in Figure 7, where the value of applied K was calculated by including the increment of apparent crack growth that had occurred at each of the twelve points. Equations (2) through (4) were used, as discussed earlier. Results from

another specimen #2 with different a/W are also shown in Figure 7 using the same procedure. The fact that the K-d plots are monotonically increasing in a smooth manner supports the earlier suggestion that crack extension under elastic conditions controls the P-d behavior in these tests, since it was an elastic crack-extension analysis that produced the smooth K-d plots. This line of reasoning is taken a step further in Figure 8, where the data of Figure 7 are plotted in the usual crack-growth resistance, K_{R} , form of applied K versus crack growth. Results from the two specimens, which have quite different starting notch lengths, are fairly well represented by the power law curve shown on the plot. It is not apparent at this point what significance there is to the type of K_{R} curve that happened to represent the results. However, since an elastic crack-extension analysis was used to calculate the K_{R} curve, this is another indication that elastic crack-extension controls the fracture behavior of these laminates. It should also be noted that others have discussed this type of increasing crack-growth resistance in fracture tests of laminates. Kortschot and Beaumont (ref 8) described a decrease in the maximum stress at the notch as damage, and notch-tip blunting occurred, which would result in increasing resistance to crack growth as damage proceeded.
