Technical Report GL-94-23  
August 1994

## A Waterborne Seismic Reflection Survey of the Inner Bar Channel and Anchorage Basin, Galveston, Texas

Prepared for U.S. Army Engineer District, Galveston

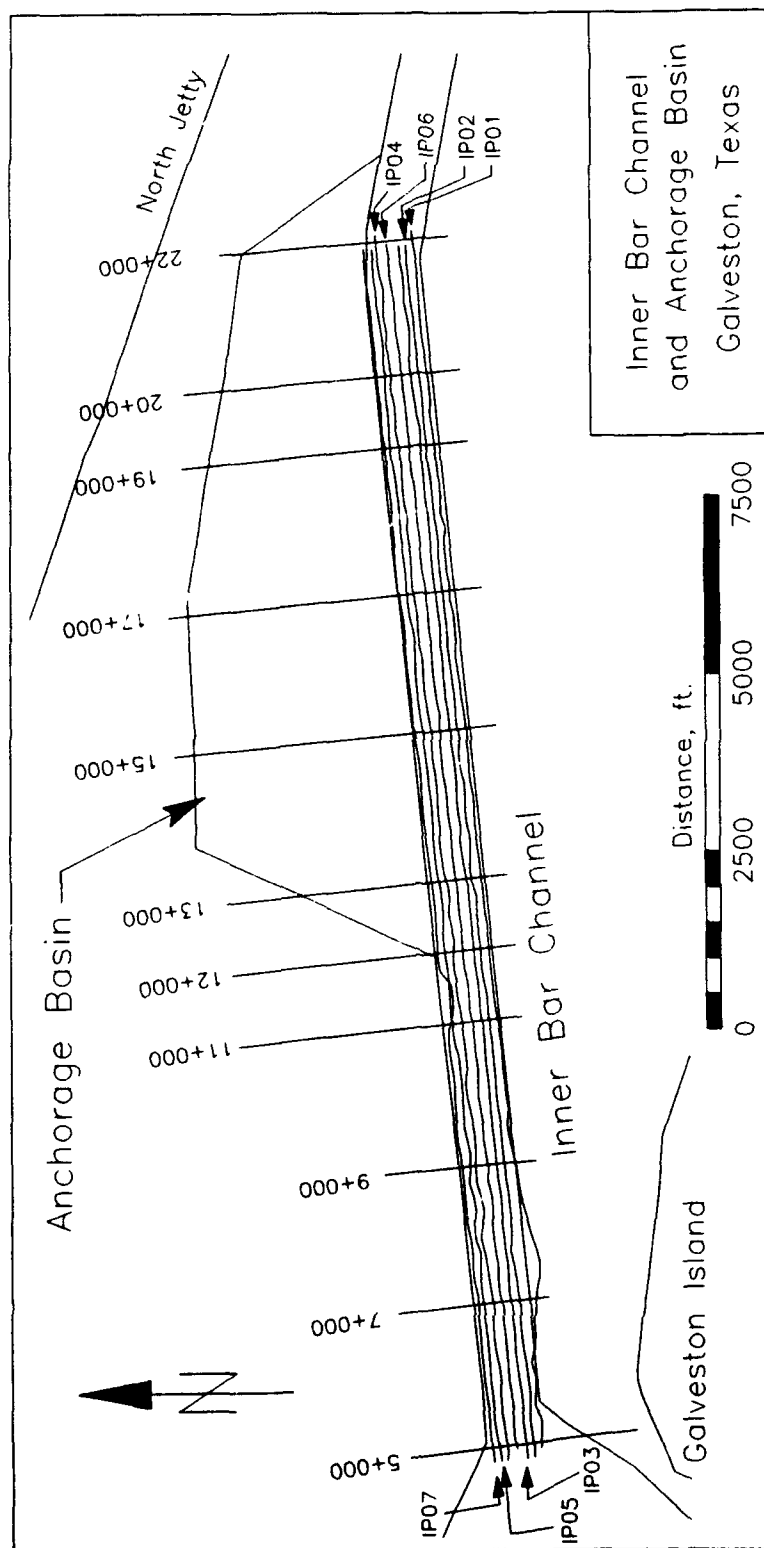
Figure 3. Geophysical survey lines, Inner Bar Channel. Survey direction denoted by label arrow

A map showing the location of the geophysical survey lines along the Inner Bar Channel and Anchorage Basin are presented in Figures 3 and 4, respectively. The survey layout of each area is described below.

The Inner Bar Channel (Figure 3) begins at station 5+000 and extends 17,000 ft to station 22+000, the beginning of the Outer Bar Channel. The survey consists of seven profile lines labelled IP01 through IP07. One survey, profile IP06, is conducted along the center line of the channel and the remaining lines are positioned at distances of 150, 250, and 350 ft along either side of the center line. The outermost surveys at 350 ft are also 50 ft off the toe or edge of the channel.

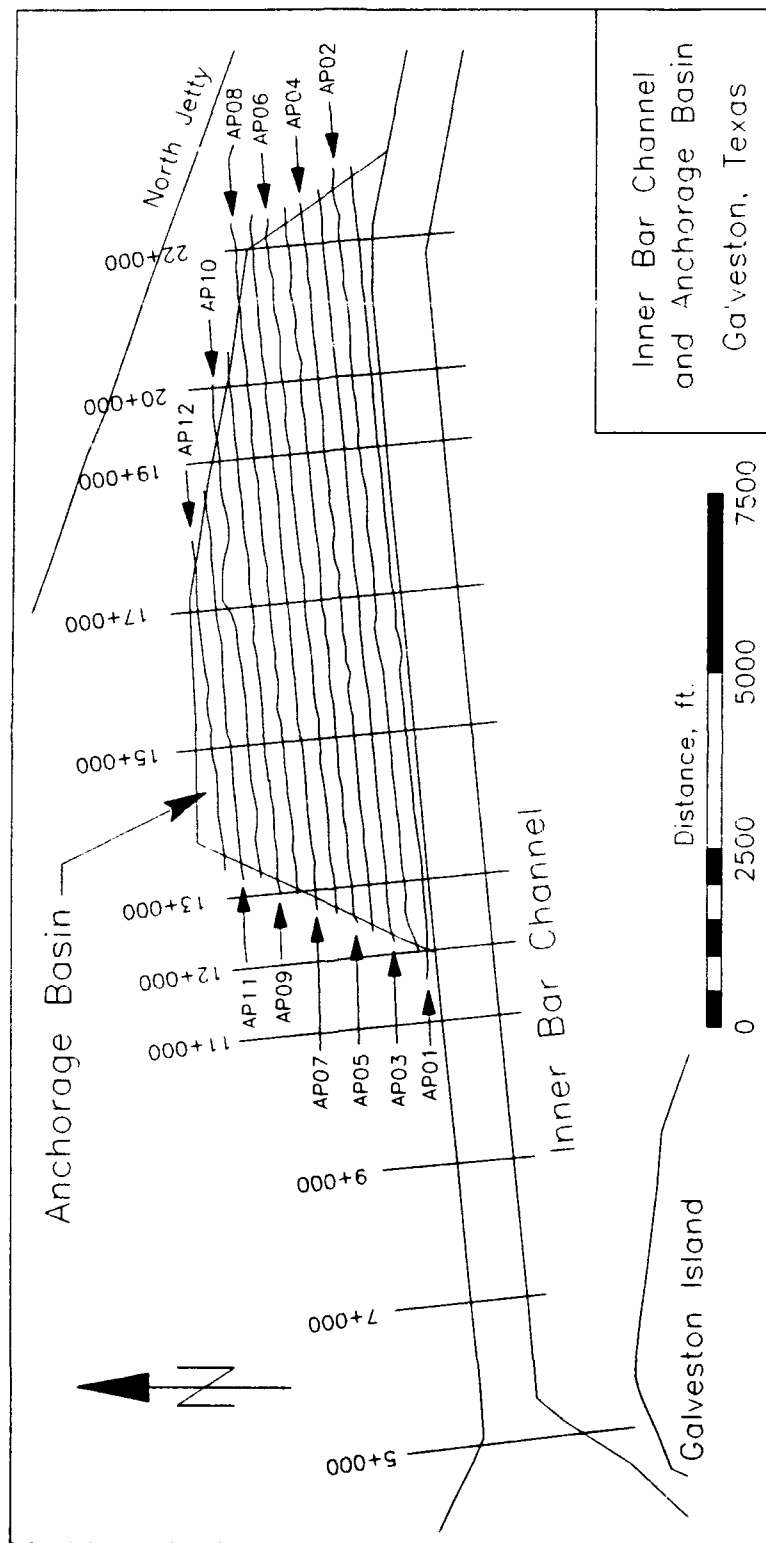
Figure 4. Geophysical survey lines, Anchorage Basin. Survey direction denoted by label arrow

The Anchorage Basin (Figure 4) begins near station 12+000 and extends 11,400 ft to station 23+400 along the Outer Bar Channel. The survey in this trapezoidally shaped area consists of twelve profile lines conducted parallel to the Inner Bar Channel. The surveys are denoted as lines AP01 through AP12 and range in length from 4,000 to 11,400 ft. The profiles are spaced 250 ft apart with the first survey line located approximately 100 ft from the north toe of the Inner Bar Channel.

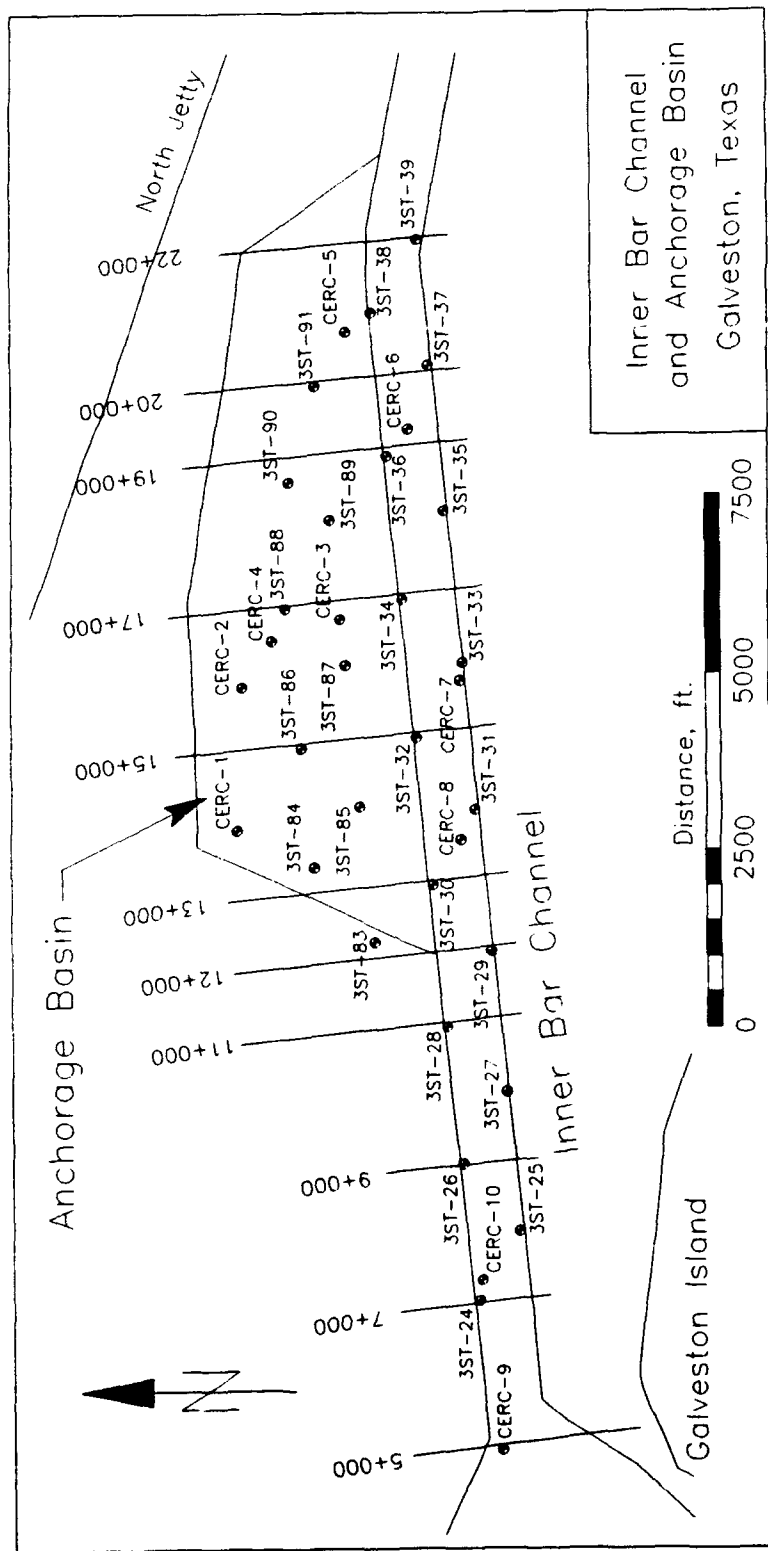
Figure 5. Site map showing CESWG and WES core locations

Existing cores completed and analyzed by CESWG were also used during this investigation (see Figure 5). These cores are denoted by the label '3ST-##', where '##' represents the core number, and were completed to an elevation range of -50 to -55 ft MLT. A short summary of the sediment analysis for cores 3ST-83 through 3ST-91 are presented in Table 2. Laboratory analysis information provided to WES for cores 3ST-24 to 3ST-39 was limited to representative soil classification at 2.5 ft intervals. Each of the CESWG cores were drilled in 1966.

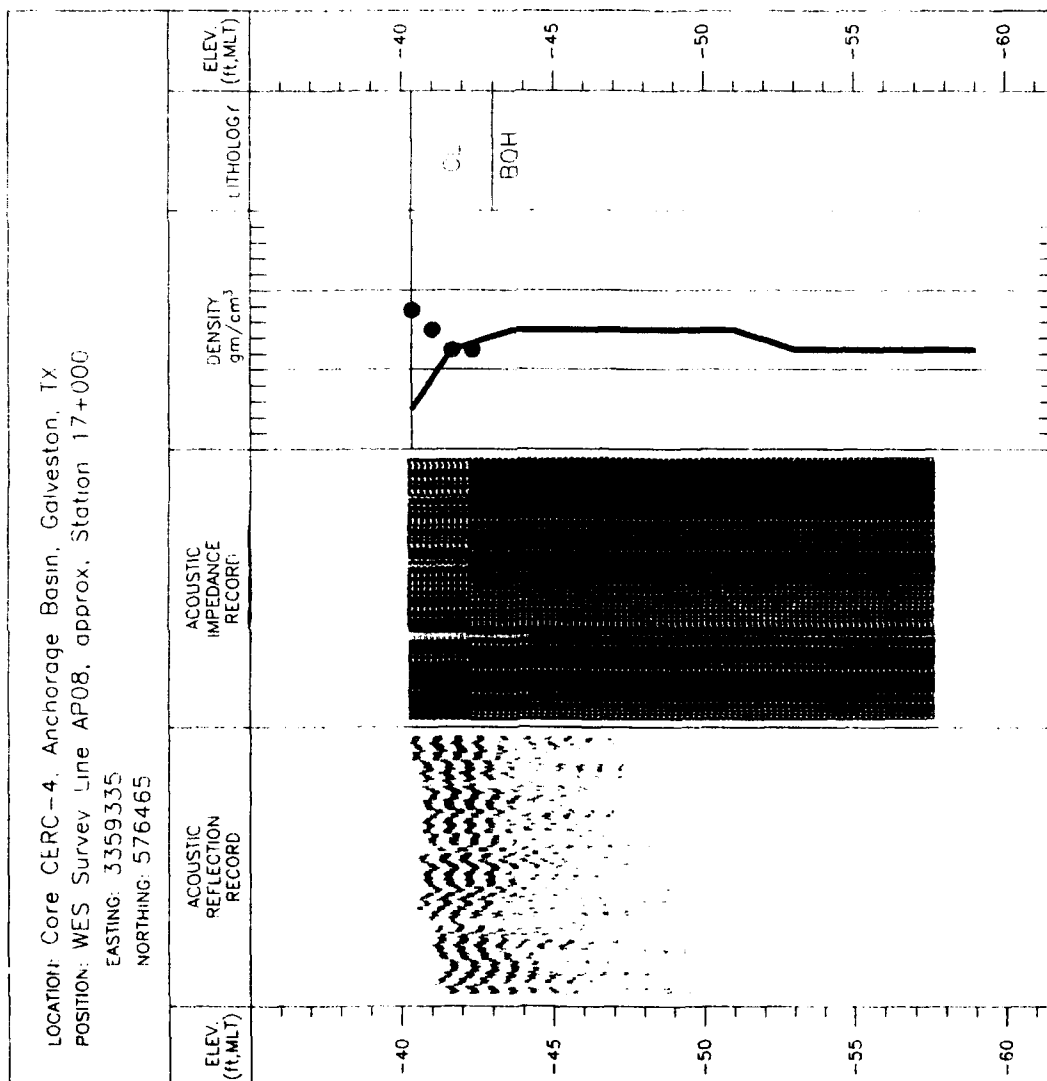
Figure 6. Bottom surface calibration at WES Core CERC-4, Anchorage Basin

density range of 1.63 to 1.85 g/cm<sup>3</sup>. Computed density estimates incorporating the calibration parameters ranged from 1.70 to 1.85 g/cm<sup>3</sup>. The acoustically derived density estimates using the calibration parameters versus the measured characteristics of cores CERC-4 and CERC-8 are illustrated in Figures 6 and 7, respectively.

Calibration locations may be thought of as acoustic cores taken at various locations within the project area. The calibration plots shown in Figures 6 through 17 illustrate the acoustically derived density values versus depth at a core location in which directly measured density values exist. Referring to Figure 7, a portion of the seismic reflection record taken at WES core location CERC-8 is presented in the leftmost block entitled 'Acoustic Reflection Record'. The darker colors represent higher amplitude signals recorded from the varying geologic interfaces. The bottom surface is detected at an elevation -41 ft MLT and a second distinct interface, where a change in impedance exists, is measured at elevation -57 ft MLT. Using surface and subbottom sediment calibration parameters, impedance values are computed for that portion of the seismic record and displayed in the block labelled 'Acoustic Impedance Record'. The impedance values are color-coded such that the darker colors are related to higher impedance values. Using the impedance versus sediment database developed by Hamilton, the higher impedance values are related to more competent sediments having higher density values such as a sand or stiff clay. In the block entitled 'Density', the solid line depicts the acoustically derived density values versus depth as related to the impedance versus density database. The black dots represent measured density values at specific depths for the core indicated in the title block. Visual sediment classification from the driller's log is outlined in the block titled 'Lithology'.

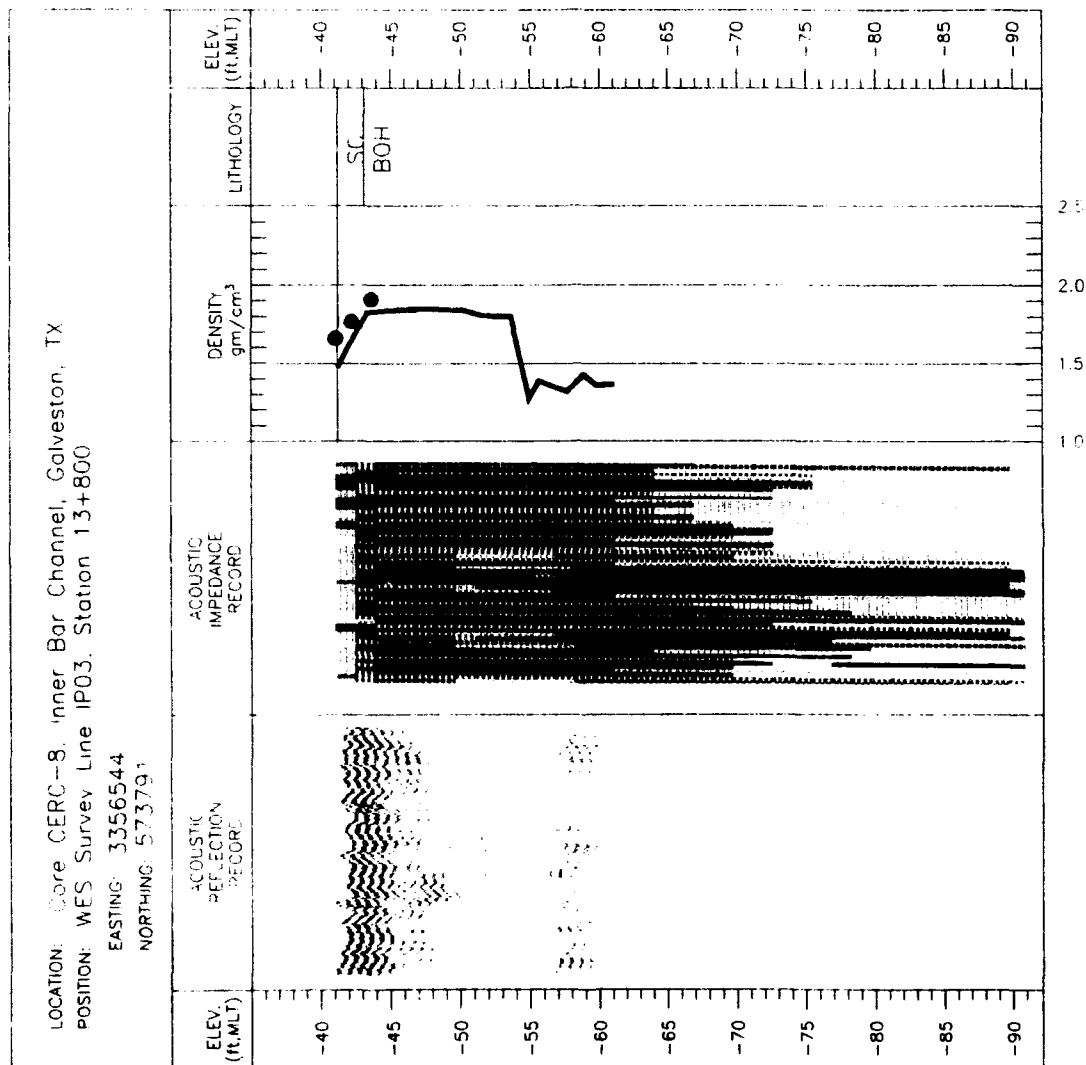
Figure 7. Bottom surface calibration at WES Core CERC-8, Inner Bar Channel

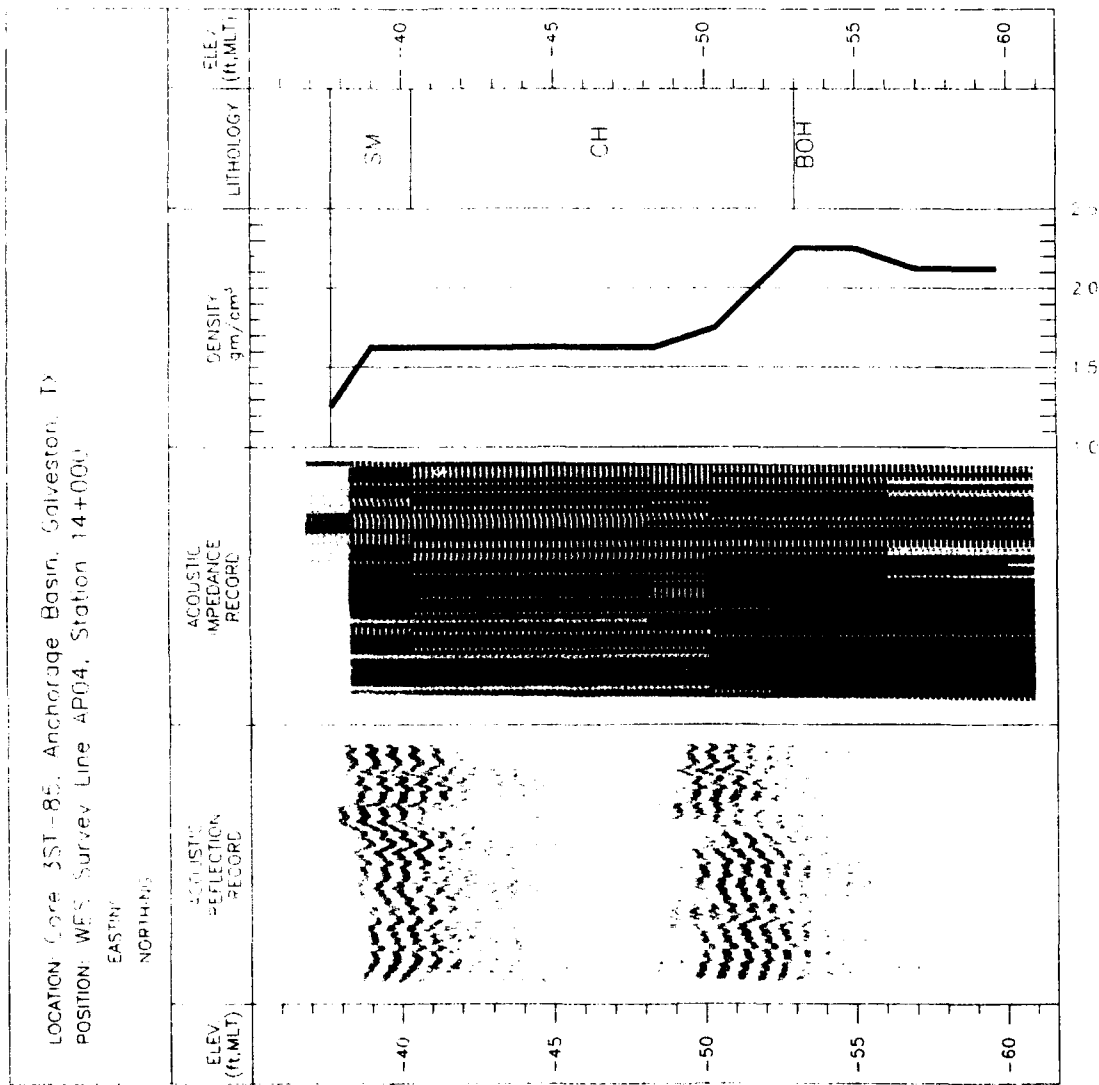
Figure 8. Subbottom sediment calibration at Core 3ST-85, Anchorage Basin

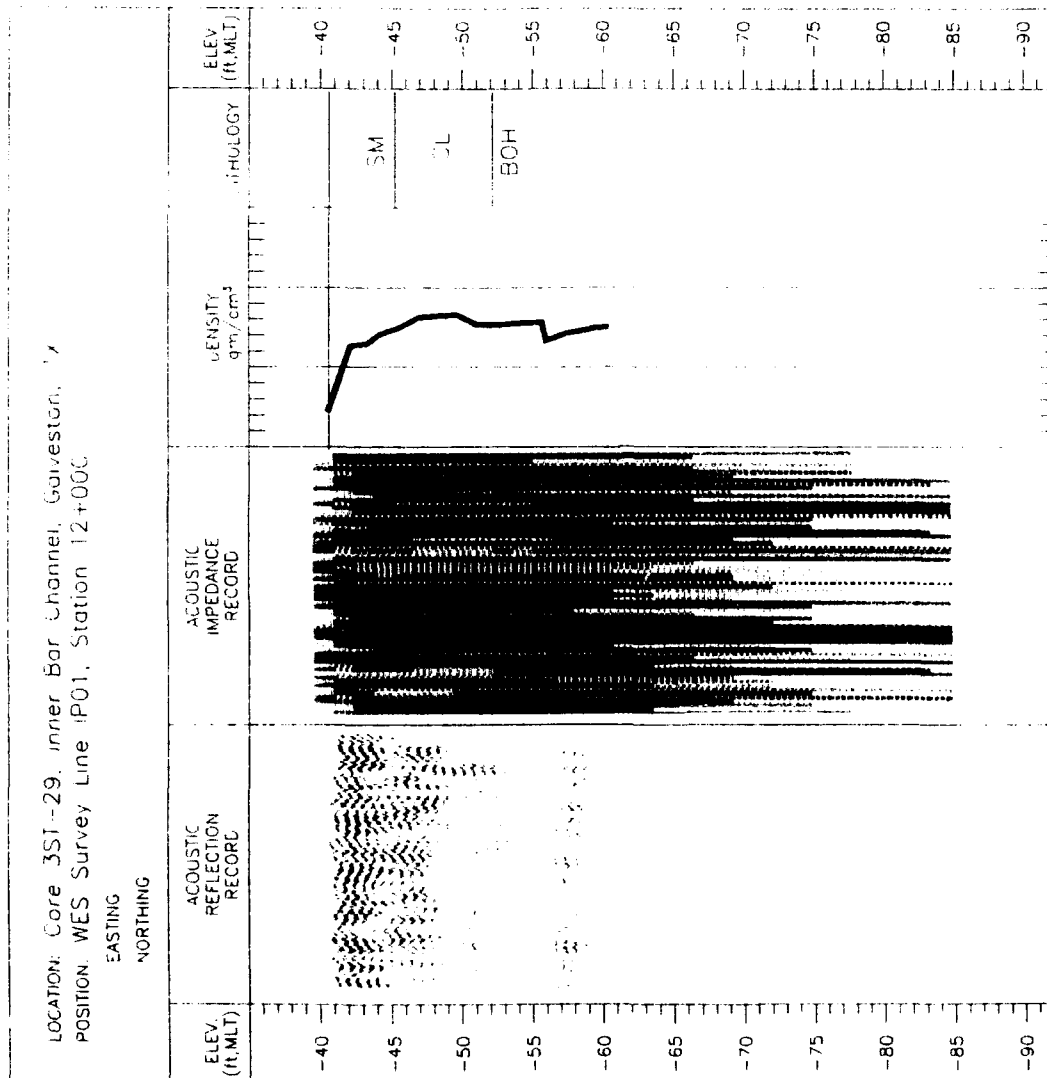
Figure 10. Check calibration at Core 3ST-29, Inner Bar Channel

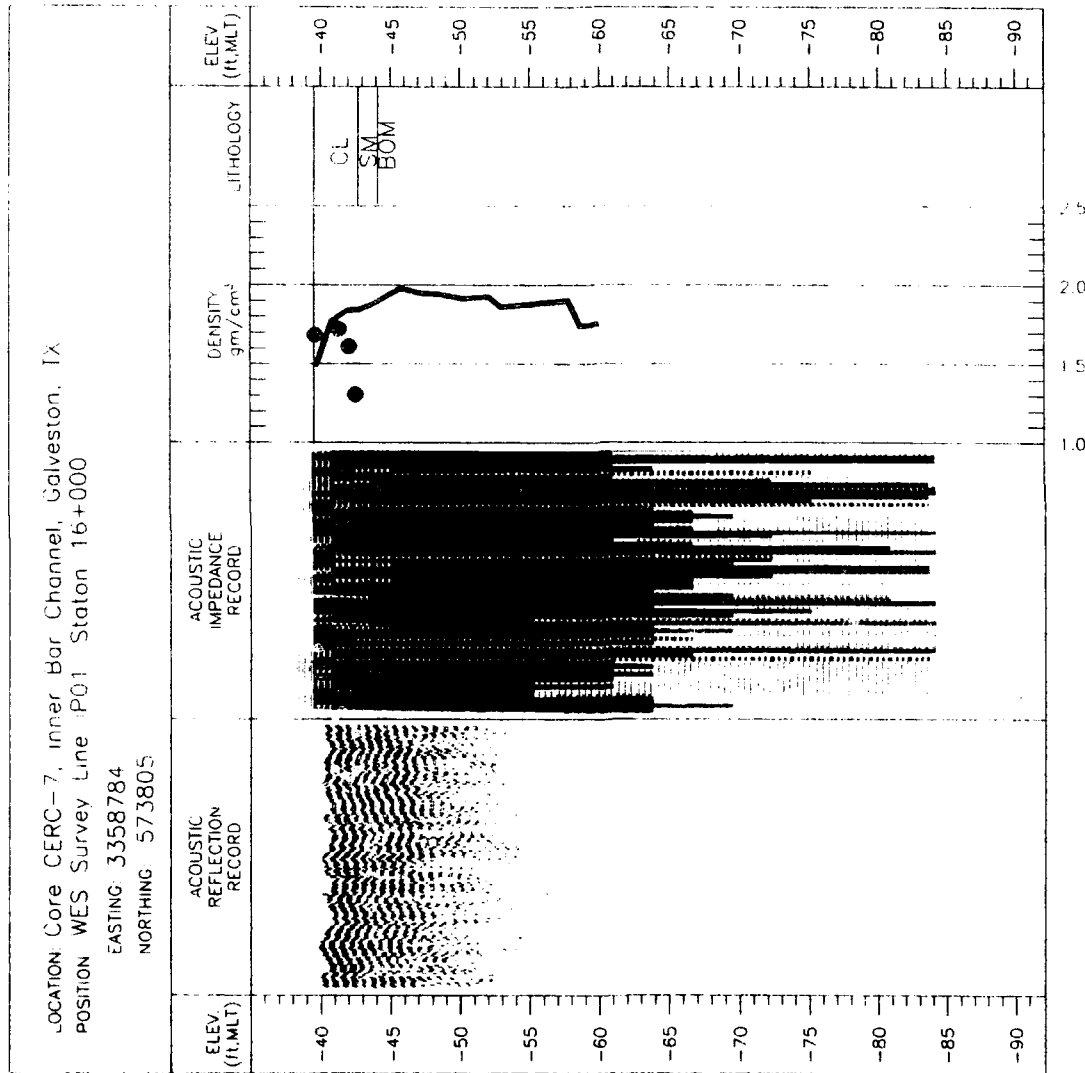
Figure 11. Check calibration at Core CERC-7, Inner Bar Channel

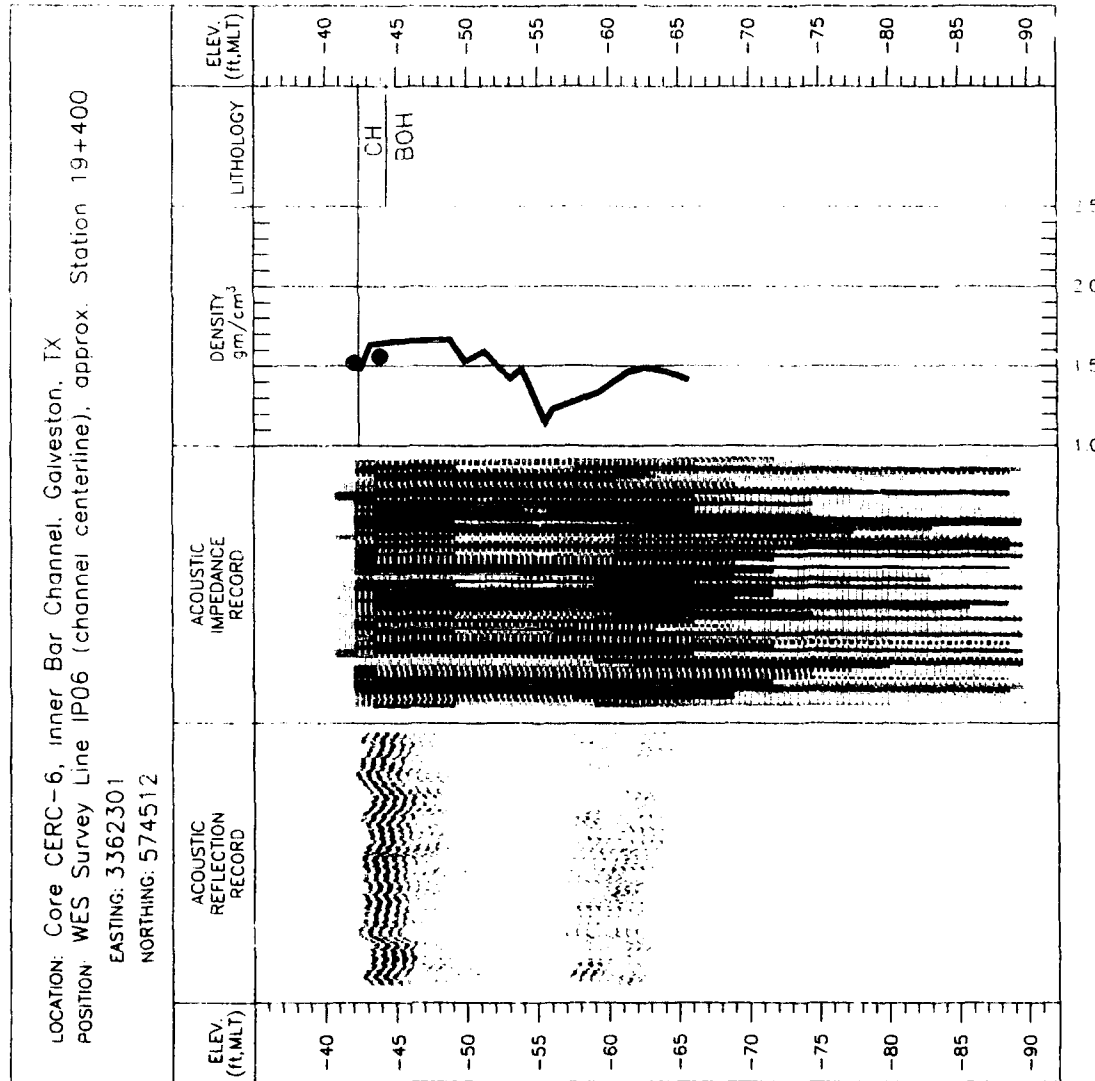
Figure 12. Check calibration at Core CERC-6, Inner Bar Channel

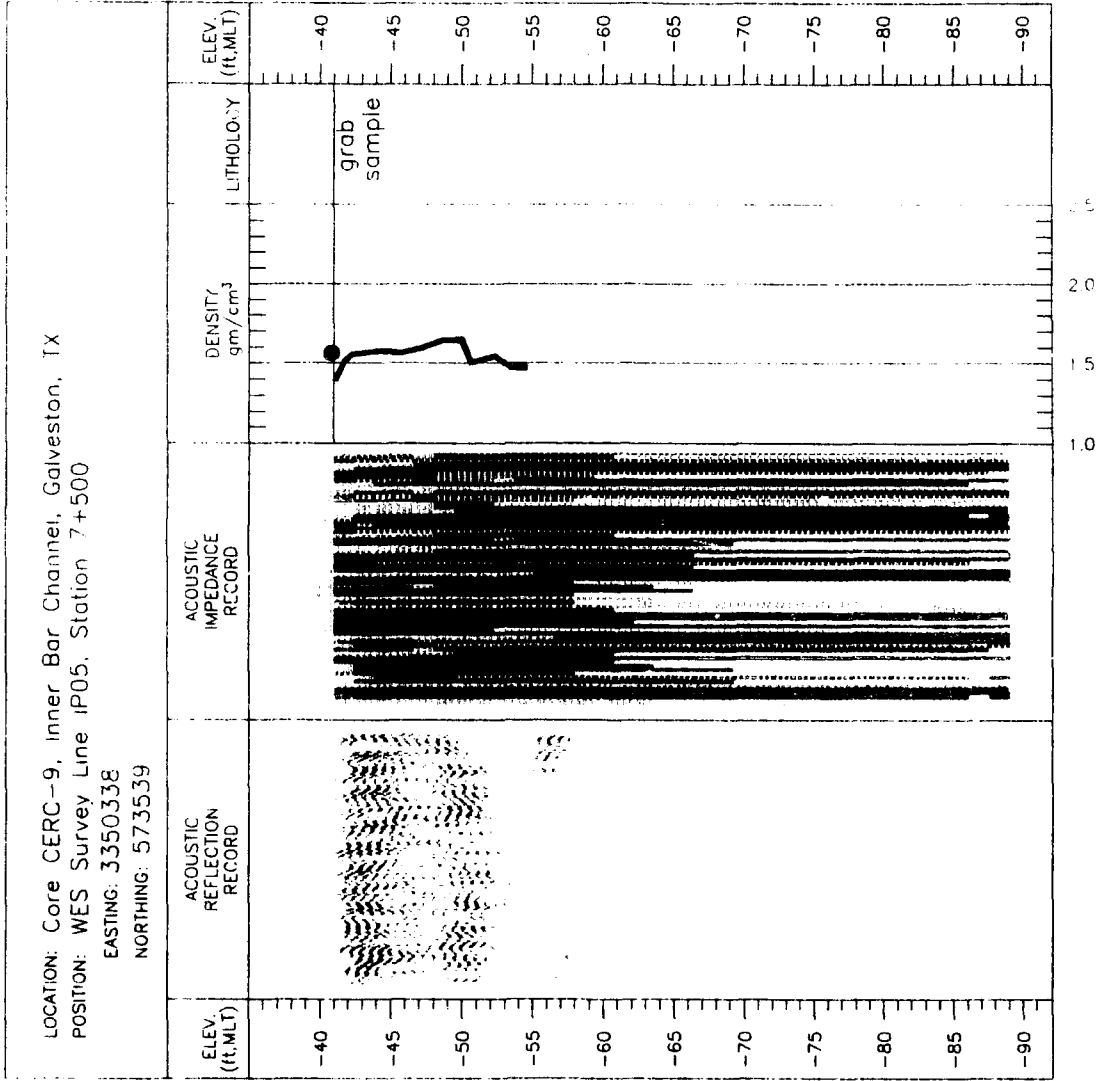
Figure 13. Check calibration at Core CERC-9, Inner Bar Channel

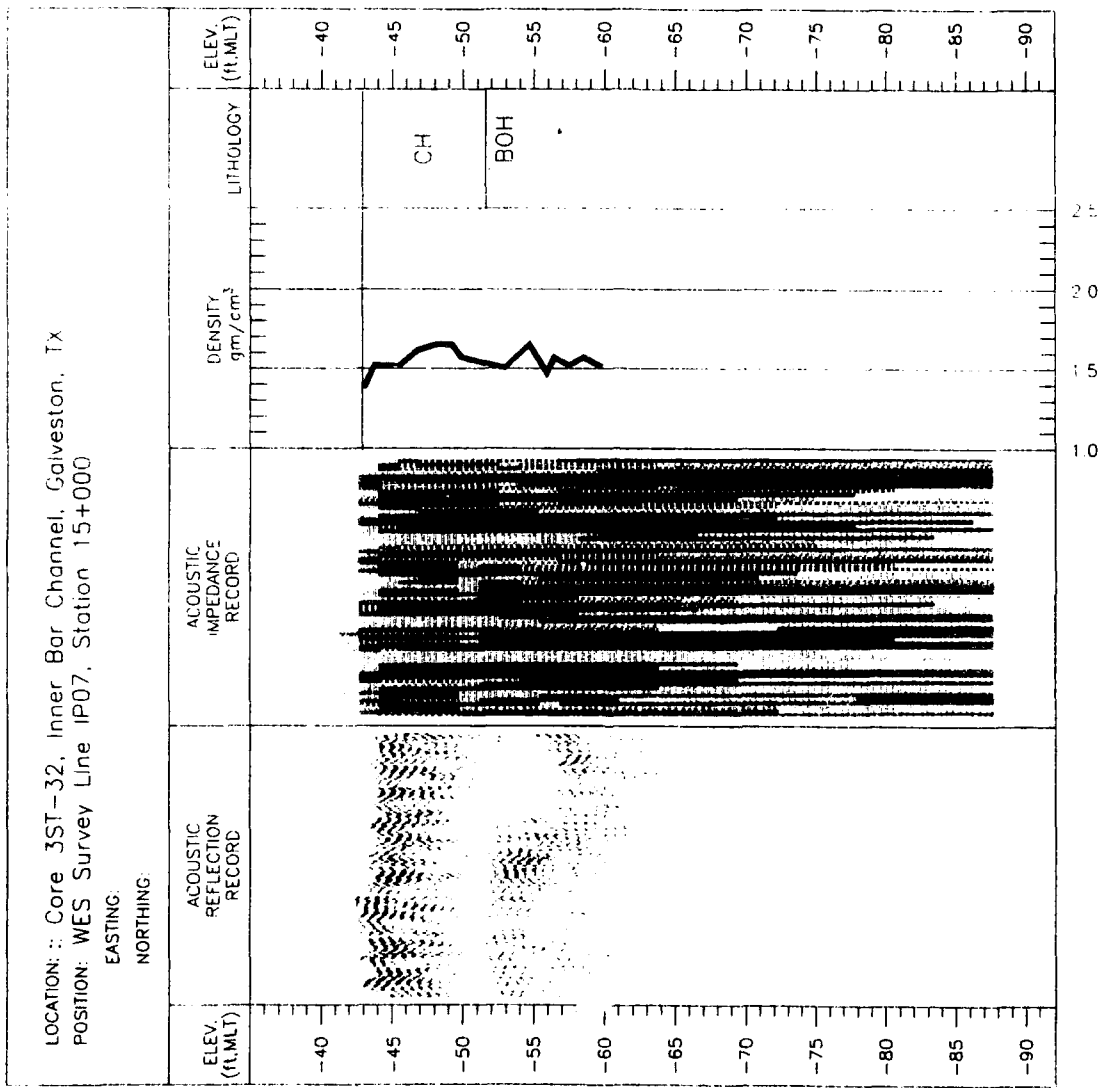
Figure 14. Check calibration at Core 3ST-32, Inner Bar Channel

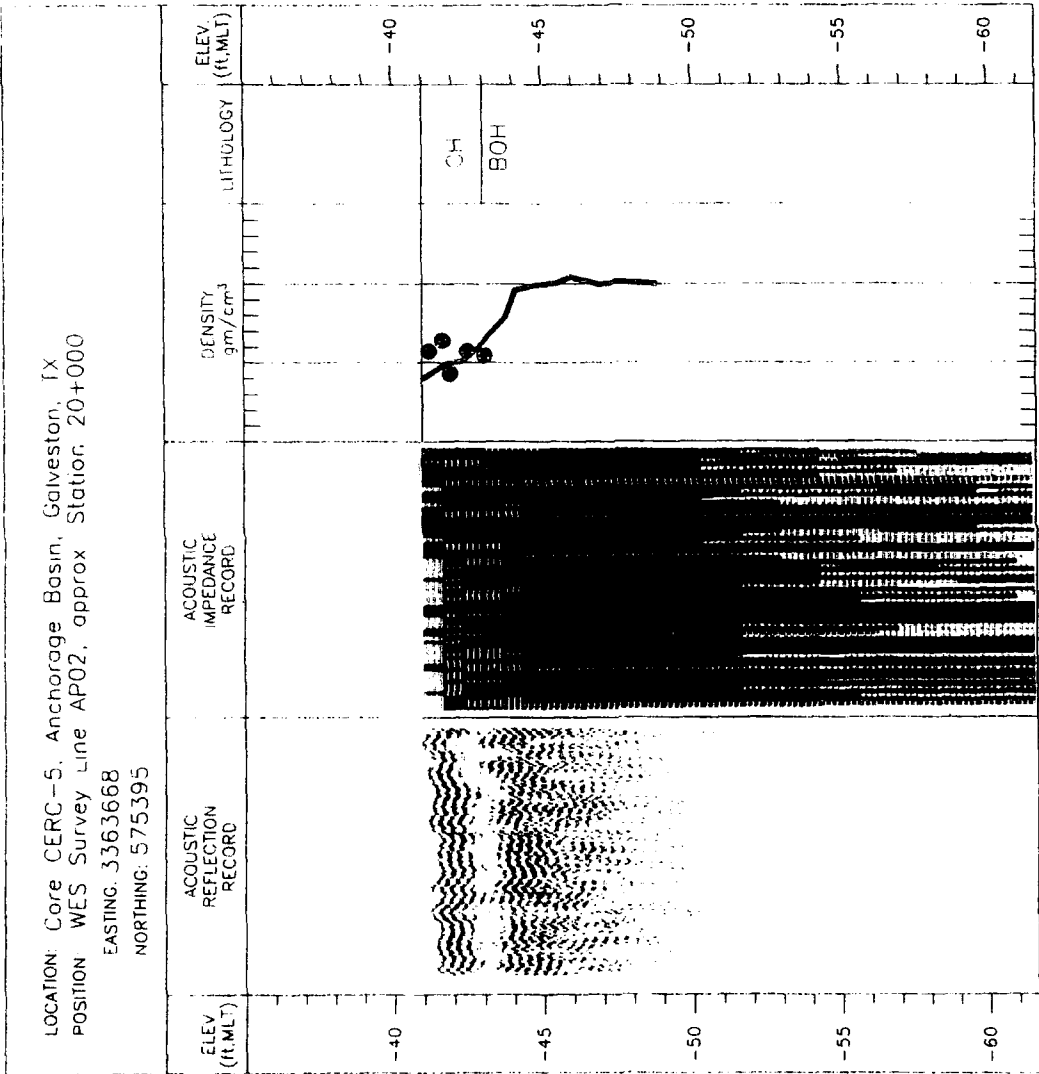
Figure 15. Check calibration at Core CERC-5, Anchorage Basin

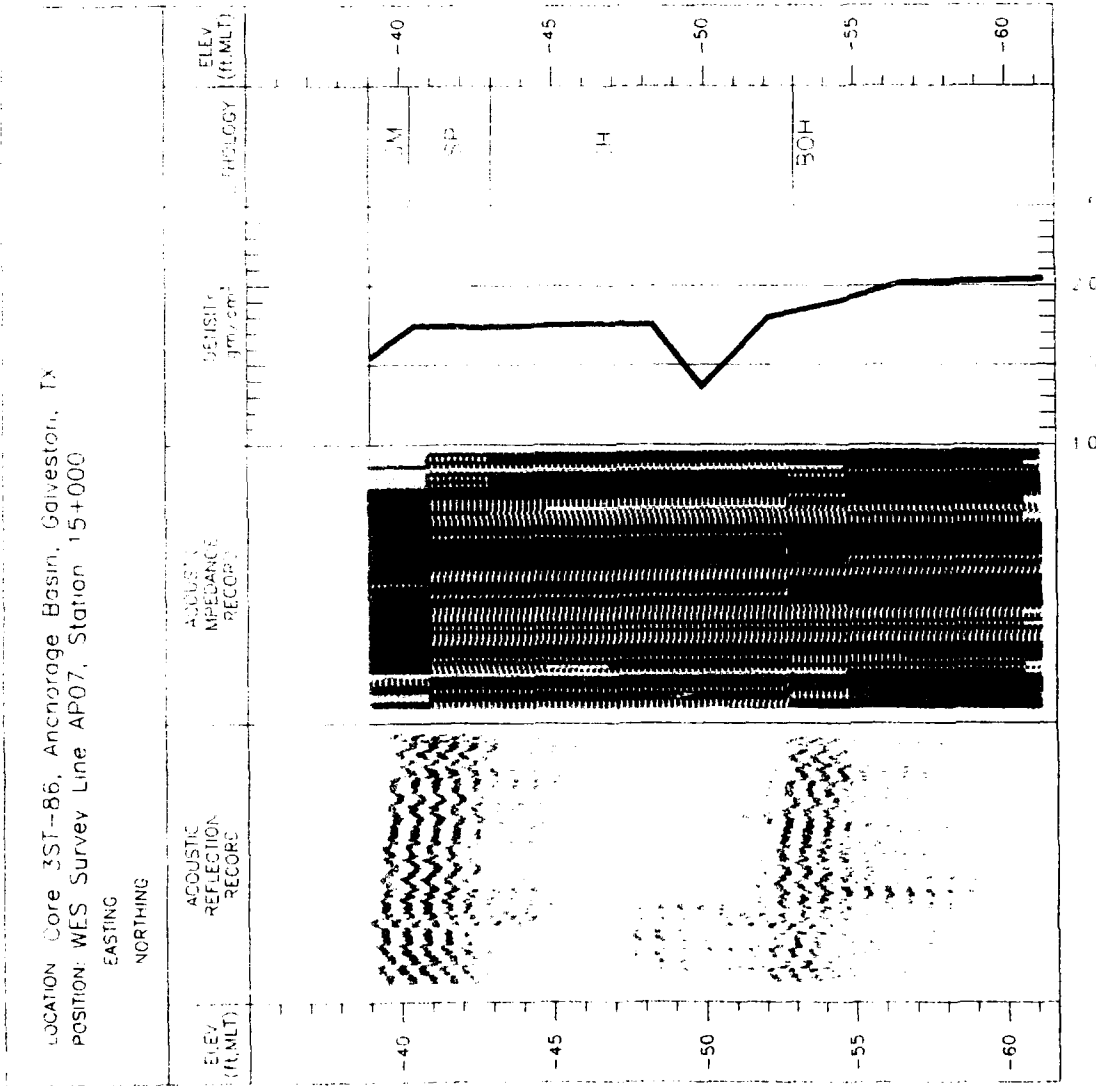
Figure 16. Check calibration at Core 3ST-86, Anchorage Basin

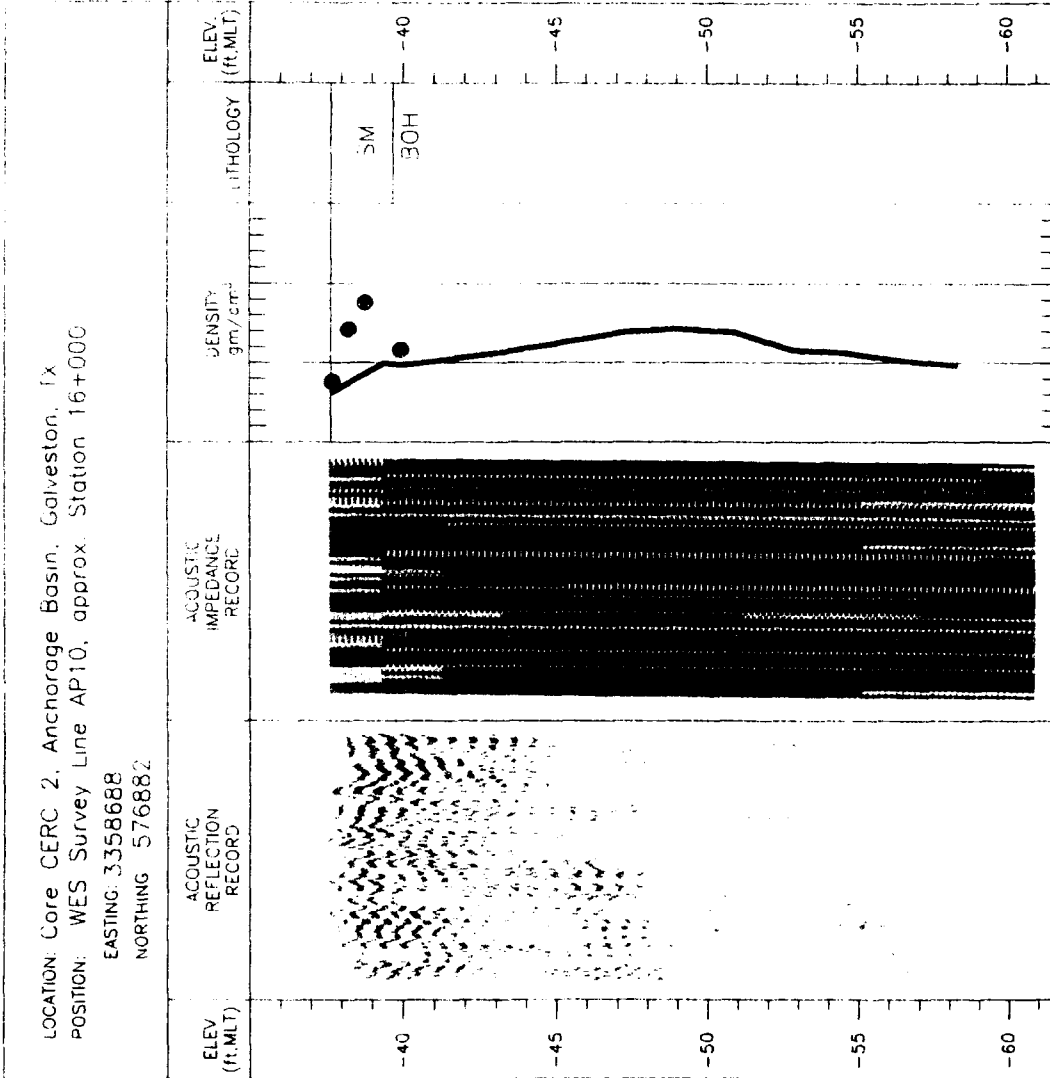
Figure 17. Check calibration at Core CERC-2, Anchorage Basin

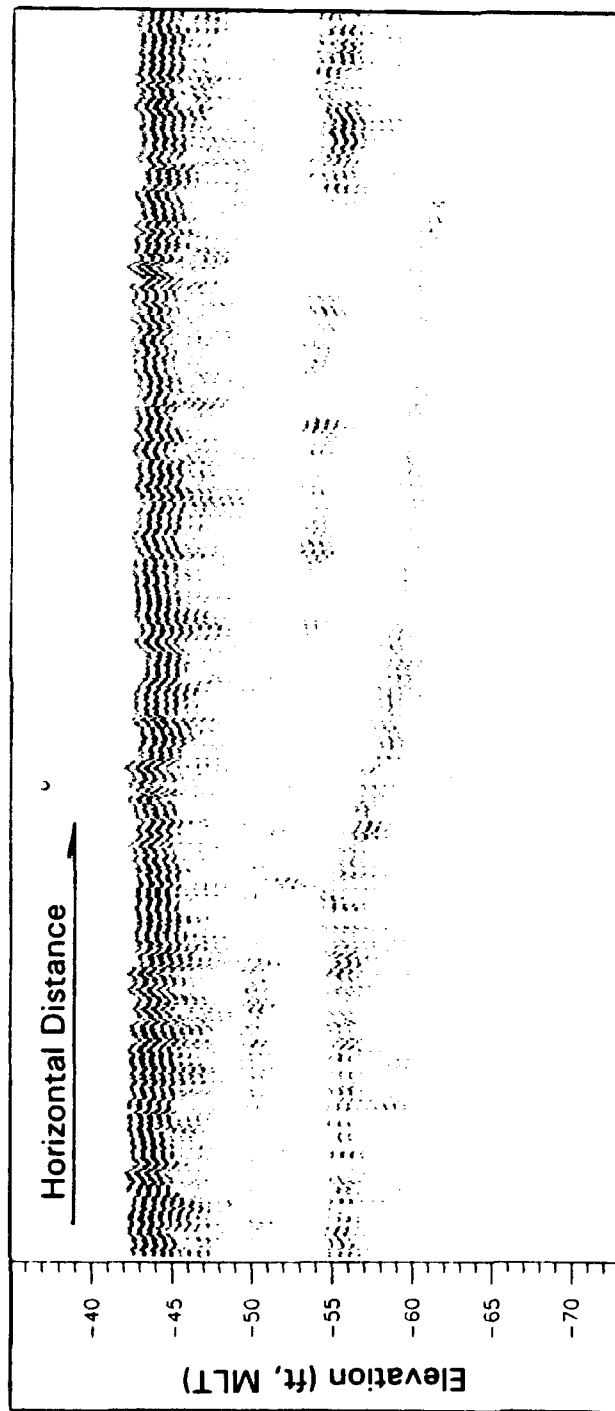
Figure 18. Subbottom reflection record along Survey Line IP06 (files 130 - 153) near Station 12 + 000. Inner Bar Channel

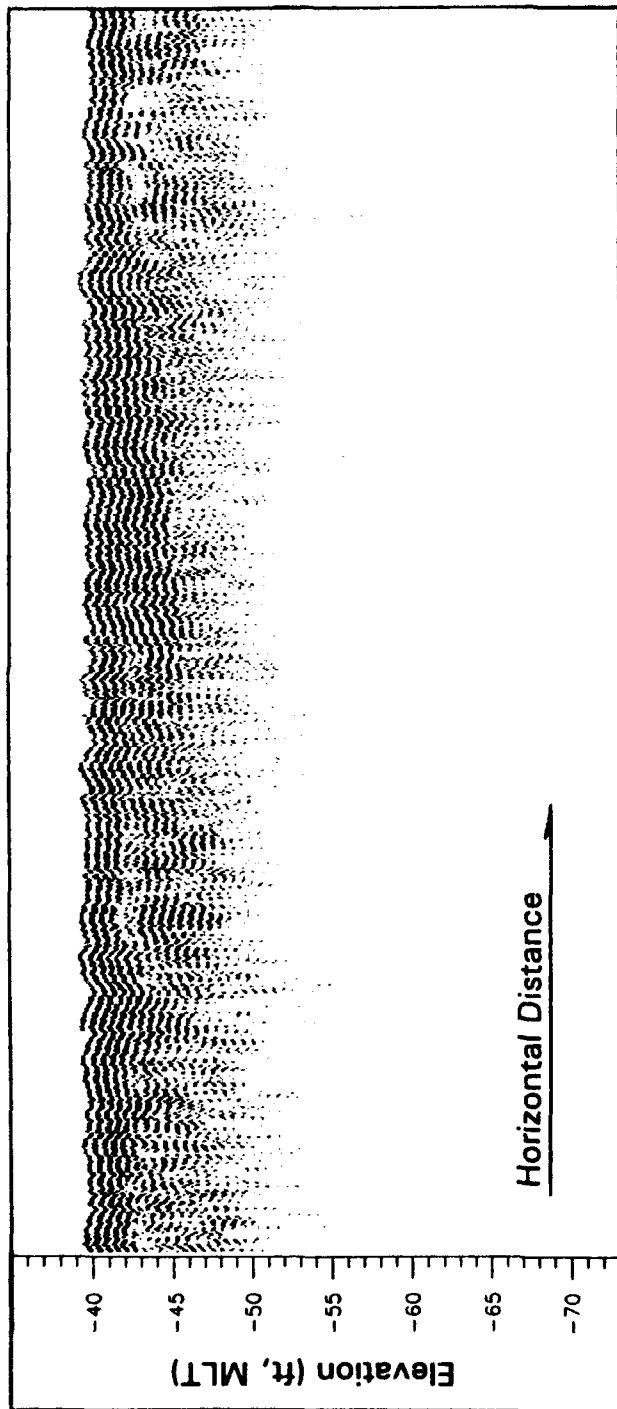
Figure 19. Subbottom reflection record along Survey Line IP01 (files 070 - 093) near Station 16+500, Inner Bar Channel

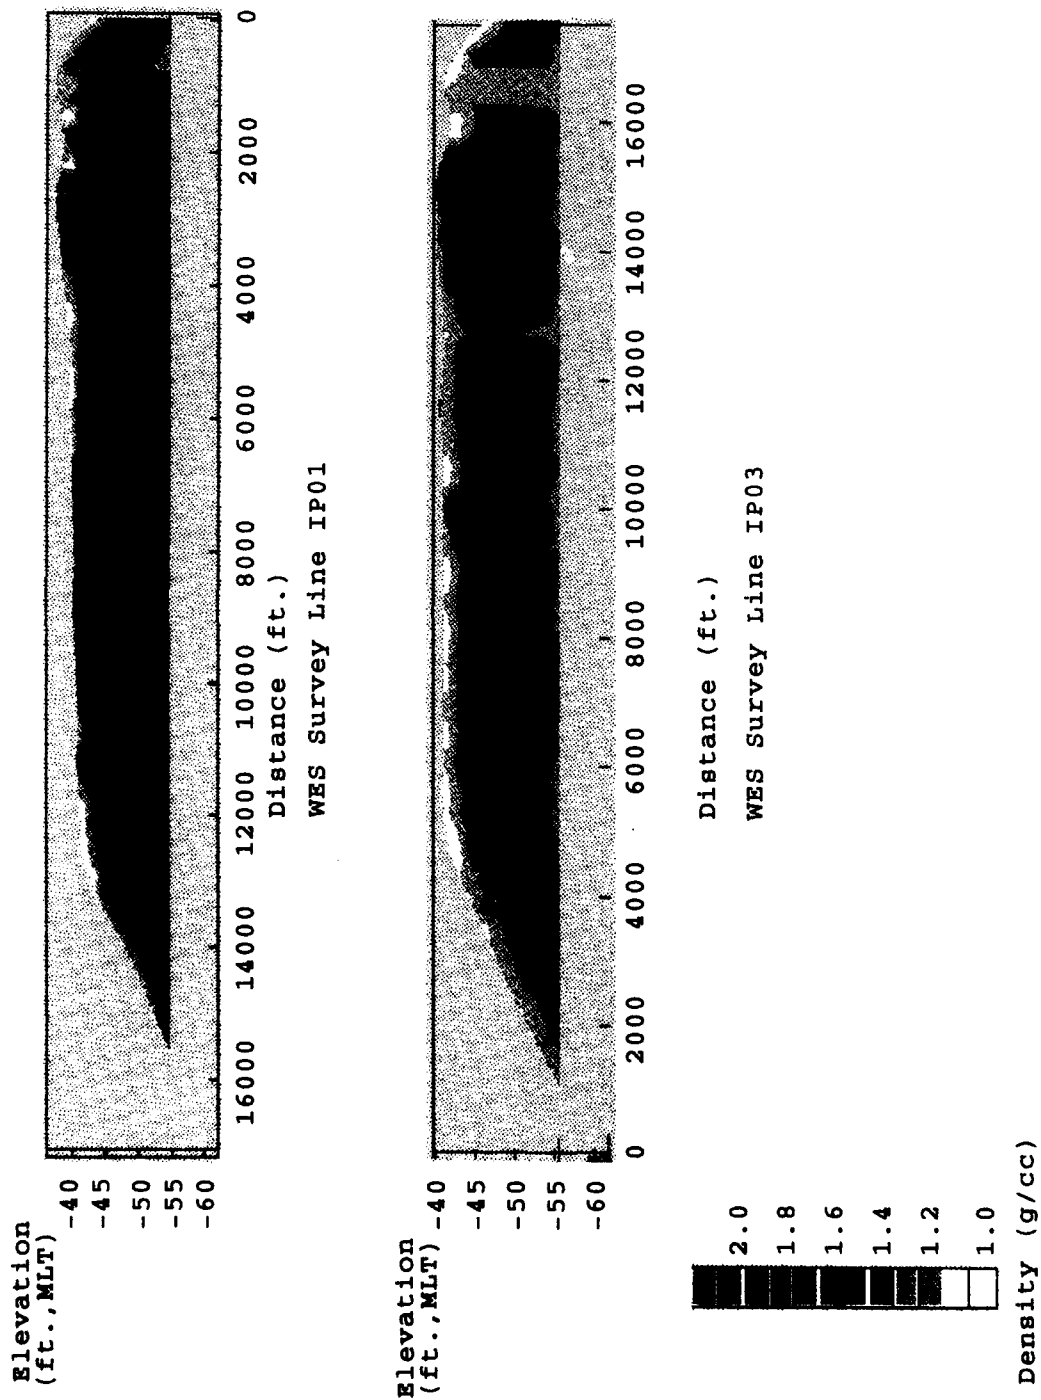
Figure 20. Color-coded density profile along Survey Lines IP01 and IP03, Inner Bar Channel

Two-dimensional, color-coded profile displays for lines IP01 through IP07 (excluding IP02) are also shown in Figures 20 through 22. These figures are generated using a statistically based, terrain modeling software package incorporating the density results computed during the project survey. The density range corresponding to each color-code is presented in Table 3. It should be noted that the horizontal distance scale associated with each display represents the distance along the survey line in the direction the survey was performed and *not* CESWG stationing. The computer generated presentations correlate well with the 2-D cross-sections illustrated in Plates 1 and 2. The sandy material detected along lines IP01 and IP03 near the south toe of the channel and in the extreme northwestern end of the channel (line IP07) are depicted by the blue zones in Figures 20 and 22. The majority of the subbottom sediment material is in the density range 1.4 to 1.8 g/cm<sup>3</sup> represented by the red and green colors which correlates well with the directly measured sediment densities.

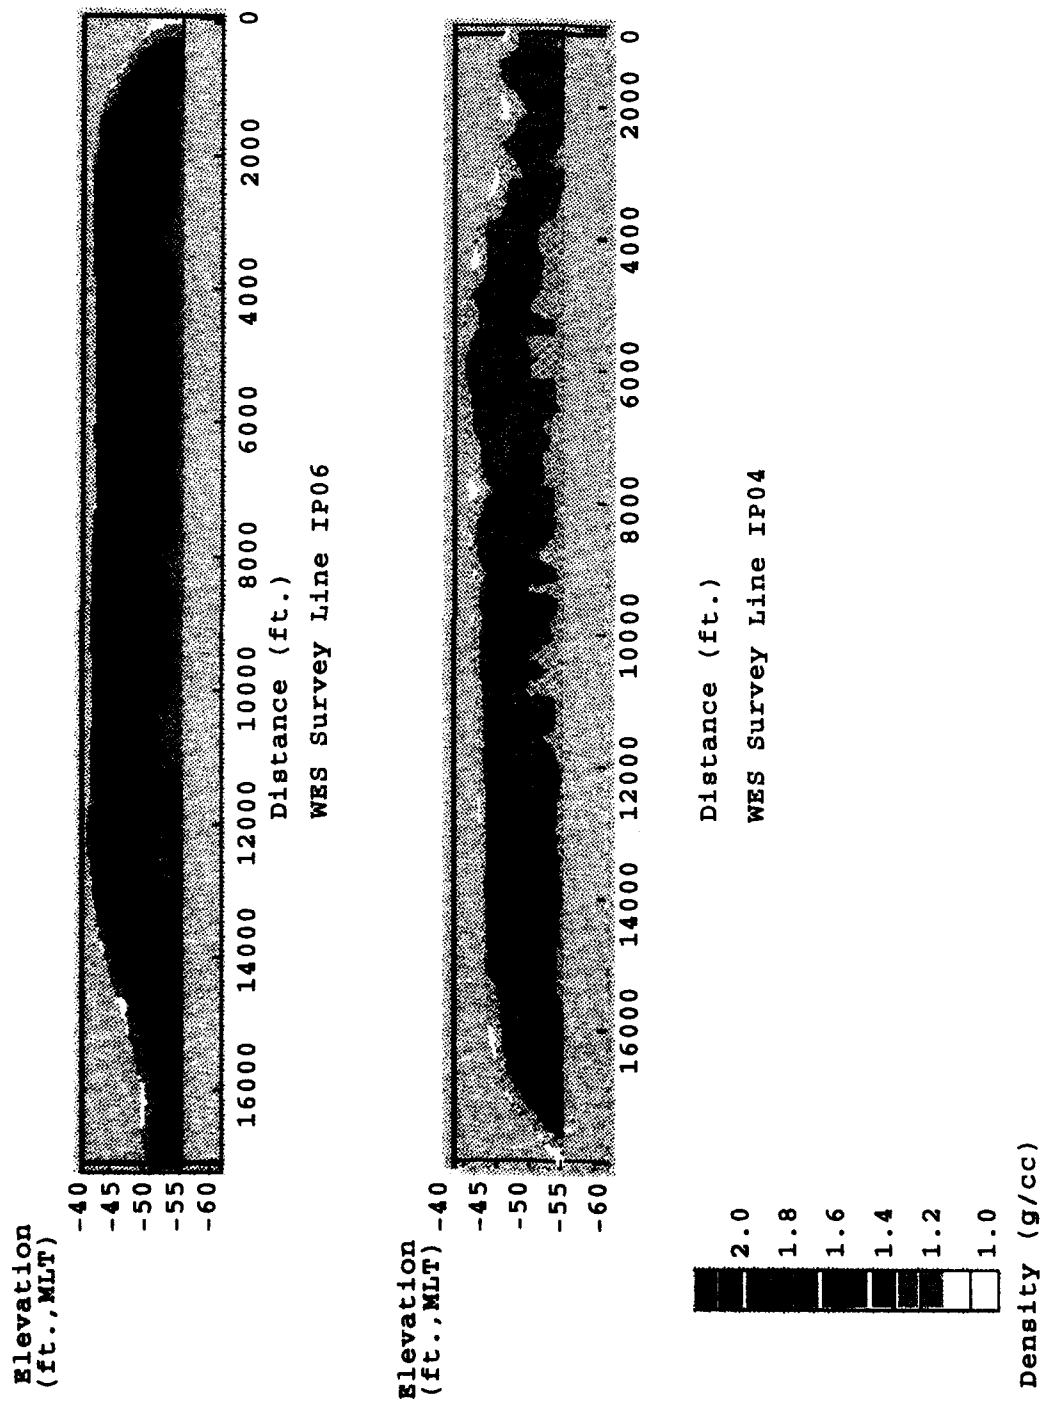
Figure 21. Color-coded density profile along Survey Lines IP06 and IP04, Inner Bar Channel
