Technical Report GL-94-23  
August 1994

## A Waterborne Seismic Reflection Survey of the Inner Bar Channel and Anchorage Basin, Galveston, Texas

Prepared for U.S. Army Engineer District, Galveston

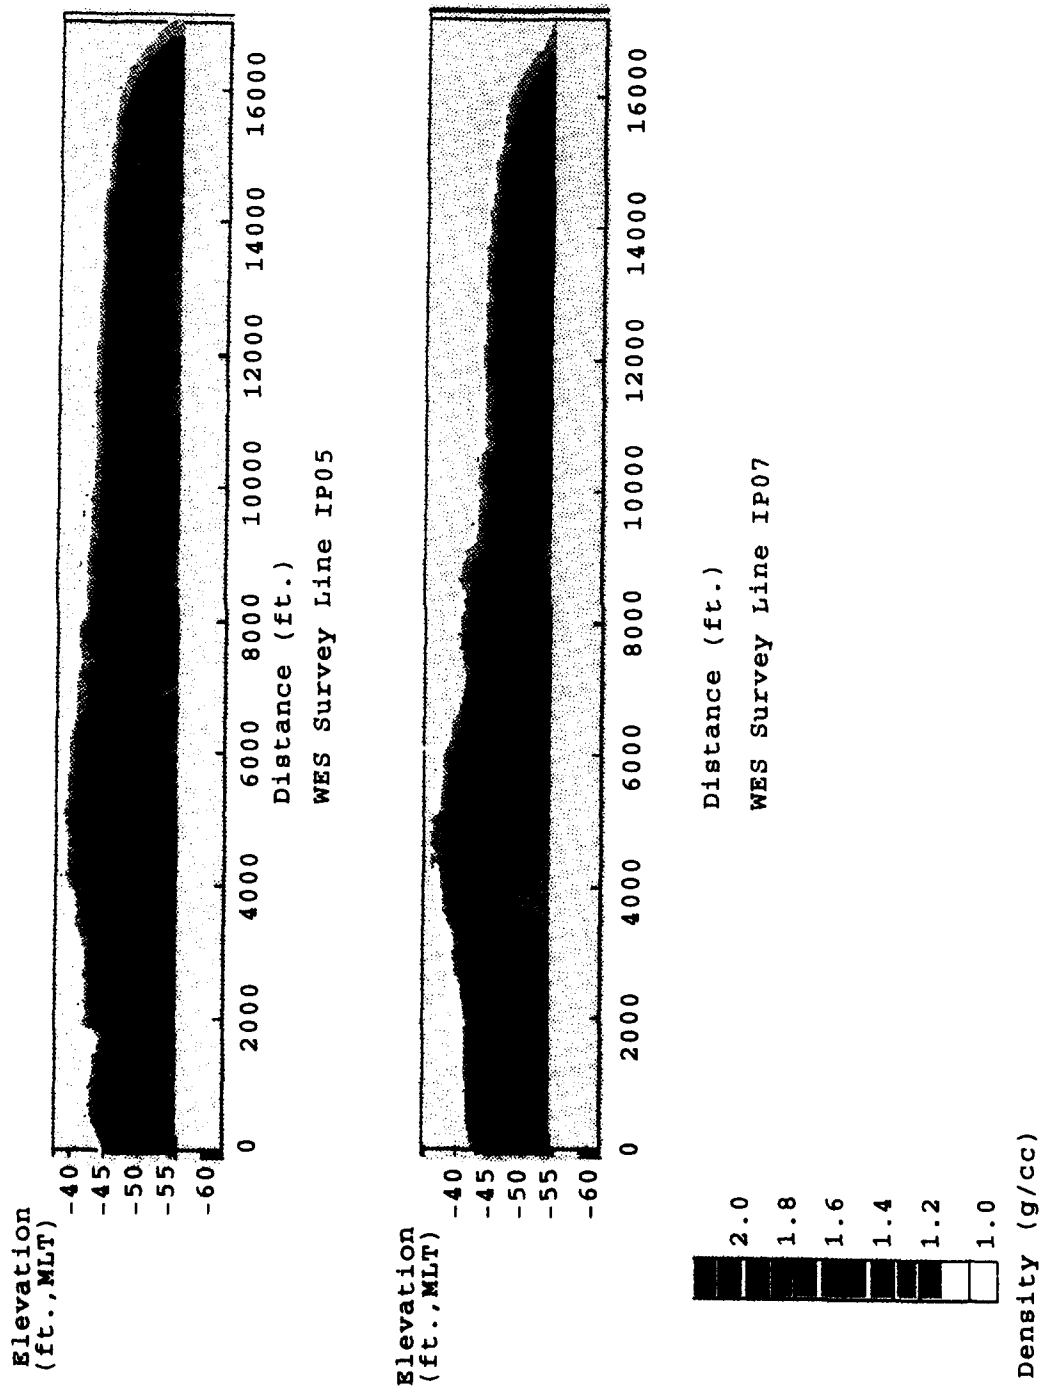
Figure 22. Color-coded density profile along Survey Lines IP05 and IP07, Inner Bar Channel

Two-dimensional, color-coded profile displays for lines IP01 through IP07 (excluding IP02) are also shown in Figures 20 through 22. These figures are generated using a statistically based, terrain modeling software package incorporating the density results computed during the project survey. The density range corresponding to each color-code is presented in Table 3. It should be noted that the horizontal distance scale associated with each display represents the distance along the survey line in the direction the survey was performed and *not* CESWG stationing. The computer generated presentations correlate well with the 2-D cross-sections illustrated in Plates 1 and 2. The sandy material detected along lines IP01 and IP03 near the south toe of the channel and in the extreme northwestern end of the channel (line IP07) are depicted by the blue zones in Figures 20 and 22. The majority of the subbottom sediment material is in the density range 1.4 to 1.8 g/cm<sup>3</sup> represented by the red and green colors which correlates well with the directly measured sediment densities.

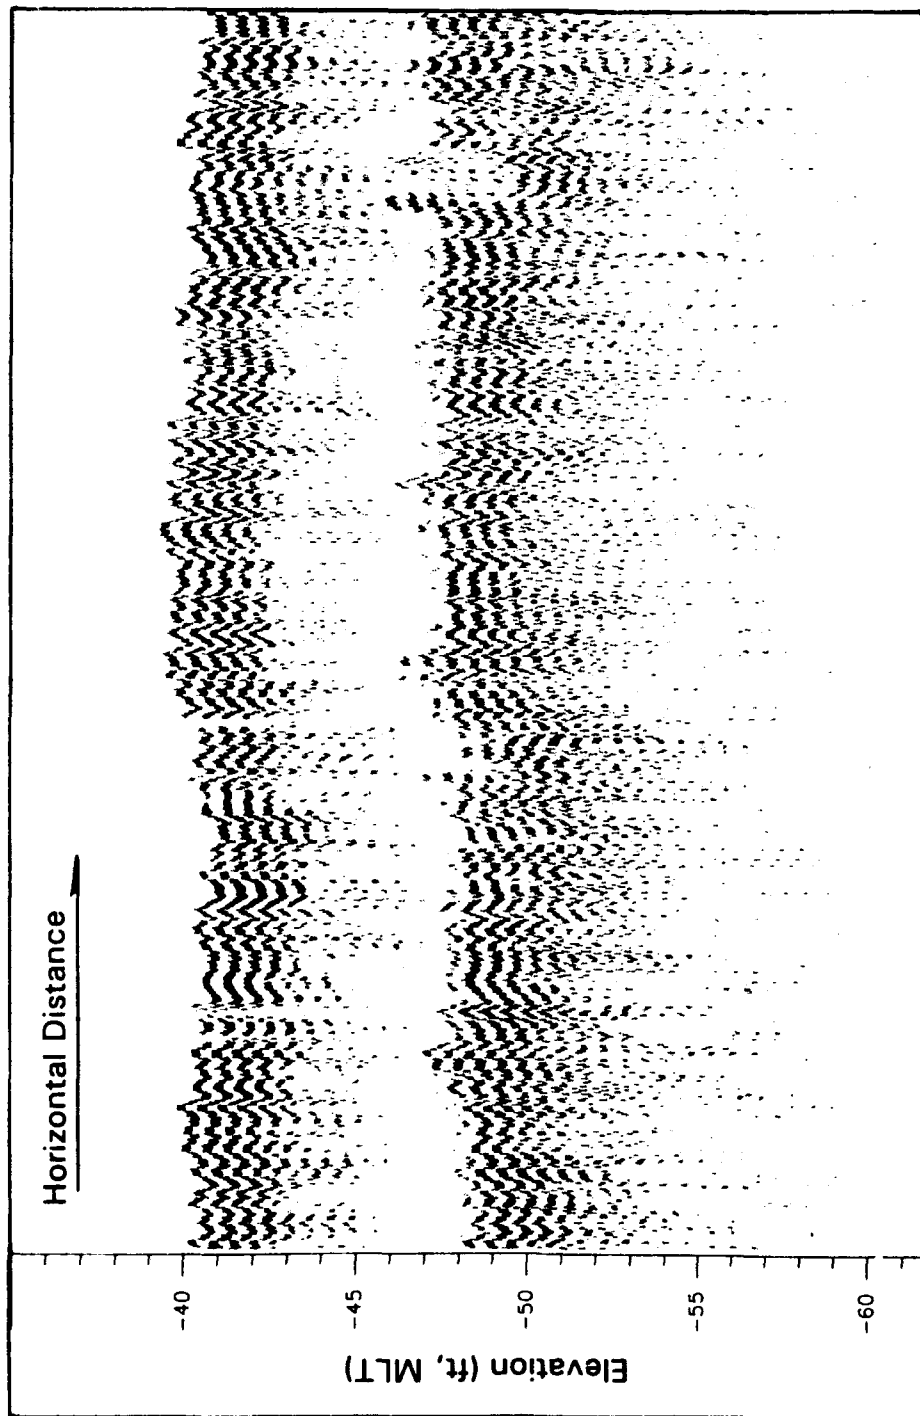
Figure 23. Subbottom reflection record along Survey Line AP05 (files 080 - 103) near Station 16+500, Anchorage Basin

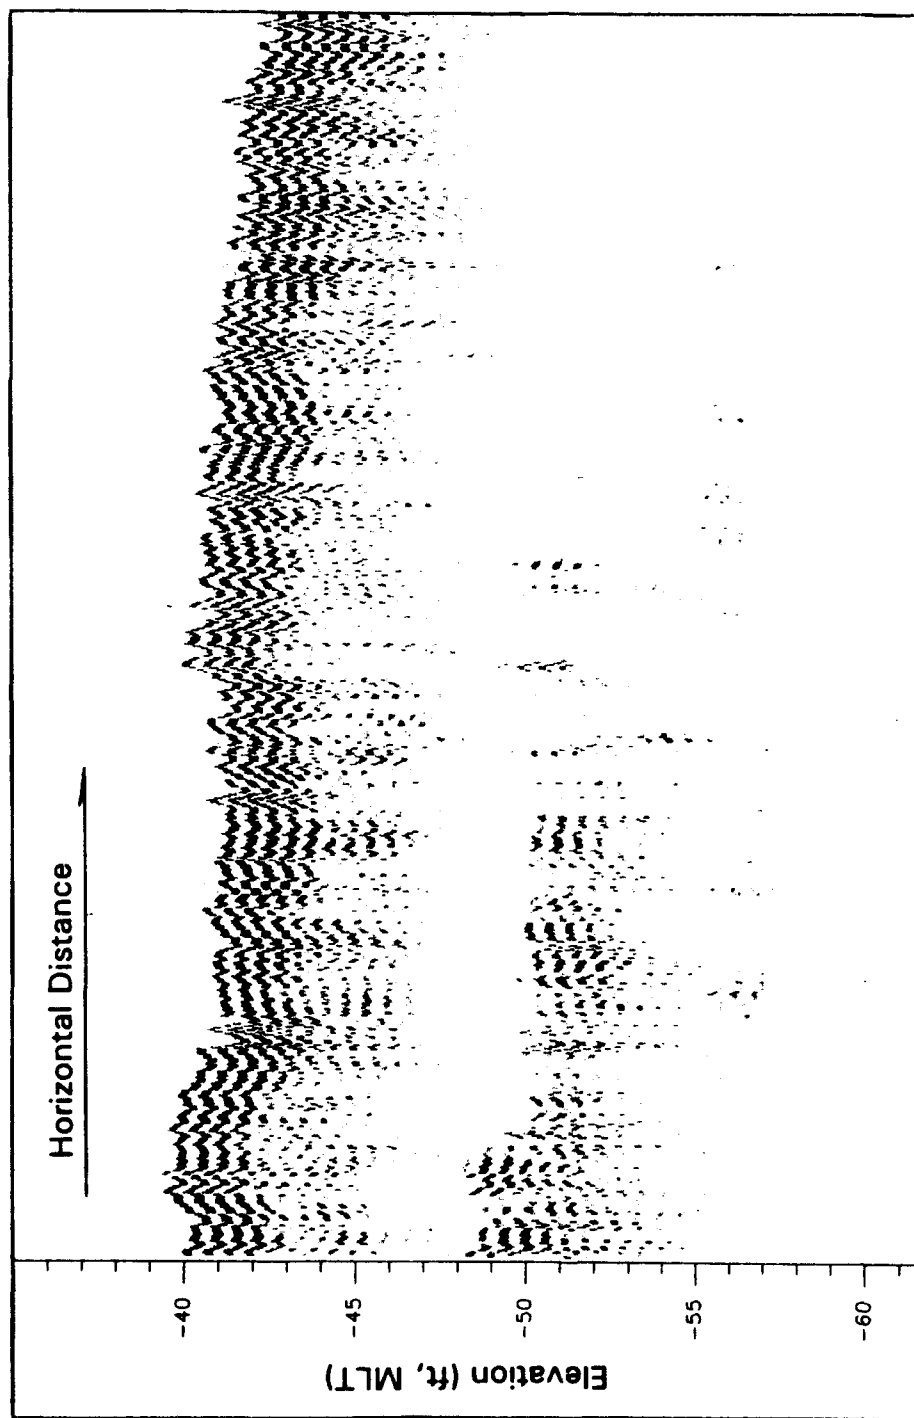
Figure 24. Subbottom reflection record along Survey Line AP07 (files 090 - 113) near Station 17 + 000, Anchorage Basin

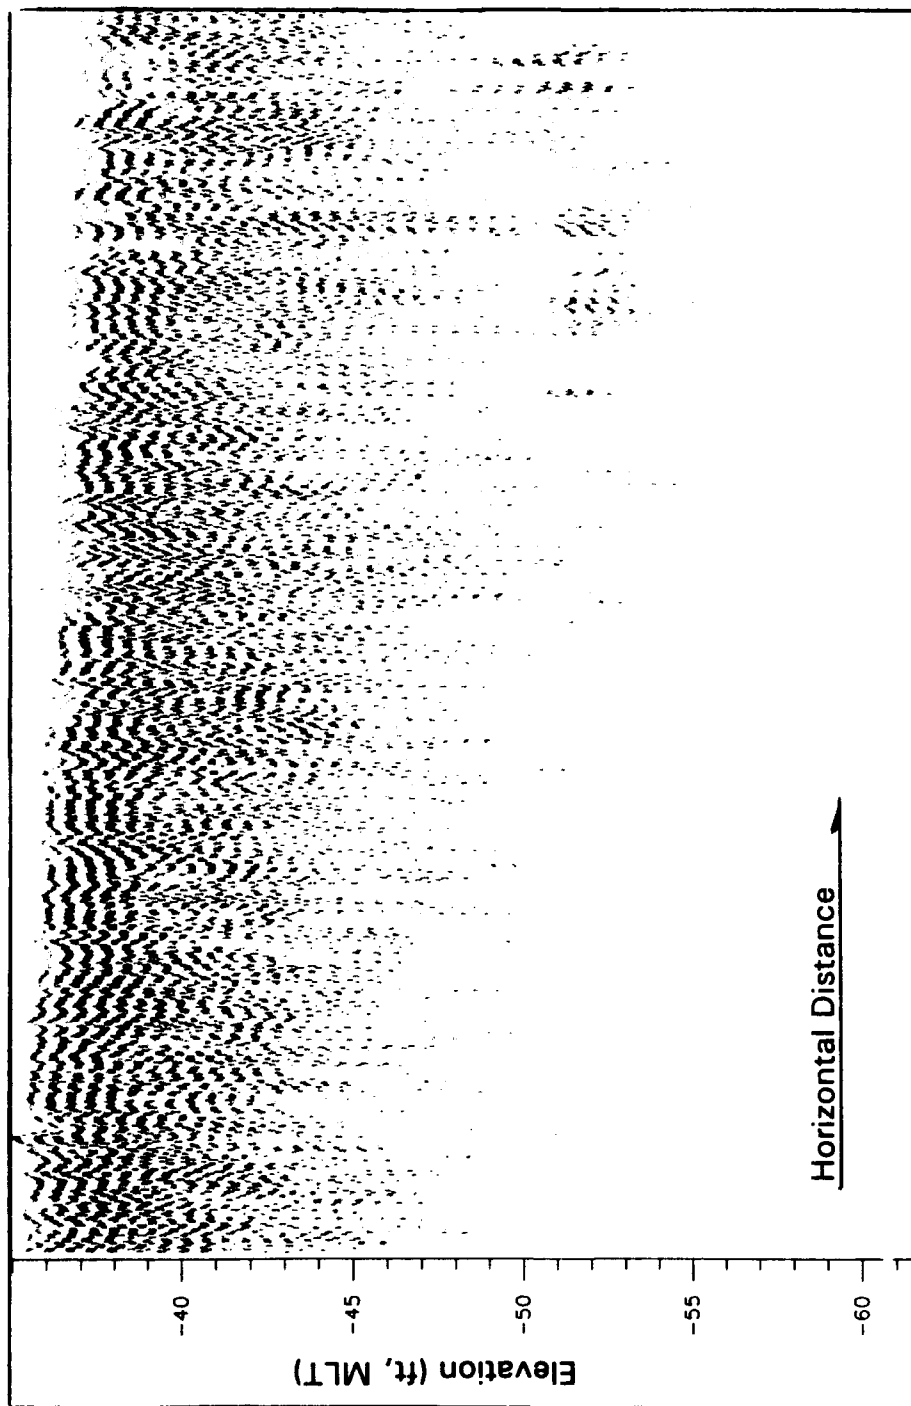
Figure 25. Subbottom reflection record along Survey Line AP11 (files 010 - 033) near Station 14 + 000, Anchorage Basin

Areas of sandy material in the northwest corner of the Anchorage Basin exist at the bottom surface as noted along lines AP09 through AP12 near Station 14+000. The computed density of this material ranges from 1.8 to 2.2 g/cm<sup>3</sup>. The thickness of this material, however, could not be resolved. The sandy material is likely a thin veneer overlying the typical silty material found in this area. CESWG personnel stated that sandy material typically settles in this area between periods of maintenance dredging. A portion of the seismic record collected along survey line AP11 near station 14+000 is shown in Figure 25 and illustrates the seismic reflection amplitudes due to the sandy material. No other areas of sandy material were found in the Anchorage Basin.

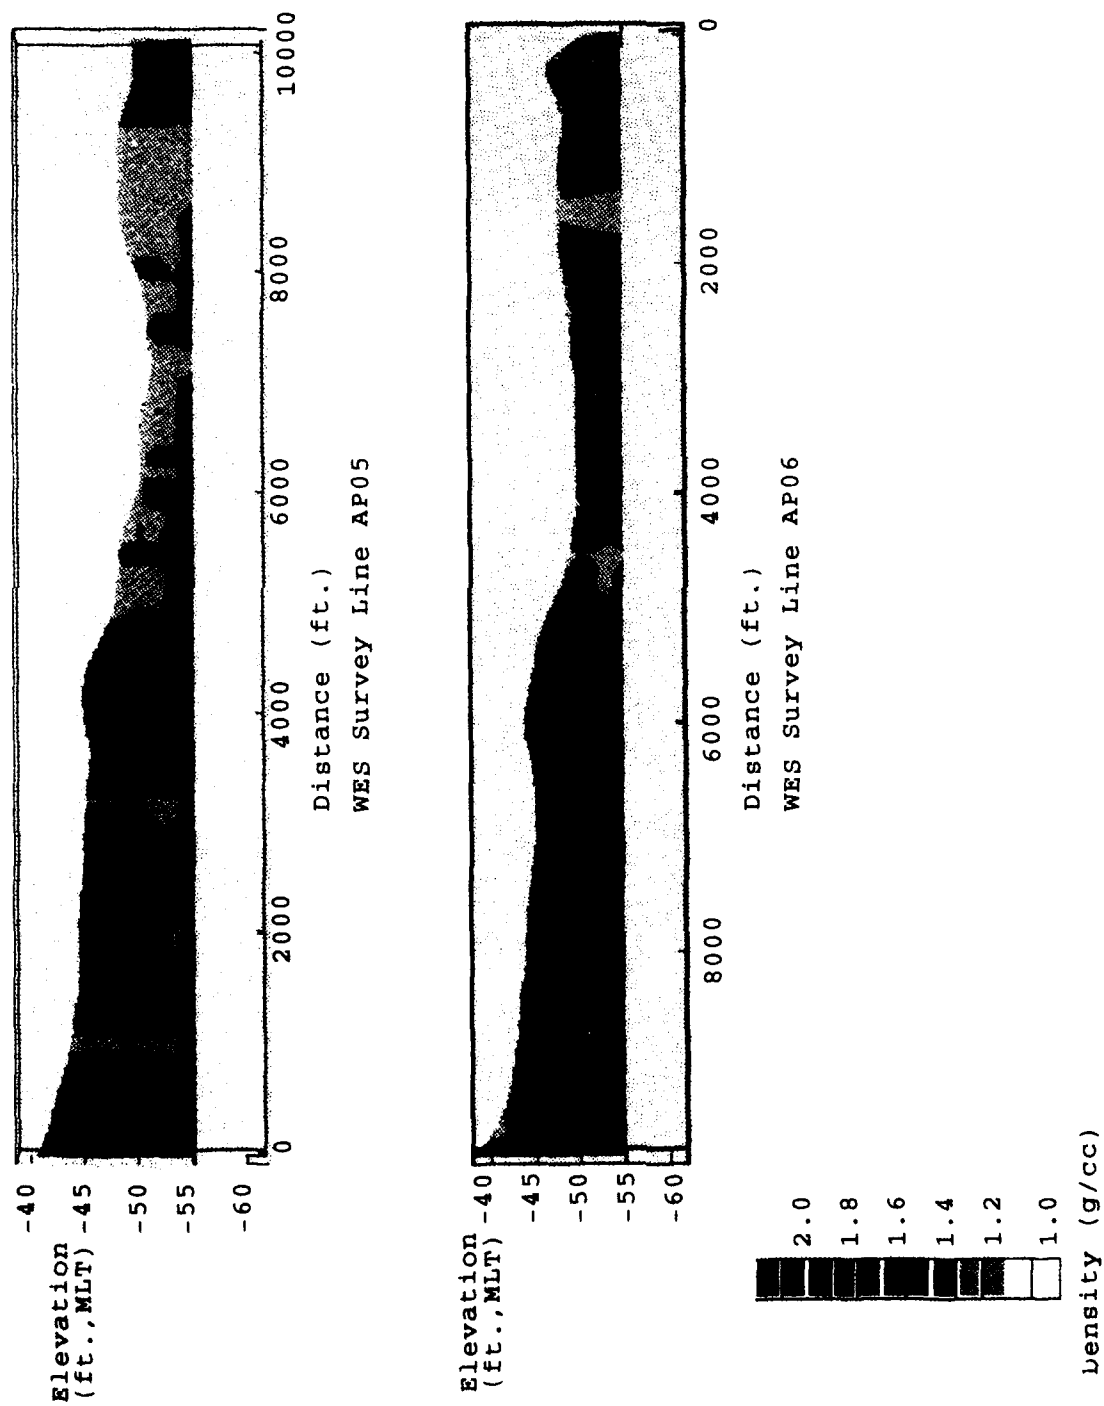
Figure 28. Color-coded density profile along Survey Lines AP05 and AP06, Anchorage Basin

Two-dimensional, color-coded profile displays for lines AP01 through AP12 are also shown in Figures 26 through 31. These figures are generated using a statistically based, terrain modeling software package incorporating all of the density results computed during the project survey. The density range corresponding to each color-code is presented in Table 3. It should be noted that the horizontal distance scale associated with each display represents the distance along the survey line in the direction the survey was performed and *not* CESWG stationing. The computer generated presentations correlate well with the 2-D cross-sections illustrated in Plates 3 through 5. The interpreted stiff clay layer having high density values detected along lines AP01 through AP07 is represented by the blue zone at elevations -50 to -55 ft MLT (see Figures 26 through 29). The sandy material detected in the northwest corner of the Anchorage Basin is depicted by the blue zone along lines AP09 through AP12 (Figures 30 and 31). Otherwise, the majority of the near-surface material is in the density range 1.2 to 1.8 g/cm<sup>3</sup> represented by the orange, red, and green colors.

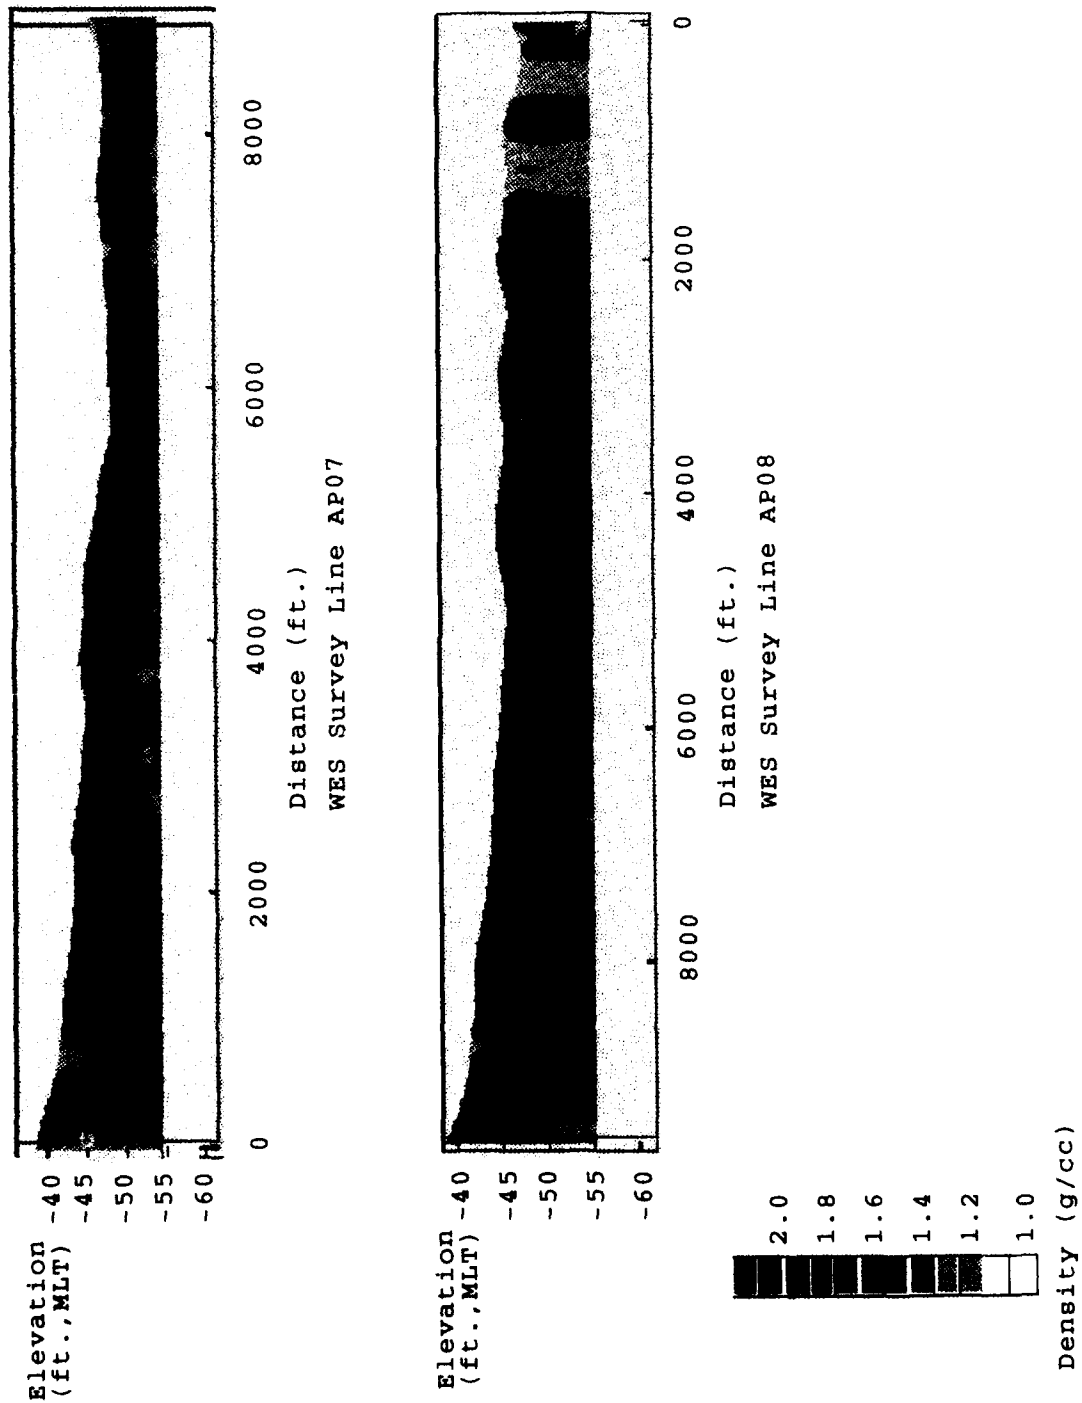
Figure 29. Color-coded density profile along Survey Lines AP07 and AP08, Anchorage Basin

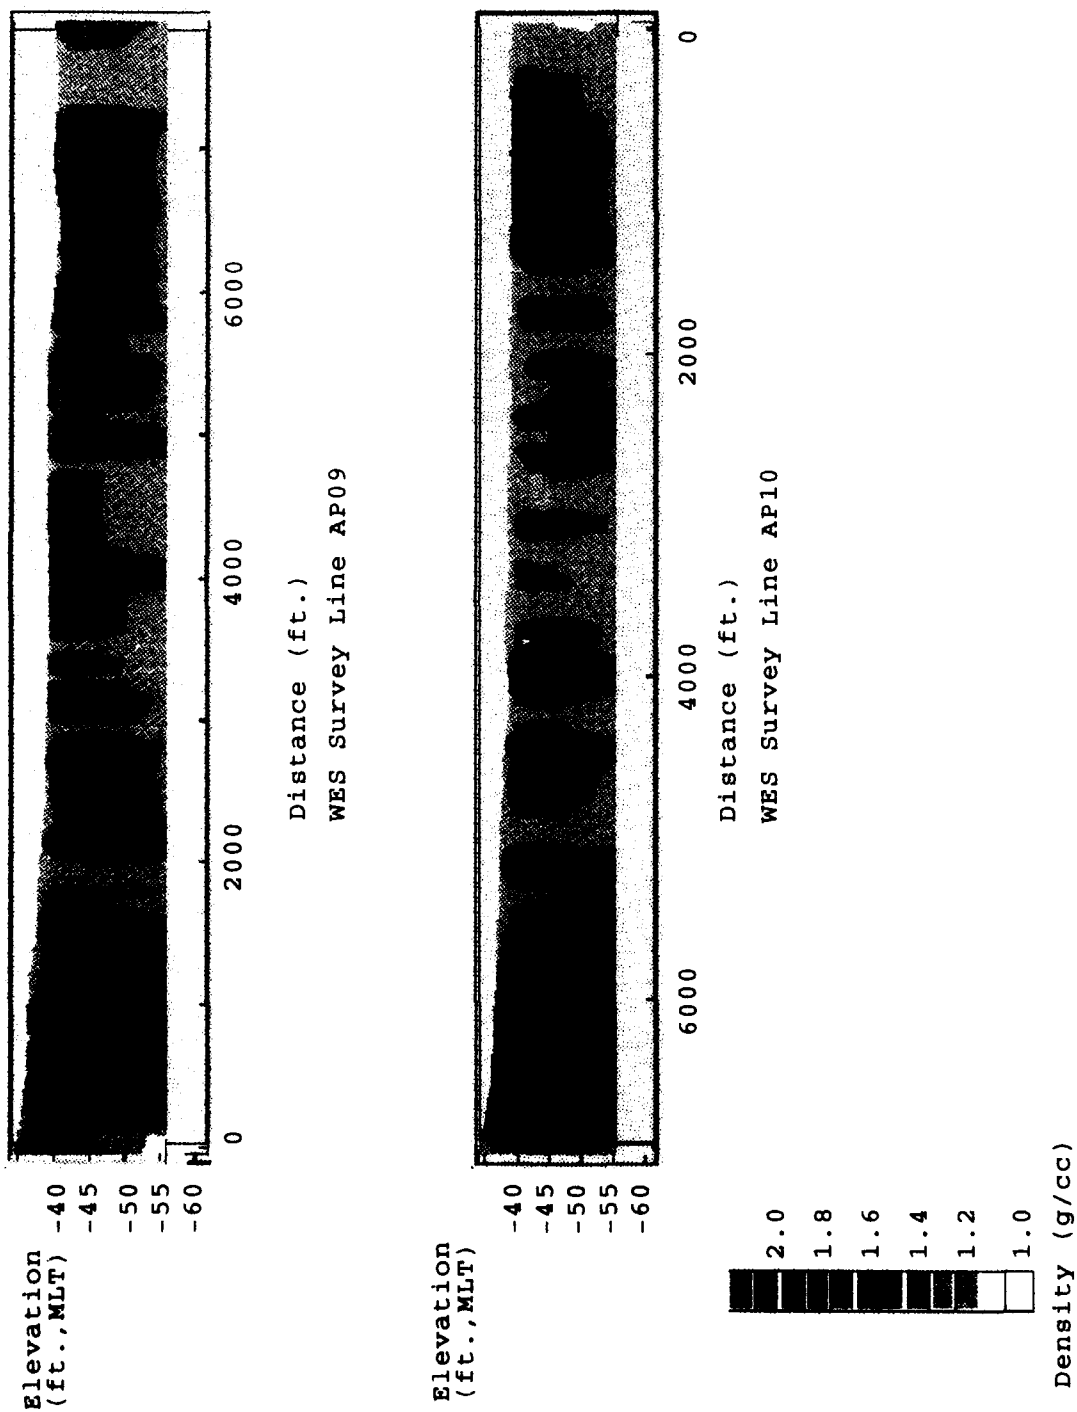
Figure 30. Color-coded density profile along Survey Lines AP09 and AP10, Anchorage Basin

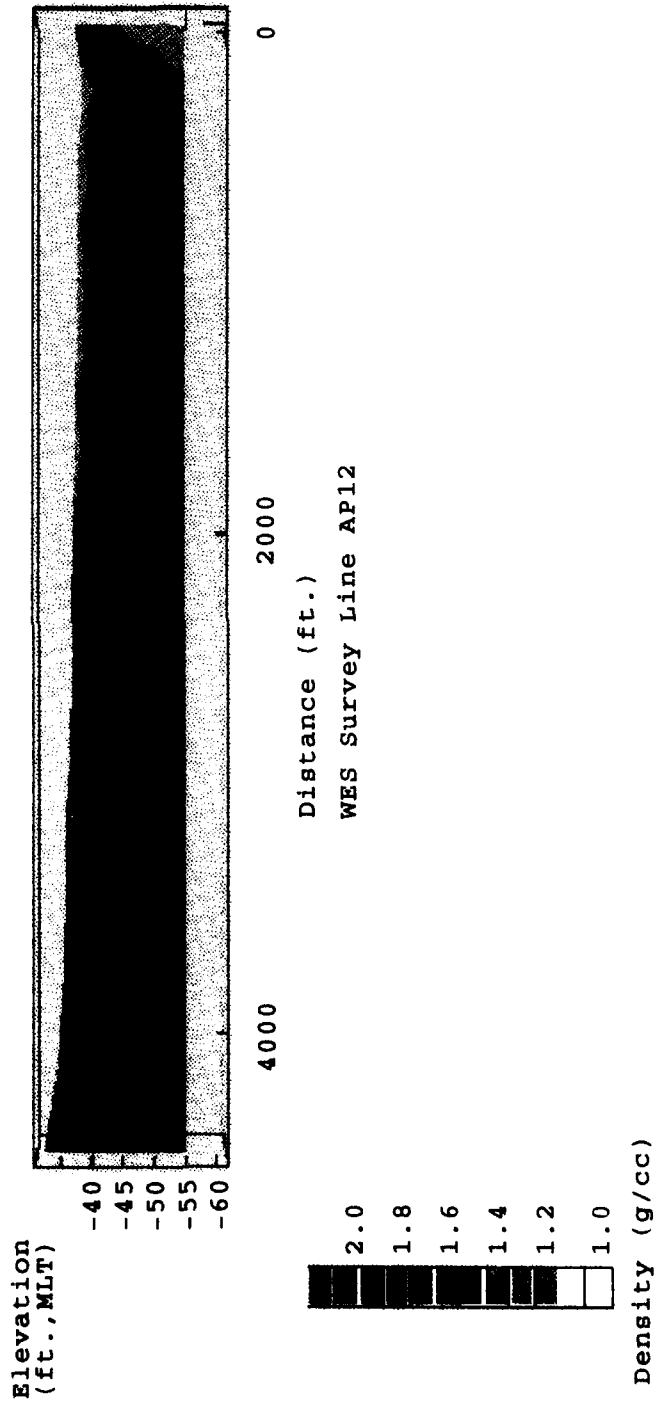
Figure 31. Color-coded density profile along Survey Lines AP11 and AP12, Anchorage Basin
