**RELIABILITY WITHOUT HERMETICITY (RWOH)  
FOR INTEGRATED CIRCUITS (IC)**

National Semiconductor, Inc.  
PO Box 58090  
Santa Clara, CA 95052-8090

March 1994

Final Technical Report for Period February 1991 - March 1993

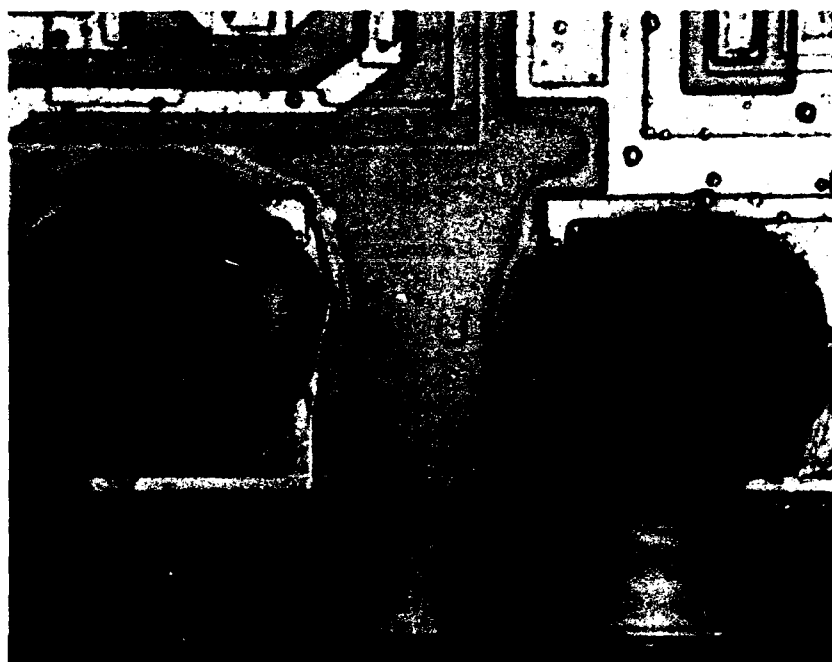
**Figure 29. Appearance of a ceramic-coated linear Op-Amp device on a leadframe chip carrier prior to plastic overmolding.**
