# RESULTS OF THE SECOND U.S. MANNED SUBORBITAL SPACE FLIGHT JULY 21, 1961

**MANNED SPACECRAFT CENTER  
NATIONAL AERONAUTICS  
AND SPACE ADMINISTRATION**

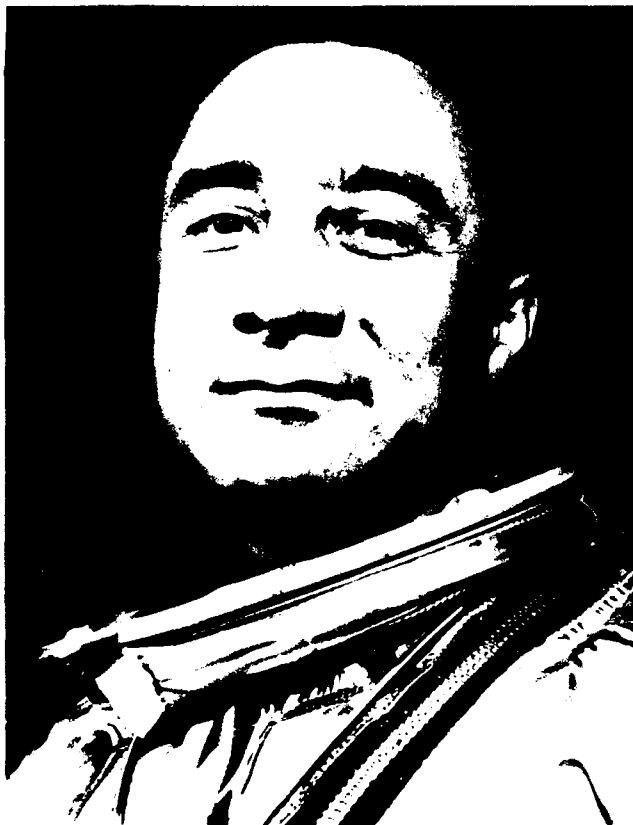
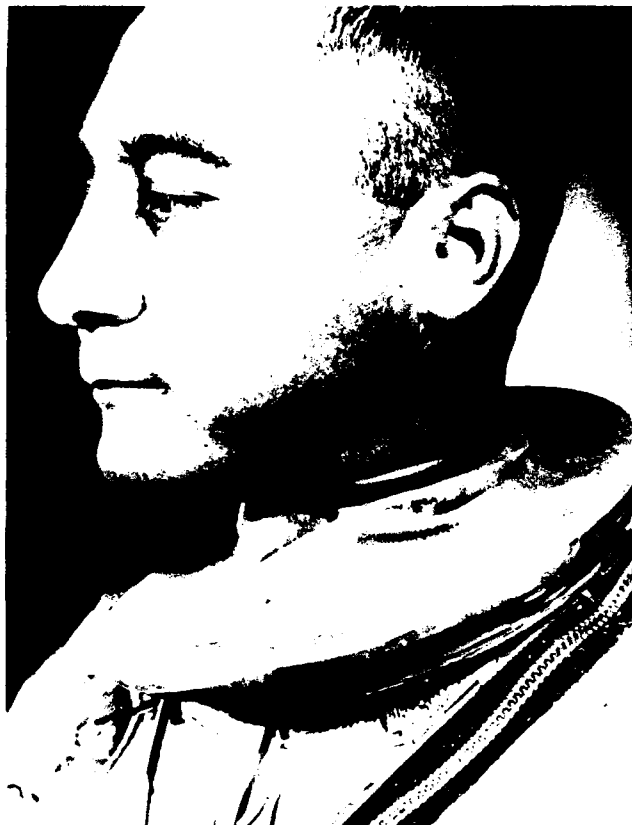
(a) Normal stored position.

(b) Unrolled position.

FIGURE 7-6. Neck dam.
