## Evaluation of an Unlighted Swinging Airport Sign

August 1994

DOT/FAA/CT-TN94/29

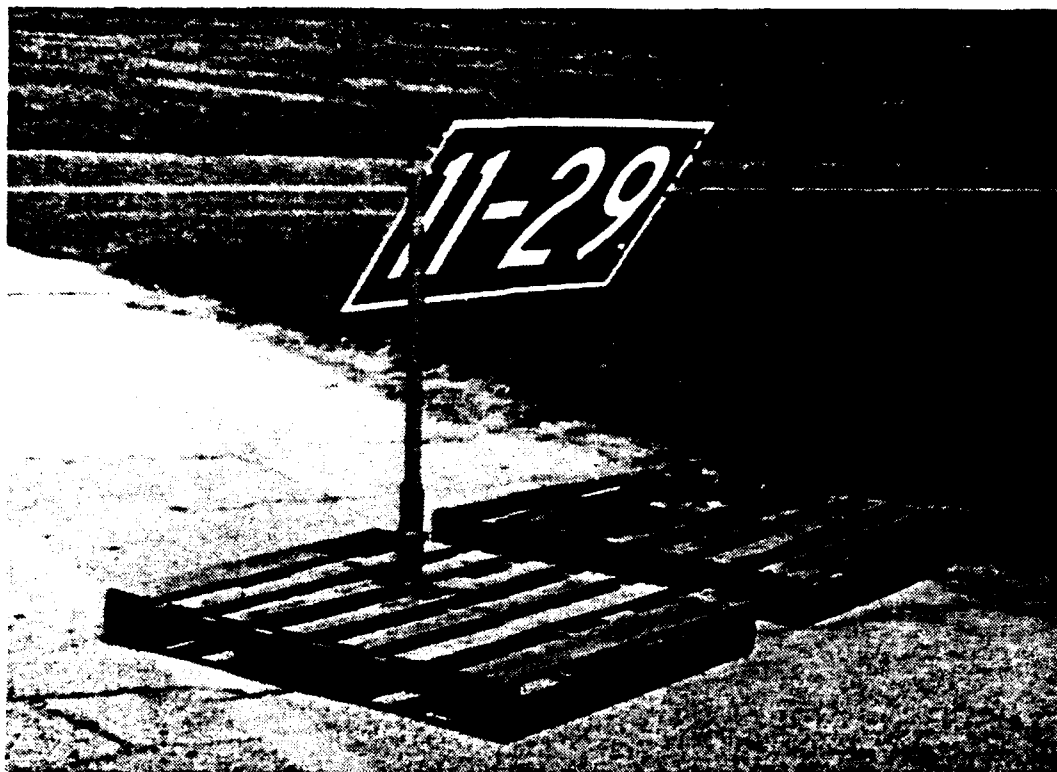
FIGURE 2. UNLIGHTED SWINGING AIRPORT SIGN -  
WIND SPEED 20 KNOTS WITH GUSTS

The ambient wind test sessions consisted of evaluating the sign's behavior under wind speeds of 10 knots (figure 1) and 20 knots with gusts (figure 2). In both cases, the portable bases were positioned so that the wind would strike the sign directly perpendicular to the sign face. Wind speeds and directions were obtained several times during each test session via radio communications with the air traffic control tower.

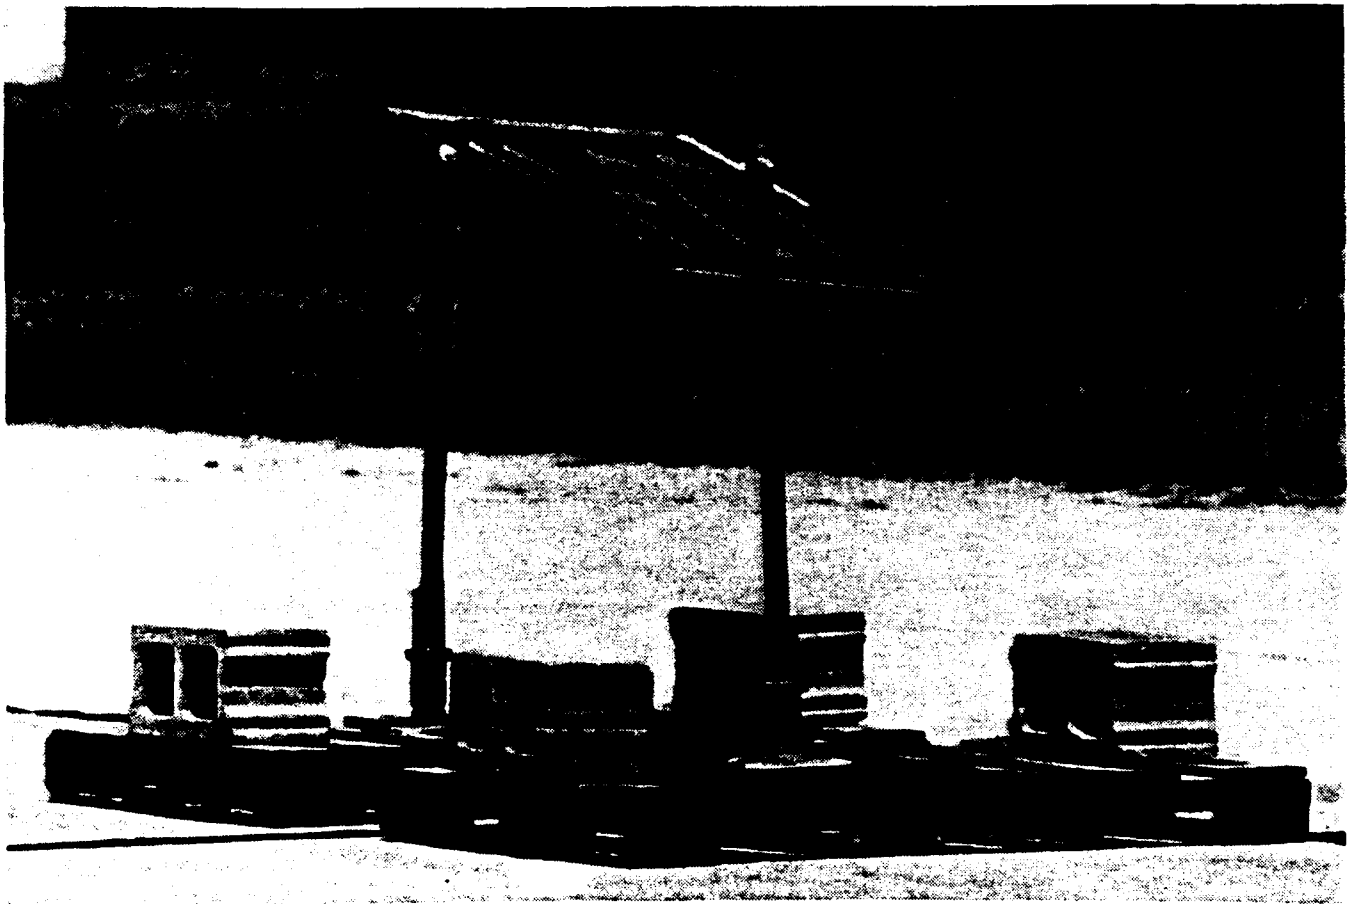
FIGURE 3. UNLIGHTED SWINGING AIRPORT SIGN -  
JET BLAST EVALUATION

The jet blast evaluation consisted of two test scenarios. The purpose of the first test was to study the effects of, and deflection angles produced by a 35- to 40-knot wind with gusts on the sign (figure 3). These wind speeds were produced from the additive effect of the ambient winds and the jet blast of an FAA Boeing 727 positioned at a specified distance from the sign.
