# **Gravel Road Test Sections Insulated with Scrap Tire Chips Construction and First Year's Results**

Robert A. Eaton, Richard J. Roberts and Dana N. Humphrey    August 1994

**U.S. Army Corps  
of Engineers**  
Cold Regions Research &  
Engineering Laboratory

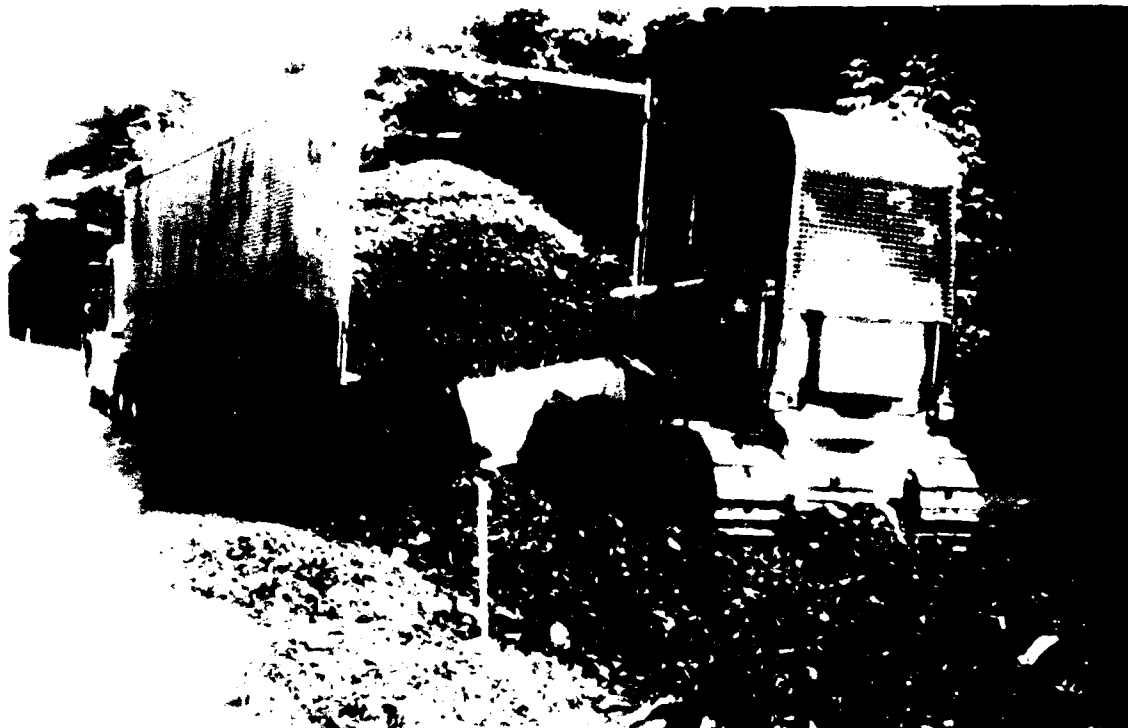
*Figure 7. Unloading tire chips from the semi-trailer and spreading them with the small bulldozer.*

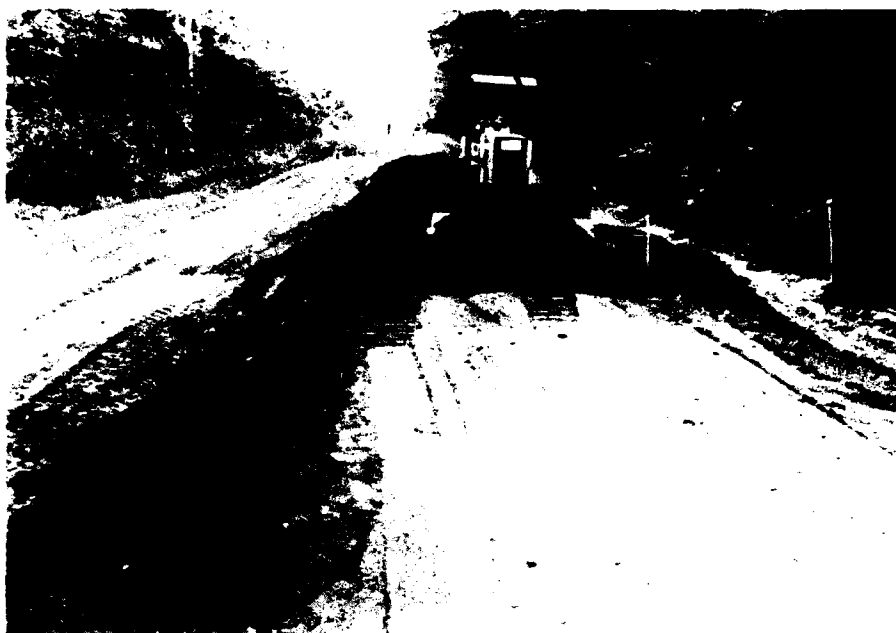
*Figure A3. Fine grading the tire chips.*

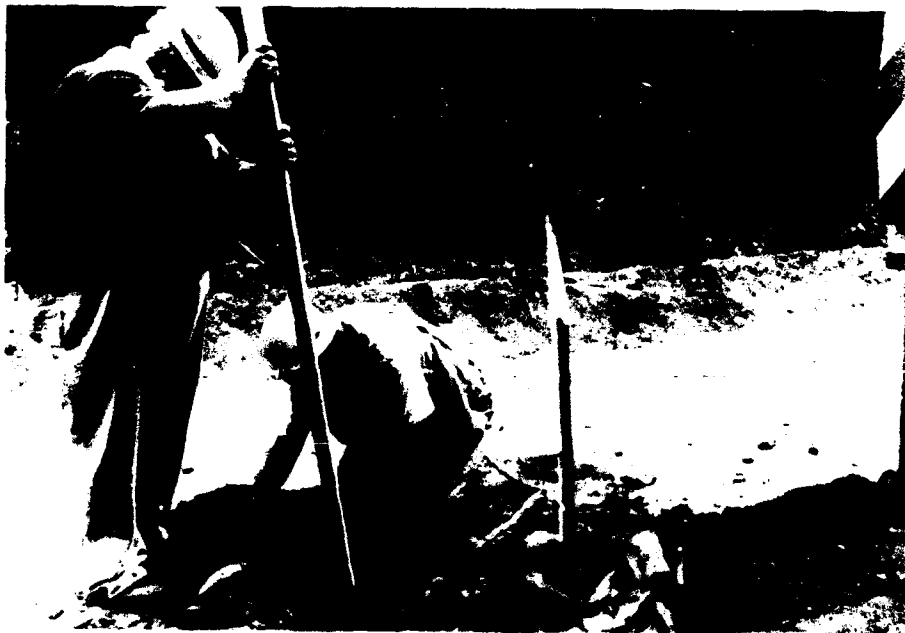
*Figure A6. Compacting the soil around a thermocouple string.*

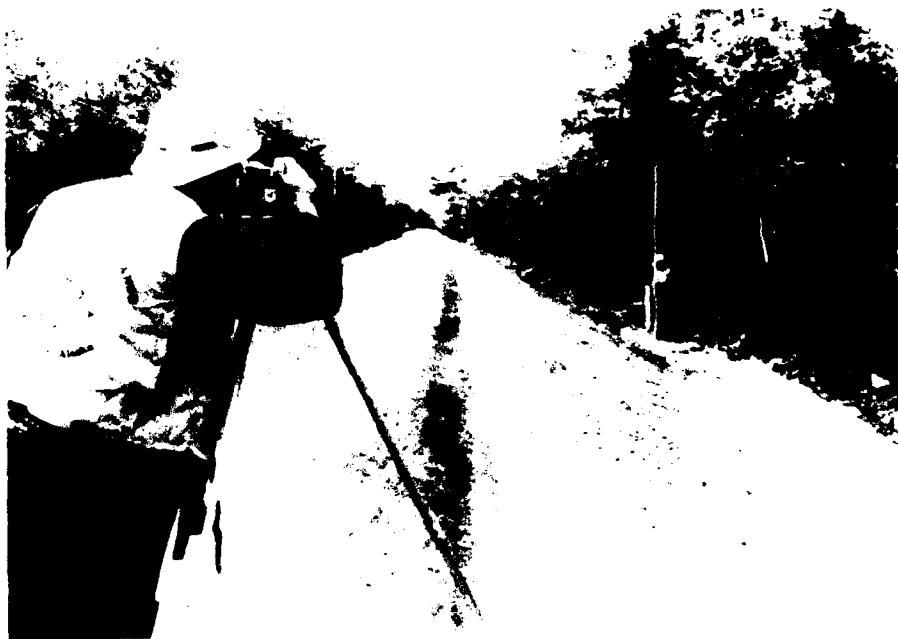
*Figure A14. Level surveys to measure frost heave.*

The heave of the road surface will be measured several times during the winter with a level survey. The two frost-free benchmarks were installed to provide stable reference points for this survey. The frost heave of the different sections are compared. All survey points are given in Appendix D.

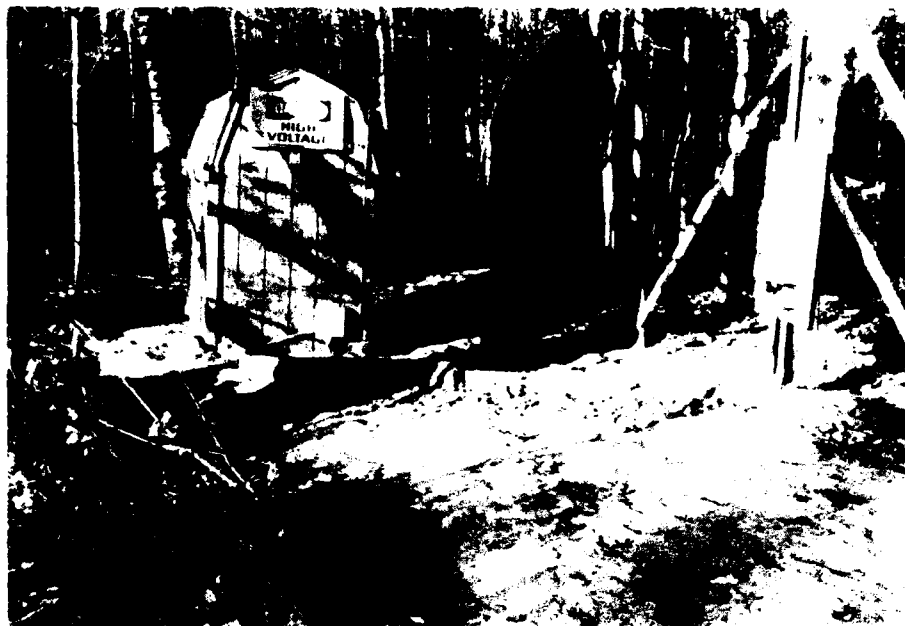
*Figure A17. Instrumentation shelter where data are collected and sent to CRREL via phone lines.*
