# Structural Performance of Cylindrical Pressure Housings of Different Ceramic Compositions Under External Pressure Loading

Part IV, Silicon Carbide Particulate  
Reinforced Alumina Ceramic

Technical Report 1594  
December 1993

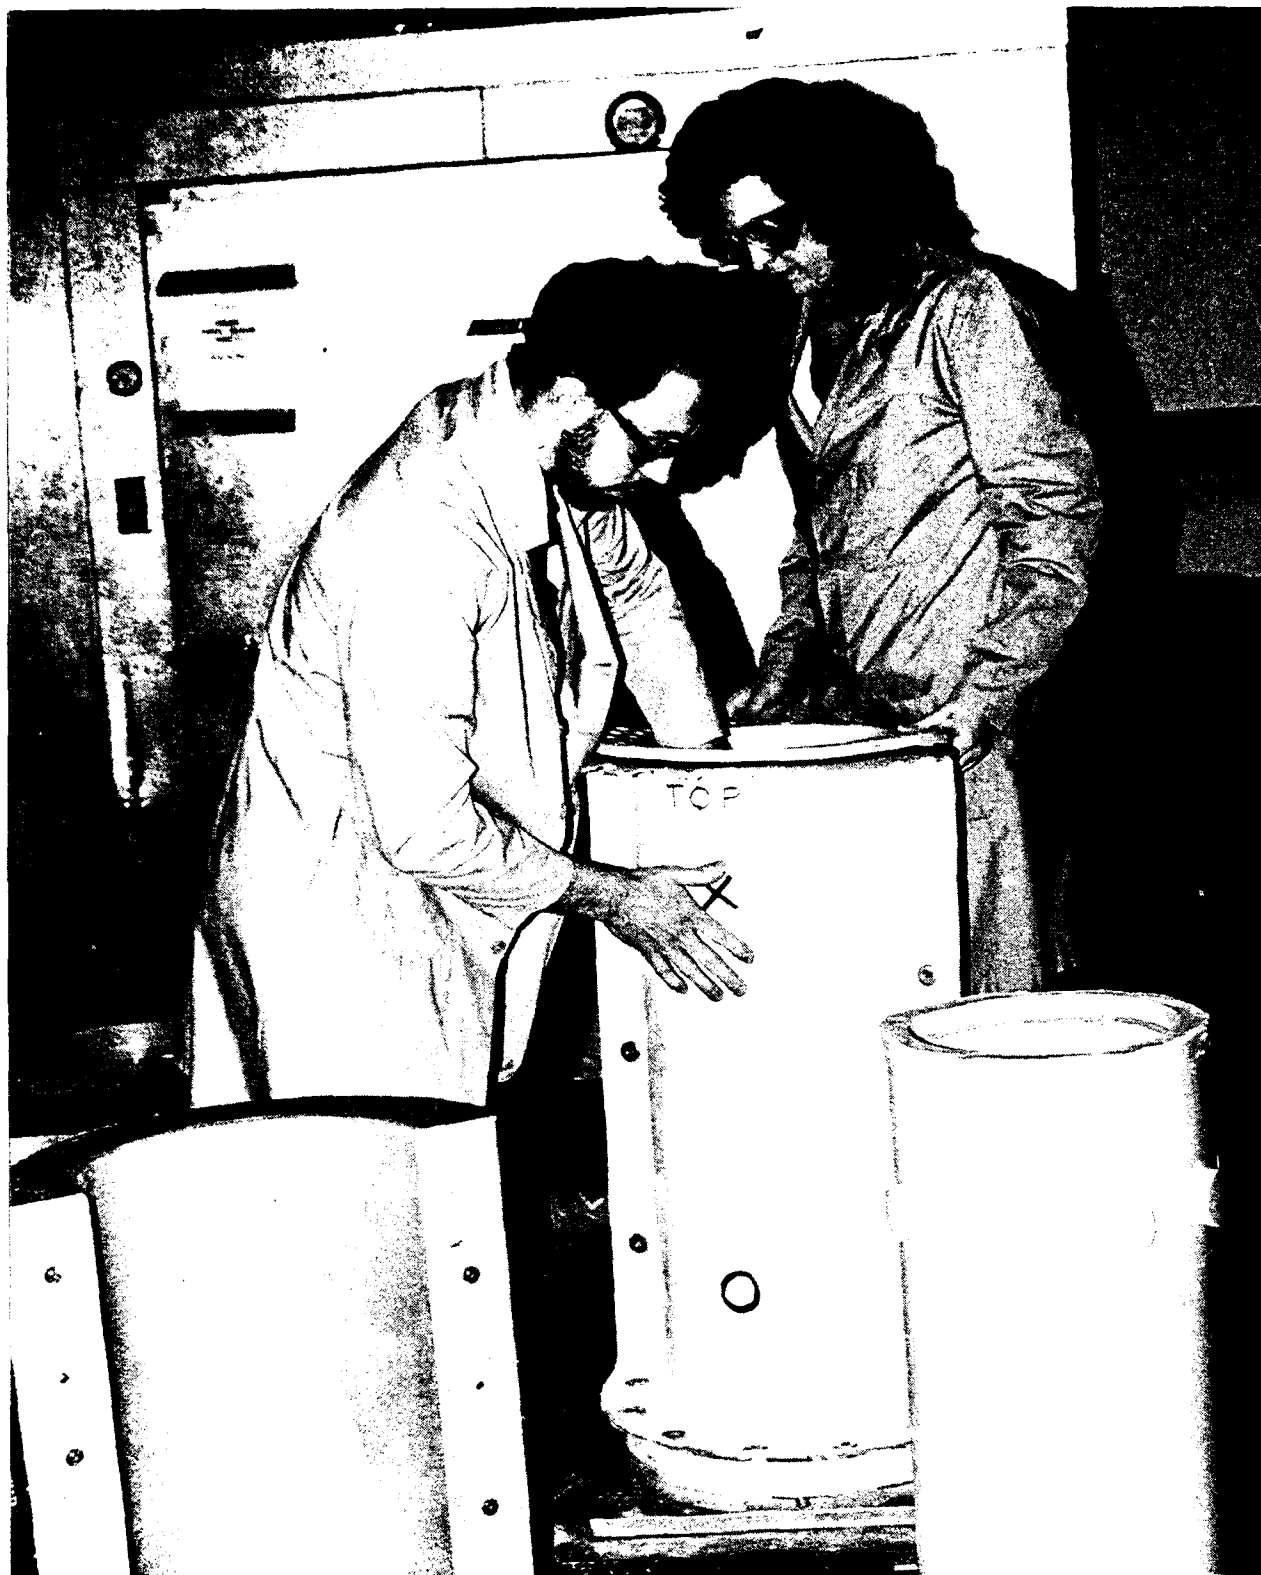
Figure 6. Rubber/fiberglass cylinder casting mold.

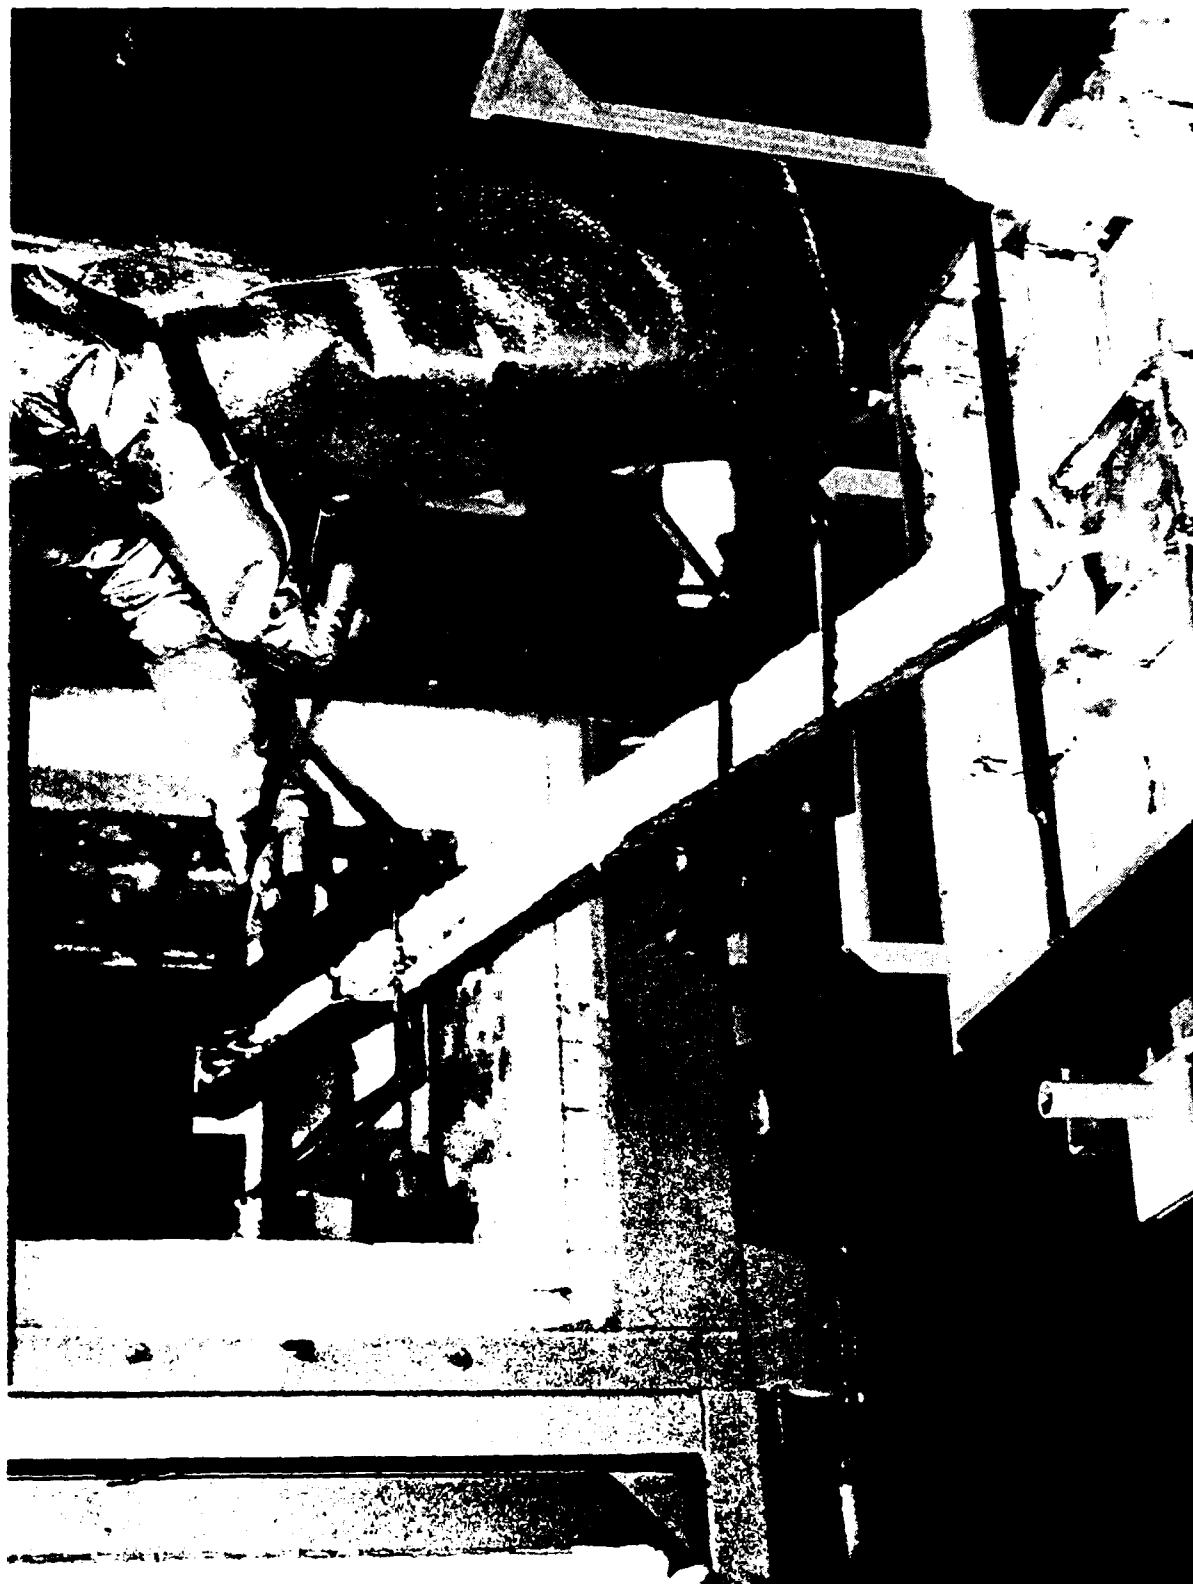
Figure 13. Closeup of the draining of molten aluminum alloy from growth shells after completion of matrix growth.

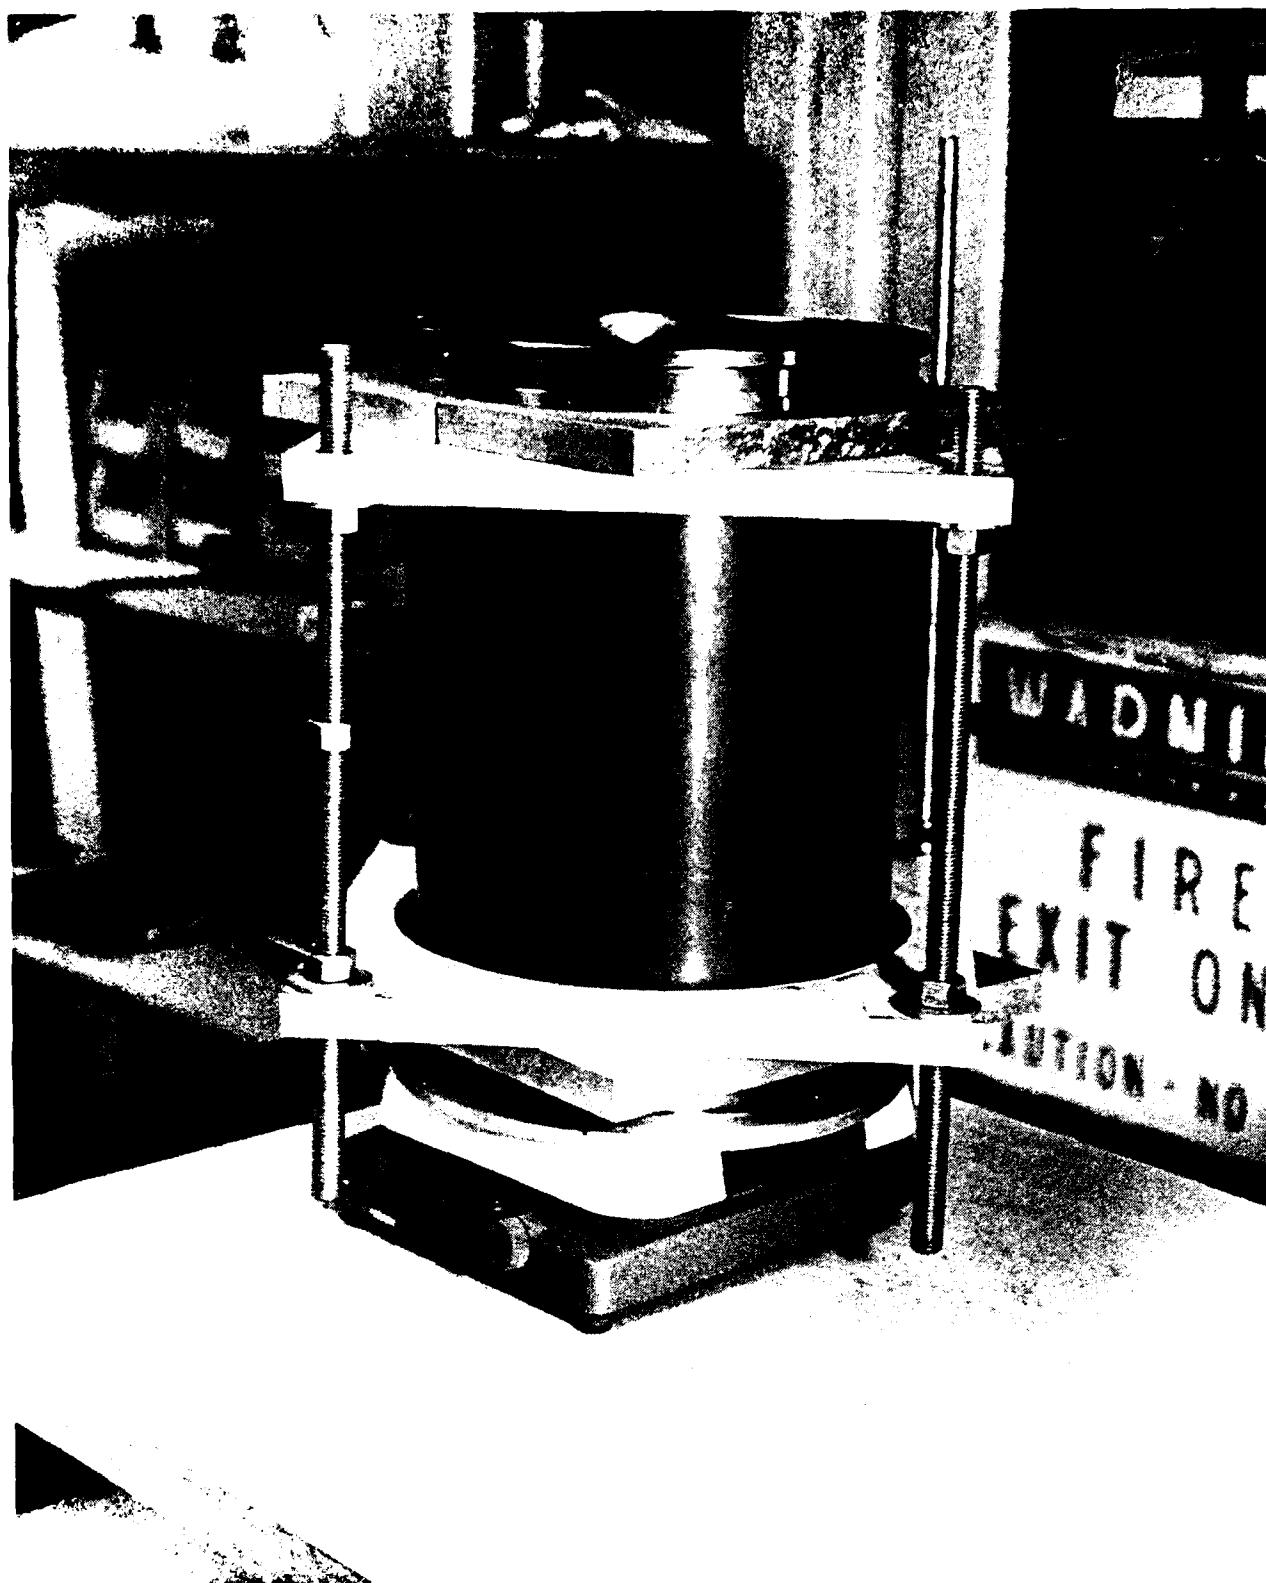
Figure 39. Fixture used to remove titanium end caps from ceramic cylinders for crack inspection after pressure testing.

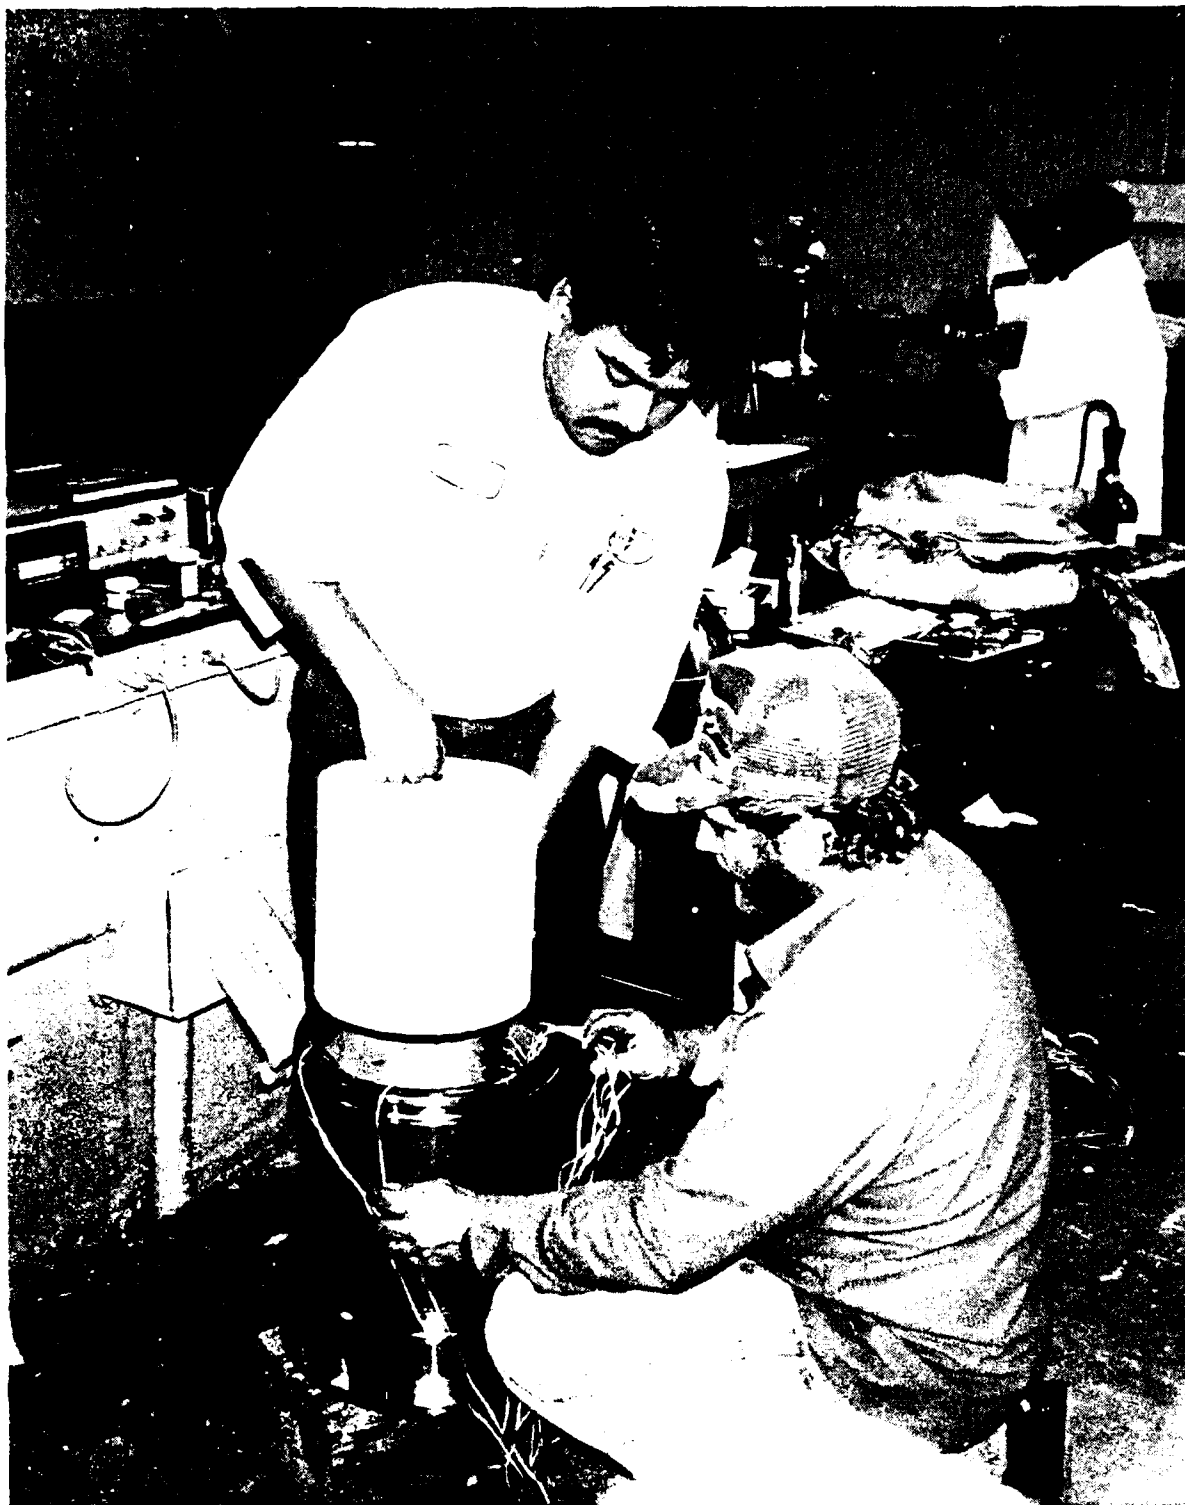
Figure A-2. Insertion of wooden plug inside the cylinder for shock mitigation.
