US Army Corps
of Engineers
Waterways Experiment
Station

The REMR Bulletin

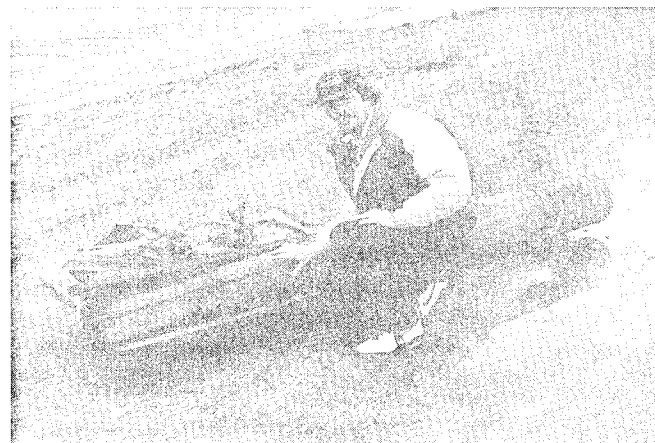
Figure 1. Portion of relief well riser exhumed by levee breach in Bois Brule levee in Missouri

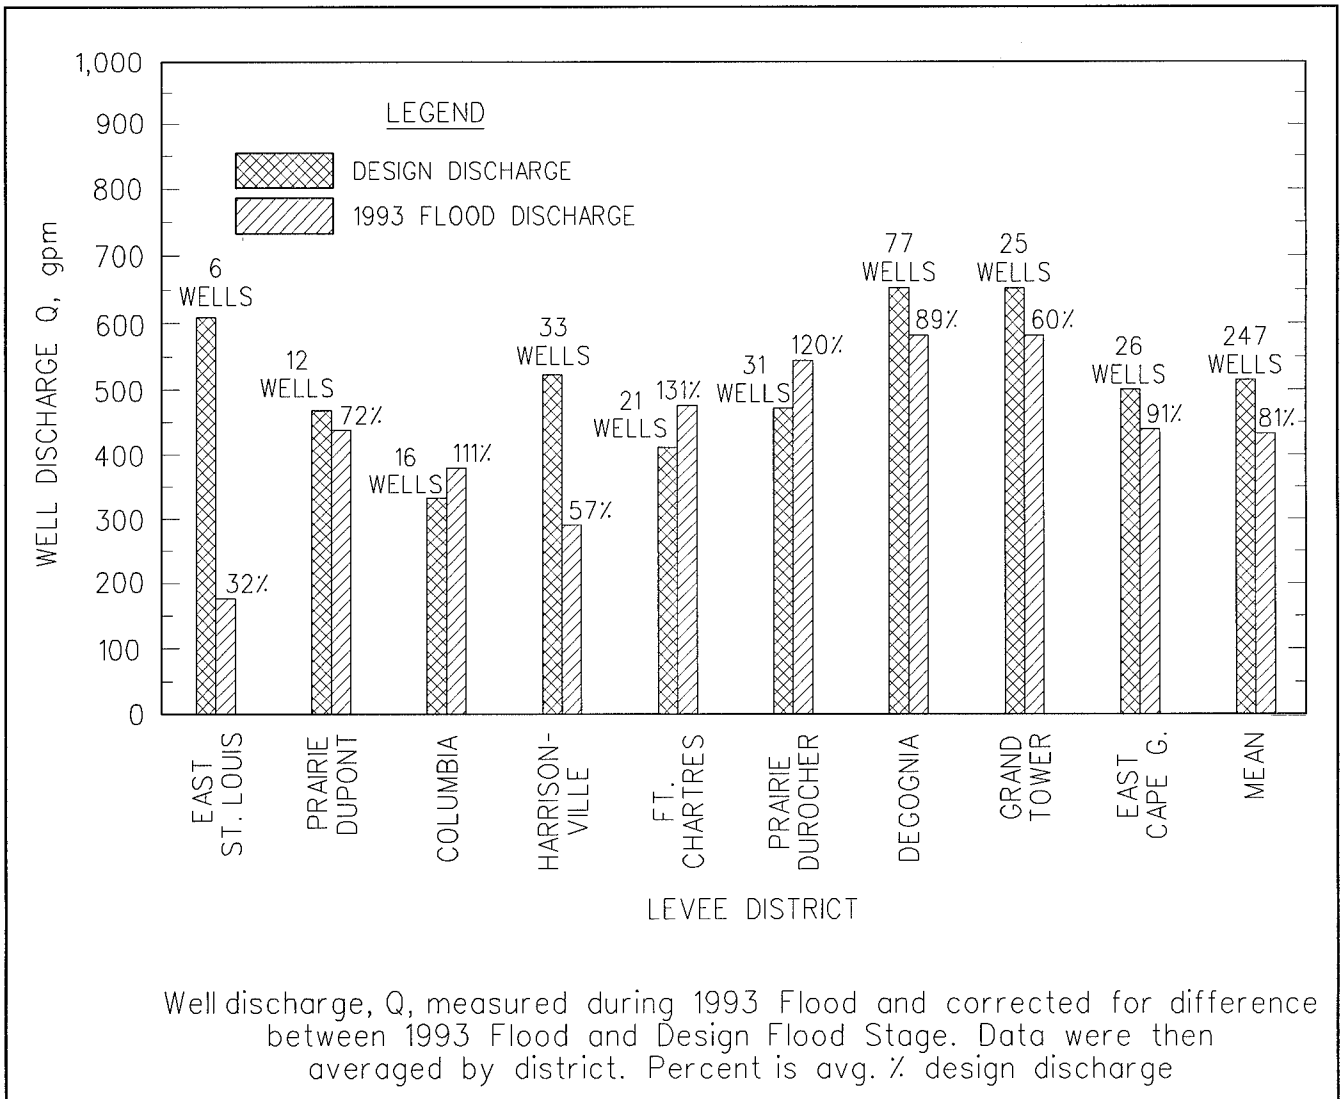
Figure 2. Bar chart of relief well discharge from 247 wells in levee districts from Alton to Gale, IL (Mississippi River levees.) Right-hand bar of each pair is the mean design discharge for the wells read within each district. Left-hand bar of each pair is the mean discharge during 1993 flood adjusted for difference between net head at design and the day of well readings discharge (grouped by district)

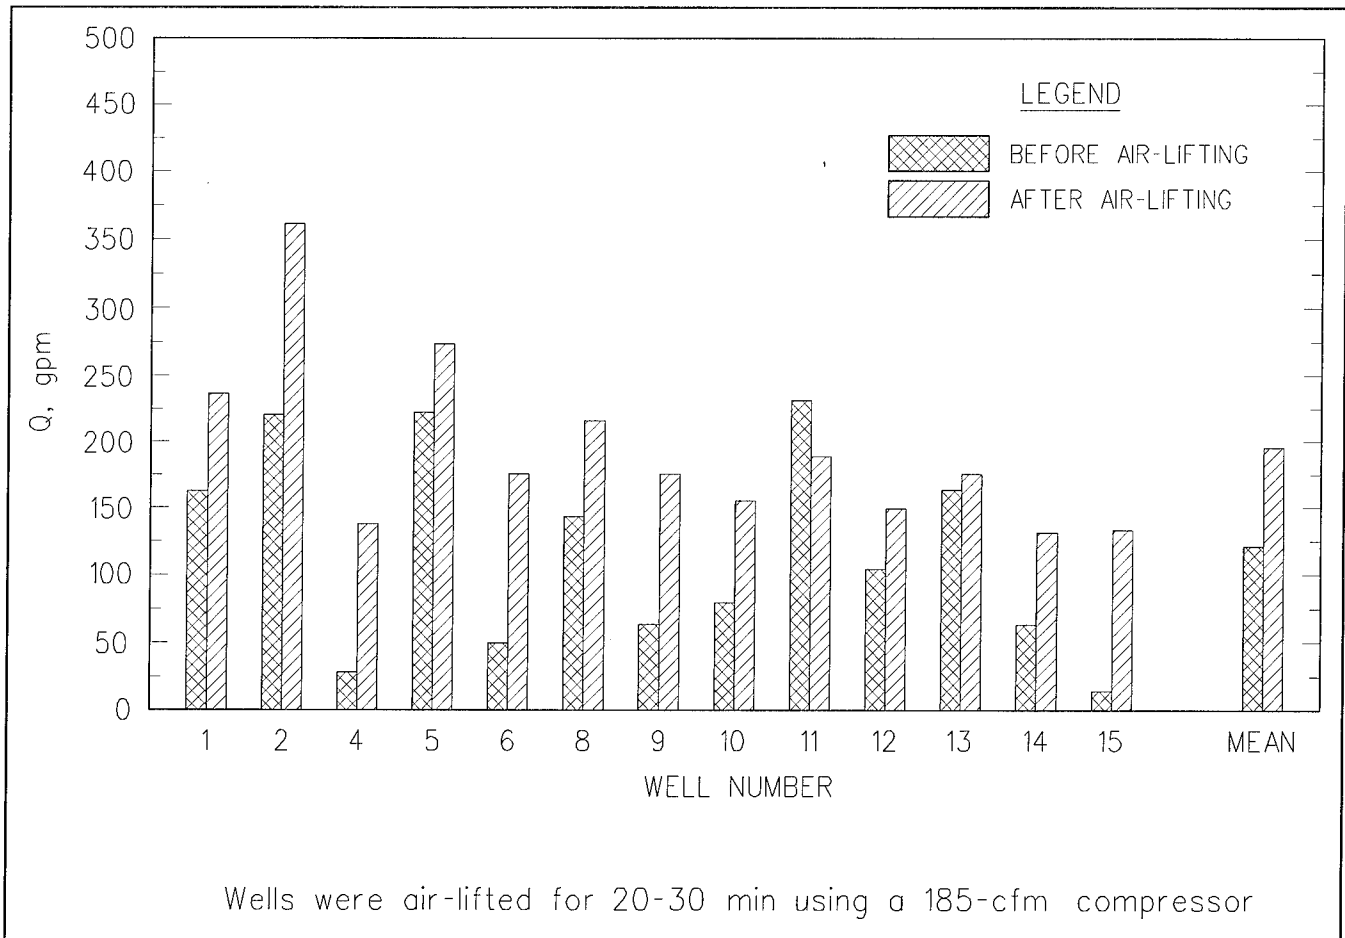
Figure 3. Bar chart of well discharge of 13 wells before and after air-lifting operation in East Cape Girardeau Drainage and Levee District (data provided by Ken Klaus, Vicksburg District)

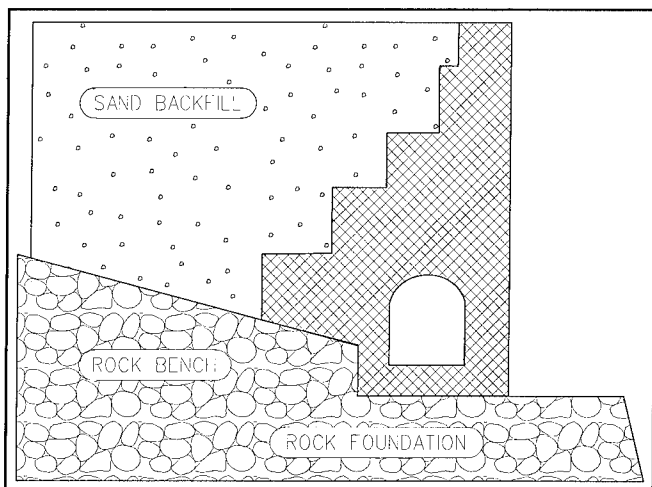
Figure 1. Cross section of the landwall monolith

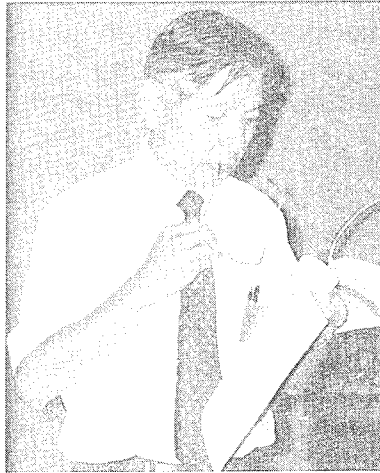
structural engineer for 8 years with the Illinois and Iowa Department of Transportation and had taught for 3 years at Saint Louis University and South Dakota State University.
