Rocky Mountain Arsenal

FINAL PHASE I  
CONTAMINATION ASSESSMENT REPORT  
SITE 36-7: SOLID WASTE BURIAL/SANITARY PITS  
(Version 3.1)

February 1988  
Contract Number DAAK11-84-D0016  
Task Number 1 (Section 36)

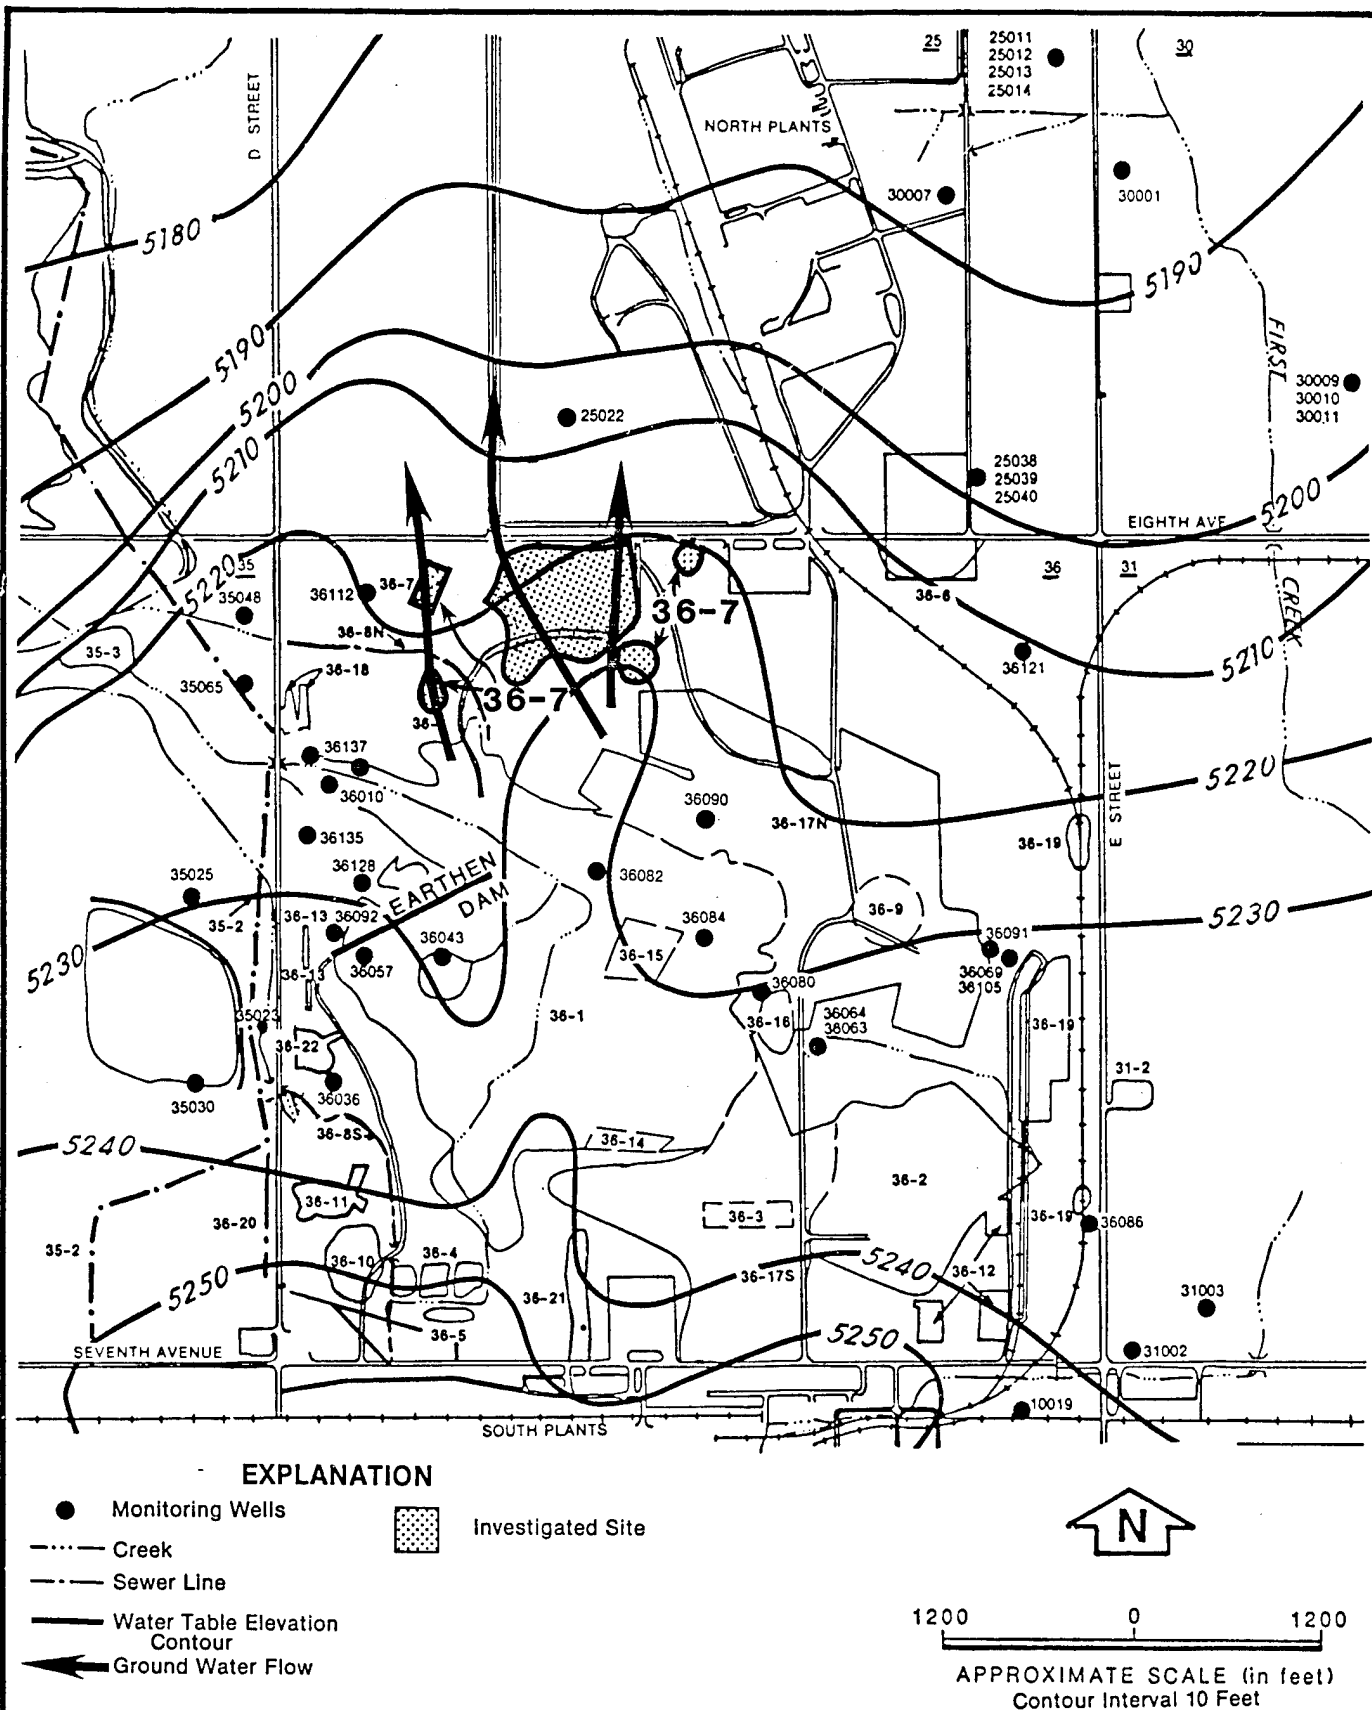
Figure 36-7-4  
 REGIONAL GROUND WATER FLOW  
 SITE 36-7  
 ROCKY MOUNTAIN ARSENAL  
 SOURCE: ESE, 1987

The general direction of ground water flow at RMA is northwest. Within Section 36, flow direction varies from northeast to west due to local bedrock influences. The ground water flow beneath Site 36-7 is to the north-northwest (Figure 36-7-4). Water level data generated in March 1986 as part of the Task 4 investigation show the water table elevation to range from 5,228 to 5,217 ft msl or approximately 14 to 65 ft below ground surface across this site (Figure 36-7-4) (ESE, 1986b, RIC#86238R08).

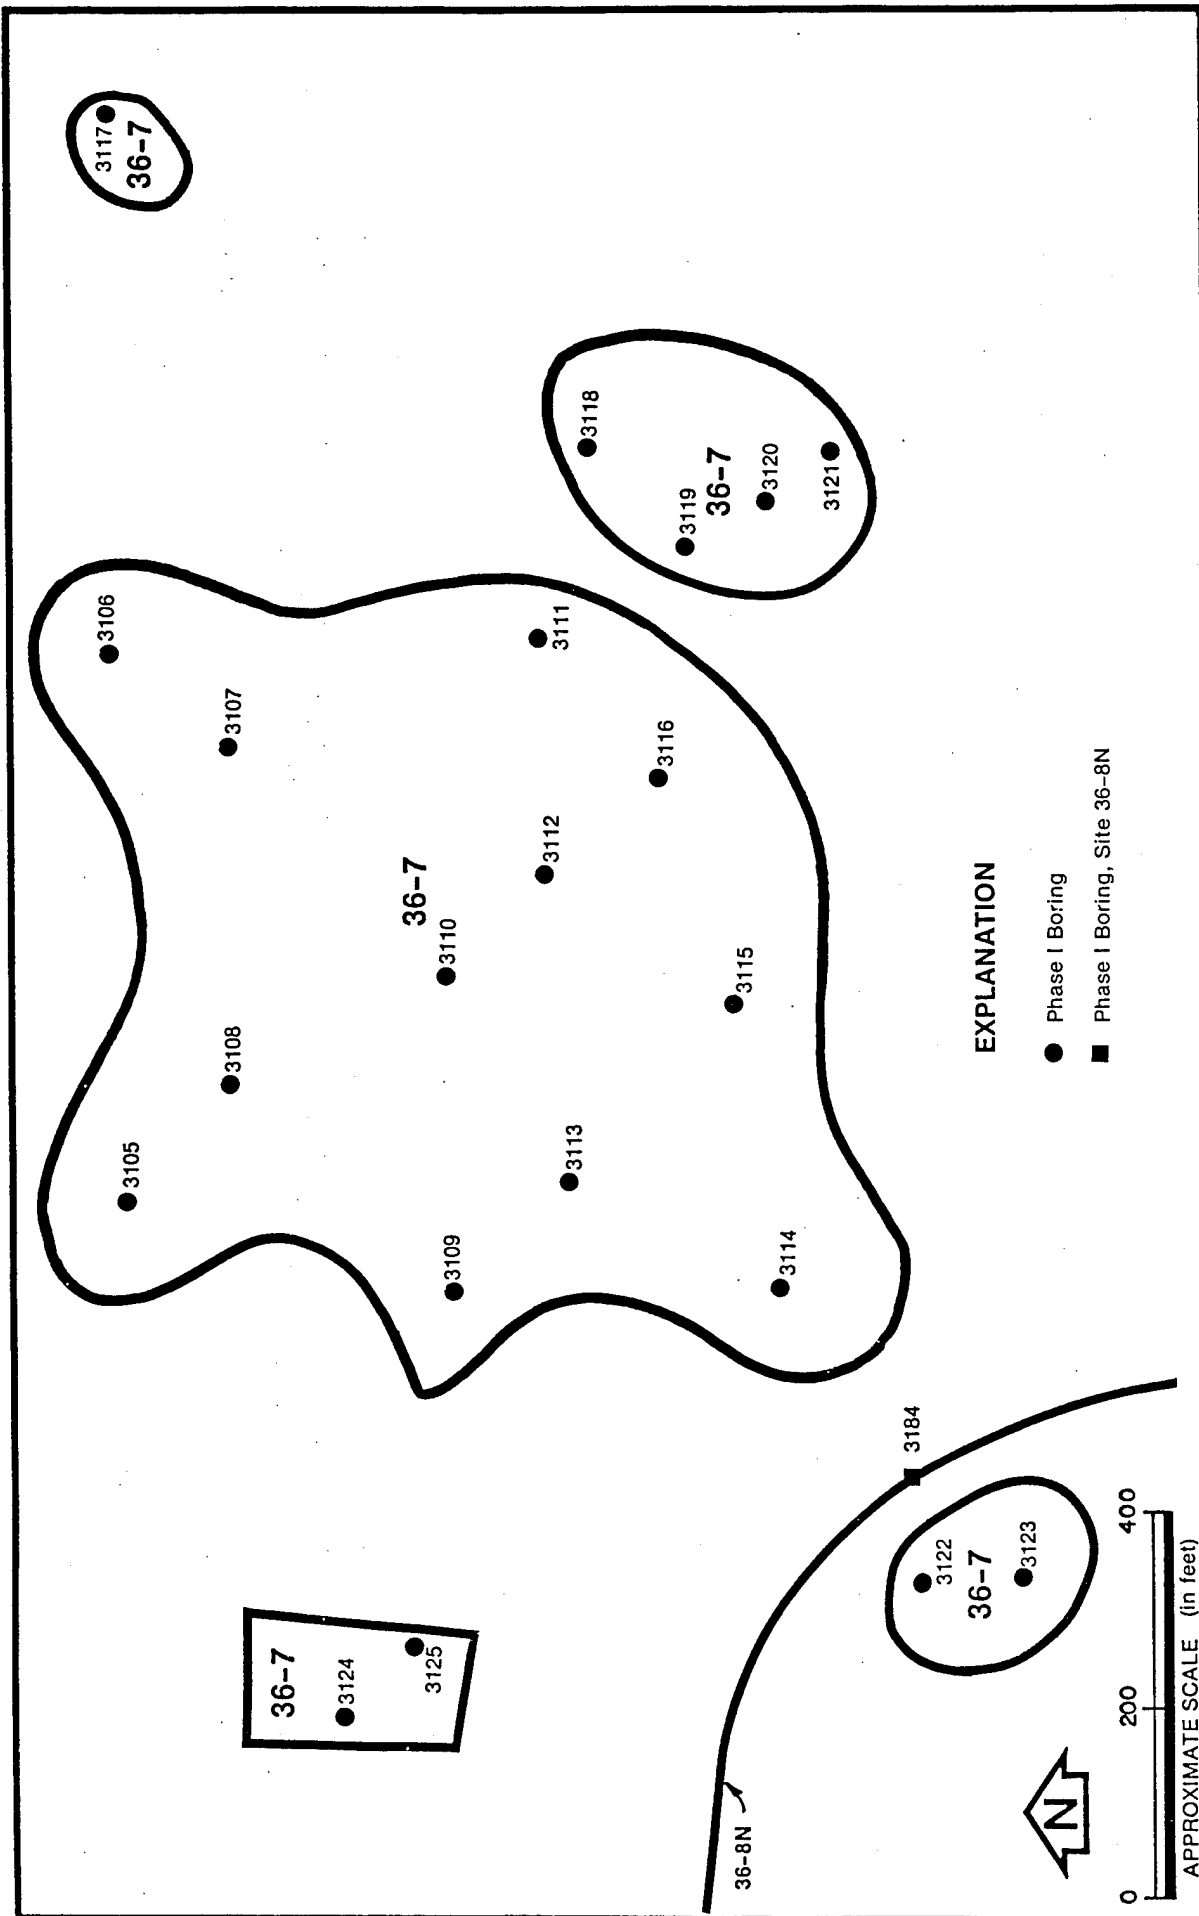
Figure 36-7-5  
 PHASE I INVESTIGATION BORING LOCATION MAP  
 SITE 36-7

The Phase I investigation of Site 36-7 consisted of drilling 21 boreholes ranging in depth from 5 to 25 ft. Borehole locations and site boundaries are shown in Figure 36-7-5. Although four borings (3118, 3119, 3120, and

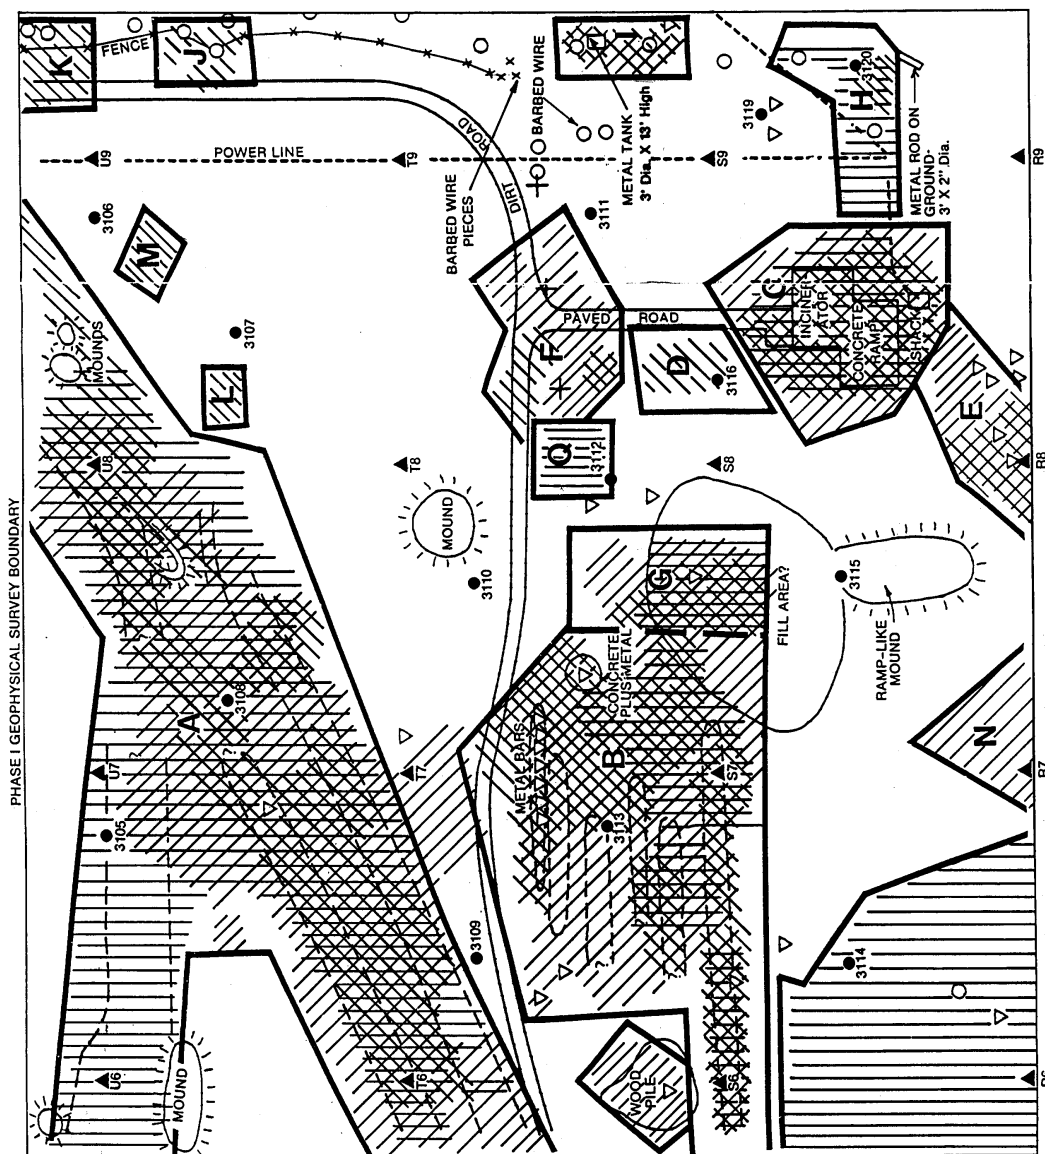
The geophysical survey consisted of alternating magnetic and EM lines spaced 25 feet apart. Continuous geophysical readings were taken along each traverse and stored on computer tape. Three individual contour maps were generated from the magnetic, EM in-phase, and EM out-of-phase data. Areas of anomalous geophysical response were noted for each map and used to produce a geophysical results summary map (Figure 36-7-6).

Anomaly A covers an area of approximately 150,000 ft<sup>2</sup> and is oriented northeast-southwest. This anomaly is characterized by strong magnetic EM in-phase and soil conductivity measurements. A 4-inch steel gas pipeline cuts through the middle of Anomaly A and continues toward Site 36-18 on the western boundary of Section 36. Visible ground scars parallel the trend of Anomaly A and correlate with the 12 trenches and 8 to 10 pits identified by Moloney (1982, RIC#85085R01). Gradiometer data indicate a complex distribution of trenches and suggest that Anomaly A may extend beyond the north and west survey area boundaries. The northern portion of this anomaly is characterized by the strongest soil conductivity values found at Site 36-7. A large ground scar was mapped in the vicinity of these high values.

Soil conductivity values were also well above background at Anomaly B. Values recorded at this anomaly were second only to those recorded at Anomaly A. An area of strong EM in-phase readings within this anomaly was investigated by Boring 3113. EM in-phase data indicate a northwest-trending anomaly in the northwest corner of Anomaly B which may be caused by surficial and buried nonferrous metal. The northwest-trending direction is a different orientation from the rest of the anomaly.

Two significant combined (magnetic, EM in-phase, and soil conductivity) anomalies (C and D) covering 26,000 ft<sup>2</sup> were produced by the Shell Chemical Company incinerator. The incinerator is built out of firebrick and steel walls with a metal mesh screen cover. A concrete ramp, probably steel reinforced, is attached to it. A corrugated metal building is just south of the incinerator. No evidence of disposal trenches, either in historical aerial photographs or in the field, were found in these anomalies. Anomaly D was investigated by Boring 3116.

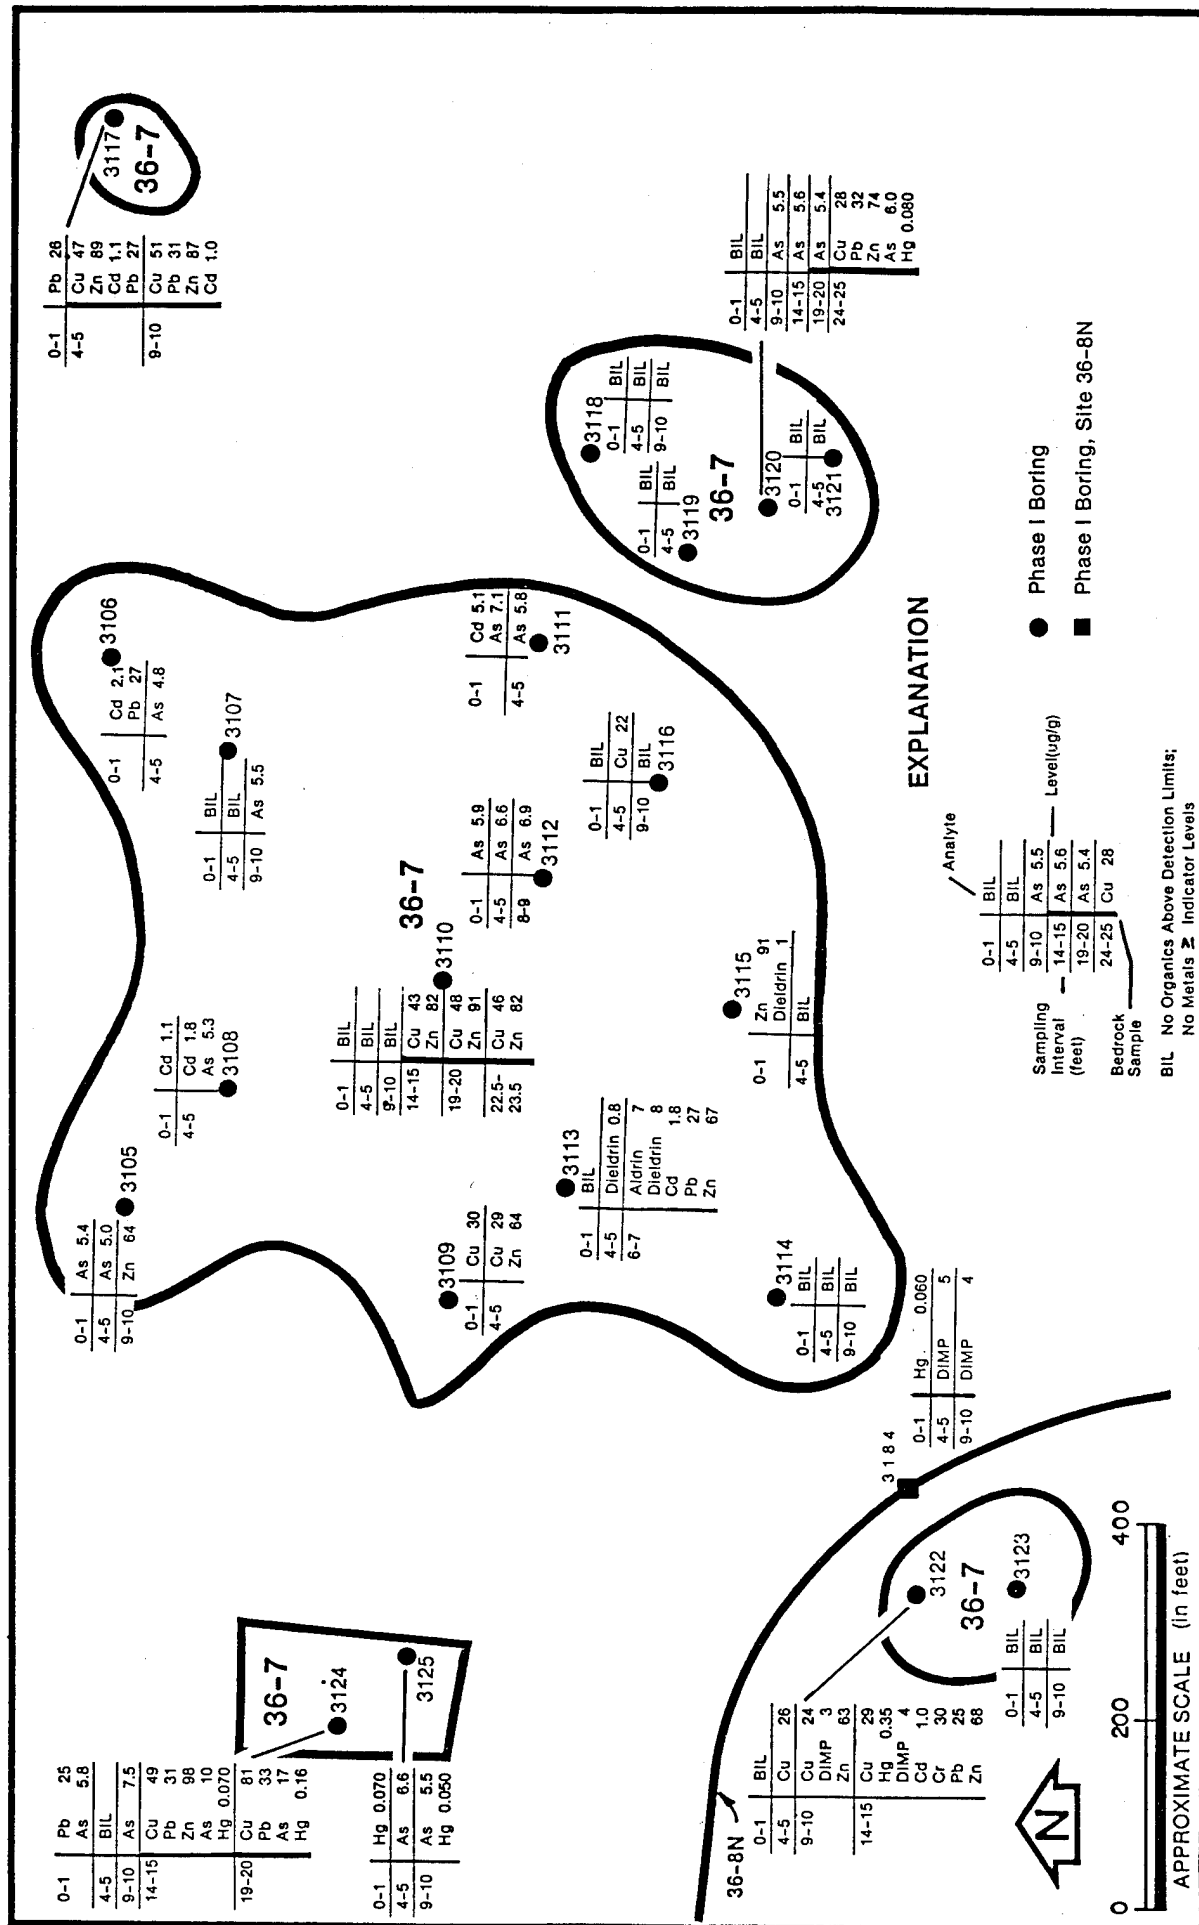
To assess the significance of metal and organic analytical values, indicator ranges were established. For organic compounds, the indicator level is the method detection limit. For metals, the indicator range reflects the upper end of the normal range for each metal as naturally found in RMA alluvial soil. Selection of these ranges is discussed in the Introduction to the Contamination Assessment Reports (ESE, 1986a). Concentrations within or above indicator levels for Phase I data are presented in Figure 36-7-7.
