WL-TR-95-4004

# AIRCRAFT MISHAP INVESTIGATION HANDBOOK FOR ELECTRONIC HARDWARE

| REPORT DOCUMENTATION PAGE | | | Form Approved<br>OMB No. 0704-0188 | |
|---|---|---|---|---|
| 13. ABSTRACT (Maximum 200 words)<br><br>This handbook contains procedures and guidelines to aid in the analysis and investigation of electrical and electronic components involved in aircraft mishap investigations. Failure analysis techniques for the evaluation of electrical and electronic components are summarized for lamps, wiring, connectors, circuit breakers, printed wiring boards, and microelectronic devices. Techniques using optical and scanning electron microscopy (SEM) for the analysis of these components are described. Energy dispersive X-ray analysis (EDAX) of elemental constituents, X-ray radiography, and specialized electrical measurements are also described. | | | | |

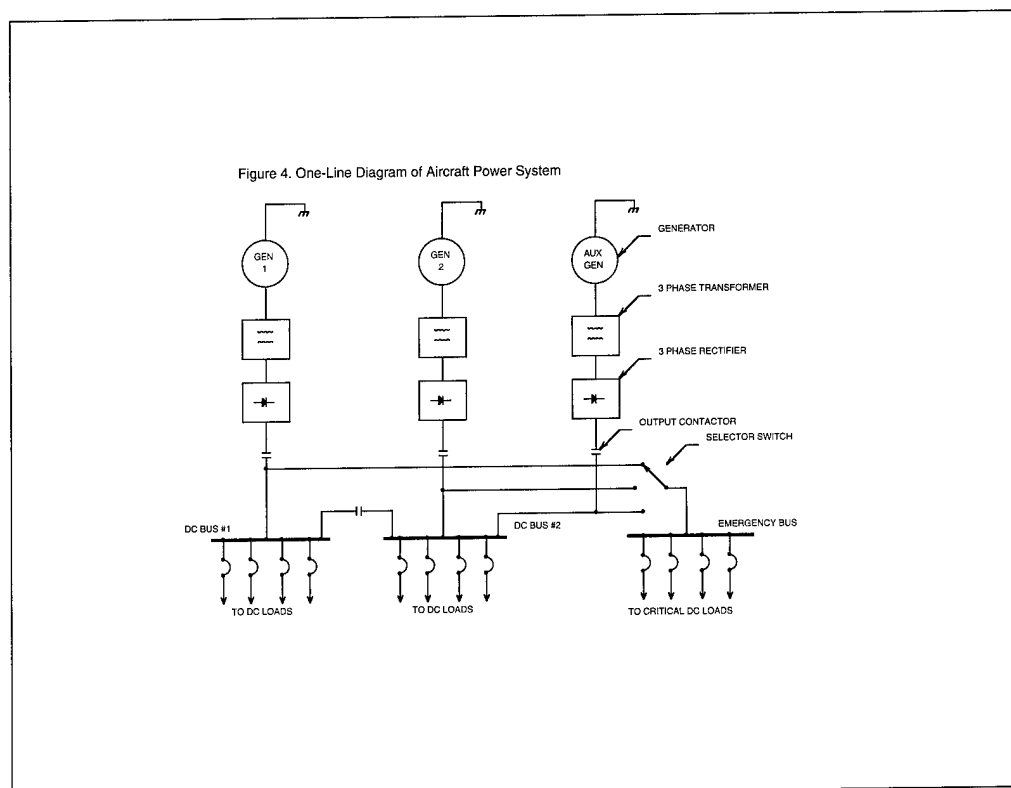
Figure 4

The simplified schematic for a hypothetical aircraft power system is shown in Figure 4. The diagram is called a “one-line diagram” since the three phases are represented by just one line on the diagram. The system has two main generators and an auxiliary generator. Power delivery is at 28 Vdc using two main buses and one emergency bus. Either of the two main generators can supply all the dc loads on the aircraft. By opening and closing the appropriate contactors any of the generators can supply the loads. The contactors are also used to disconnect a generator circuit when a failure is detected so that power from one generator does not flow back into one of the others.

In emergency conditions the auxiliary generator is connected to the loads. A selector switch is provided for a separate emergency bus which provides power to critical loads.

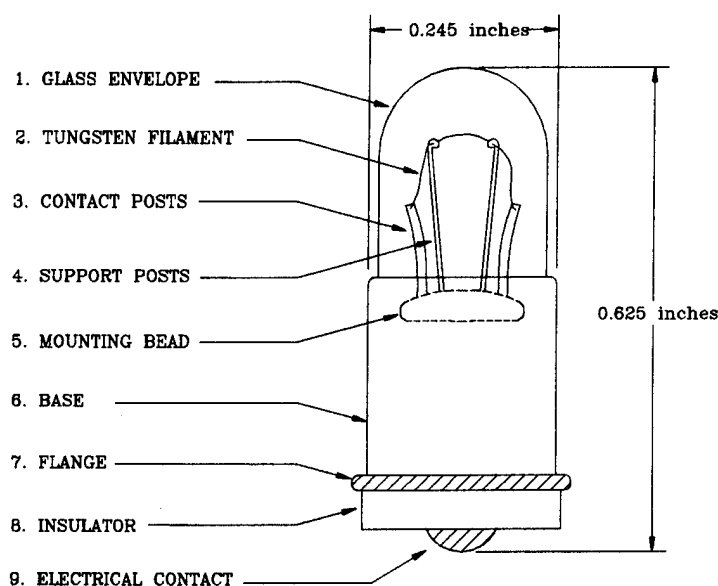
**Figure 1.1** Components of a small flange base incandescent lamp.

| <b>Glass Envelope</b> | The filament structure is surrounded by a glass envelope. The envelope is either evacuated or filled with an inert gas to prevent oxidation of the filament. |
| <b>Tungsten Filament</b> | Incandescent lamp filaments are made from nearly pure Tungsten which is fabricated into wire form using a powder metallurgy process. The voltage and power requirements dictate the dimensions of the wire. In small lamps the wire is usually so long that it must be coiled or double coiled to fit in the envelope. |

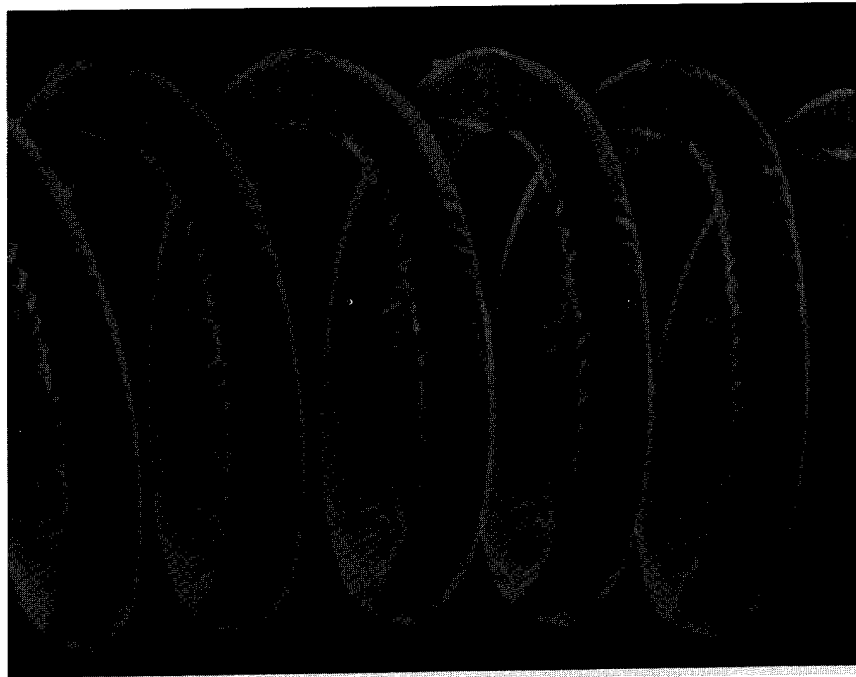
**Figure 1.2** Dc notching of filament wire. Magnification: about 250X.

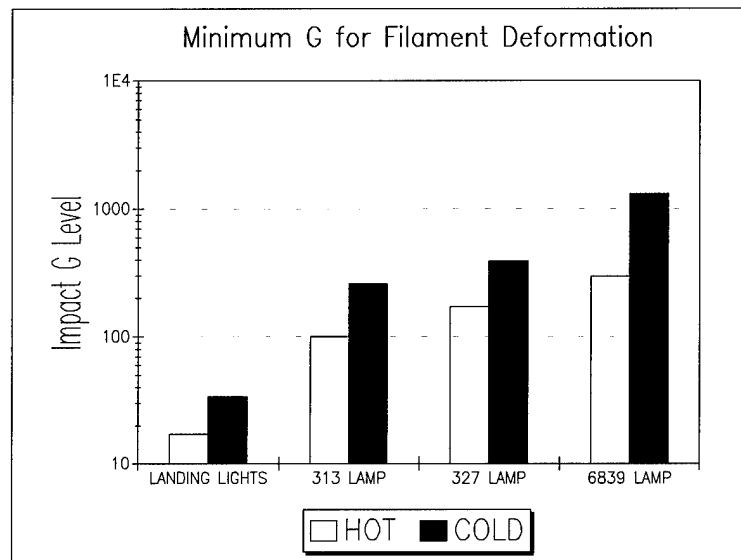
**Figure 1.3** G Level thresholds for aircraft lamps.

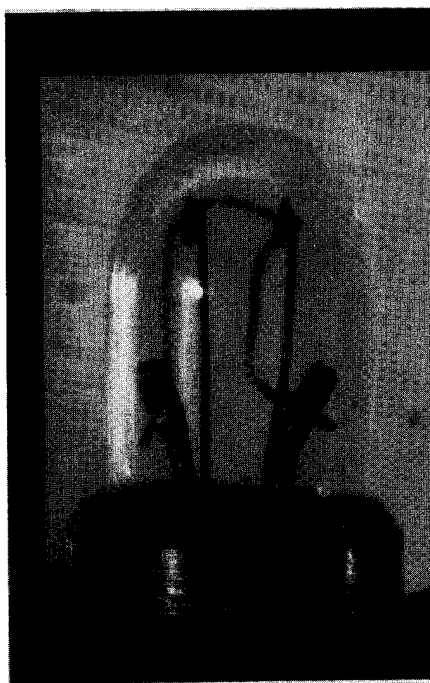
**Figure 1.7** Typical deformation of an ON 6839 lamp filament. Magnification about 7X.

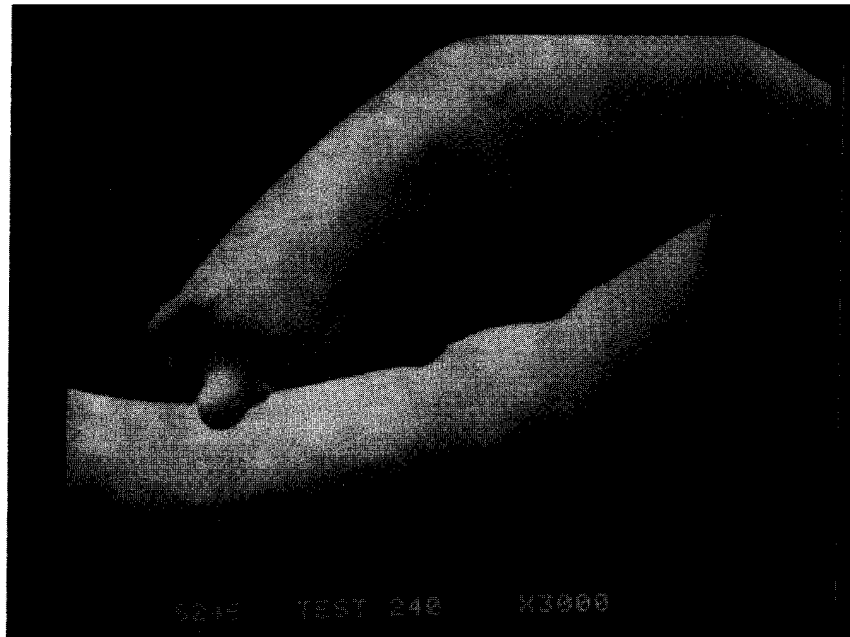
**Figure 1.8** Ductile/melted fracture of type 327 lamp. Magnification is 3000X.

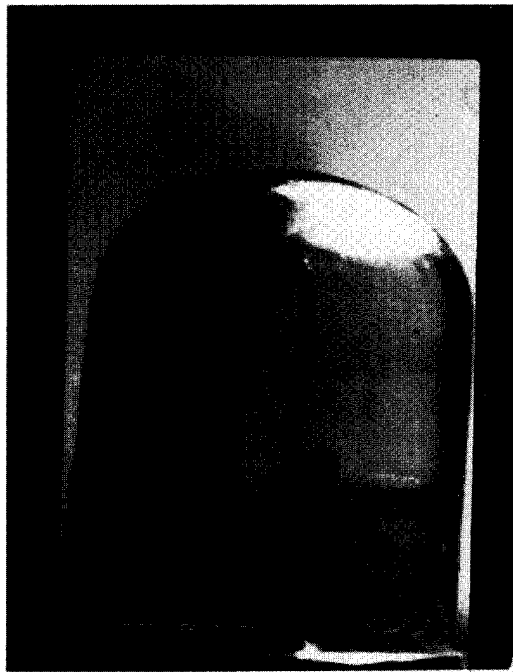
**Figure 1.10** Multiple brittle fracture of type 327 lamp. Magnification about 20X.

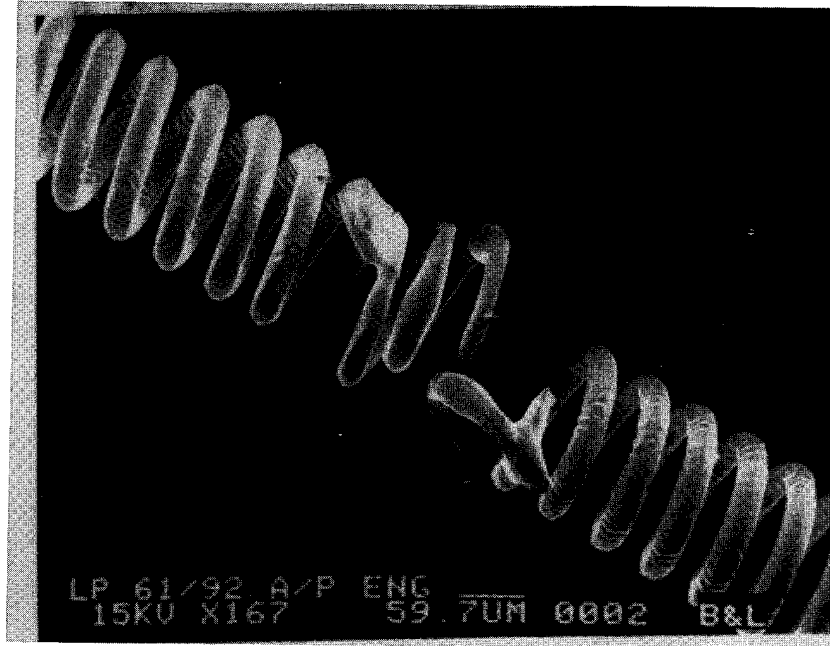
**Figure 1.13** Filament burned out from an overvoltage condition. Magnification about 167X.

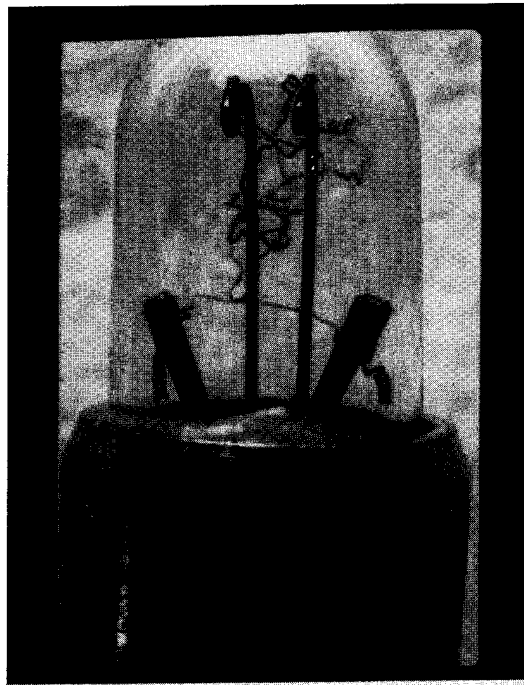
**Figure 1.16** Entanglement caused by resonance condition in type 6839 lamp. Magnification about 10X.

| <b>Observation</b> | Filament and support post resonance results in severe tangling and deformation of the filament. The condition can be observed during microscopic examination. |

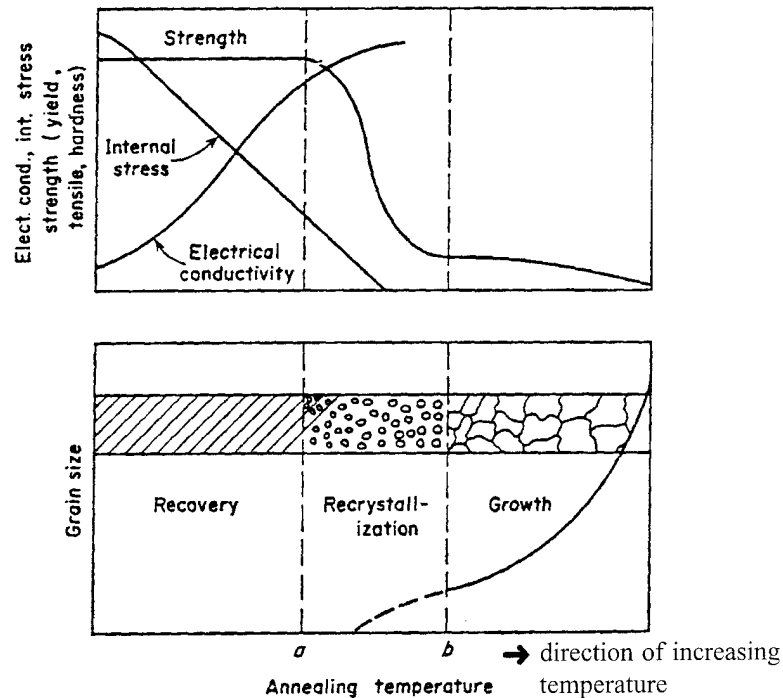
**Figure 2.2** Recrystallization process.

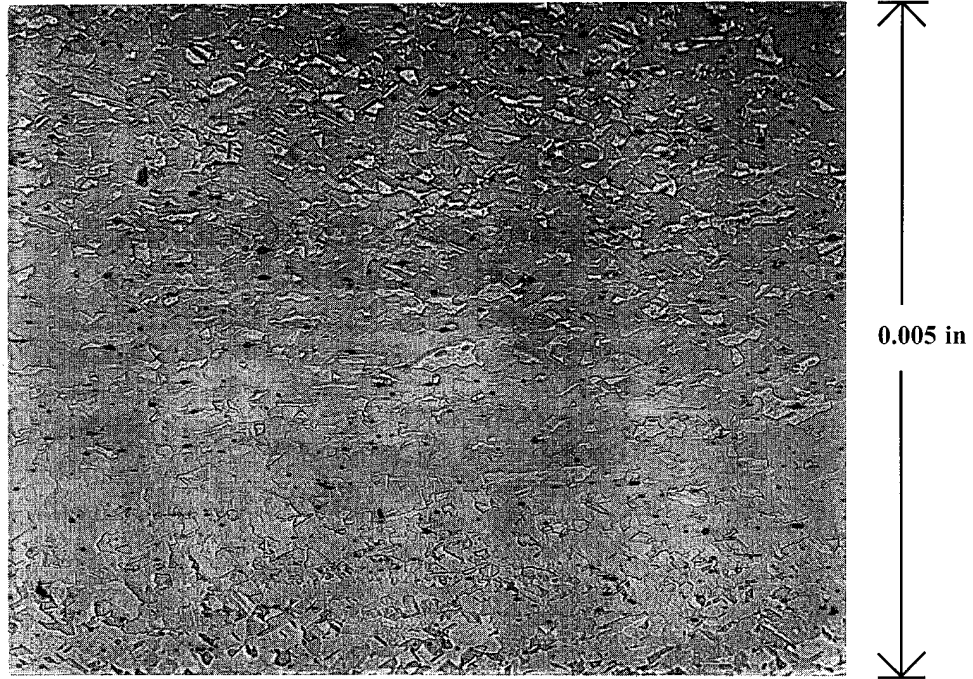
**Figure 2.3** Grain structure of normal OFHC wire (500X).

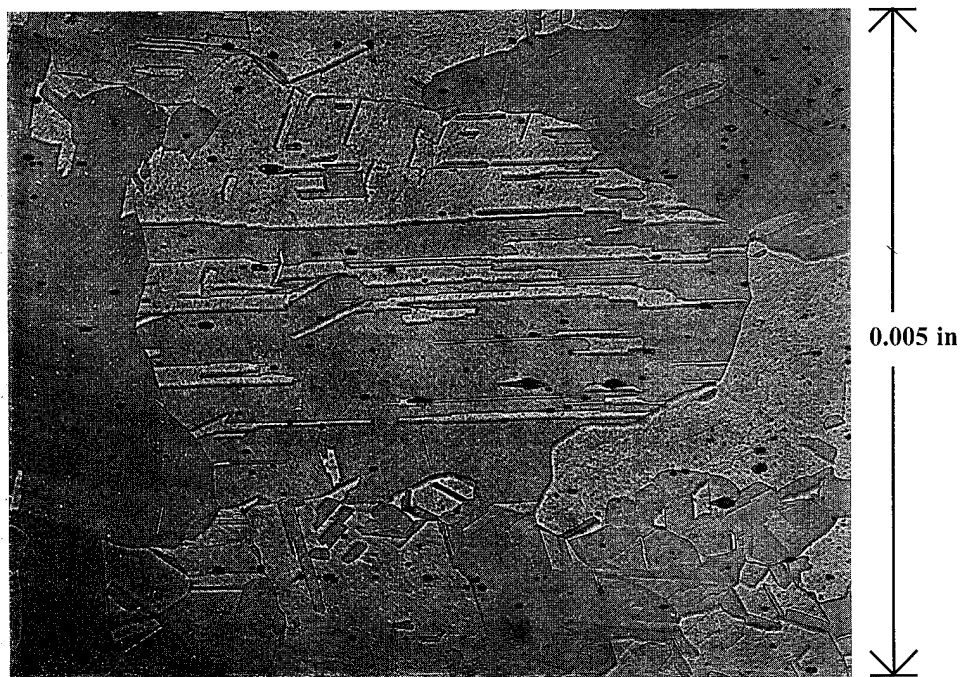
**Figure 2.4** Grain structure of OFHC wire after five minutes at 600°C (500X).

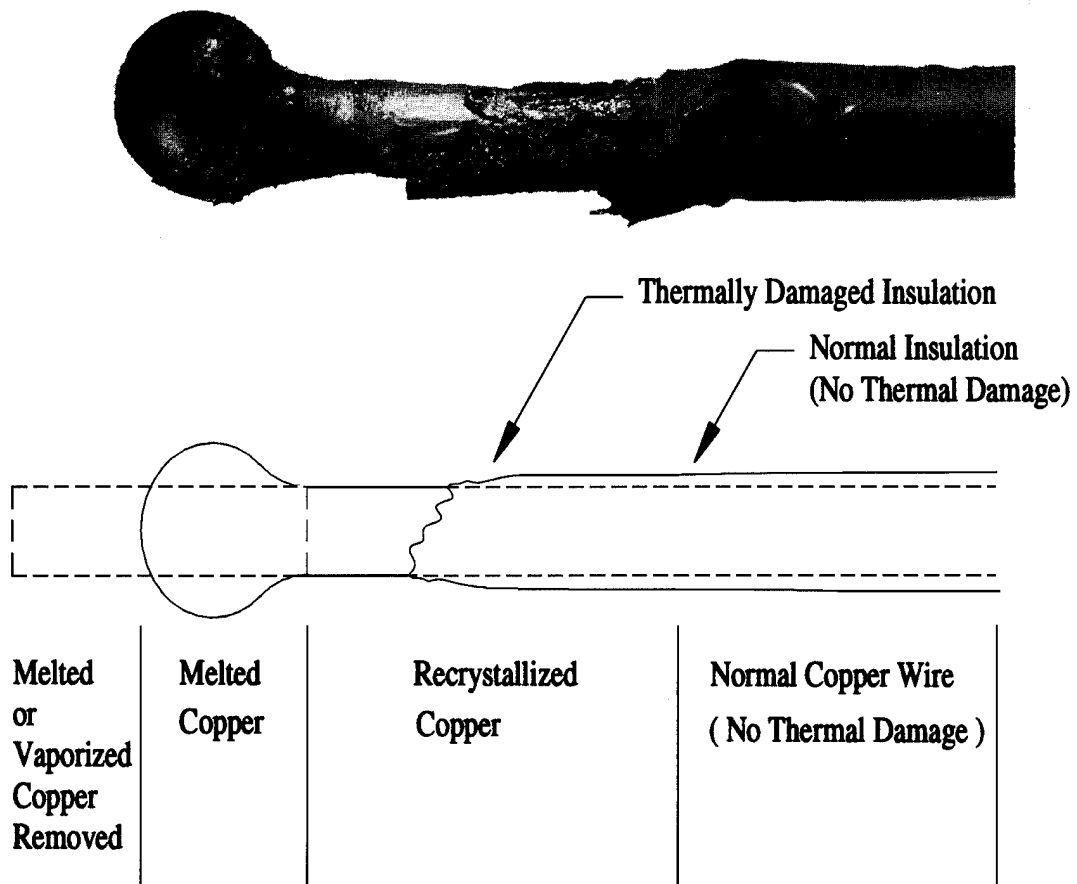
**Examples** Figure 2.5 shows the appearance of a wire that was involved in arcing on a 28 Vdc system.

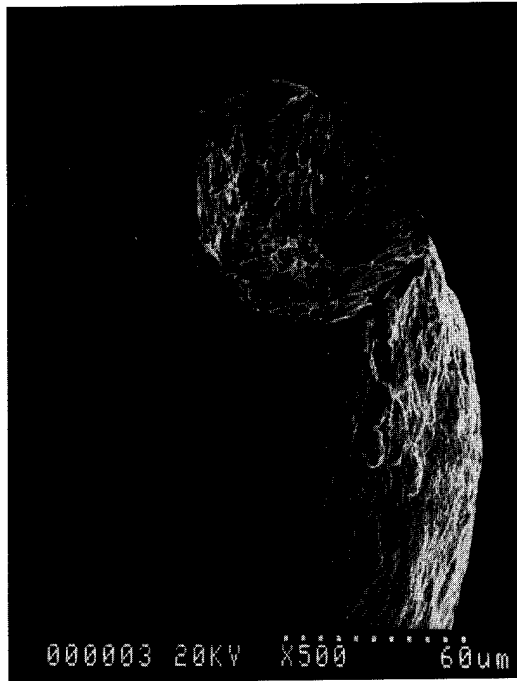
**Figure 2.10** Figure 2.10 shows the cup-and-cone fracture surface and elongation typically associated with mechanical failure of a copper conductor.

**Observation** A cup-and-cone fracture can occur when a ductile material undergoes tensile loading that exceeds its tensile strength.

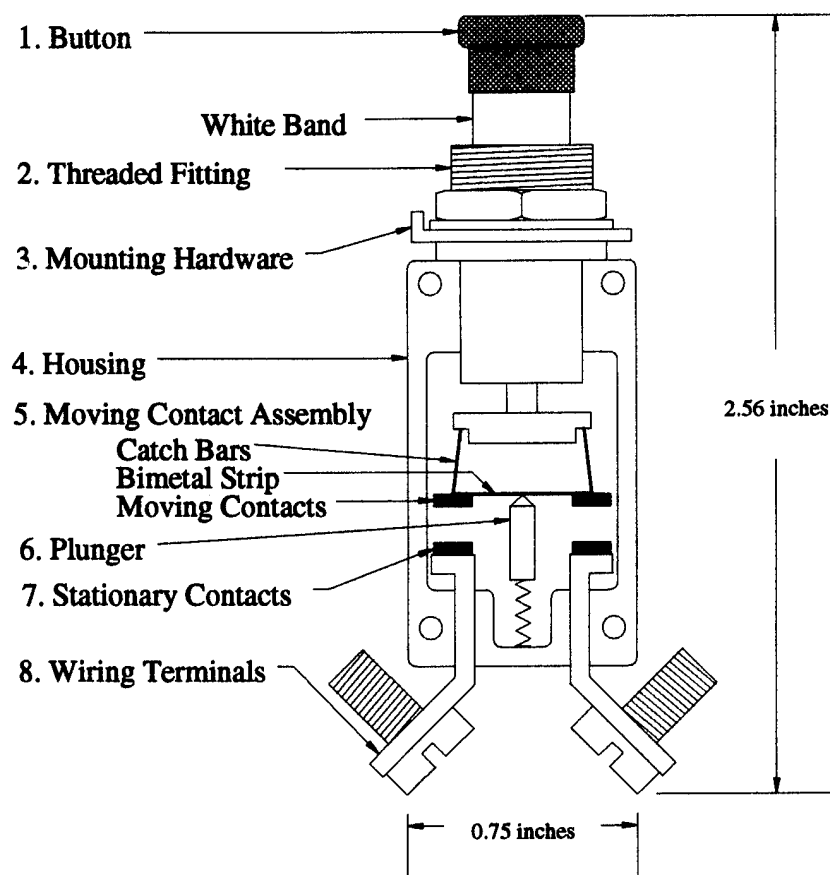
**Figure 3.1** The construction of one type of aircraft circuit breaker is shown in Figure 3.1. It is shown in the open circuit position.

**Button** The button is the manual operating means and its position indicates the state of the circuit breaker. Pushing the button closes the circuit and latches the button mechanism. The button can be pulled out to open the circuit.

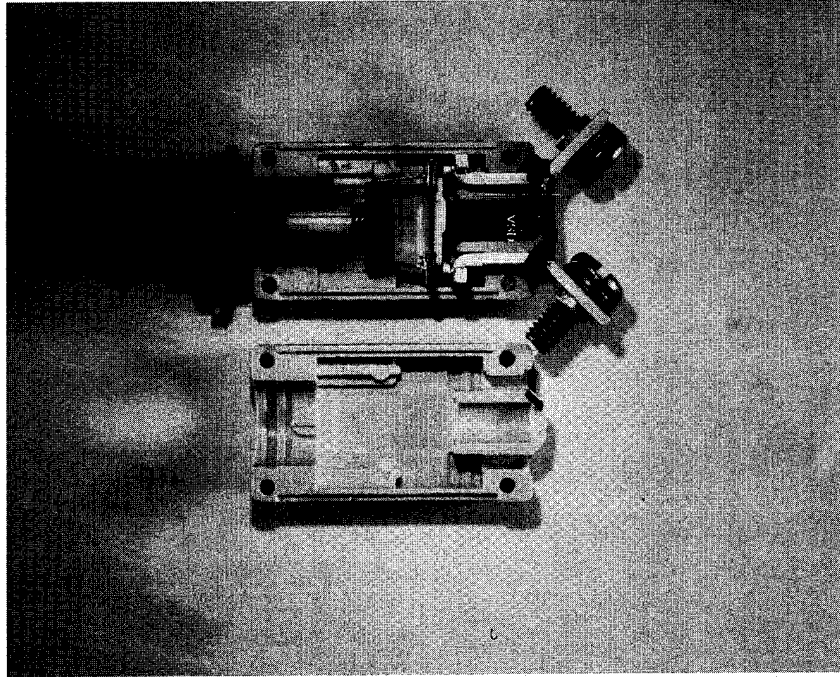
**Figure 3.2** Photo of a 10 A circuit breaker made by Klixon Division of Texas Instruments shown in the closed position. Magnification: about 1X.

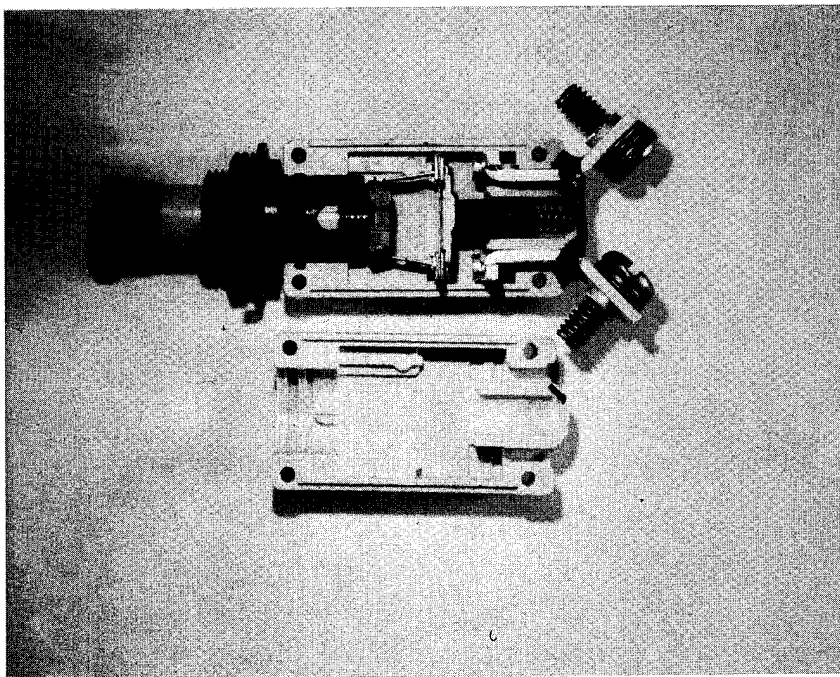
**Figure 3.3** Photo of a 10 A circuit breaker made by Klixon Division of Texas Instruments shown in the opened position. Magnification: about 1X.

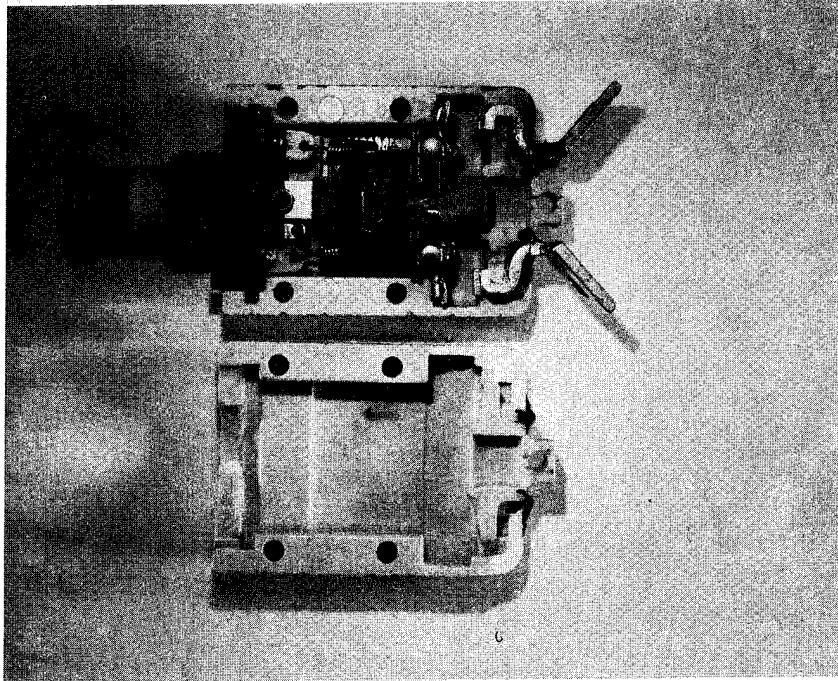
**Figure 3.4** Photo of a 10 A circuit breaker made by Mechanical Products shown in the opened position. Magnification: about 1X.

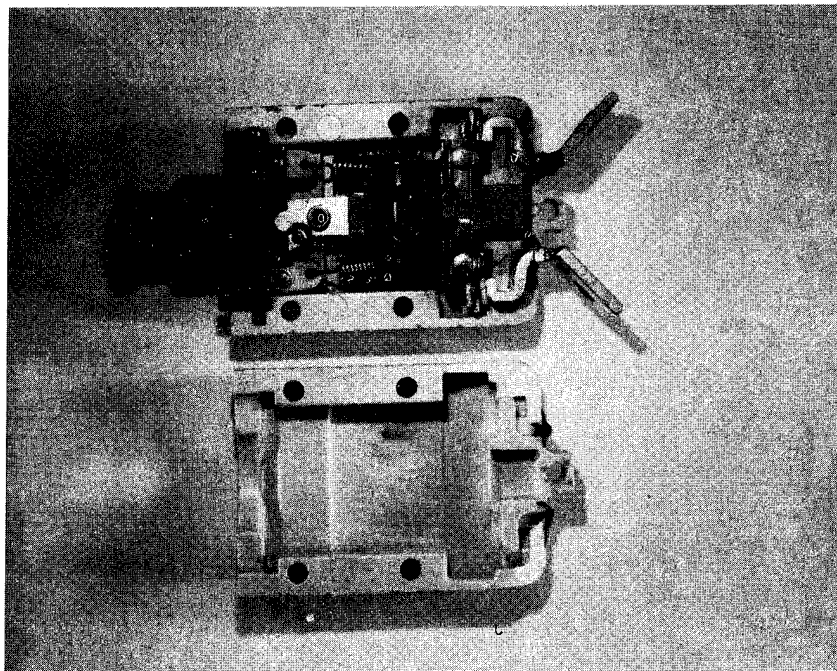
**Figure 3.5** Photo of a 10 A circuit breaker made by Mechanical Products shown in the closed position. Magnification: about 1X.

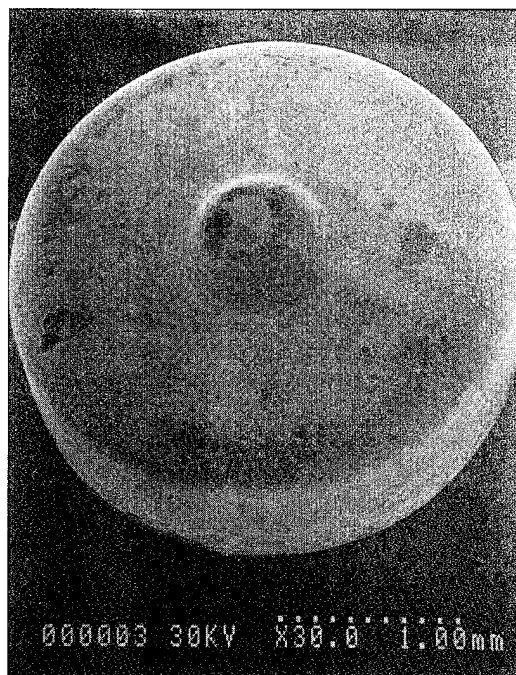
**Figure 3.8** Contact from a 10 A circuit breaker cycled 10,000 times with no load. Magnification: 30X.

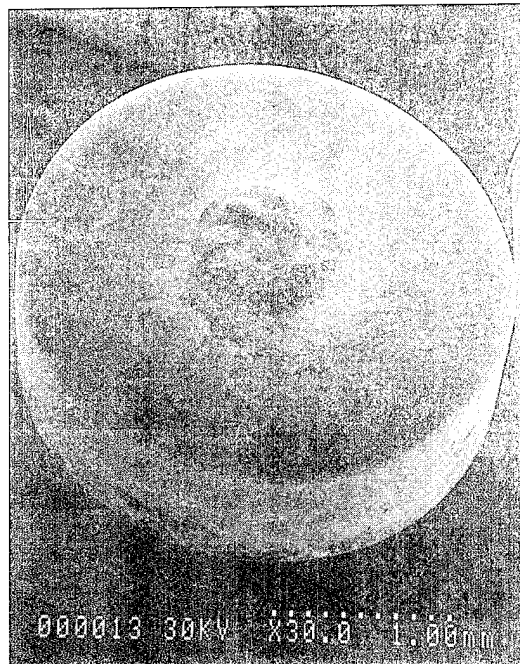
**Figure 3.10** Contact from a 10 A circuit breaker cycled 20,000 times at rated dc load current at 28 Vdc. Magnification: 30X.

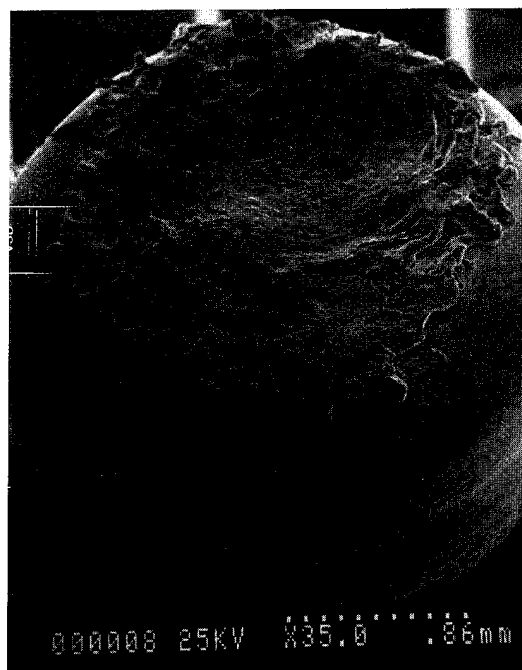
**Figure 3.20** Positive contact (anode) from 10 A aircraft circuit breaker after 10 interruptions at 1000 Adc. The duration of the current interruption was about 2 ms. Magnification: 35X.

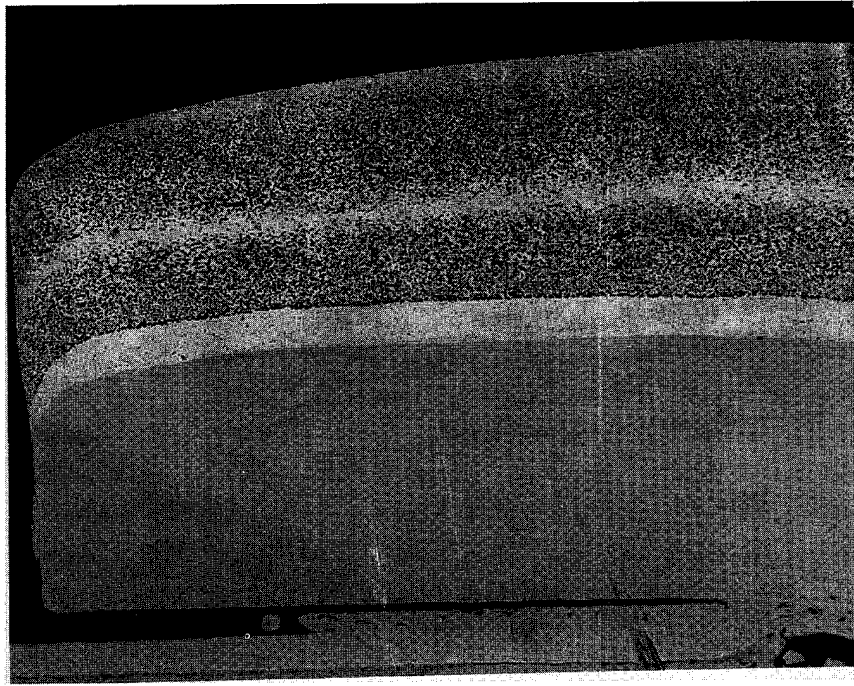
**Figure 3.21** Metallurgical microscope photograph of a circuit breaker contact. The speckled appearance on the upper half of the contact indicates the AgCdO alloy. Magnification: about 100X.

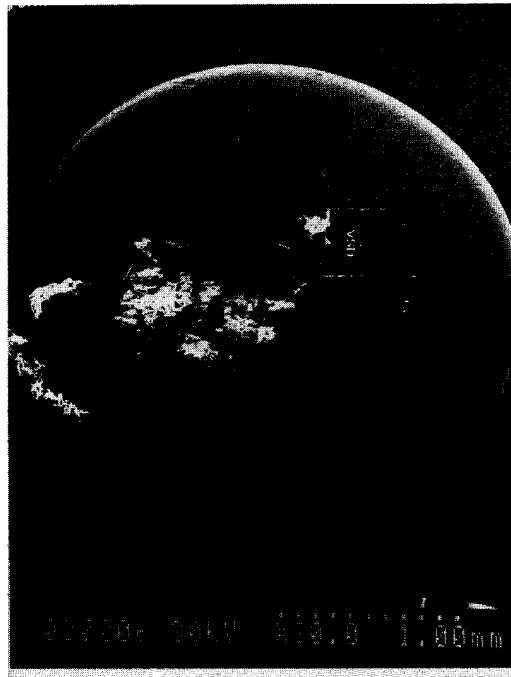
**Figure 3.22** A circuit breaker contact which has been contaminated by the housing material - a glass-filled polyester. Since the material is non-conductive, it charges up in the SEM and appears bright white as in the photo below. Magnification: 30X.

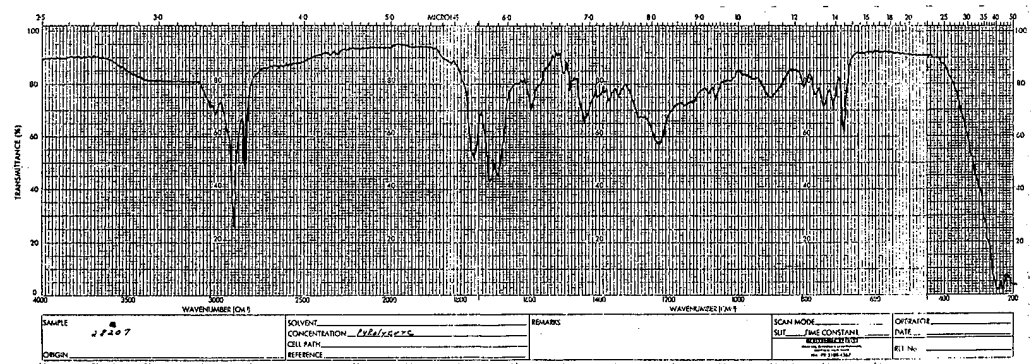
**Figure 3.23** A sample of infrared spectrographic analysis data identifying the acrylic fibers found inside a switch.

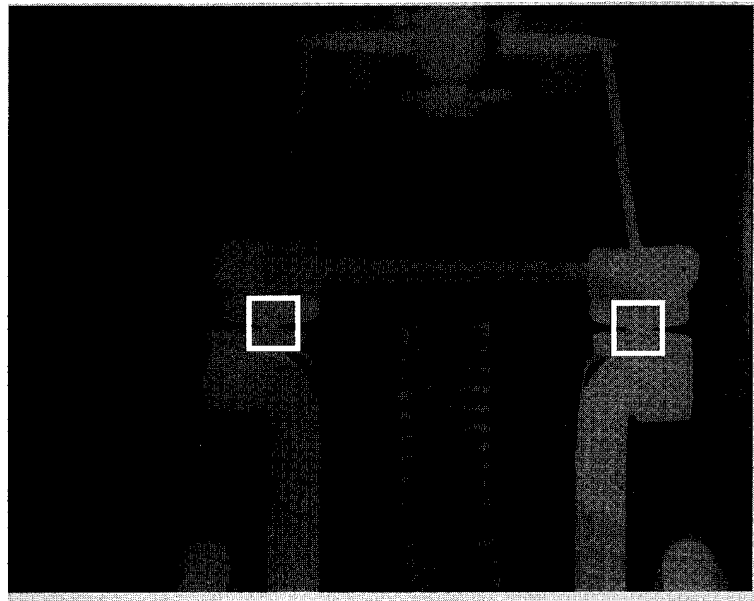
**Figure 3.24** An X-ray radiograph of a circuit breaker operating mechanism. The point of contact between stationary and moving contacts is visible in the photograph and is shown by the boxes. Magnification: about 5X.

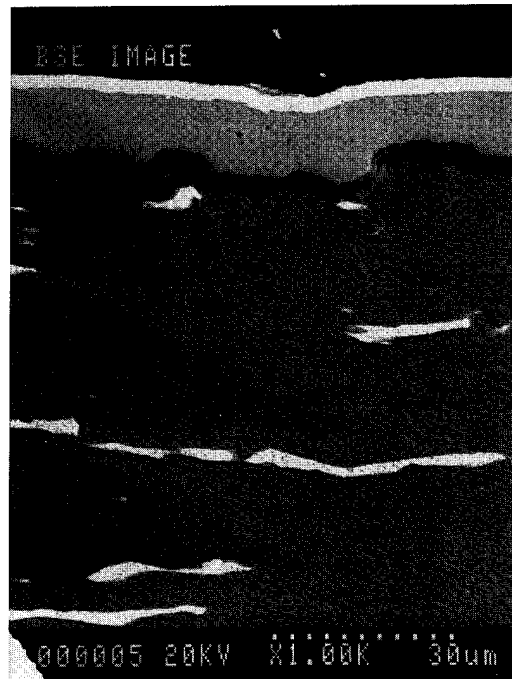
**Figure 4.2** SEM backscatter image of the cross section of a contact pin showing plating thickness. Magnification: 1000X.

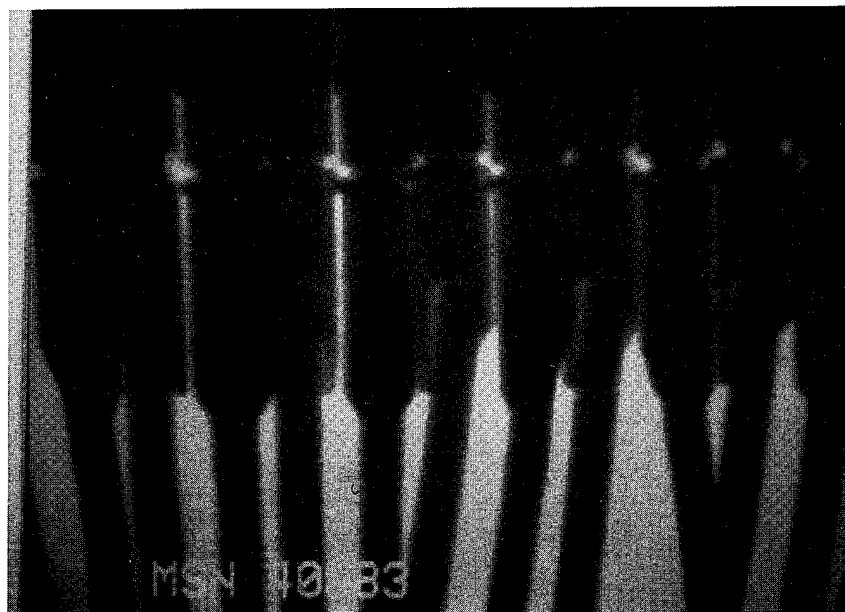
**Figure 4.3** Microfocus x-ray radiograph of solder reflow anomaly on a connector. Note the missing solder in alternating contacts. Magnification: about 5X.

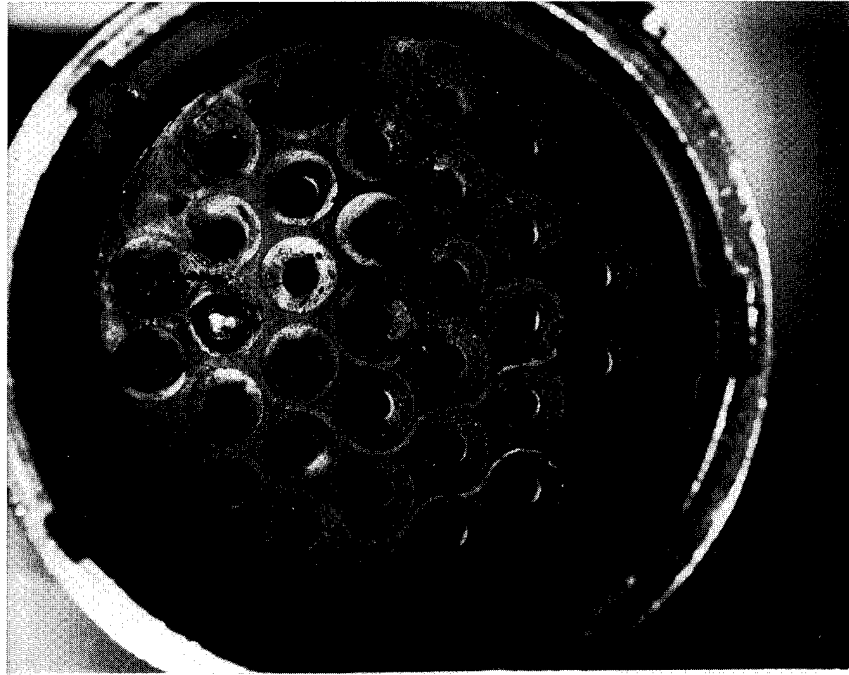
**Figure 4.4** Decomposition and cracking of a connector insert occurring as a result of wire insulation breakdown. Magnification: about 3X.

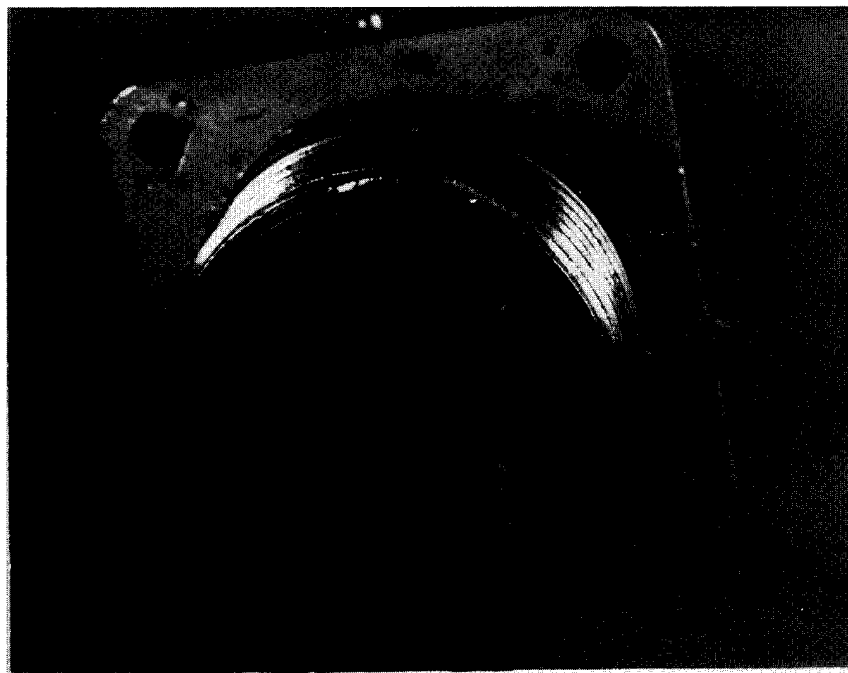
**Figure 4.5** Damage to insert at the rear of the connector after wire insulation breakdown. Magnification: about 2X.

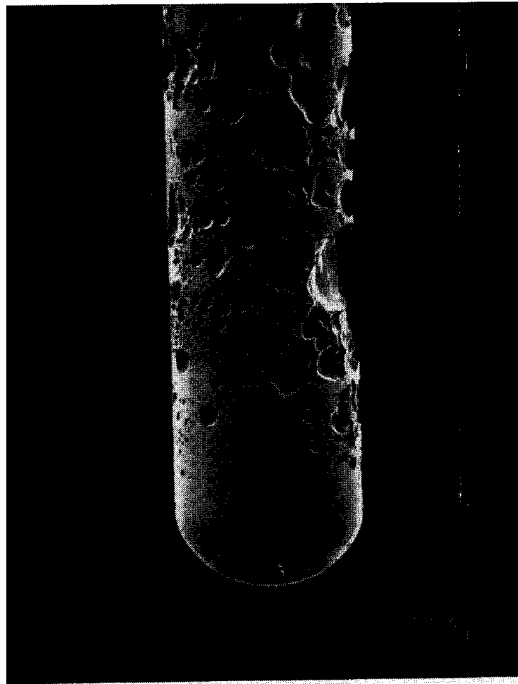
**Figure 4.6** Effect of acid etch on gold plated contact pin. Magnification: 35X.

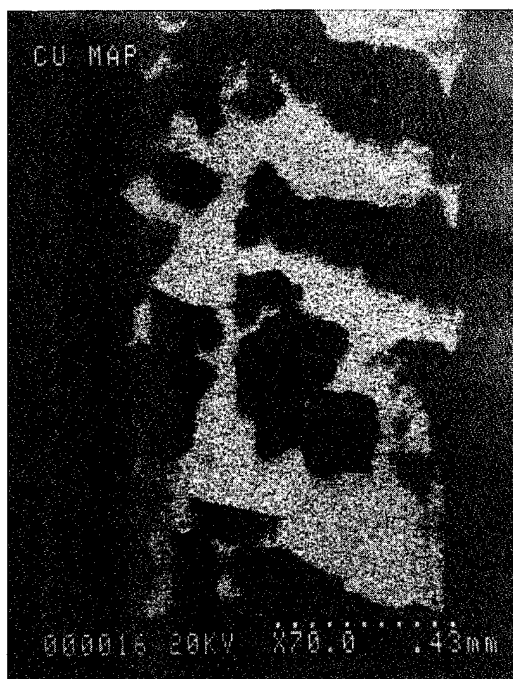
**Figure 4.8** Copper EDS map of etched connector pin. Magnification: 70X.

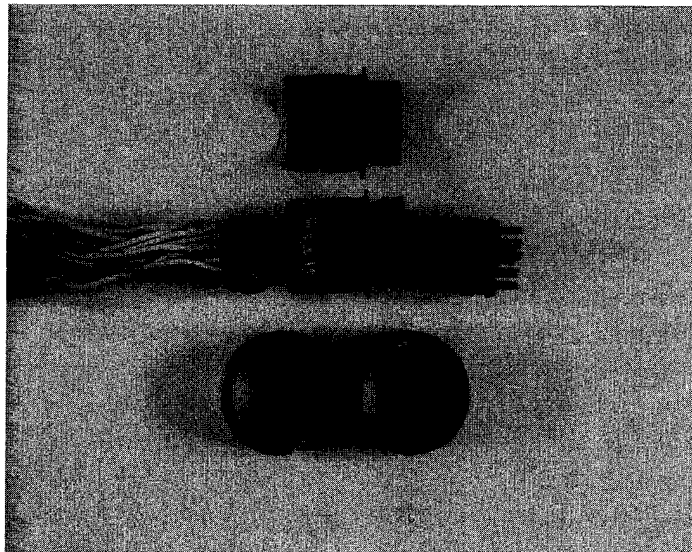
**Figure 4.9** Parts of a connector shell cut open to facilitate disassembly. Magnification: about 0.5X.

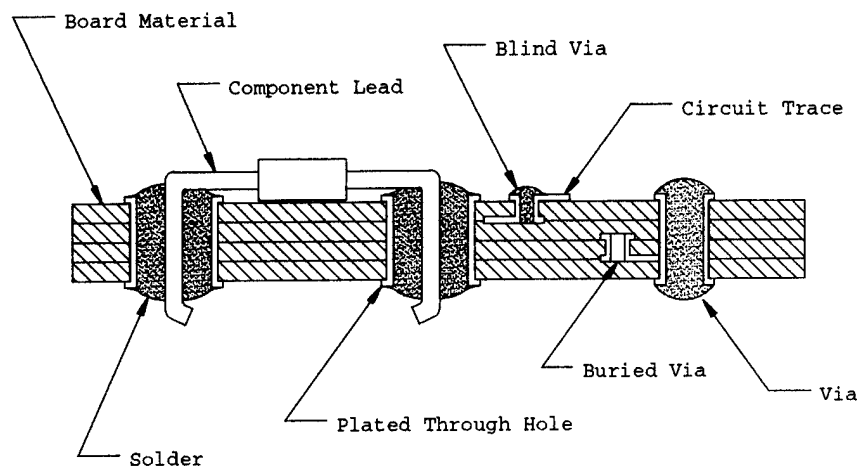
**Figure 5.1** Simplified diagram of a multi-layer printed wiring board.

**Board Material** The board material is an insulating substrate that provides mechanical support for components and electrical insulation between the circuit traces. A glass-fiber and epoxy resin composite (glass-epoxy) is the most common material.

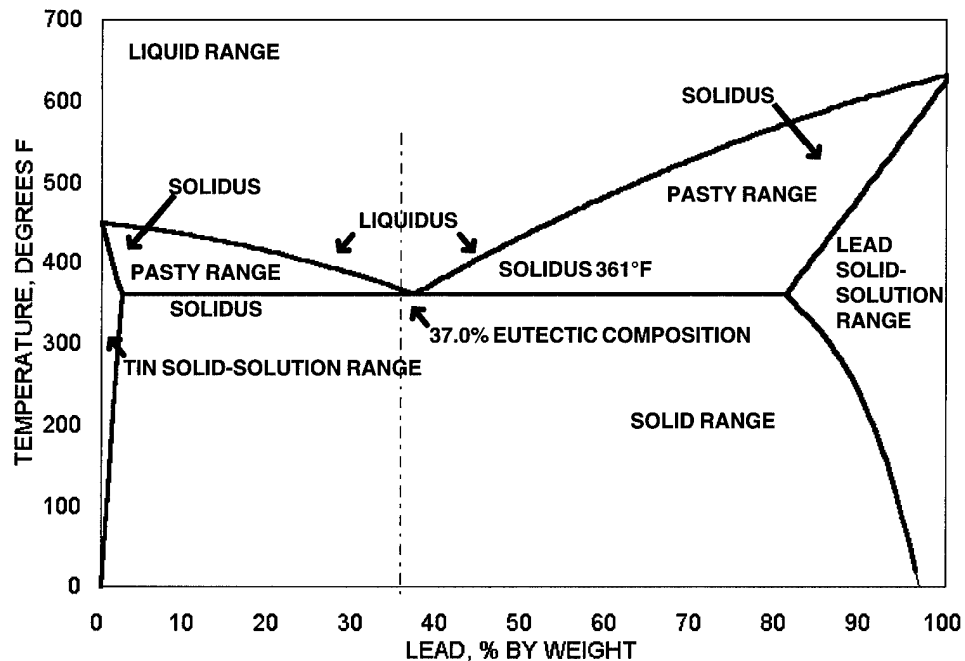
**Figure 5.3** Phase diagram of tin-lead alloy used for electronic solder.

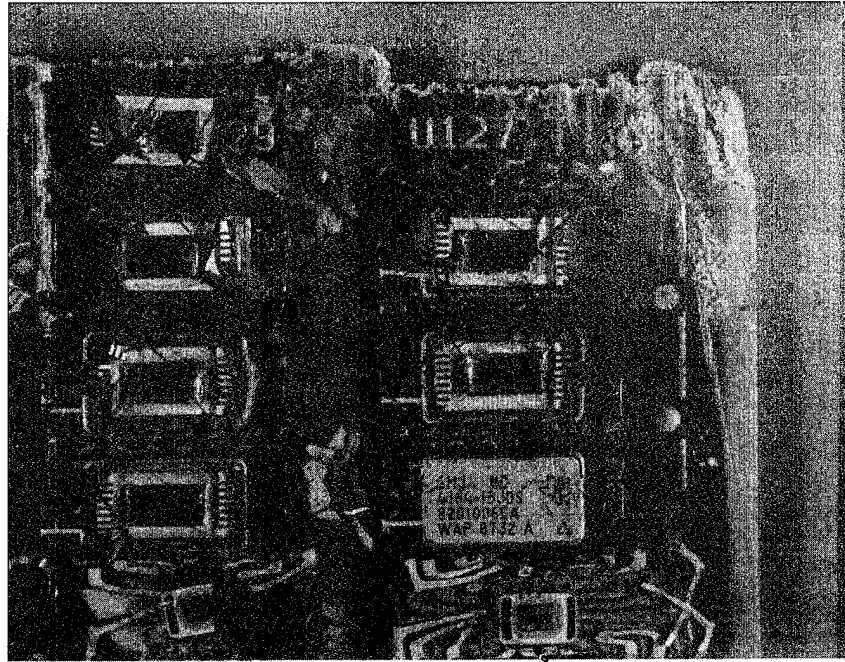
**Figure 5.4** Segment of a multi-layer PWB showing severe impact damage. Magnification: about 2X.

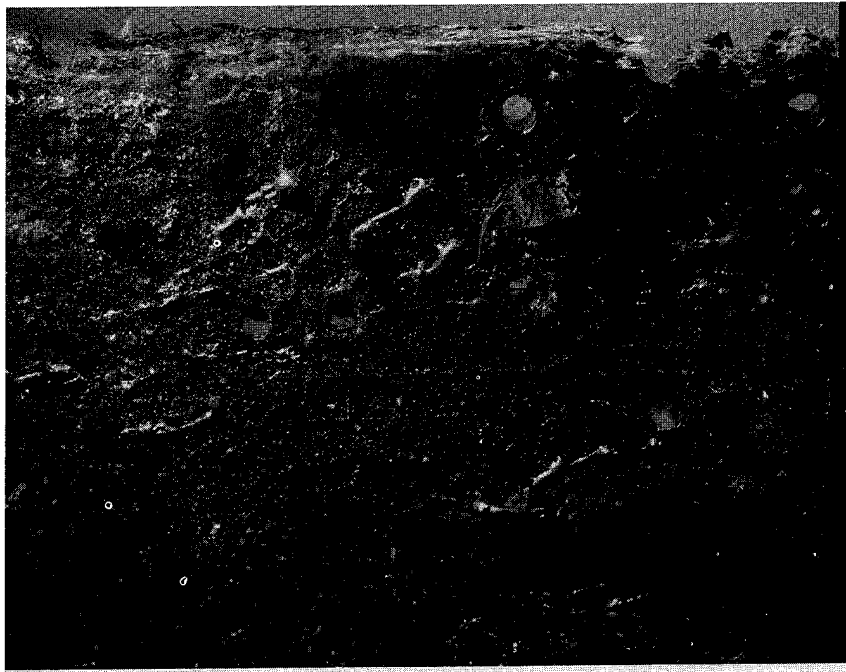
**Figure 5.6** Melted solder displaced on PWB during impact. Magnification: about 2X.

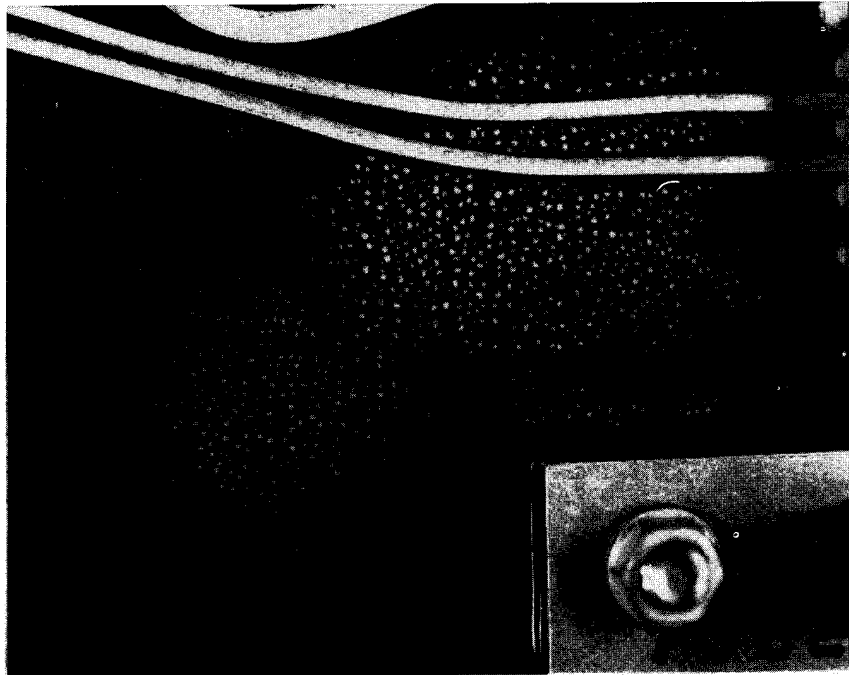
**Figure 5.7** Fingerprint left on PWB from incomplete cleaning during fabrication. Magnification: about 3X.

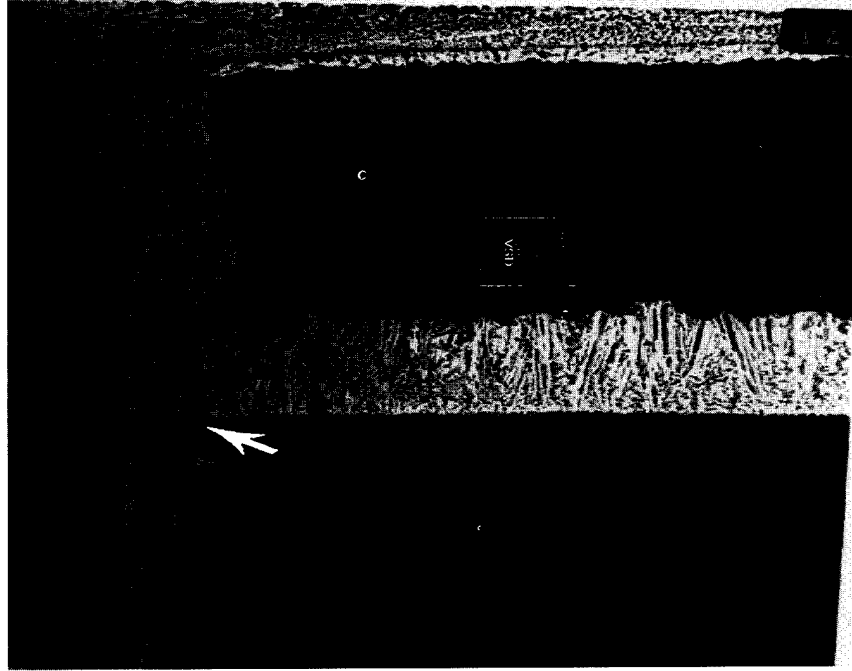
**Figure 5.9** Microphotograph of plated-through-hole showing incomplete attachment to internal layer of multi-layer board as shown by the arrow. Magnification: about 750X.

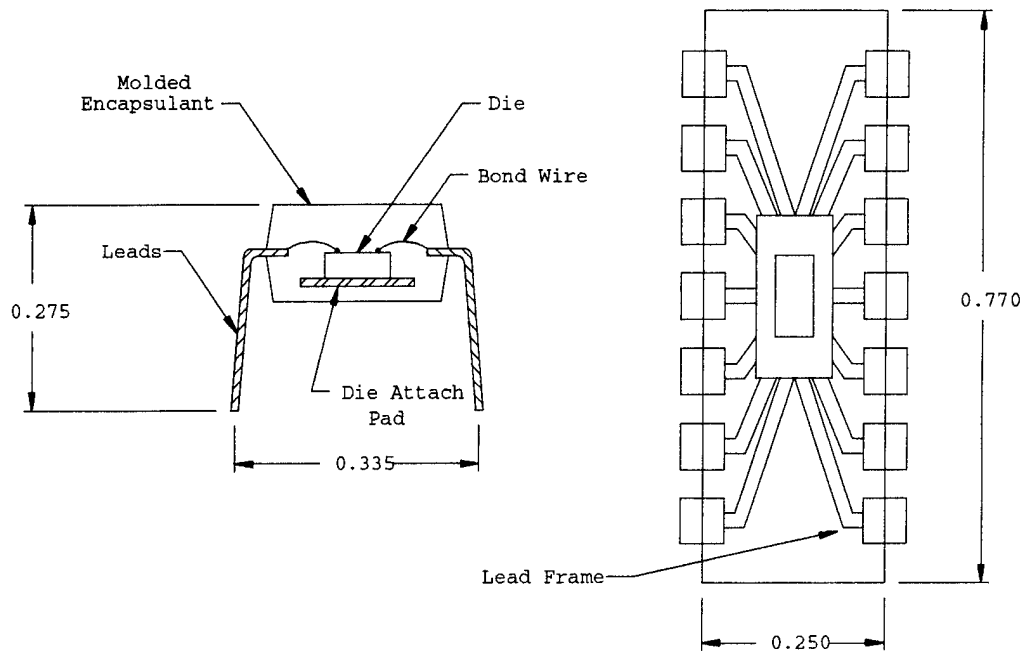
**Figure 6.4** The basic construction of a molded plastic IC package.

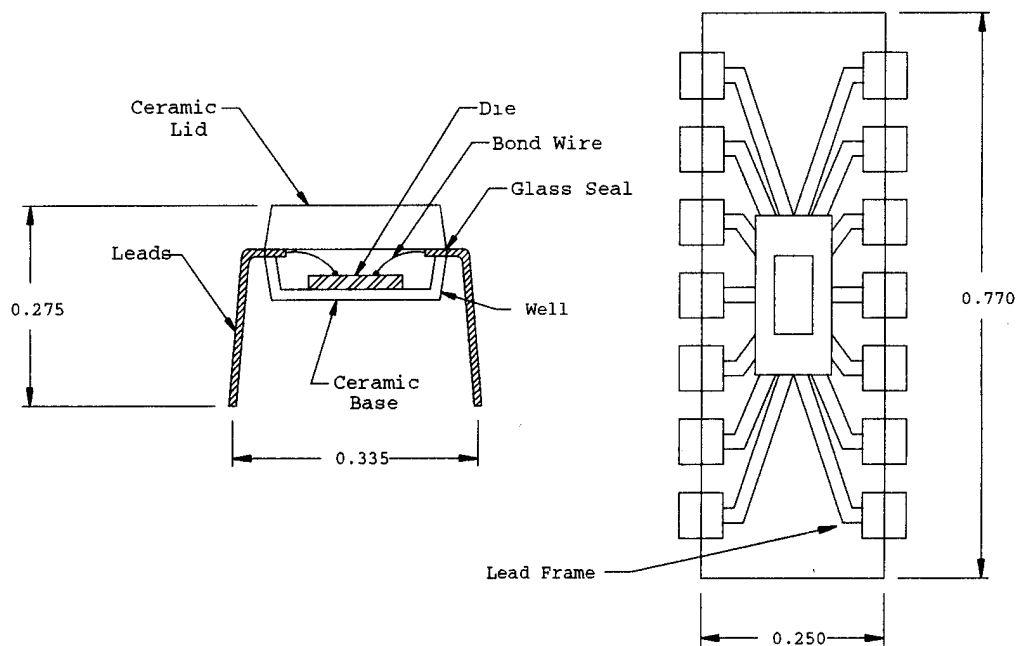
**Figure 6.5** The basic construction of a ceramic IC package (CERDIP).
