WL-TR-95-4004

# AIRCRAFT MISHAP INVESTIGATION HANDBOOK FOR ELECTRONIC HARDWARE

| REPORT DOCUMENTATION PAGE | | | Form Approved<br>OMB No. 0704-0188 | |
|---|---|---|---|---|
| 13. ABSTRACT (Maximum 200 words)<br><br>This handbook contains procedures and guidelines to aid in the analysis and investigation of electrical and electronic components involved in aircraft mishap investigations. Failure analysis techniques for the evaluation of electrical and electronic components are summarized for lamps, wiring, connectors, circuit breakers, printed wiring boards, and microelectronic devices. Techniques using optical and scanning electron microscopy (SEM) for the analysis of these components are described. Energy dispersive X-ray analysis (EDAX) of elemental constituents, X-ray radiography, and specialized electrical measurements are also described. | | | | |

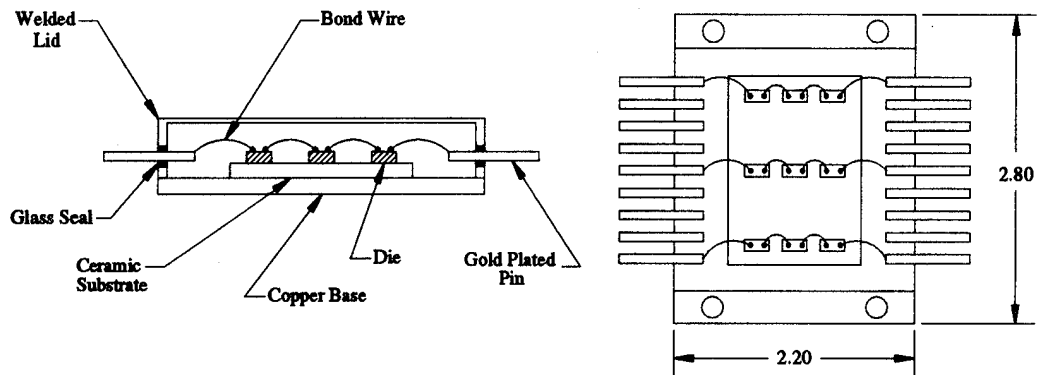
**Figure 6.6** The basic construction of a hybrid IC package.

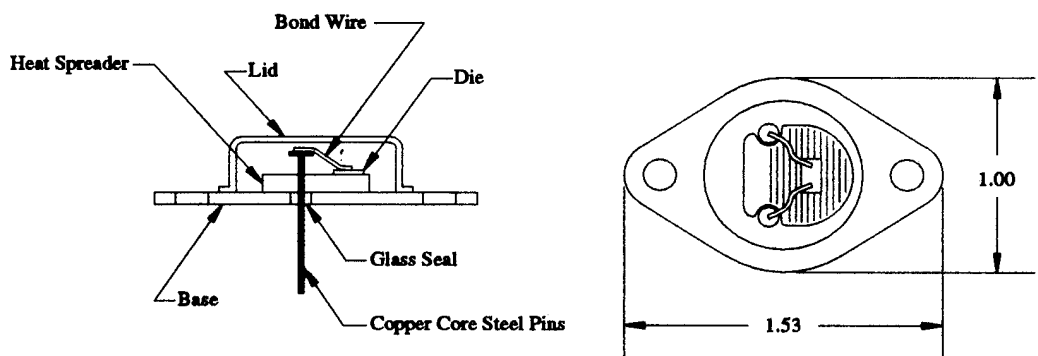
**Figure 6.7** The basic construction of a typical metal case transistor package.

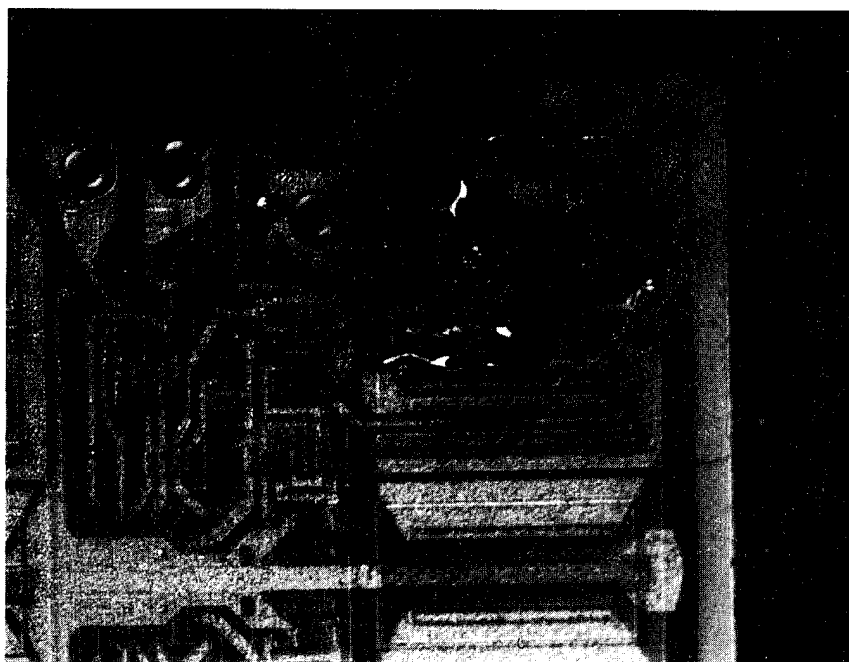
**Figure 6.11** Figure 6.11 shows melted aluminum metallization on the output transistor of an operational amplifier. Magnification: about 60X.

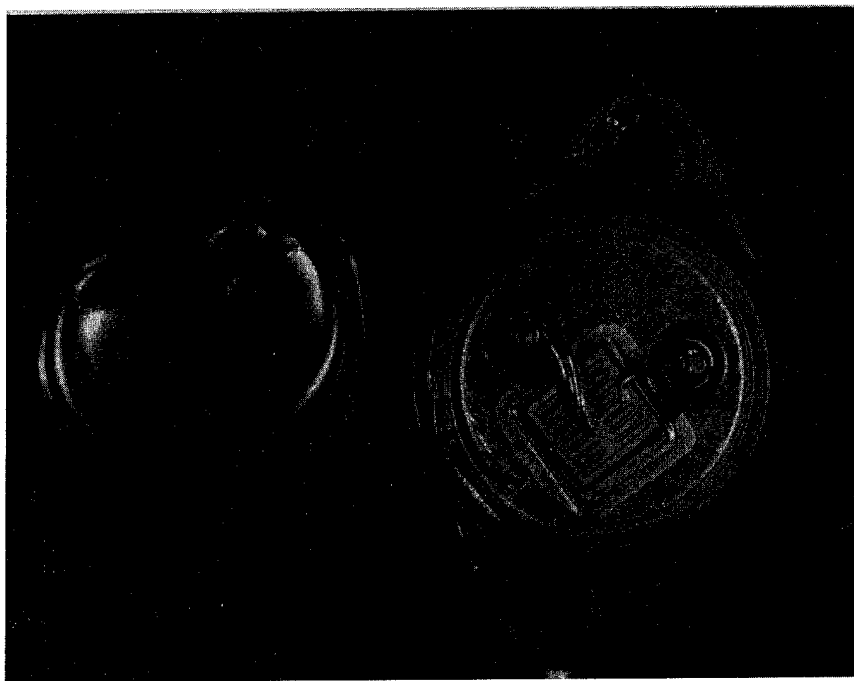
**Figure 6.13** Damaged power transistor removed from an F-111. Magnification: about 2X.

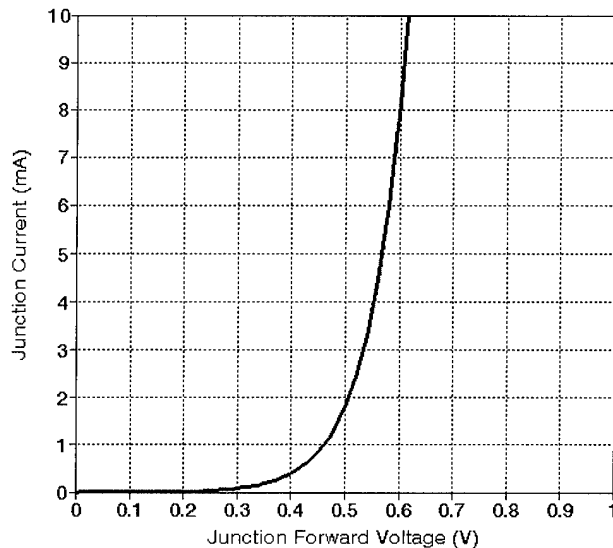
**Figure 6.14** Curve tracer results showing forward conduction characteristics of a good silicon diode.

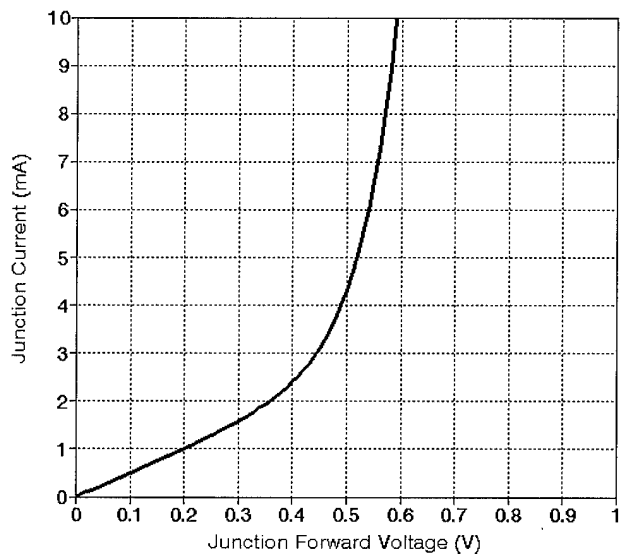
**Figure 6.15** Curve tracer results showing forward conduction characteristics of a silicon diode with excessive forward leakage current.

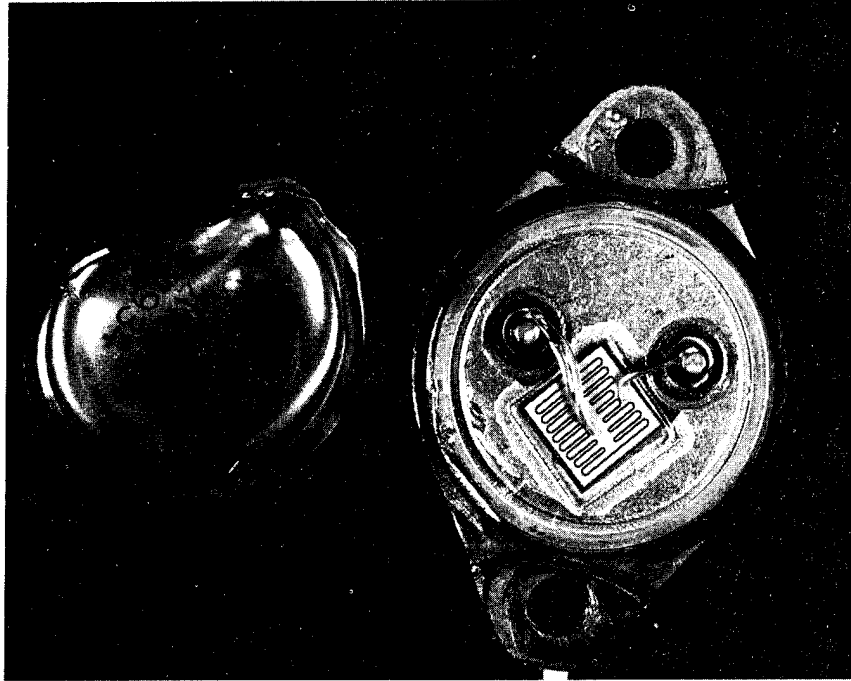
**Figure 6.16** Figure 6.16 shows a TO-3 package power transistor which has been opened by mounting in a lathe and thinning the lid near the bottom. Magnification: about 2X.

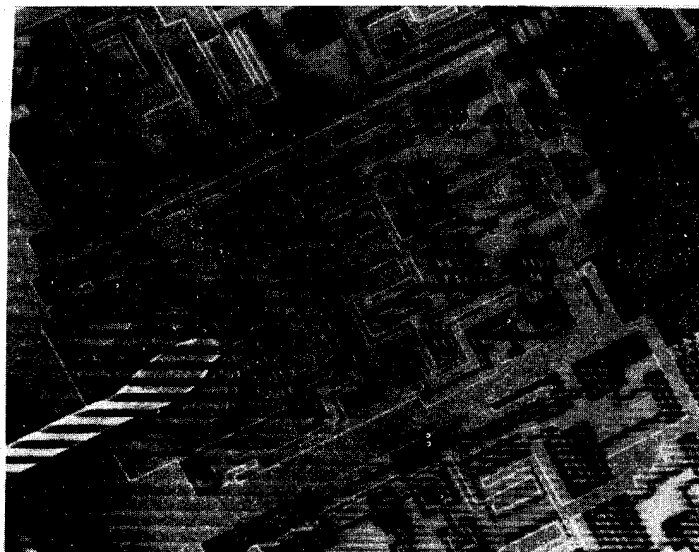
**Figure 6.19** Stroboscopic voltages contrast of a memory IC shows different frequencies of operation. Magnification: about 500X.

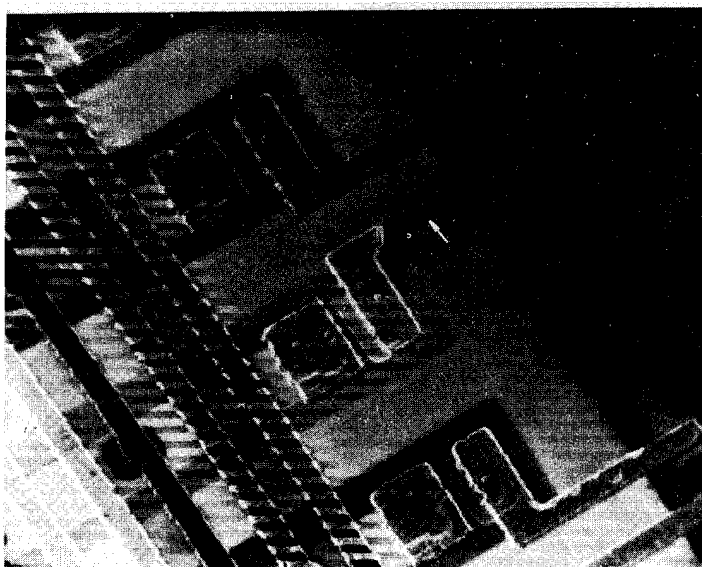
**Figure 6.20** Broken interconnect made visible by the voltage difference across break. See arrow in center of photograph. Magnification: about 1000X.

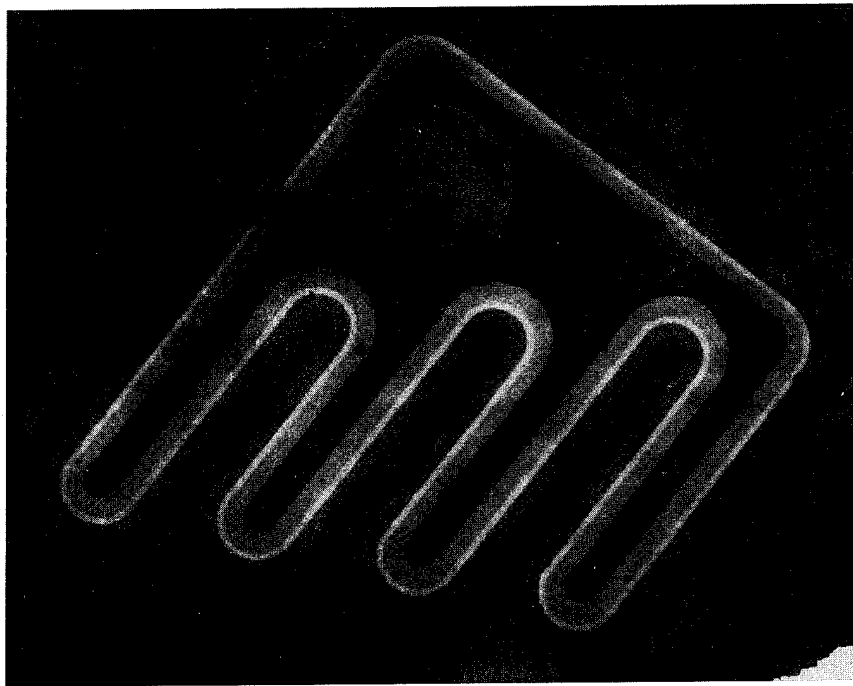
**Figure 6.21** EBIC photo of NPN transistor junction. Magnification about 20X.
