Wetlands Research Program Technical Report WRP-SM-5

Construction and Monitoring of Water and Sediments in Wetlands Created in the Black Butte Reservoir Fluctuation Zone, Orland, California

by Charles W. Downer

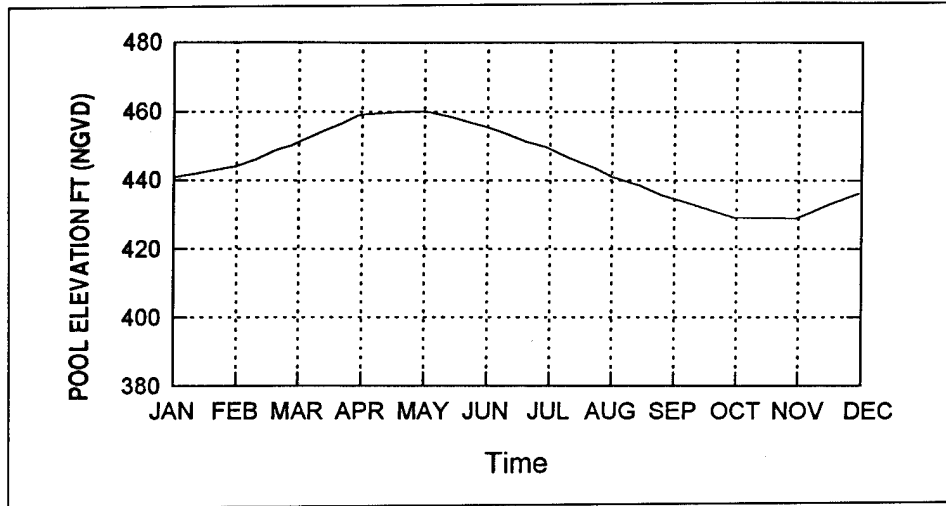
Figure 2. Rule curve for Black Butte Reservoir

The lake is operated on the rule curve shown in Figure 2.¹ The actual recorded water levels for the period October 1975 to October 1991 are plotted in Figure 3.¹ The rule curve dictates a water level fluctuation of 30 ft during the year, but the actual variation during the year can be as much as 70 ft.

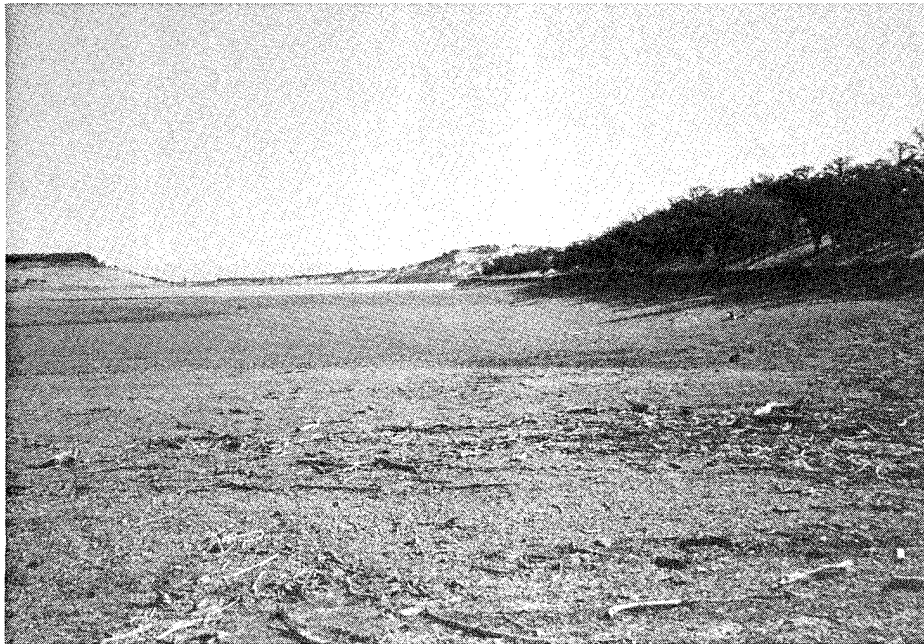
Figure 4. Exposed mud flats at Black Butte Reservoir

This type of operation creates large mud flats in the reservoir during the summer and fall months. These mud flats are largely unvegetated or are covered by cockleburrs, with few desirable plants. See Figure 4.

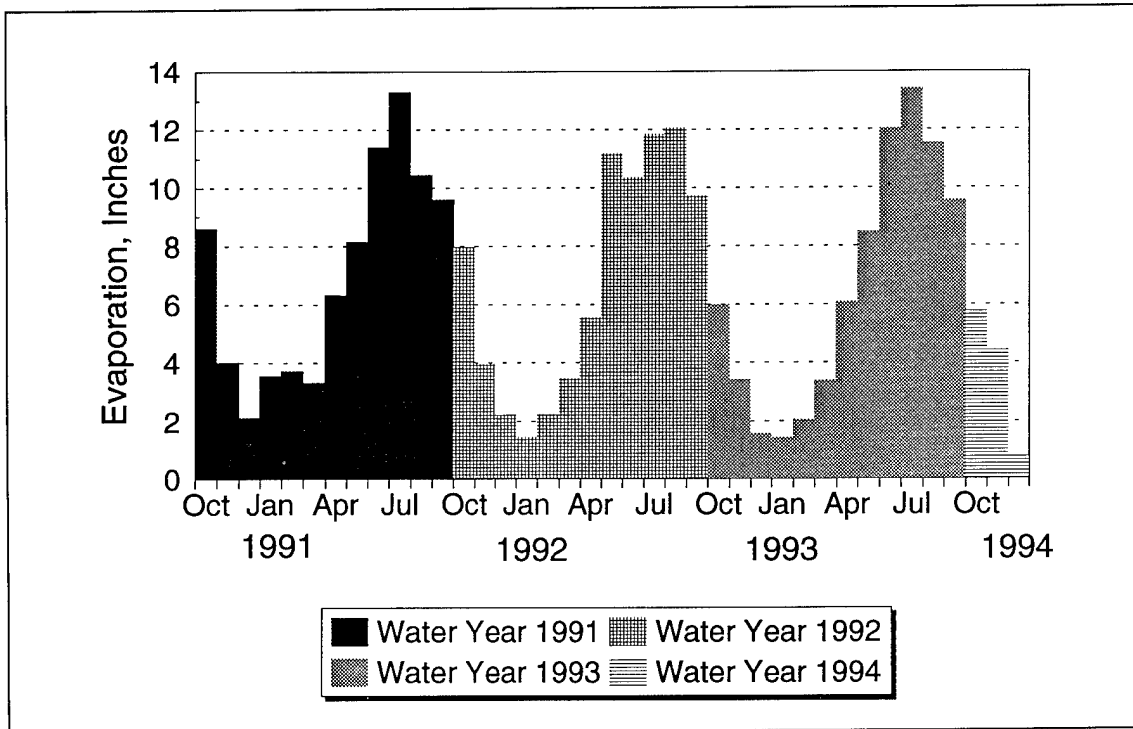
Monthly rainfall and evaporation levels are shown in Figures 12 and 13. Rainfall during the spring of 1992 and 1993 was well above normal. This produced a very large volume of runoff, which caused the reservoir to remain unusually high in these years. Although spring rainfall was very heavy, summer rainfall was actually below normal; there was no rainfall during the months of July, August, and September during either year. Rainfall patterns during 1994 were more near the normal levels. Pan evaporation measured at the site did not vary significantly from long-term levels. Pan evaporation rates were high, 20 to 33 cm per month, during late spring and summer when the wetlands contained water but were not inundated by the reservoir.

Figure 12. Monthly rainfall at Black Butte Reservoir

Figure 13. Monthly pan evaporation at Black Butte Reservoir

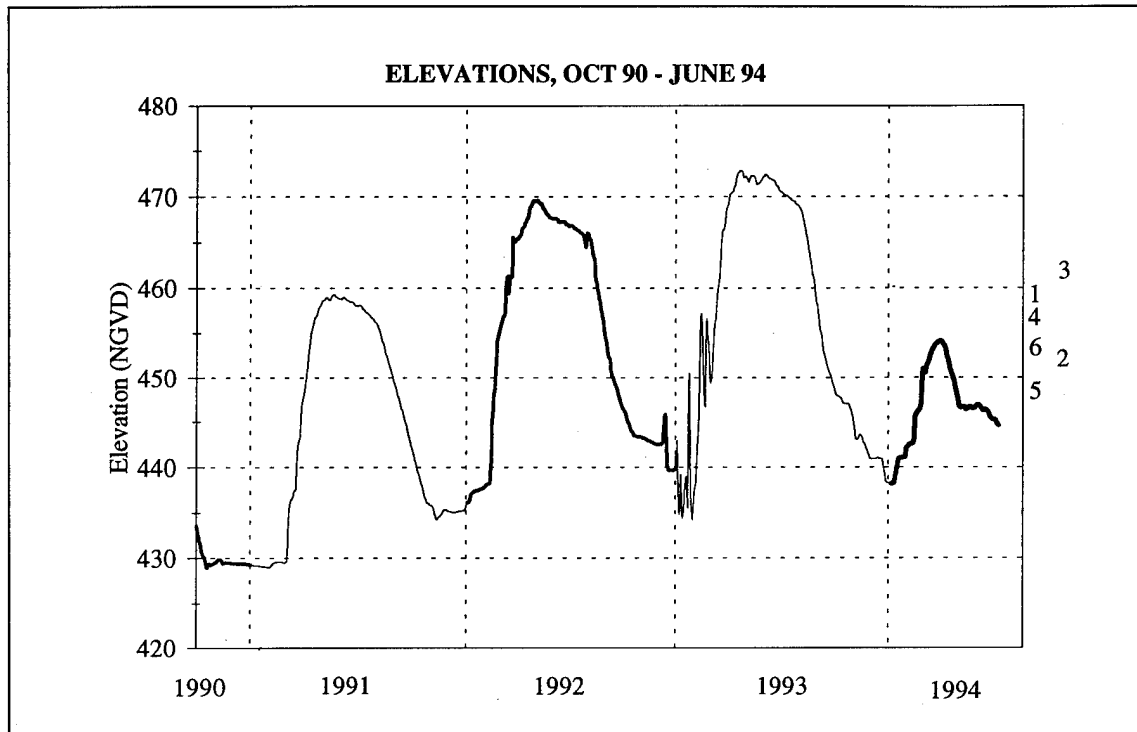
Figure 16. Black Butte Reservoir water surface elevations

Reservoir levels and wetland inundation. Water levels in Black Butte Lake from October 1991 through July 1994 are shown in Figure 16. The

elevation of the six wetlands are shown on the right-hand side of Figure 16. As described earlier, the wetland construction was complete in February 1992. Since their construction, the wetlands have been inundated much of the time. Unusually heavy rainfall and a resulting reduction in the need for irrigation water resulted in unusually high summer water levels. Because of this, the wetlands were inundated for much of the summer growing seasons in 1992 and 1993. Water levels in 1994 more closely mimicked "normal" pool operations. The water levels for 1994 were slightly below the rule curve. Only Wetlands 2 and 5 were inundated by the lake during 1994. The history of inundation of each of the wetlands is shown in Table 5. The wetland is considered inundated once the lowest place on the dike, the spillway, is below the reservoir water surface elevation.

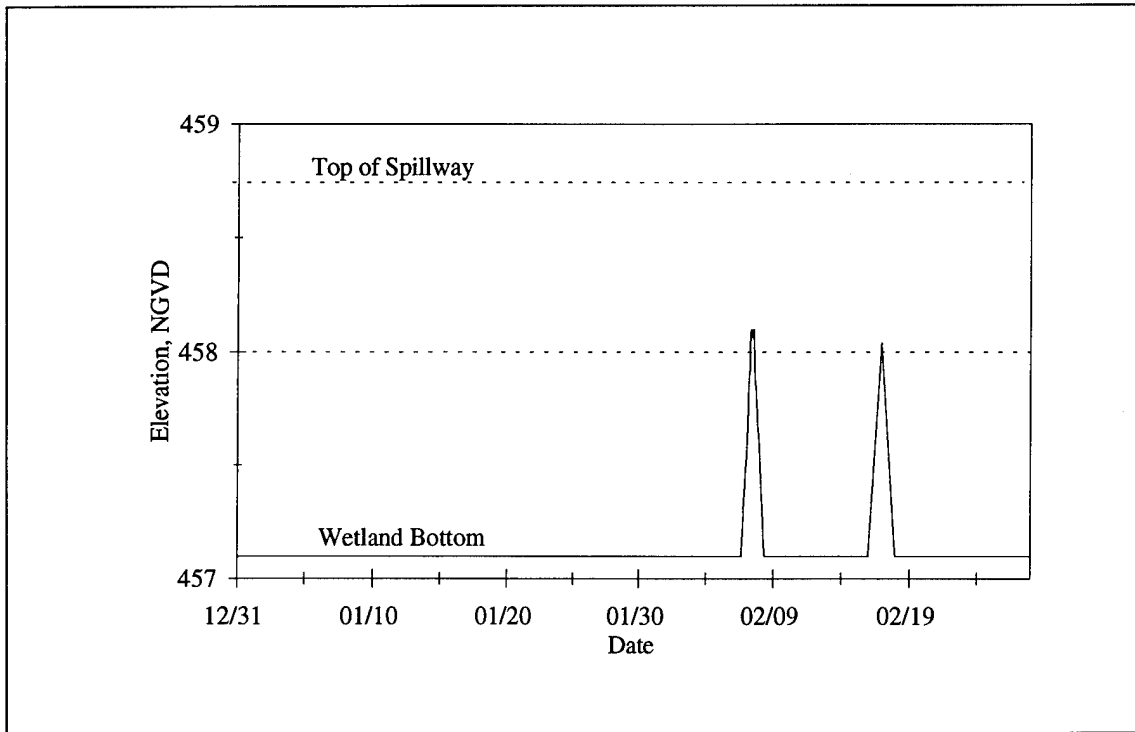
Figure 17. Wetland 1, 1994 water surface elevations

Wetland 1. The 1994 water levels in Wetlands 1 are shown in Figure 17. Wetland 1 was not inundated by the reservoir during 1994. Heavy rainfall on February 6 and 7 caused enough runoff to nearly fill the wetland, leaving 0.304 m (1.0 ft) of water in the wetland. Because of large seepage losses, the wetland was dry by midday on February 8 (Figure 17). A similar rainfall event occurred on February 17, but again, large seepage losses left the wetland dry 2 days later. No significant rainfall events occurred after this date except in late April, which left water in the wetland for only a few days. The wetland was dry for the rest of the summer. No overflows from the wetland occurred during the 1994 monitoring period. Seepage losses from the wetland are estimated at 0.39 m/day (1.27 ft/day).

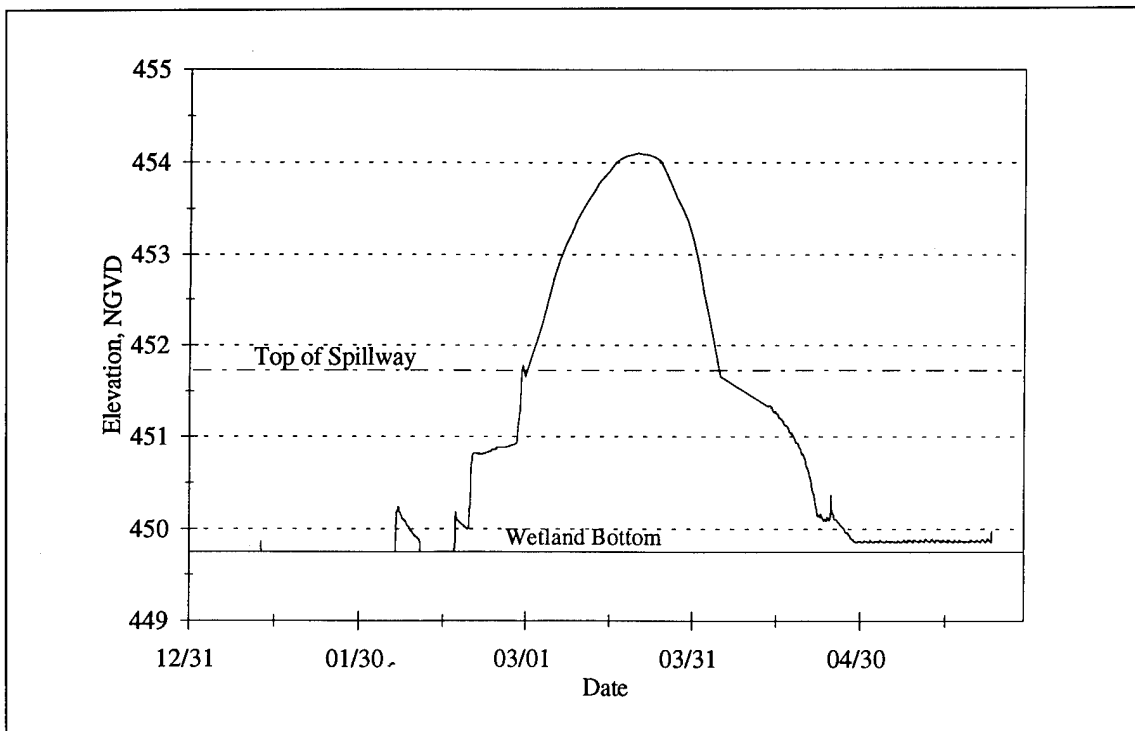
Figure 18. Wetland 2, 1994 water surface elevations

Wetland 2. Water surface elevations in Wetland 2 are shown in Figure 18. Wetland 2 was partially filled by early February rains. The rising lake water level kept seepage losses from Wetland 2 small during February. As described earlier, Wetland 2 was inundated by the reservoir from March 2 until April 4. Once the lake receded, water loss as a result of seepage began, slowly at first, and then faster as the lake receded. A late April rain delayed the eventual drying of the wetland. Wetland 2 held water until the first of May. There were no outflows from Wetland 2 in 1994. The peak seepage rate from the wetland is estimated at 0.064 m/day (0.21 ft/day).

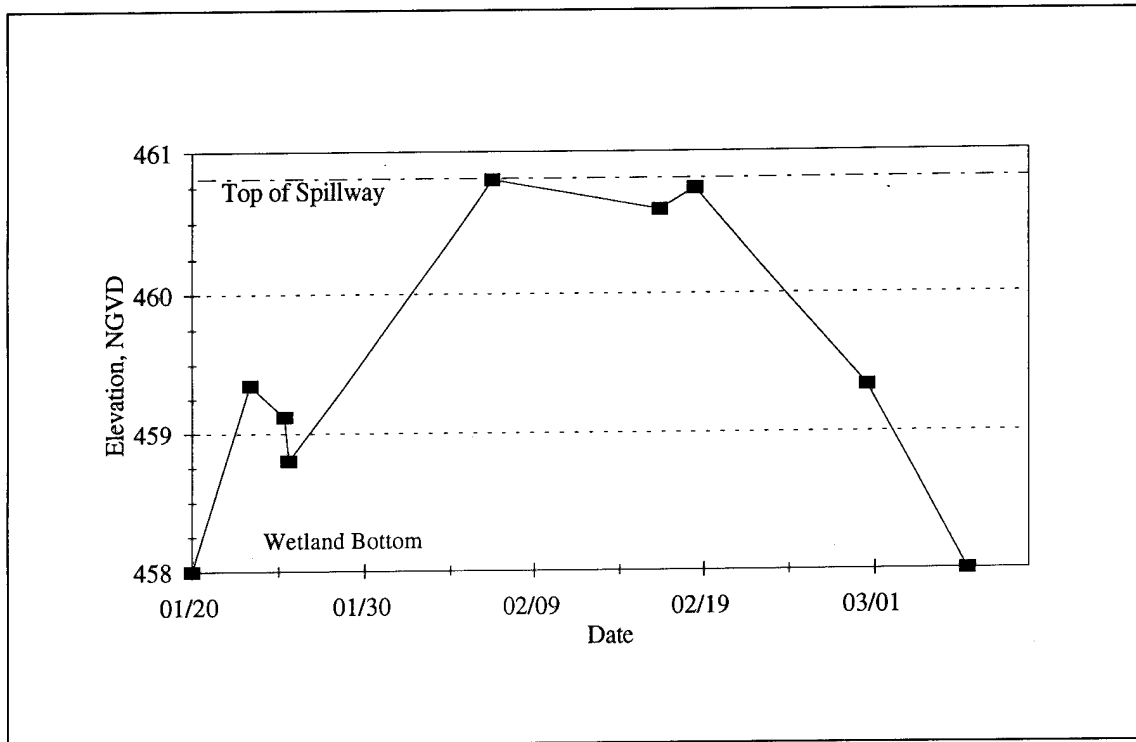
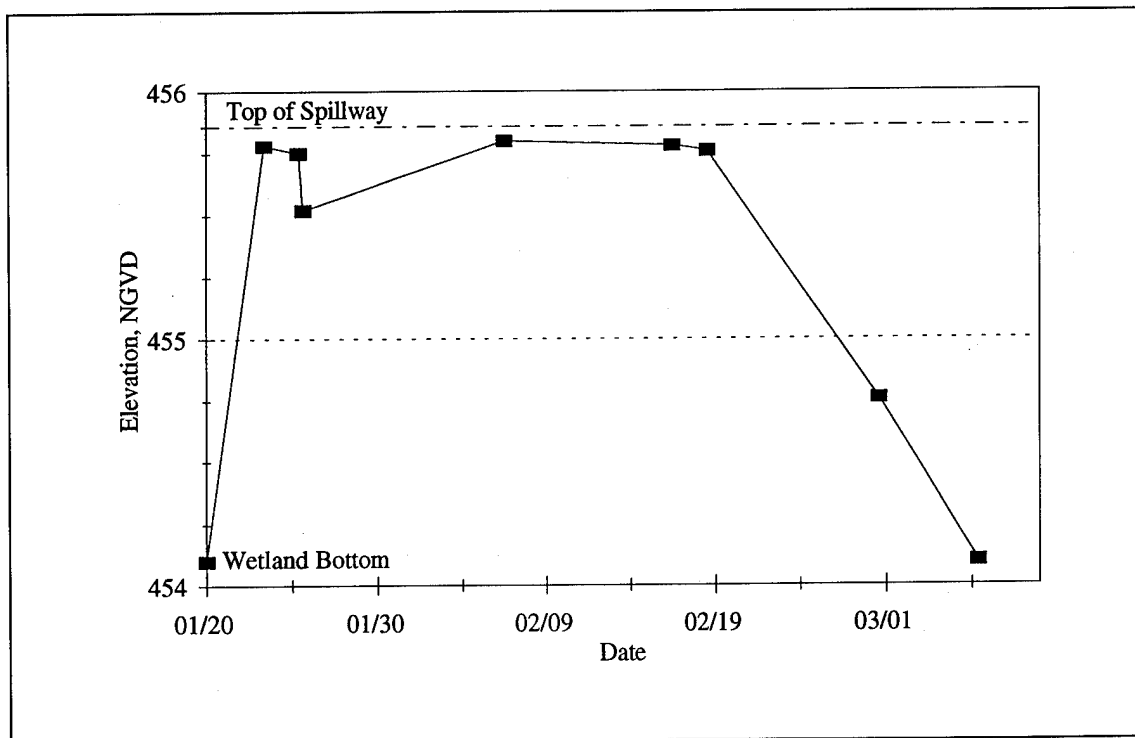
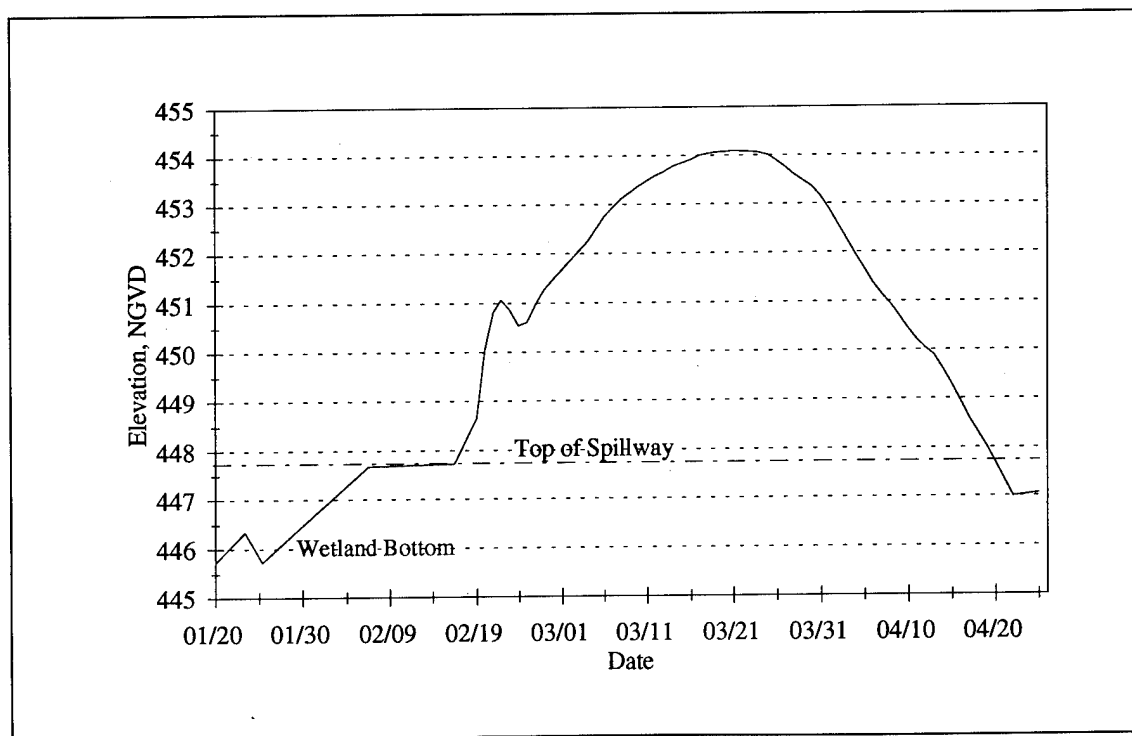
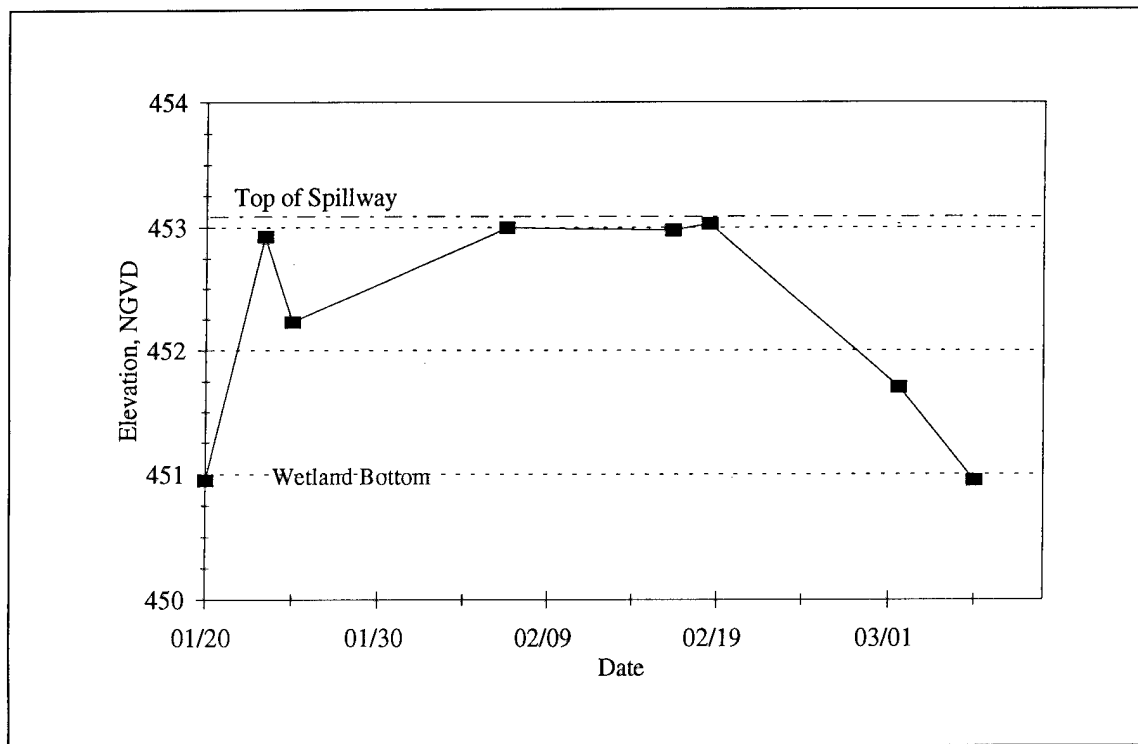
Wetlands 3-6. Observed wetland water surface elevations for Wetlands 3-6 are shown in Figures 19-22. The water levels in Wetlands 3, 4, and 6 followed a similar pattern. Late January precipitation filled the wetlands. Frequent rainfall events in February kept the wetlands full and caused small overflows from the wetlands. Once the frequency of rainfall lessened, the wetland water level quickly dropped; the wetlands were dry in early March. Seepage losses from Wetlands 3, 4, and 6 are estimated at 0.057 m/day (0.19 ft/day), 0.033 m/day (0.11 ft/day), and 0.042 m/day (0.14 ft/day), respectively. Wetland 5 was filled in late January, but was inundated by the lake from February 20 to April 21 (Figure 21).

Figure 19. Wetland 3, 1994 water surface elevations

Figure 20. Wetland 4, 1994 water surface elevations

Figure 21. Wetland 5, 1994 water surface elevations

Figure 22. Wetland 6, 1994 water surface elevations

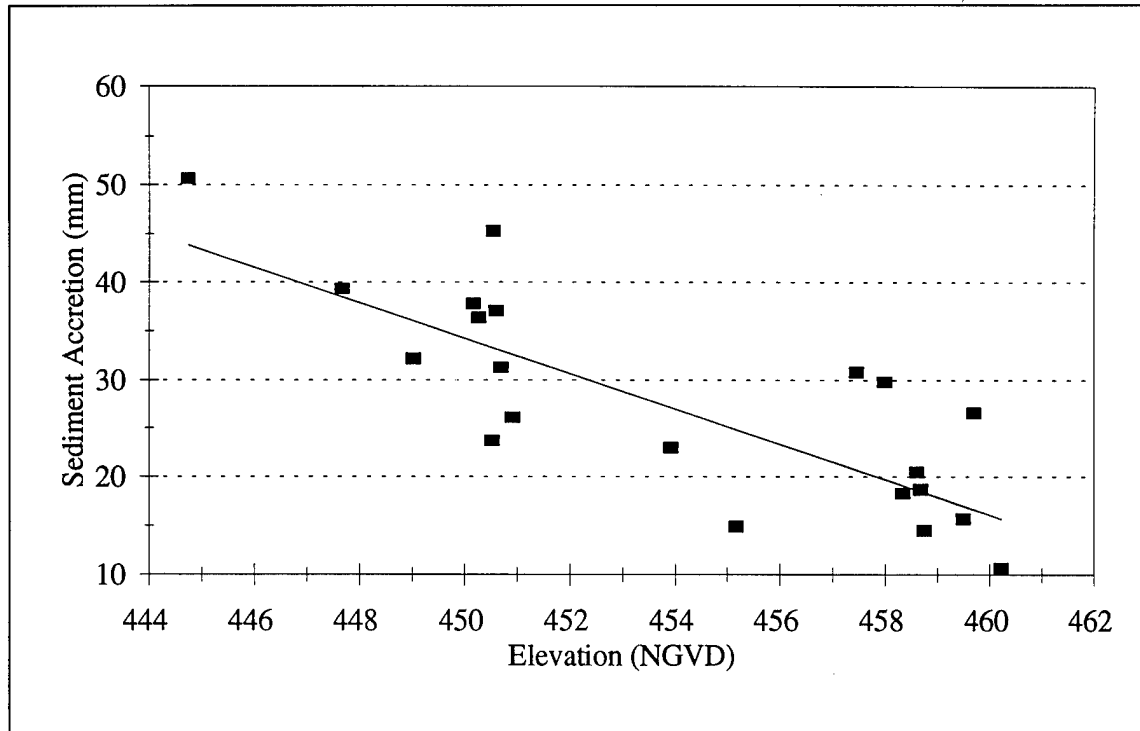
Figure 23. Data and regression from 1992 feldspar pad sampling of Wetlands 1 and 2

$$\text{Sediment Accretion (mm)} = 853.29 - 1.82 \text{ Elevation (NGVD)}$$

The Correlation Coefficient (R^2) value was 0.64, indicating that a trend in the data does exist. A regression of the 1992 data produced an R^2 value of only 0.30. All accretion/accumulation data showed similar trends of increasing sedimentation at lower elevations. The trend between mass accumulation on the feldspar pads and elevation for 1992 was stronger, $R^2 = 0.66$, than the trend for sediment accretion. A regression of all 31 data points of accretion (millimeters) on the feldspar pads from 1992 and 1993 versus elevation (NGVD) yielded an R^2 of 0.51, indicating a weak relation between sediment accretion and elevation. While this analysis indicates that sediment accumulation is increasing with decreasing elevation, many other variables such as drainage basin characteristics and time of inundation also influence the sedimentation process. A plot of all sediment accretion data is shown in Figure 24.
