Environmental Effects of Dredging

Vol D-95-2

Eagle Harbor Superfund Project

by
Eric E. Nelson, Amy L. Vanderheiden, and A. David Schuldt

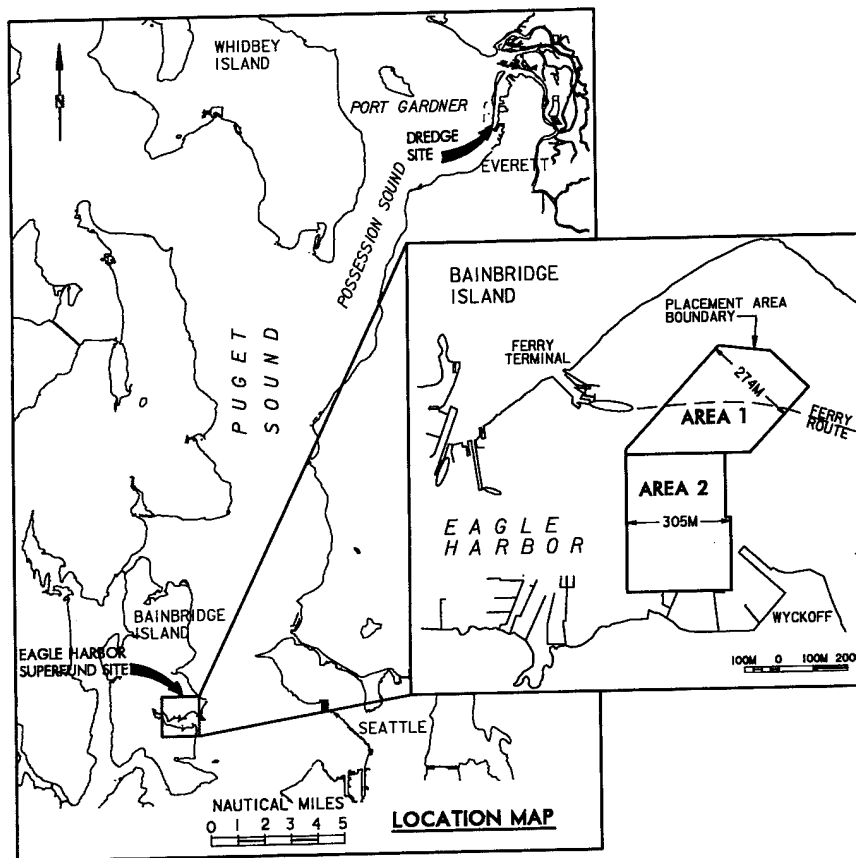
Figure 1. Eagle Harbor Superfund site

tion of the placement area had particularly soft bottom sediments. Thus, the northern portion of the site required a placement method that was rapid enough to place material in the 40-minute interval between ferry trips, while the southern portion required a method that was slow enough to avoid resuspending contaminated sediments. Because of the apparent conflicting nature of these two requirements, different placement methods were specified for each area (Figure 1).

In the relatively unobstructed northern portion of the Harbor (Area 1), a standard placement procedure used at open-water disposal sites appeared to be the most efficient way to place the required amount of material in the short period of time available. In this procedure, a bottom-dump barge, towed or pushed by a tug, discharges its load while under way. However, without some controls, this placement method would have resulted in materials being deposited unevenly and at a rate that might have caused an unacceptable level of disturbance of existing sediments.

In the southern portion of the Harbor (Area 2), where bottom sediments were particularly soft, the goal was to spread material uniformly throughout the area with the least possible disruption of the contaminated bottom sediments. Discharging a sand-water slurry at the water surface and allowing sediment particles to fall to the bottom at their individual settling rates appeared to be the most appropriate means to accomplish this goal. Allowable methods of placement included pumping dredged material out of a barge hydraulically or washing it from the deck of a flat-deck barge with a high-pressure water jet.

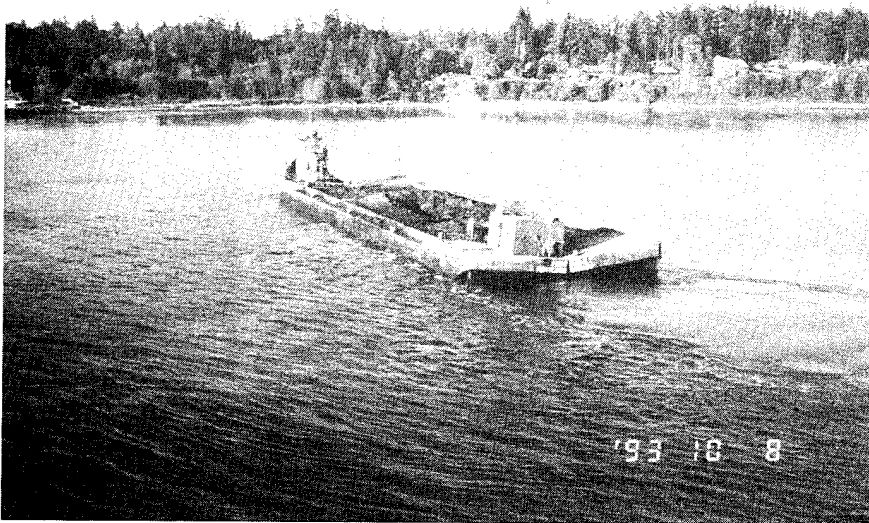
Figure 2. Placement in Area 1 using a bottom-dump barge

After successfully demonstrating that the disposal times of the bottom dump could be extended to as long as 40 minutes at the Port Gardner disposal site, the contractor began placing material in Area 1 (Figure 2). The average load was 1,450 m³, and disposal times varied from 20 to 35 minutes. By shortening the towline length, the tug operator

was able to maneuver within the placement area, even when the area was being shared with a 134-meter-long ferry. Controlling the rate of placement from the bottom-dump barge required constant adjusting of the opening angle. An initial angle of several degrees allowed sand to be dispersed fairly uniformly. As material was eroded from the bottom of the load, the barge opening angle had to be increased to keep

material flowing from the barge. Occasionally, a portion of the load would "hang up" and then rapidly exit the barge in a large mass.

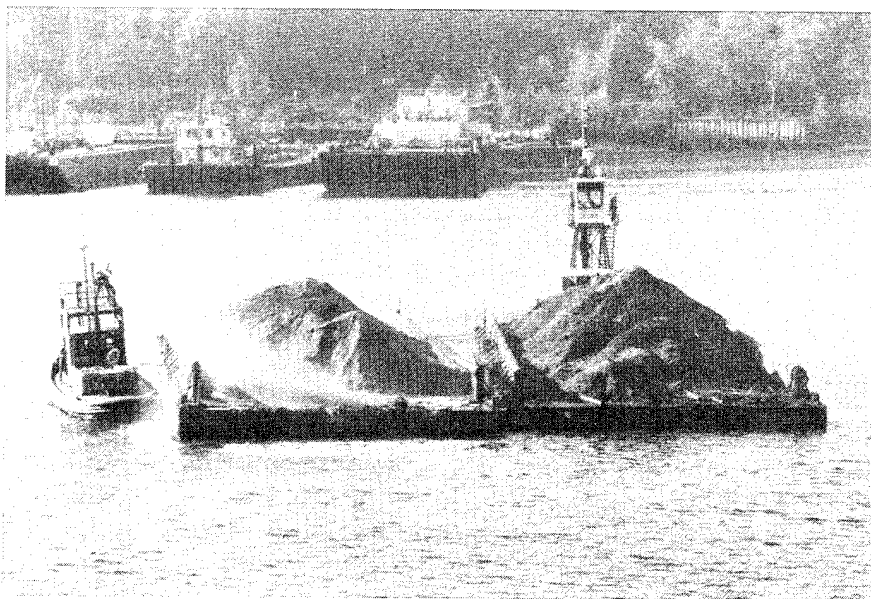
Figure 3. Placement in Area 2 using a high-pressure water jet

In Area 2, the material was washed from the flat-deck barges with a high-pressure water jet. The barges were secured together, and a smaller tug (equipped with a fire monitor) was tied alongside. As material was washed from the barges, a larger tug continuously moved the barge/tug combination to avoid excessive placement at one location. The contractor was able to place about 1,150 m³ (575 m³ per barge) in 5 to 6 hours, for an average placement rate of about 3.5 m³ per minute (Figure 3). The method of placement for Area 2 was intended to disperse dredged material widely and slowly enough to allow a large portion of the sediment to settle through the water column at the individual particle settling rate, rather than in a convective descent. As was expected, short periods of elevated turbidity were measured near the bottom during the placement process, but dissolved oxygen levels remained at or above 5.5 milligrams per liter, well above the EPA's minimum water quality criterion.

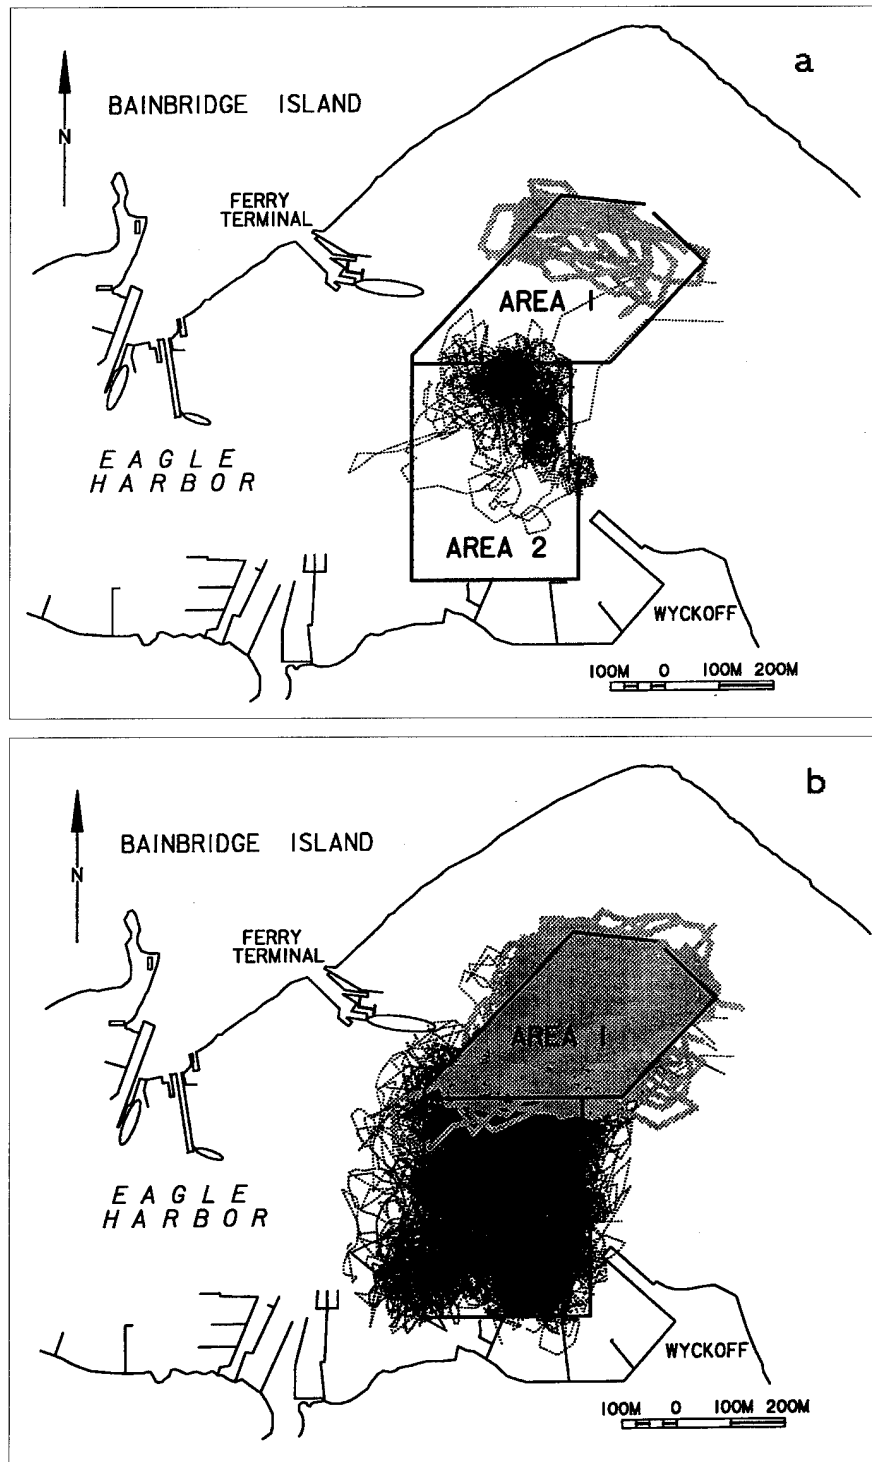
Figure 4. Barge track lines in Eagle Harbor (a) after 1 week of placement and (b) near completion of project

The success of both placement methods was critically dependent on the ability to monitor and to record barge position. The position of the barge was determined using a differential global positioning satellite (GPS) system and displayed to the tug operator, in "real time," on a laptop computer located in the tug wheelhouse. The barge location was updated every 30 seconds, and a circle was plotted on the computer screen. As new locations were added, the tug operator was able to maneuver to

create a uniform coverage of the areas. Every minute, barge positions were recorded onboard the tug and, via radio link, at the District office. By plotting and connecting the positions on the District's computer-aided drafting and design system, barge track lines were created. As the track lines filled in the areas, the density of track lines was used to estimate areas that needed additional material or areas that were to be avoided because they had received excessive material (Figure 4).

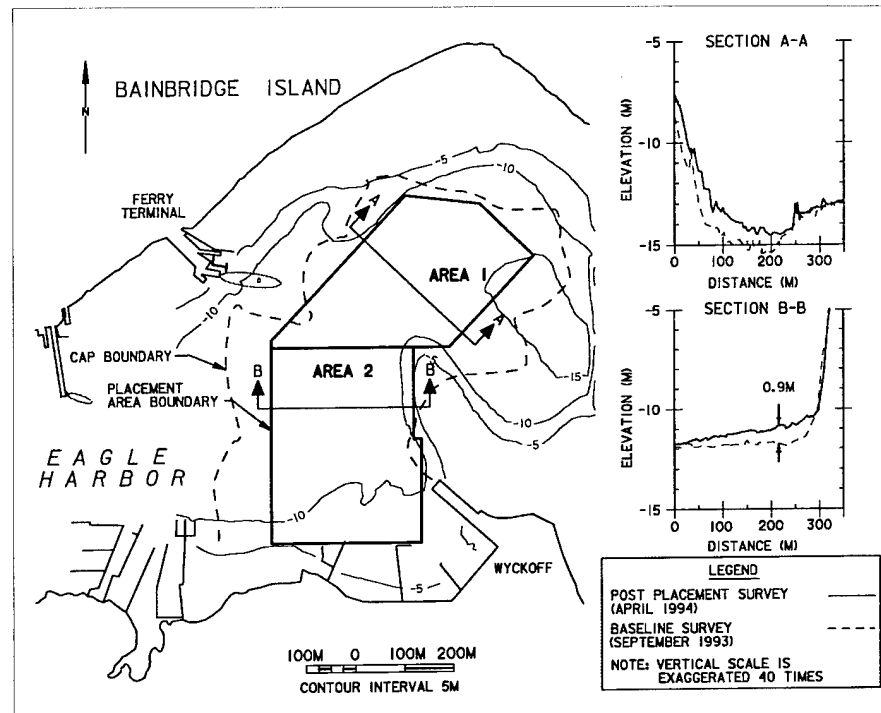
Figure 5. Comparison of pre- and postbathymetric surveys, Eagle Harbor

A comparison of pre- and post-bathymetric and SVPS measurements showed that a 0.3- to 0.9-m layer of dredged material had been placed over essentially all of the area of concern (Figure 5). A detailed description of the monitoring methods and the data that were obtained are presented in the "Statement of Findings" for the project (U.S. Army Engineer District, Seattle 1994).

The first phase of the EPA's remedial action plan for Eagle Harbor appears to have been completed successfully. Postconstruction surveys using the sub-bottom sonar profiler have confirmed that a layer of clean sediment was placed over the target area. The project was completed on schedule and for a cost well below that anticipated in the initial planning phase. In 178 days of construction, essentially all of the suitable dredged material that was available from the Snohomish River was placed over the creosote-contaminated sediments of Eagle Harbor. A total
