Observations of Star Fracture
and Longitudinal Splitting in
BIS 812 EMA and Q1N Submarine
Construction Steels

I.A. Burch and D.S. Saunders

Ship Structures and Materials Division
Aeronautical and Maritime Research Laboratory

DSTO-RR-0014

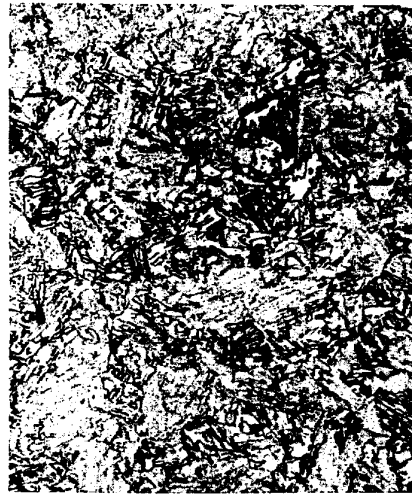
Figure 3. Microstructures of (a) BIS 812 EMA and (b) Q1N steels, optical micrographs of dark etching phases of (c) BIS 812 EMA and (d) Q1N steels. (x250)

The microstructure of Q1N is similar to that of BIS 812 EMA as shown in Figure 3(a) and (b). One characteristic, common to both steels is the presence of dark etching bands on specimens prepared for metallography, Figures 3(c) and (d). The dark etching bands appear primarily at the central region of the plates aligned with the rolling direction. As the distance away from the centre of the plate increases (in the short transverse direction) the banding becomes lighter and diminishes. The banding is more pronounced in the centre of the Q1N plate (in the short transverse direction) but as the distance away from the centre of the plate increases the difference in the darkness of the bands in the two steels is not easily discernable.

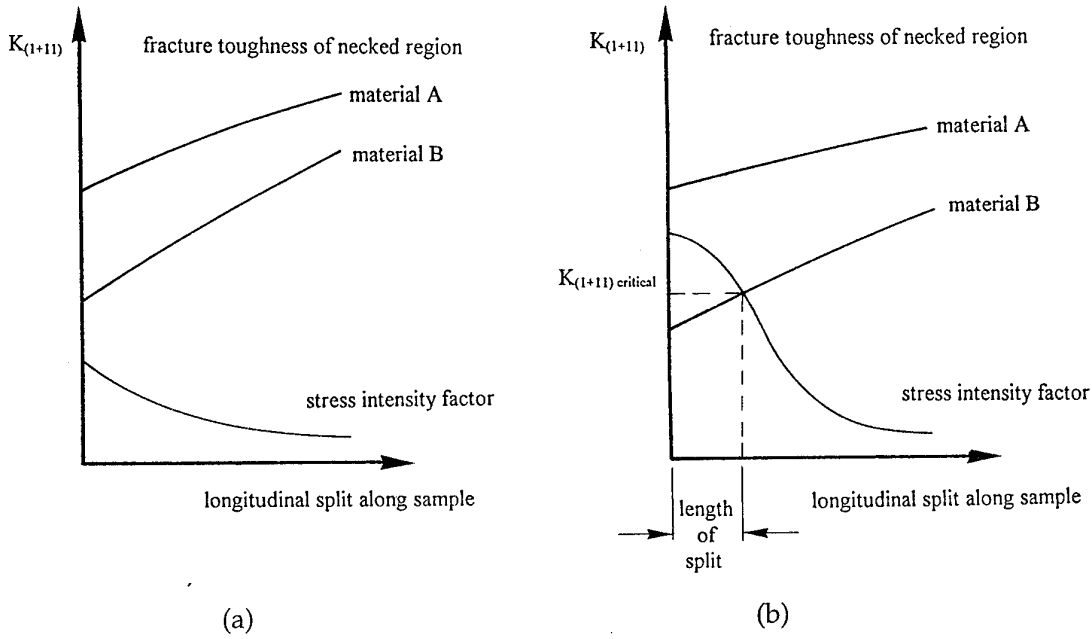
Figure 21. Schematic representation of longitudinal splitting in (a) plain and (b) notched tensile specimens.

It is possible to represent these competing processes schematically, as shown in Figure 21.

The above figure shows the conditions which are necessary for the formation of longitudinal splits in ductile material. The stress intensity factor for an axial split is as yet undetermined, but it is considered that it would be a function of the distance along the neck, l , and related to the three principal stresses within the neck:

Two toughness levels (A and B) are plotted in this diagram and cover material in specimens which are necked and un-necked. Considering the un-necked material first, the mixed mode stress intensity factor at hypothetical longitudinal cracks is extremely small, longitudinal splitting does not occur, even with material of toughness level B. For material which has necked, the toughness of the material in the region of necking is below the stress intensity factor and splitting will occur, the crack growing a distance along the neck until the toughness exceeds the stress intensity factor, this occurs for

material of toughness level B. The fracture toughness planes are shown as dipping within the necked region, this behaviour is believed to occur by rearrangement of the microstructure due to the necking process, as proposed by Zok and Embury [6]. The proposed downward curvature of the fracture toughness surfaces in Figure 21 also explains why specimens with machined notches do not exhibit longitudinal splitting for material of the same mechanical properties. The material does not deform to create a microstructure which is of low toughness, the low toughness state can only be achieved by higher deformation levels or lower temperatures as shown by the present work. Where the geometry of the necked regions are similar, the length of splitting is possibly related to the crack arrest properties of the material.
