# Graphite Fiber Reinforced Thermoplastic Resins

R.C. Novak

United Technologies Research Center  
East Hartford, Ct. 06108

National Aeronautics and Space Administration  
NASA Lewis Research Center  
Contract NAS3-20077

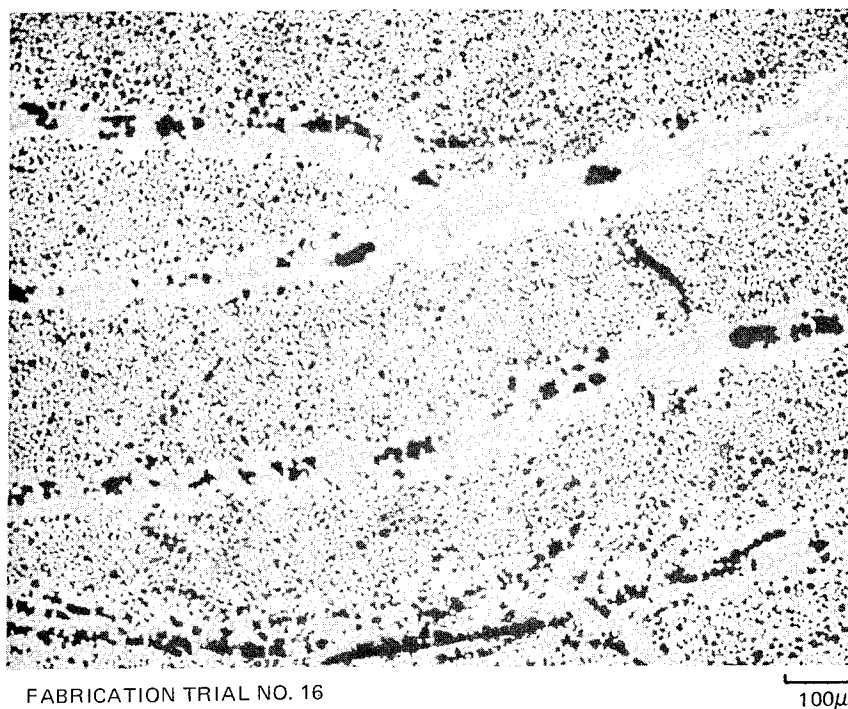
FABRICATION TRIAL NO. 16

HMS/P-1700 POLYSULFONE FROM 7.5% SOLUTION

One path which was explored to reduce this porosity was to use a more dilute solution thereby lowering the viscosity and improving the chances of the resin fully penetrating the bundle. It was demonstrated that the 7.5% resin solutions did not provide sufficient resin in the composite, and at least an 8.7% solution was necessary. The effect of the lower concentration is shown in Fig. 2. It was also shown that the application of greater pressure, as in numbers 19 and 22 where the latter was hot pressed at a pressure five times higher than the former, did not improve the microstructure of the composite as illustrated in Fig. 3.

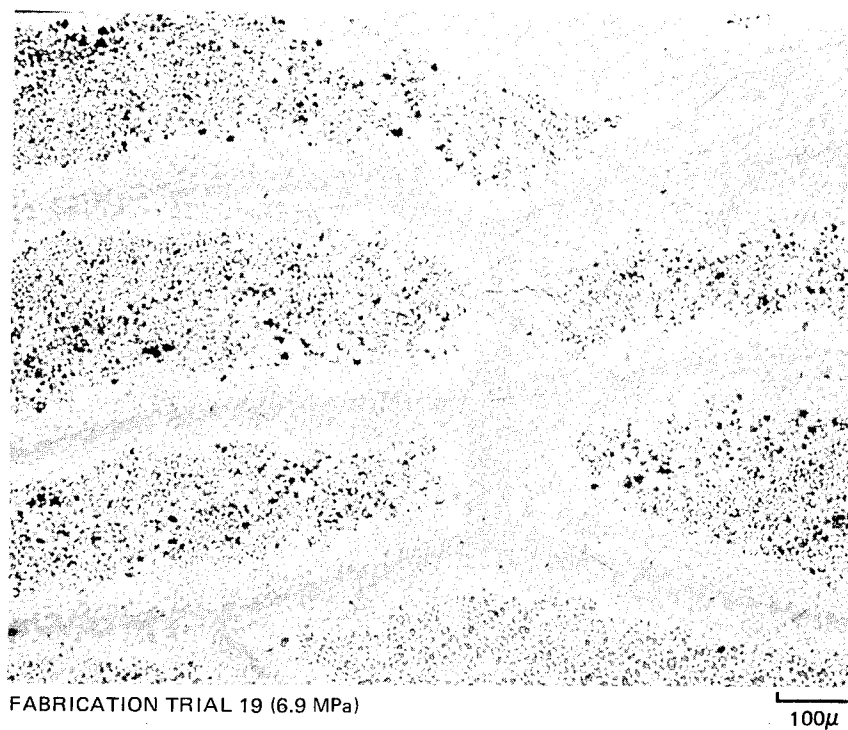
EFFECT OF CONSOLIDATION PRESSURE ON HMS/P-1700 POLYSULFONE

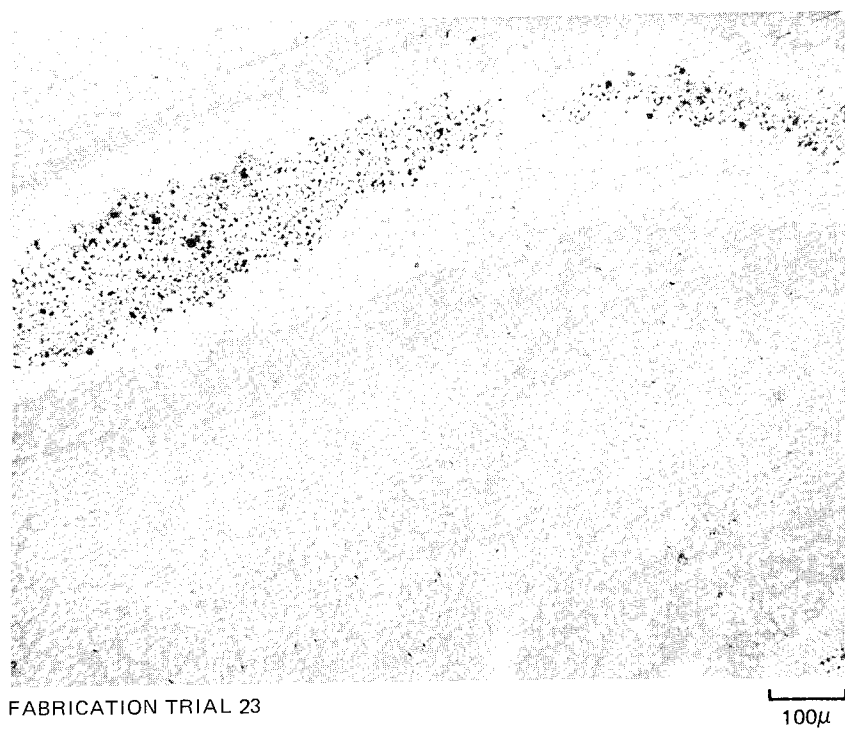
DRYWOUND AND PAINTED HMS/P-1700 POLYSULFONE

Fairly good bundle penetration was obtained with the dry winding and hand painting technique employed in composites 21 and 23 as shown in Fig. 4. This possibly resulted from applying the resin to the tow while it was spread out on the drum and/or the penetration/separation which resulted from the brushing operation. This technique is much more time consuming than the wet winding process and does not lend itself to larger scale operations. Consequently, it was felt to be desirable to achieve better infiltration with the wet winding process.

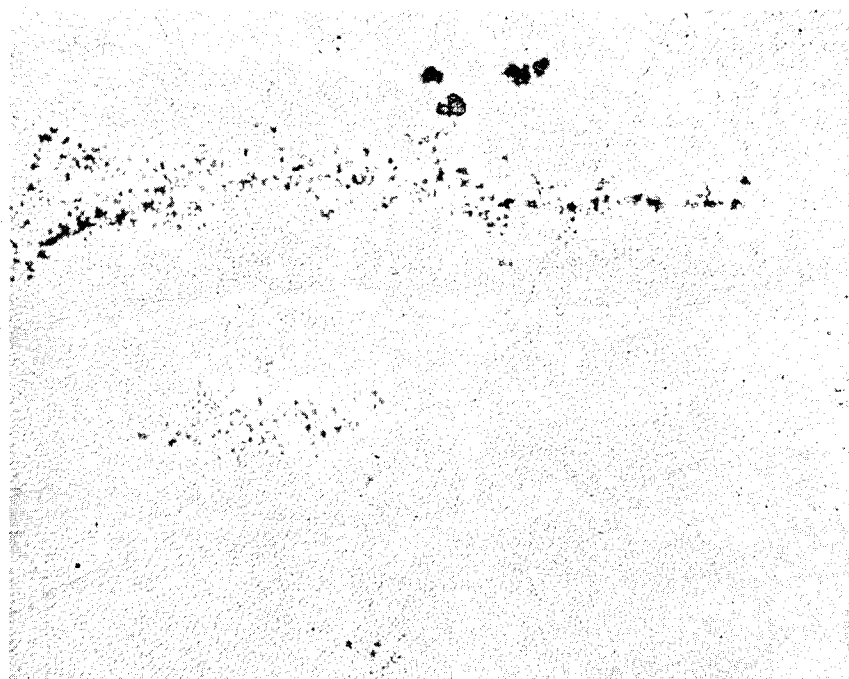
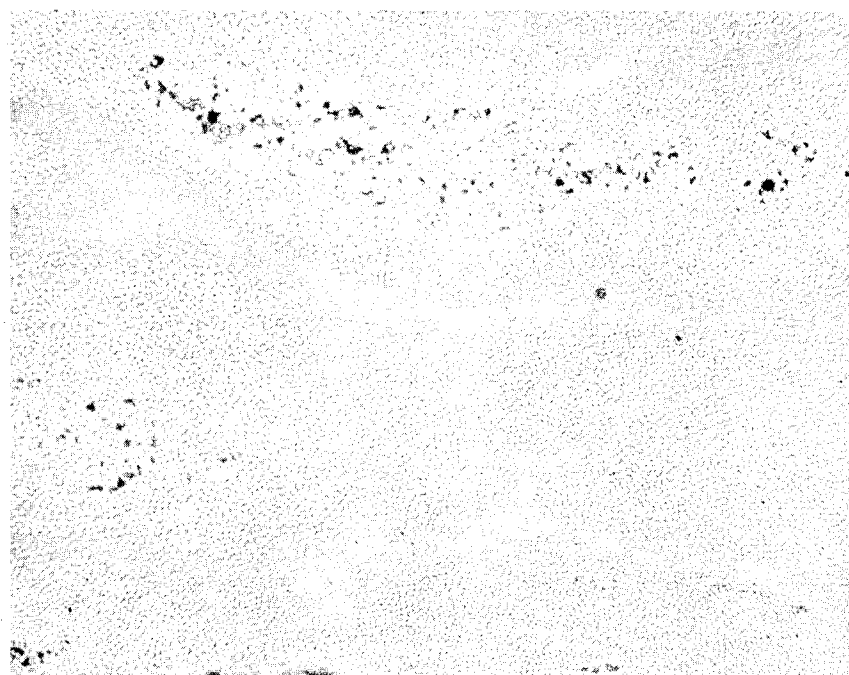
EFFECT OF IMPROVED TAPE DRYING ON HMS/P-1700 POLYSULFONE

FABRICATION TRIAL 32

FABRICATION TRIAL 34

The series of composites beginning with number 29 and running through 38 was primarily intended to explore the possibility that the porosity was due to entrapped solvent which was not fully removed from the impregnated tape prior to hot pressing. This had encouraging results in that several of the composites had lower porosity than earlier ones. In particular, specimens 32 and 34 shown in Fig. 5 had the best microstructures of any of the polysulfone matrix composites examined to that date. Both exhibited areas which were void free but also had some bundles with internal porosity.

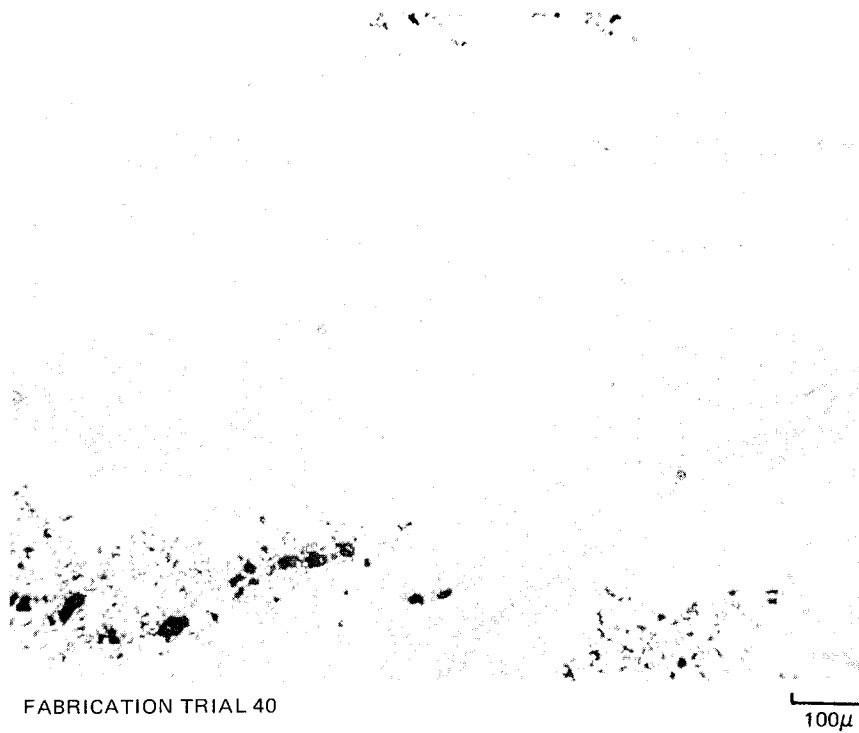
EFFECT OF TWO DRIVE SYSTEM ON HMS/P-1700 POLYSULFONE

A modification of the tape making process was initiated with composite 39. In order to reduce the tension in the yarn during the impregnation process and thereby improve the degree of infiltration, a driven roller was placed in line just before the impregnation bath. The speed of the roller was adjusted to produce nearly the same circumferential velocity as the take-up drum which resulted in very low yarn tension between the two. The rollers were covered with soft foam rubber to produce the necessary friction to drive the fiber bundle without abrading it.

Microscopic examination of the composites indicated that the two drive system tended to make the microstructures more uniform than in the past and that the overall porosity levels were somewhat reduced. However, it was found that composites which were hot pressed for short time periods (2-5 min) still possessed some porosity as in Fig. 6 which shows the specimen from trial 40. Longer duration hot pressing cycles were evaluated (nos. 43 and 44) and in both instances void content was substantially reduced. Microscopic observation revealed sporadic porosity in the bundle centers of the composite pressed for 30 min, and no porosity in the composite pressed for 60 min. Apparently the longer period allowed sufficient time for the resin to flow internally and fill the voids within the bundles. Figure 7 shows the microstructures of the two composites.

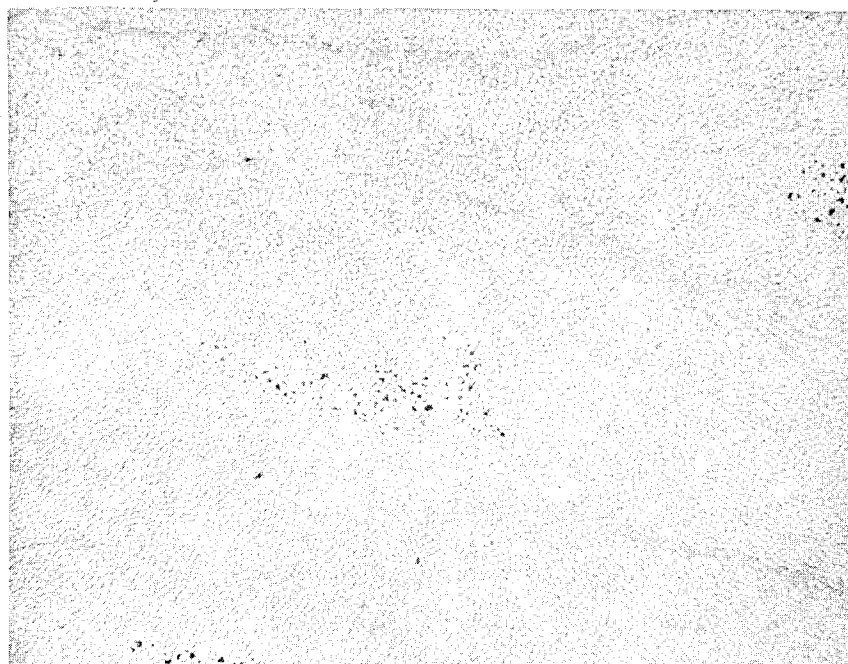
FABRICATION TRIAL 20

**OPTIMIZED HMS/300 P POLYETHERSULFONE COMPOSITE**

The final optimization came about by utilizing the driven roller prior to impregnation (no. 14), increasing the resin content in the impregnating solution to 12.5% (no. 16), and by hot pressing for 60 minutes. This resulted in a nearly void-free microstructure as shown in Fig. 11 which is a photomicrograph of composite 20. Although some porosity is evident in the bundle centers in Fig. 11, much of the composite was totally free of voids.
