NASA Technical Paper 1584

Lubrication and Wear Mechanisms of Polyimide-Bonded Graphite Fluoride Films Subjected to Low Contact Stress

Robert L. Fusaro

JANUARY 1980

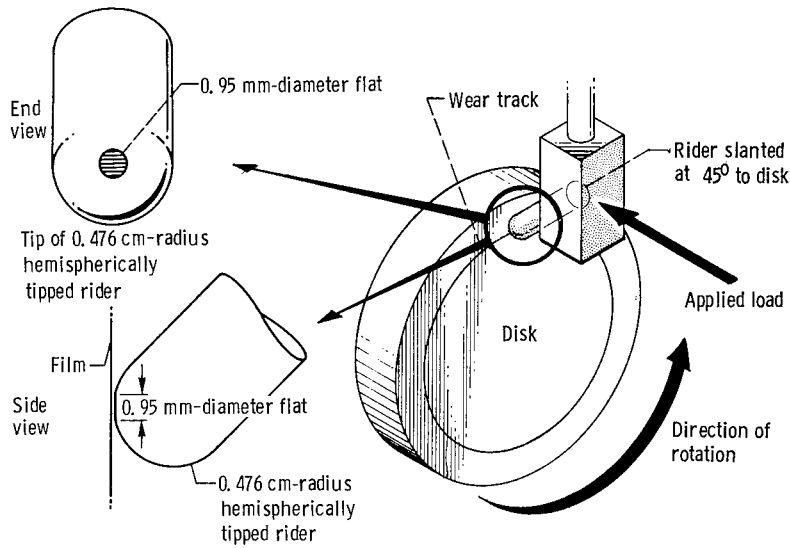
Figure 1. - Schematic arrangement of friction specimens.

A conventional pin-on-disk friction and wear apparatus was used in this study (fig. 1), except that before the experiments, a 0.95-millimeter-diameter flat was worn on the 0.476-centimeter-radius hemispherically tipped rider (pin) by sliding it against a graphite fluoride film rubbed on a sandblasted disk. The rider was not removed from the holder during cleaning, and it and the disk (with applied polyimide-bonded graphite fluoride film) were positioned (and indexed) in the apparatus by using a linear variable differential transformer (LVDT) so that a flat-on-flat configuration was produced with minimal misalignment.

A 1-kilogram load applied to the flat on the rider gave a projected contact stress of 14 megapascals (2000 psi) against the film. The disk was 6.3 centimeters in diameter, and the rider slid on the disk at a radius of 2.5 centimeters. The disk was rotated at 1000 rpm, for a linear sliding speed of 2.6 meters per second. The friction specimens were enclosed in a chamber so that the atmosphere could be controlled. The controlled air atmosphere of 10 000 ppm H₂O (~50 percent relative humidity) was achieved by mixing dry air with dry air bubbled through water. These experimental conditions, except for the projected contact stress, were the same as those used in reference 6.

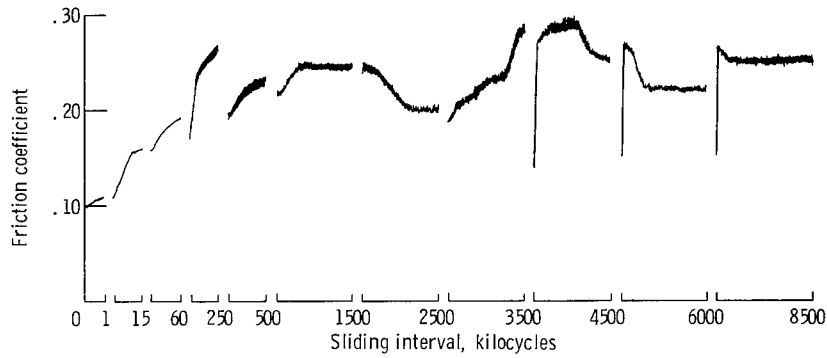
Figure 2. - Friction trace for 440C HT stainless-steel rider (with 0.95-mm-diam flat) sliding on polyimide-bonded graphite fluoride film. Load, 1 kilogram; speed, 2.6 meters per second; test temperature, 25° C; test atmosphere, moist air (10 000 ppm H₂O).

A friction trace for a 0.95-millimeter-diameter flat sliding against a polyimide-bonded graphite fluoride film is shown in figure 2. The friction trace is shown discontinuously because the tests were stopped at the indicated intervals to make wear measurements and to observe the sliding surfaces with an optical microscope. As had been found for the hemispherically tipped rider sliding on the same film (ref. 6), the friction coefficient started at a low value of 0.08 to 0.09, then rose gradually with sliding distance, and eventually leveled off at 0.24 ± 0.02 . This was slightly higher than the friction coefficient found in reference 6 (0.20 ± 0.02).

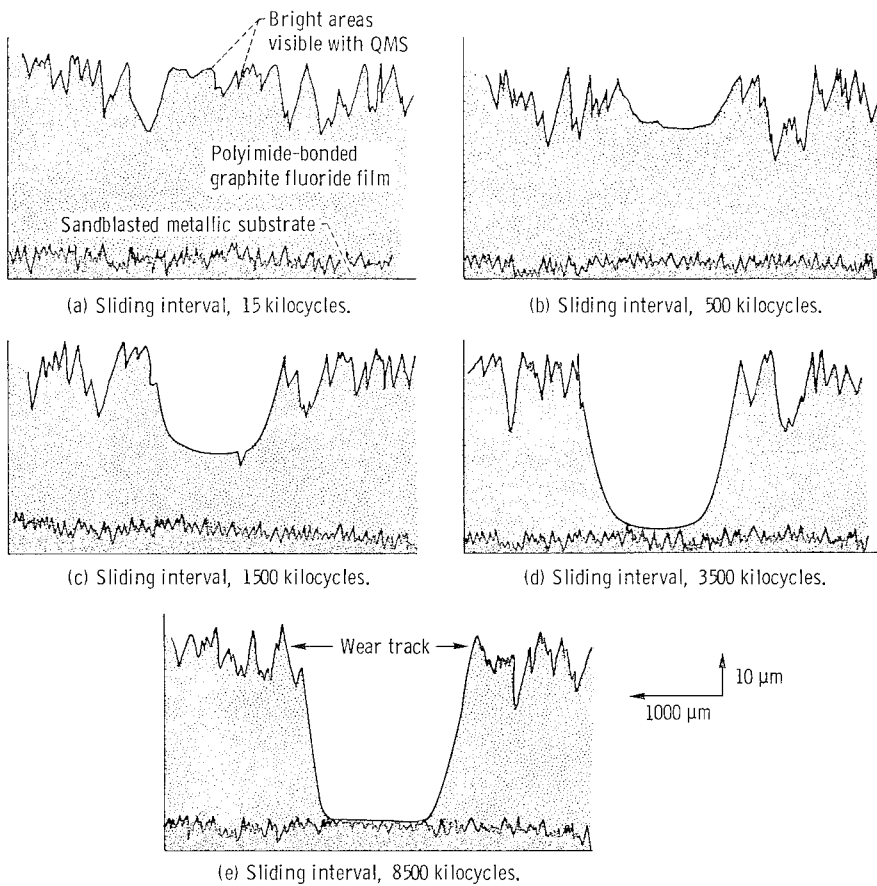
Figure 3. - Surface profiles taken after various sliding intervals for 0.95-mm-diameter flat sliding on polyimide-bonded graphite fluoride film. Rider and disk substrate, 440C HT stainless steel; load, 1 kg; estimated contact stress, 14 MPa (2000 psi); sliding speed, 2.6 m/sec; temperature, 25^o C; atmosphere, moist air (10 000 ppm H₂O).

Film wear was studied by taking surface profiles of the film wear track after each sliding interval. Figure 3 gives typical surface profiles after sliding intervals of 15, 500, 1500, 3500, and 8500 kilocycles. Because the vertical magnification of the surface profiles is about 50 times the horizontal magnification, the view of the surface is distorted.

The surface profiles indicate that the wear process was one of gradual wear through the film. It took approximately 3500 kilocycles for the rider to wear through the 45-micrometer-thick film and make contact with the sandblasted metallic substrate. Once the metallic substrate was reached, there was a gradual increase in wear track width.

After 500 kilocycles of sliding, the film asperities were worn away (fig. 3). As figure 3 shows, the rider continued to wear gradually through the film until the metallic asperities on the substrate were reached at approximately 3500 kilocycles of sliding. Figure 8(a) shows the film wear track after 1500 kilocycles of sliding, and figure 8(b) shows the film wear track after 3500 kilocycles of sliding. Very tiny bright spots can be seen in the film after 3500 kilocycles of sliding. These are the tips of the metallic asperities on the substrate.

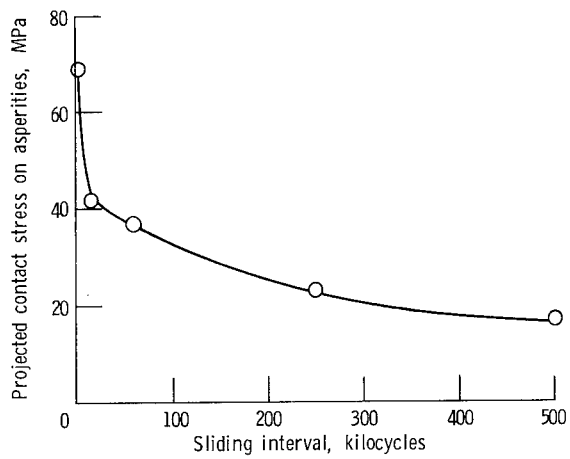
Figure 6. - Projected contact stress on asperities of polyimide-bonded graphite fluoride films as function of sliding interval. Rider and disk substrate material, 440C HT stainless steel; load, 1 kg on 0.95-mm-diameter flat on rider; sliding speed, 2.6 m/sec; temperature, 25° C; atmosphere, moist air (10 000 ppm H₂O).

To quantify the contact stresses involved, we observed the wear track by using QMS. Table I shows how the estimated area of contact increased (in percent) as a function of sliding duration and the corresponding calculated stress. Figure 6 gives the estimated contact stress on the film asperities as a function of sliding duration. The stress was calculated by assuming that all bright areas were contacting the rider flat at any particular interval. However, this may not have been the case, and these values of contact stress may be low. Nevertheless, the data give an estimate of the contact stresses involved.

Assuming full contact on the film asperity tips, the rider contact after 1 kilocycle of sliding was estimated to be approximately 20 percent of full contact. Thus, the contact stress supported by the film asperities was at least 69 megapascals (10 000 psi). Because of film asperity wear, the contact stress dropped very rapidly during the first 15 kilocycles of sliding (fig. 6), to 42 megapascals (6100 psi). After 15 kilocycles of sliding the wear rate also decreased, and it took approximately 500 kilocycles of sliding to reach a steady-state value of approximately 17 megapascals (2500 psi). This represents a contact area of approximately 80 percent of full contact. Because of the mechanisms by which the film wore, full contact never occurred.

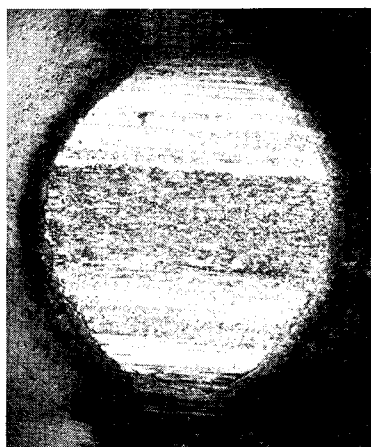
(a) Flat before sliding.

(b) Flat after 1 kilocycle of sliding.

(c) Flat after 250 kilocycles of sliding.

(d) Flat after 1500 kilocycles of sliding.

(e) Flat after 4500 kilocycles of sliding.

(f) Flat after 8500 kilocycles of sliding.

Figure 12. - Photomicrographs of 440C HT stainless-steel rider contact area after various intervals of sliding on polyimide-bonded graphite fluoride films. Disk substrate material, 440C HT stainless steel; load, 1 kg; estimated contact stress, 14 MPa (2000 psi); sliding speed, 2.6 m/sec; temperature, 25°C; atmosphere, moist air (10 000 ppm H₂O).

Thin transfer films were found on the rider after 6000 and 8500 kilocycles of sliding (figs. 12(f) and 13(d)); however, they looked somewhat different than the thin transfer films found after 1 kilocycle of sliding (figs. 12(b) and 13(a)). Interference fringes were only visible in the entrance of the rider contact area (fig. 13(d)); and the transfer in the contact area itself was milky colored, an indication that the transfer was thinner than the wavelength of light ($0.4 \mu\text{m}$).
