Technical Report ITL-95-4  
June 1995

# Parametric Evaluation of Construction and Analysis Procedures Using Nonlinear, Incremental Structural Analysis

by Barry D. Fehl, WES  
Kevin Z. Truman, Gary Warmka, Washington University

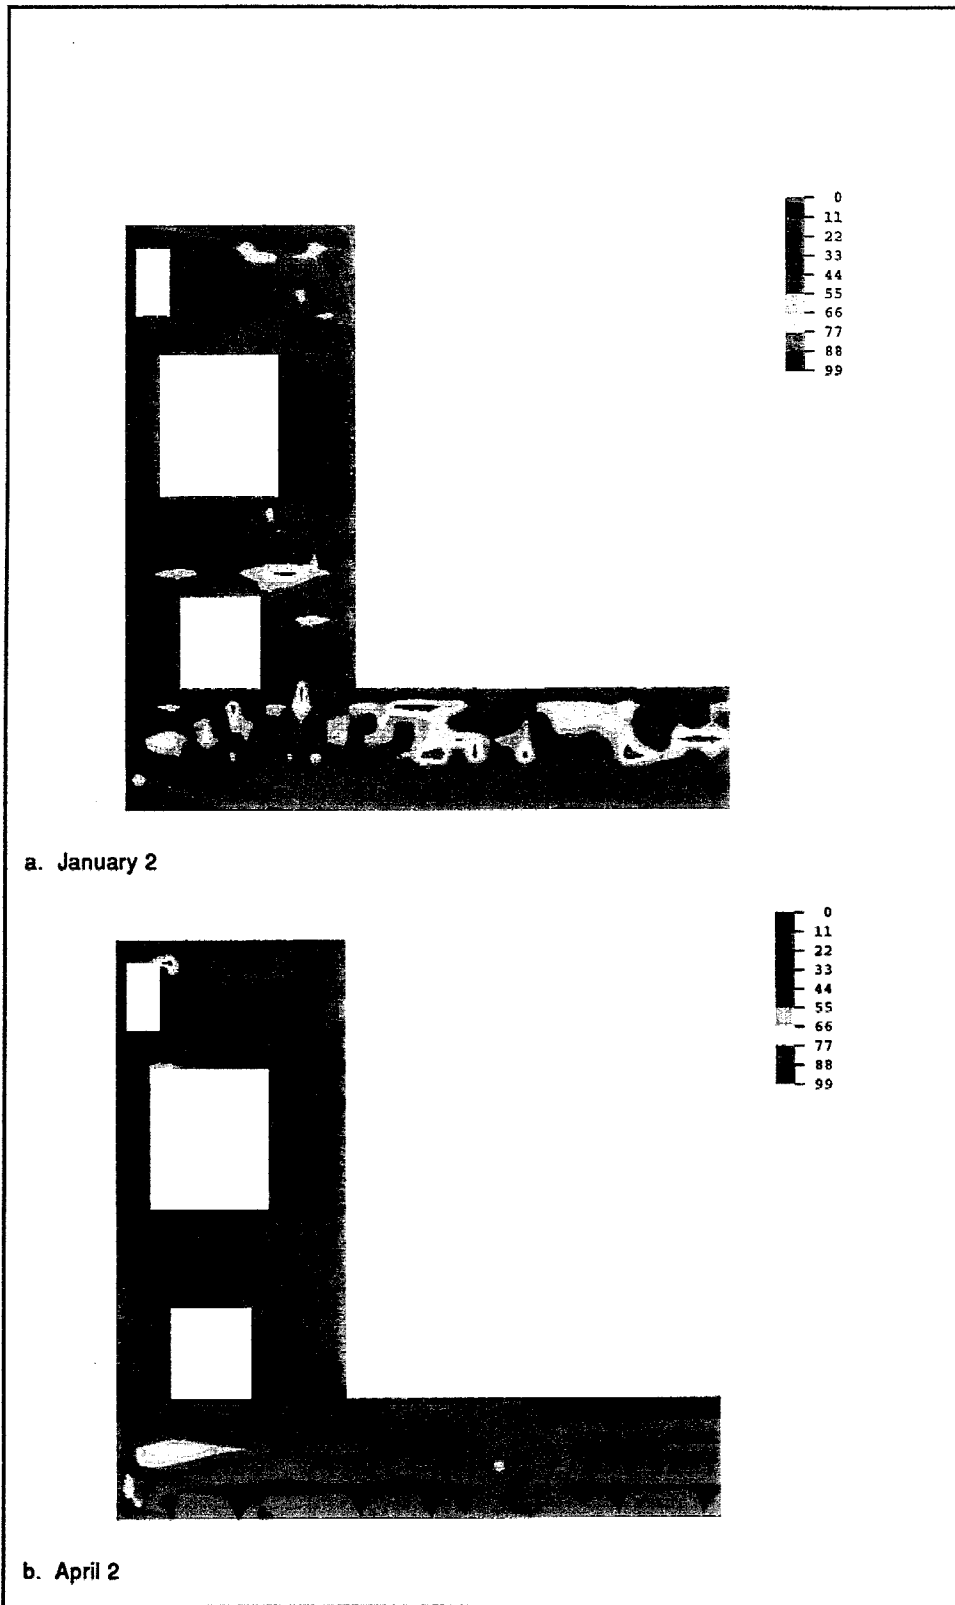
Figure 35. Crack potential contours for 725 days after start of construction (step = 241, amp = 725) (Continued)

Figures 34 and 35 show the crack potential contours for 545 and 725 days. Note that these figures show results similar to the 185- and 365-day contours. The January start of construction provides the highest potential for cracking for the 545-day contours with several critical regions. All four start dates have crack potential above 80 percent at the end of 2 years, with the gallery corners and the bottom exterior corner of the slab being critical regions.
